# Condition Assessment & Treatment Recommendation

**Breakfast Room Mural**  
Coe Hall, Planting Fields Arboretum SHP  
Oyster Bay, New York

Erin Moroney & Mary Betlejeski  
Division for Historic Preservation  
New York State Office of Parks, Recreation & Historic Preservation  
March 2012

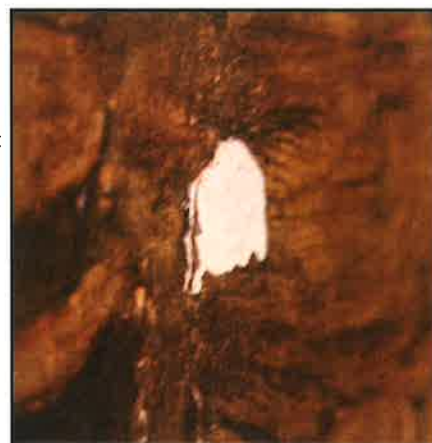
Breakfast Room 2012. Detail of detachment. Gesso layer has detached from plaster.

Areas of detachment should be consolidated to prevent additional loss of the painted and gilded surface. It will be necessary to inject or saturate select areas with consolidant. Research revealed that Paraloid B-72 is the most effective consolidant for the mural. Fills will be required to restore the original surface texture of the mural. Finally, areas of loss will be in-painted. Again, it is important to remember that this conservation treatment will not solve all of the inherent problems with the Breakfast Room mural. It will however reduce the loss of historic fabric and improve the condition and appearance of the mural. Cleaning the painted surface in the form of grime removal will proceed as safety permits.

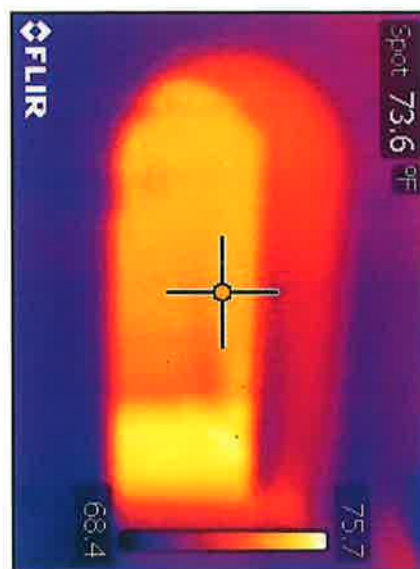
North Elevation—East Door.  
Infrared image of the opening.  
Warmer temperatures (with higher humidity)  
are indicated with orange and cooler  
temperatures are indicated in blue.

- The HVAC system should be inspected to determine if it is operating according to designed parameters.
- The interior doors to the Breakfast Room should remain closed at all times to allow the environment to remain as stable as possible.
- The custom blackout curtains should be drawn when Coe Hall is closed to the public.
- Environmental conditions in the Breakfast Room should continue to be monitored (data loggers) and the data analyzed on a regular basis—at least twice a year.
- The protective Plexiglas panels should be re-installed at the public entrance to the room to protect the mural from abrasion.
- Visitor seating in the room should be located away from the walls to prevent contact with the mural. We recommend limiting visitor seating to the west wall, directly in front of the large windows/doors.

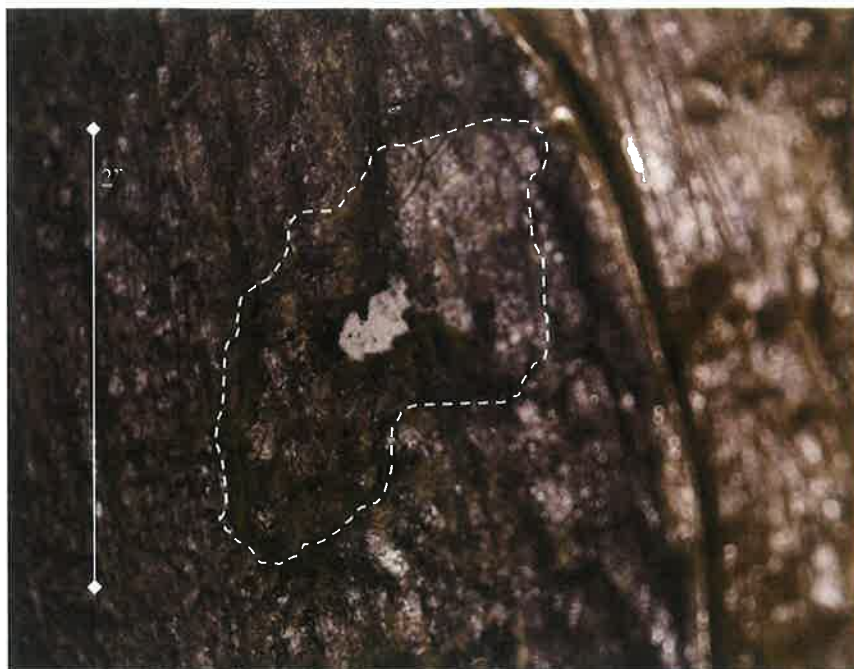
North Elevation—Approximate Grid Location: 16  
Typical condition: note highlighted large pocket of highly unstable detached paint and gesso around a section of loss. The outlined area has detached from the plaster.

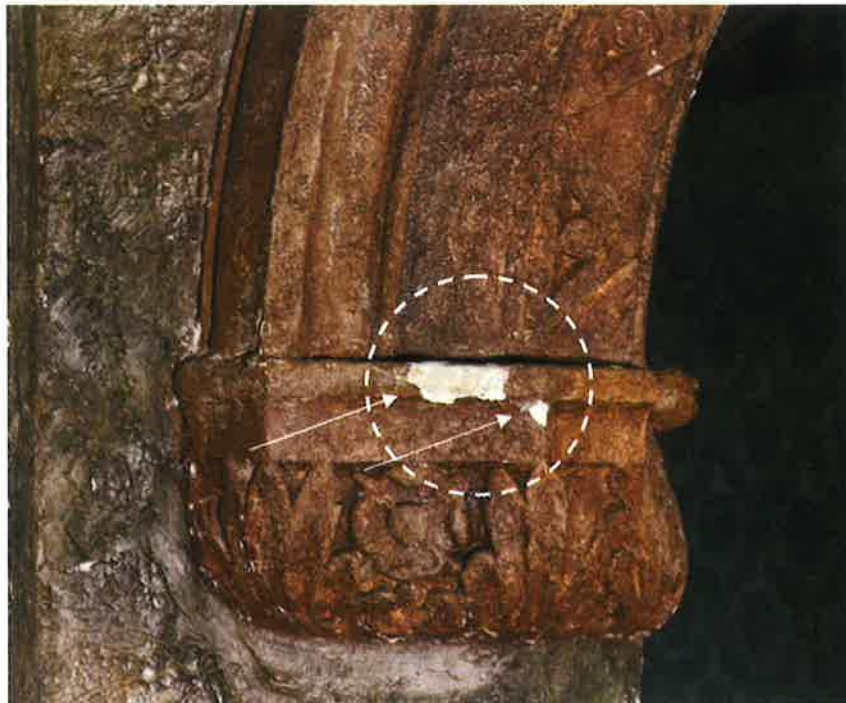
North Elevation—Approximate Grid Location #20  
Losses around the northwest archway. Relatively large losses of delicate areas caused by physical contact.

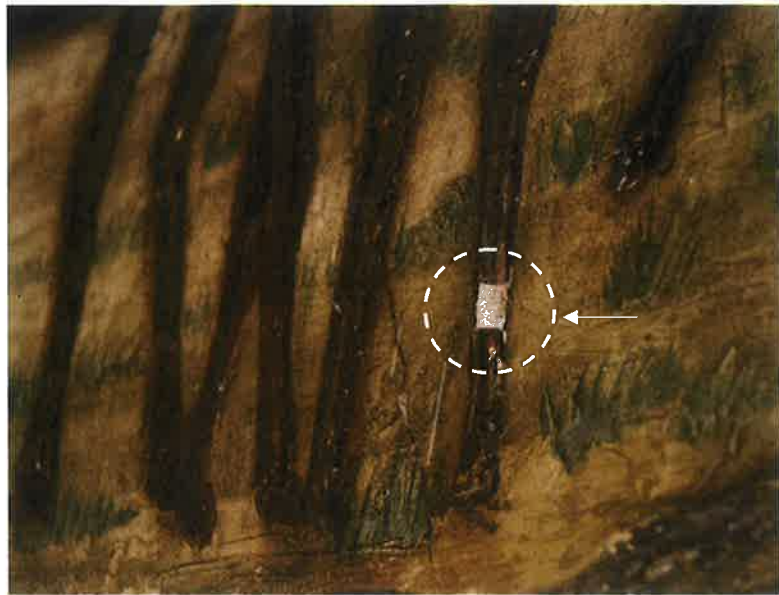
East Elevation  
Approximate Grid Location #72

Note: Loss of significant area of  
gesso, paint and gilding on doe's leg.  
Damage has occurred  
since the 2007 survey.

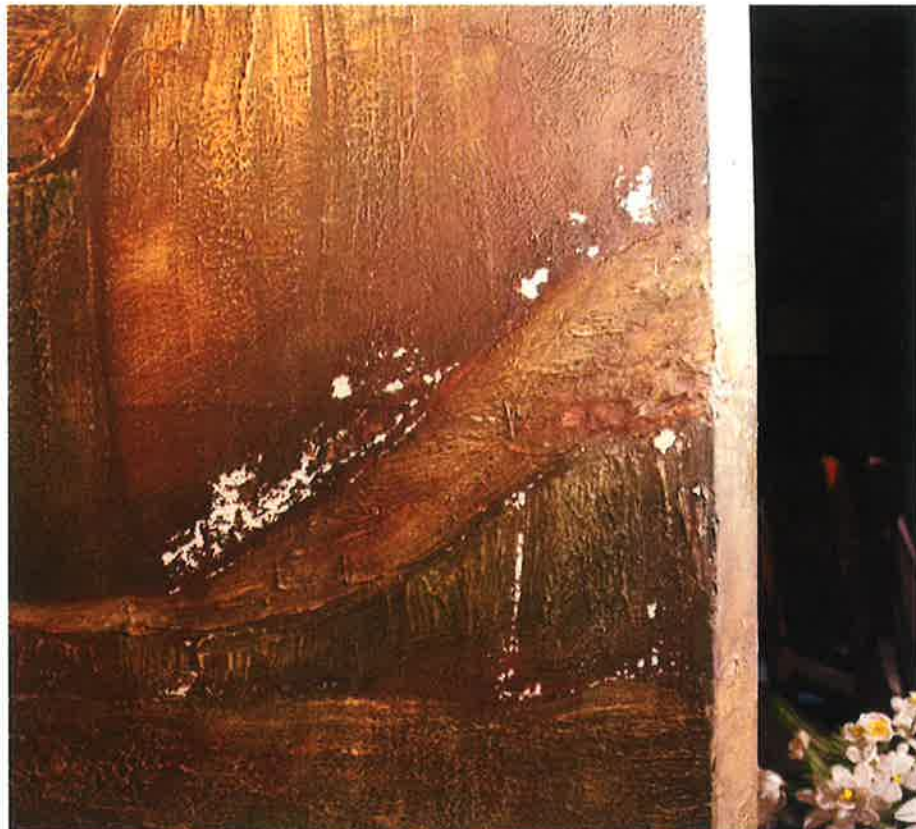
North Elevation—  
Archway—Public Entrance

- The Plexiglas panels that served to protect the mural at the public entrance/exit to the breakfast room have been removed. The progression of the deterioration is more severe at the at this location. It is very possible that without the Plexiglas protection visitors have inadvertently caused damage by brushing up against the unstable surface.

Note significant area of paint loss  
since 2007.  
Plexiglas protection panel was  
removed from this location.

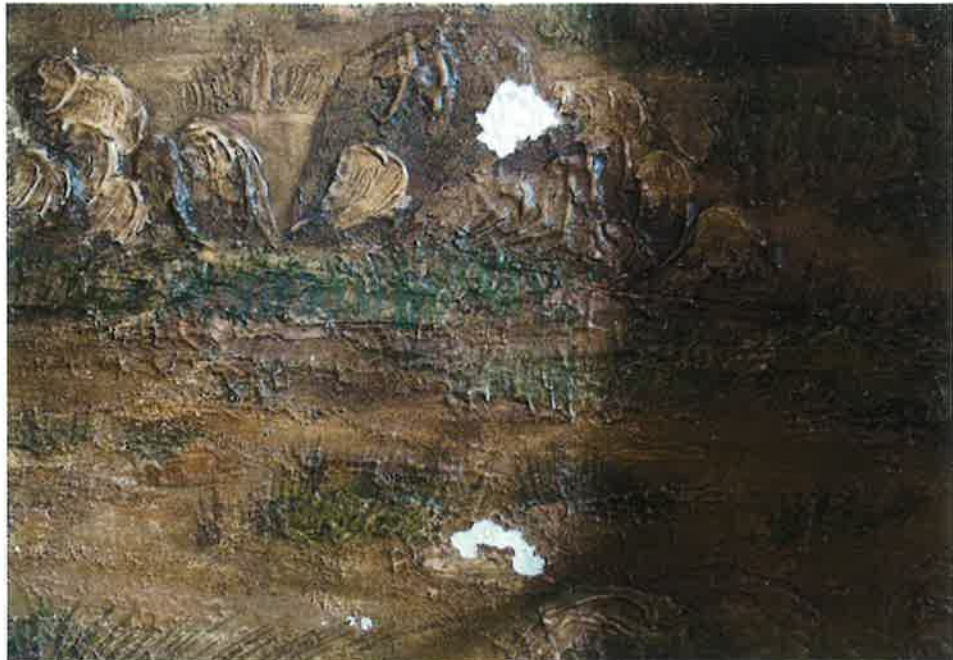
East Elevation  
Approximate Grid Location #15  
Large areas of recent loss that  
have expanded since 2007
