Brussat Sculpture Conservation, LLC

Examination and Treatment Report

Carrier Productions, LLC/Planting Fields Foundation

Case Clock

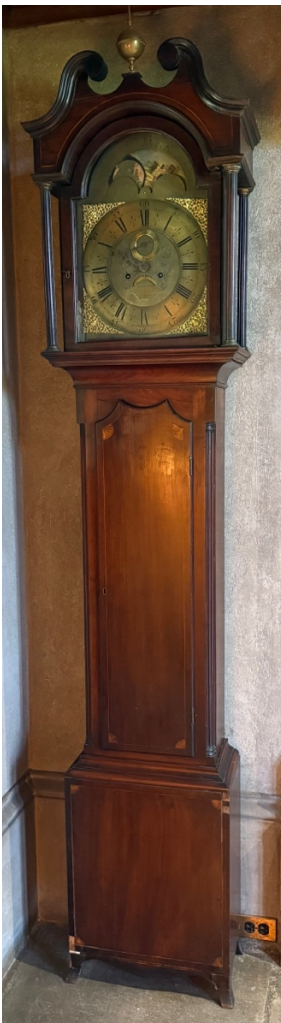
1. Before Treatment, overall

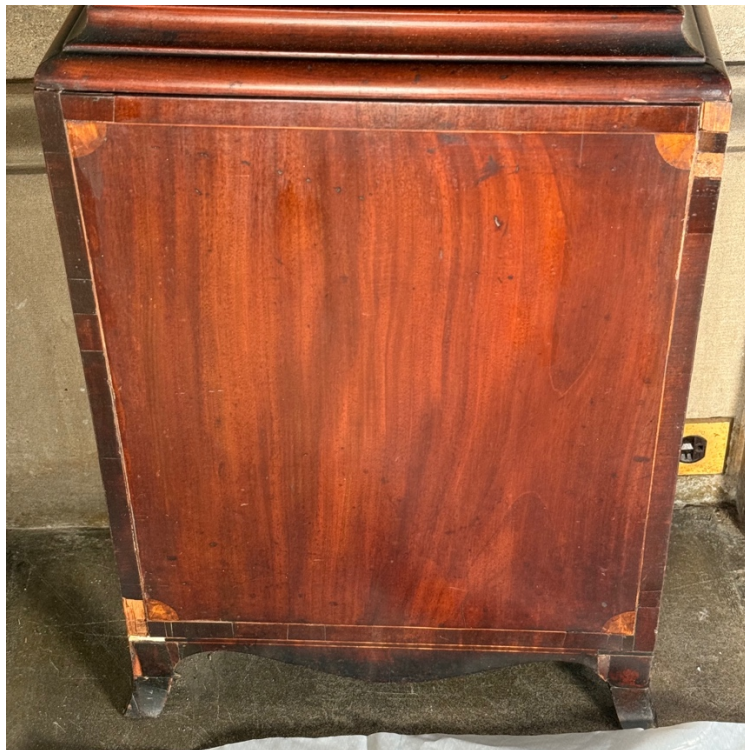
The clock was damaged during a film shoot and has three areas of missing veneer. On the top right of the base, a 3/4" square piece of veneer was saved. Another similar sized piece of veneer just below it is missing and was not recovered. At the bottom left, a 1 1/2" x 3/4" piece of veneer is missing, along with a thin piece of the corner just below this area.

2. Before Treatment, detail of losses

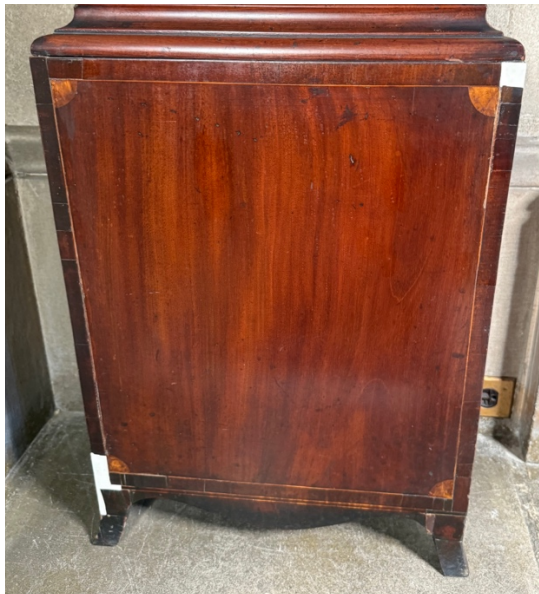
3. During treatment, missing veneer replaced and losses filled

1. The case clock was dusted and vacuumed with a soft brush and a variable speed vacuum.
1. The surviving piece of veneer was adhered.
 - a. The old adhesive was removed mechanically and with water.
 - b. The break edges were sealed with dilute Kremer high tack fish glue.
 - c. The broken fragment was adhered with Kremer high tack fish glue.
2. The break edges of the remaining losses were sealed with dilute B72, an acrylic conservation adhesive.
3. The losses were filled with WoodEpoxy epoxy putty, chosen for its strength, because the losses are in vulnerable locations. The WoodEpoxy was allowed to cure, then carved and sanded to the correct size.
4. The fills were sealed with Kremer shellac, then inpainted with Gamblin Conservation Colors mixed with shellac, and coated with shellac to match the gloss of the surrounding wood.

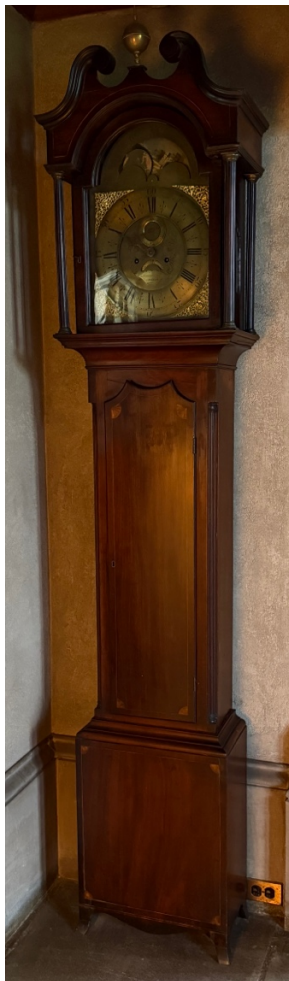
5. After treatment, overall

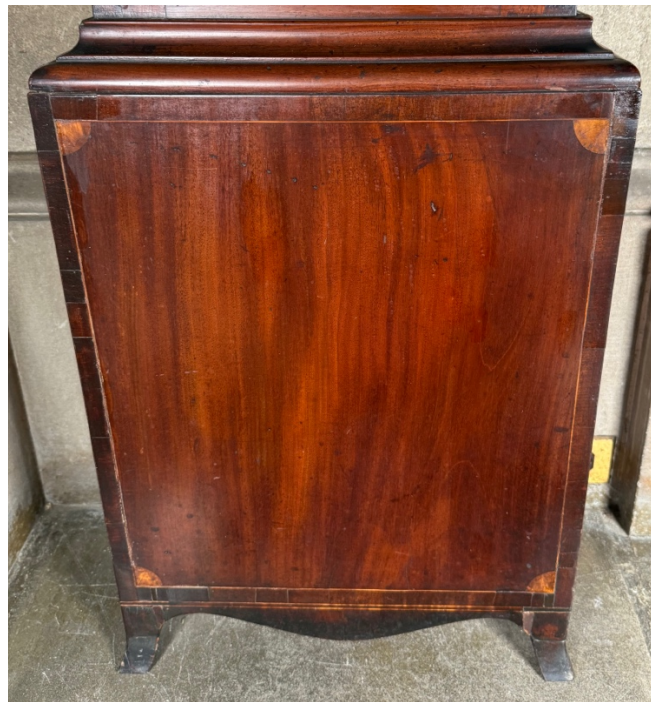
6. After Treatment, detail

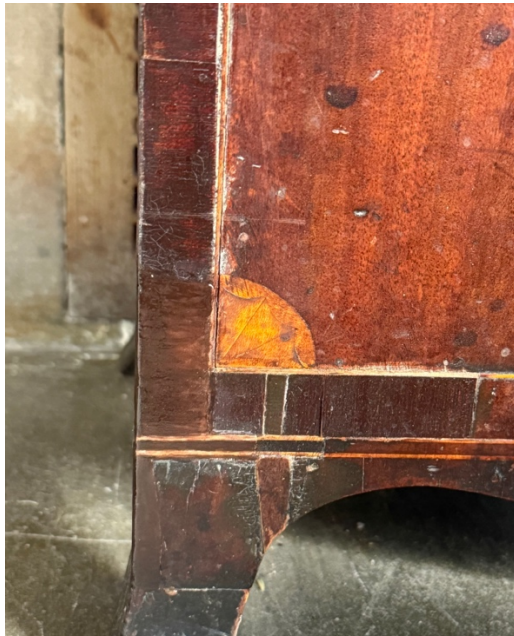
5. After Treatment, detail

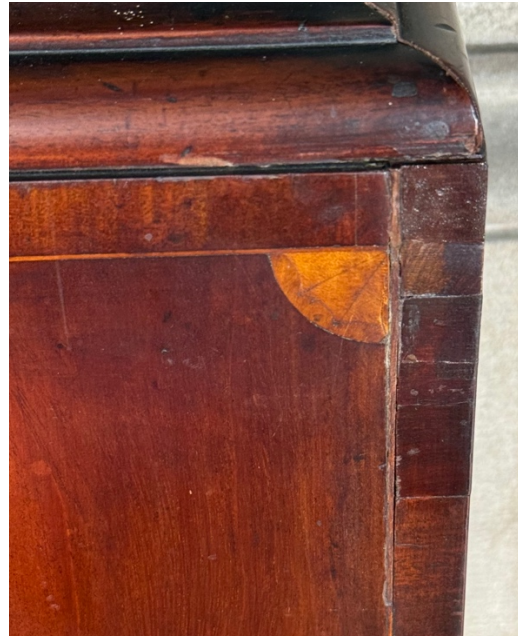
6. After Treatment, detail
