OFFICE OF HISTORIC PRESERVATION  
INDIVIDUAL STRUCTURE SURVEY FORM

HISTORIC NAME: Engine Co. #3  
LOCATION: 201 Jefferson St.

MUNICIPALITY: Hoboken  
USGS QUAD:

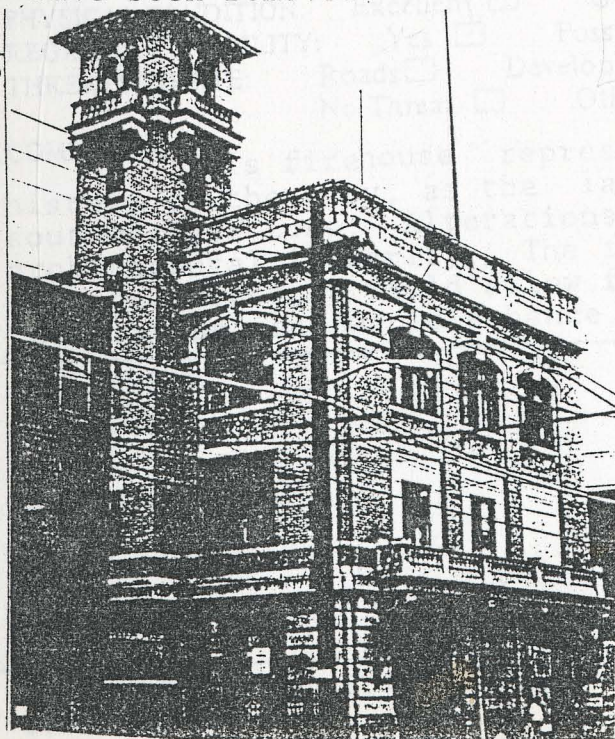
Additional Architectural Description: Rusticated limestone basement with segmentally-arched engine door apertures. A limestone balcony with stone balustrade runs the width of the principal facades, and is supported by pronounced stone brackets. Limestone coping and bands courses accentuate the roofline. Decorative brick medallions are set into the spandrel panels between the second and third floors. The fire tower has a terra cotta roof, and is suggestive of a bellvedere with its balustraded balcony and modillion cornice. The building has sustained several major changes in the recent past; among them are: window apertures of the second floor have been bricked in to create smaller openings; the balustrade and entire cornice of the building have been removed.

ORIGINAL USE: firehouse  
 PHYSICAL CONDITION: Excellent ☐ Good ☒ Fair ☐ Poor ☐  
 REGISTER ELIGIBILITY: Yes ☒ Possible ☐ No ☐ Part of District ☒  
 THREATS TO SITE: Roads ☐ Development ☐ Zoning ☐ Deterioration ☐  
 No Threat ☐ Other ☒ insensitive alterations

COMMENTS. This firehouse represents an important link to the fire-fighting history of the city, as the last of the grand firehouses to serve the southwestern zone. Alterations have severely compromised its architectural integrity. The finding of National Register eligibility for the structure would allow for the possibility of its future restoration, and would enhance the proposed Thematic Nomination of Hoboken's firehouses.
