REPORT ON ACCIDENT TO  
AVRO ARROW 1 - 25201  
PART 2

June 11, 1958

71/ENG PUB/10

This Report is in two parts. Part 1 contains details of the accident and the investigation into the cause. Part 2 contains details of damage to the aircraft resulting from the accident, and details of the necessary repairs.

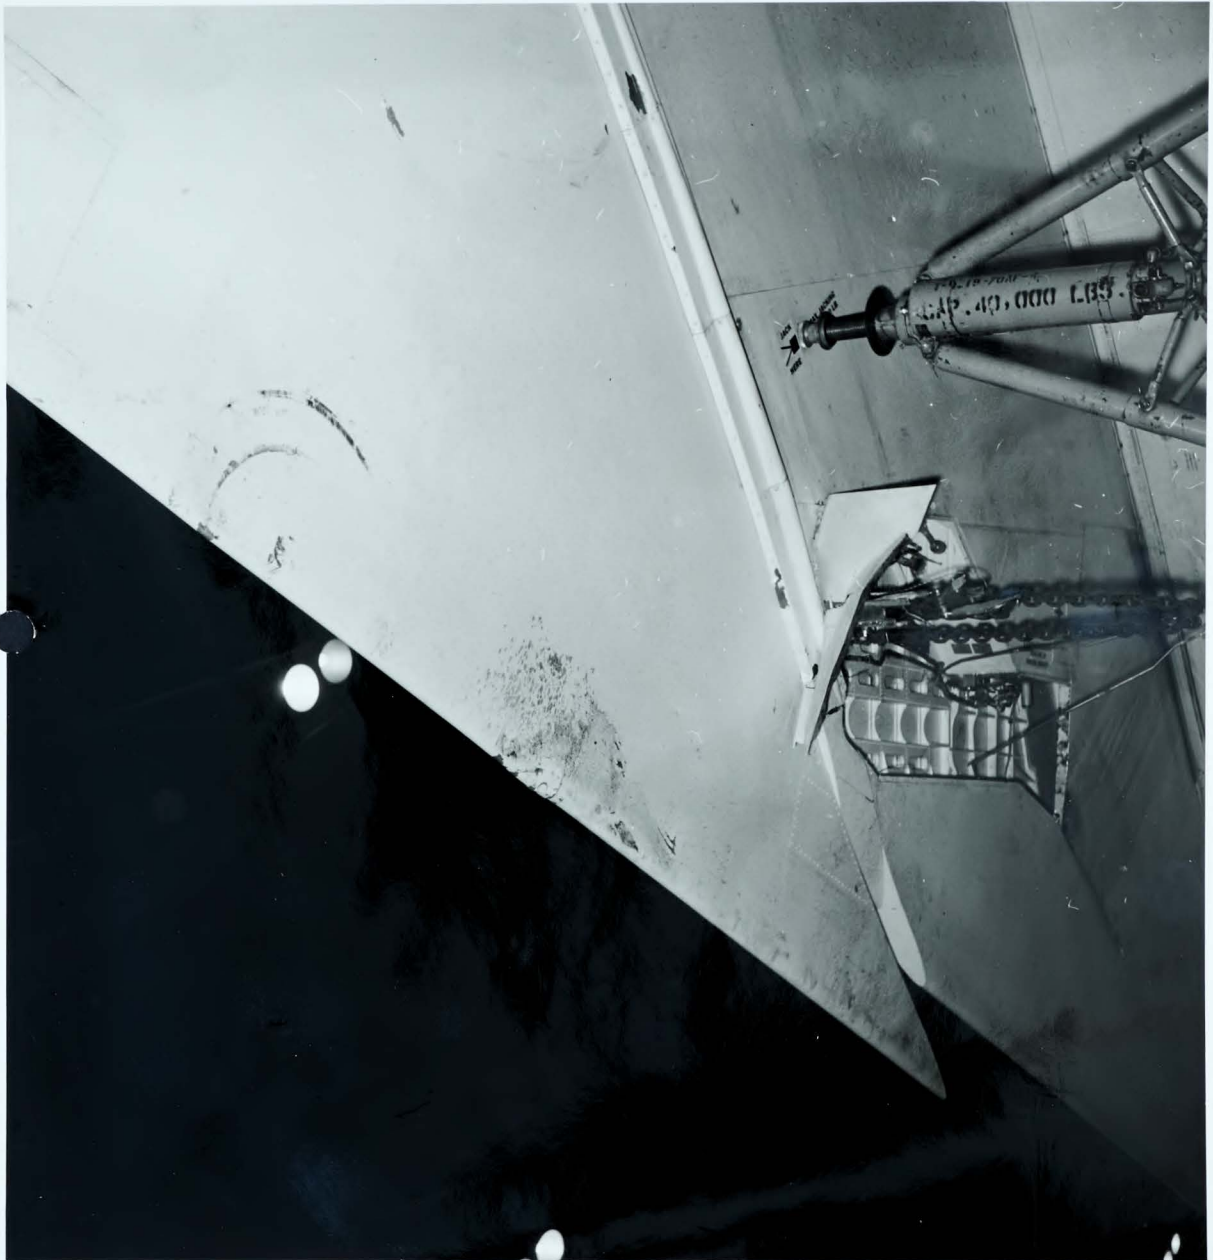
FIG. 1

Part of the outer wing leading edge and lower surface were damaged by contact with the L.H. landing gear wheels. (see Figures 1 and 2)

Repairs to this area were as follows:

- (a) Nose ribs 6,7,9, 10 and 11 were replaced.
- (b) New portions of stringers 2 and 3 were spliced in.
- (c) Nose skin between ribs 6 and 14 was replaced.
- (d) New portion of nose skin spliced in between ribs 3 and 6.
- (e) Navigation light fairing and cover replaced.

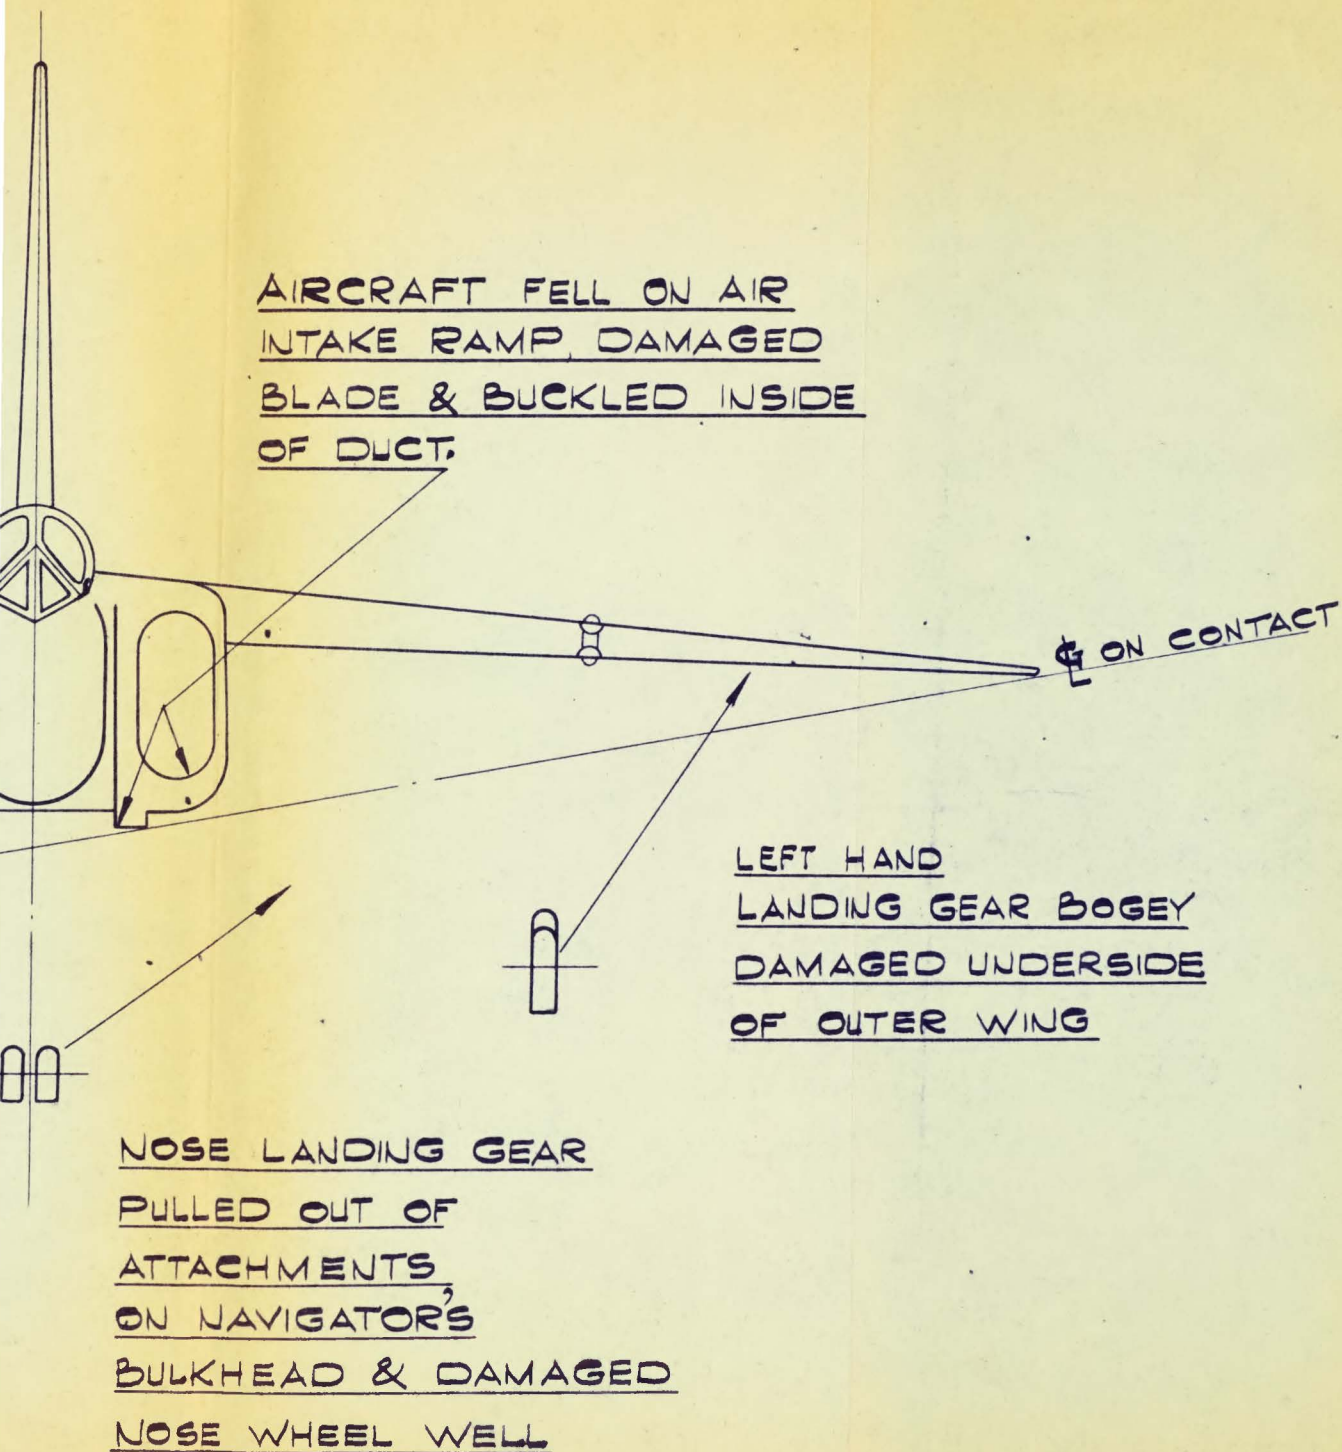
FIGURE 23

The position of contact with the ground is shown in Figures 23 and 24.

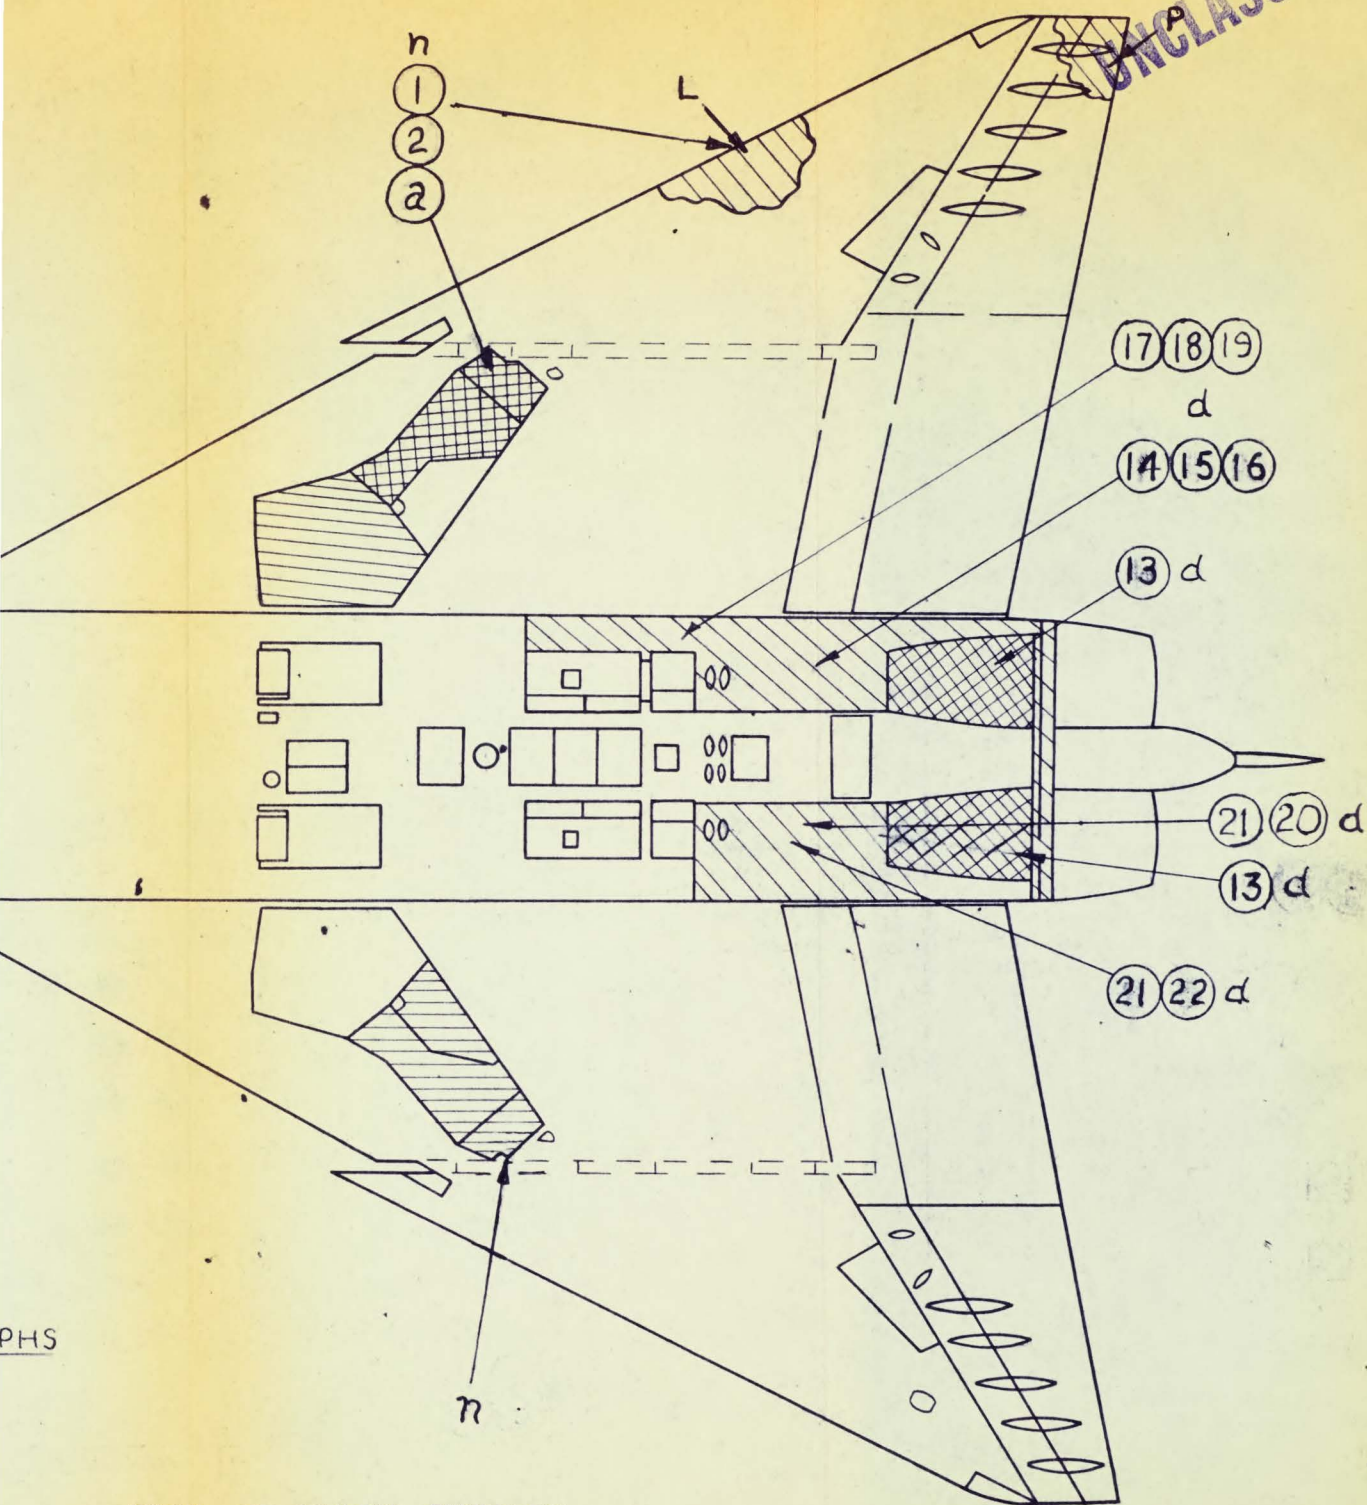
FIGURE 25

3.1 The initial survey revealed the following damage: (see Figure 25).

- (a) Left-hand main landing gear torn out of its housing.
- (b) Right-hand main landing gear broken at top of wheel bogey.
- (c) Nose landing gear torn out of attachment fittings.
- (d) Rear fuselage buckled and torn, mostly on left-hand side.
- (e) Left-hand air intake ramp buckled at bottom edge.
- (f) Left-hand air intake scoop buckled inside.
- (g) V-struts broken at station 742.0.
- (h) Vertical strut buckled at station 717.36.
- (k) Left-hand main landing gear door buckled.
- (l) Left-hand outer wing leading edge dented.
- (m) Engine bay bottom formers and skin buckled from station 697.0 to station 742.0.
- (n) Inner wing skins over main landing gear pivot housings damaged due to salvage operation.
- (p) ~~Left-hand~~ aileron damaged due to wing striking the ground.

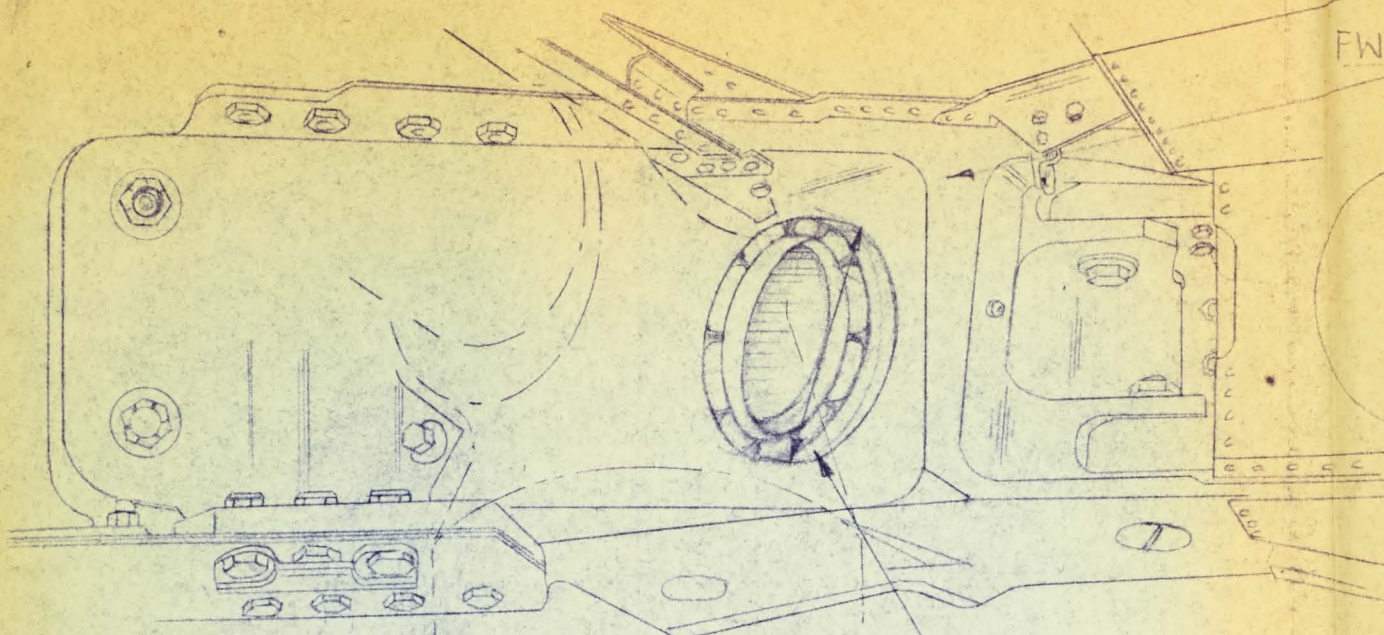
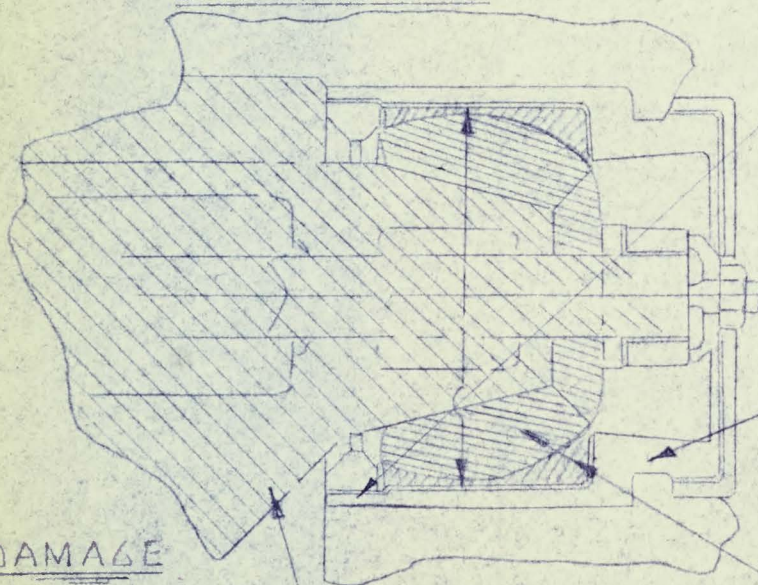
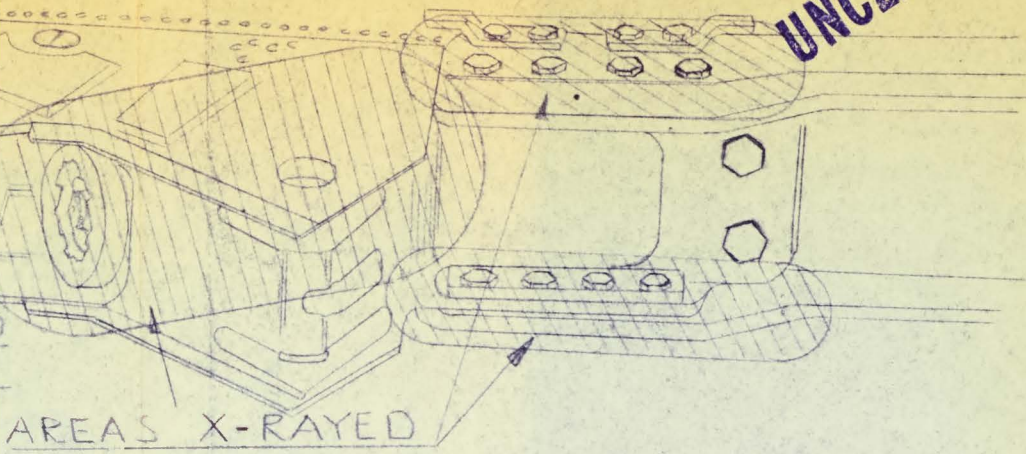
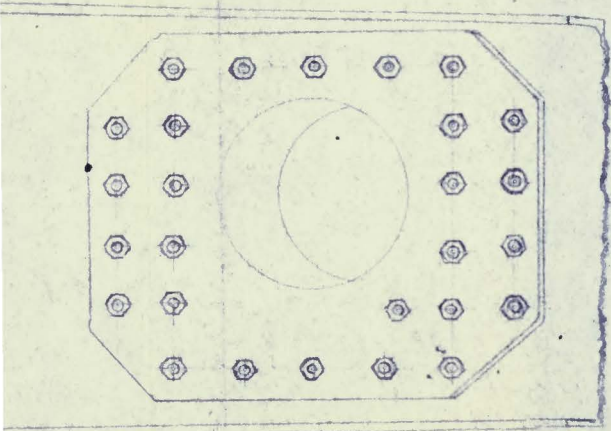
FIGURE 26

Radiography and measurement checks indicated that no damage had occurred to the right wing. Figure 26 shows the examination conducted on main landing gear leg attachments.

APPROX. .030 OVALITY  
DIAM. SLEEVE AND PIVOT FTG.  
L.H. SIDE ONLY

RETAINING RING  
ON SLEEVE DAM  
L.H. SIDE ONLY

L.H. SIDE SHAFT PULLED OUT

BEARING BROKEN  
L.H. & R.H. SIDES

The accident caused elongation of the sleeve insert which carries the main leg pivot forward fitting. The sleeve was removed using heat lamps and dry ice. Examination showed that the bore of the pivot fitting had elongated with the sleeve. The fitting was rebored in situ using a special boring bar. (Ref. Figures 3,4,5 and 6). A modified sleeve was made to fit the rebore, and the internal bore of the sleeve was honed out to suit the pivot shaft.

REPAIR L.H. SIDE  
L.H. SLEEVE REMOVED  
PIVOT FITTING REBOR  
NEW D/S SLEEVE FIT
