UNCLASSIFIED
REPORT ON ACCIDENT TO
AVRO APERCH 1 25201
AT WILTON
UNCLASSIFIED
June 11, 1958

71/ENG PUB/9

This Report is in two parts. Part I, contains details of the accident and the investigation into the cause. Part II will detail the damage to the aircraft resulting from the accident, and will be issued when the aircraft has been fully stripped and examined.

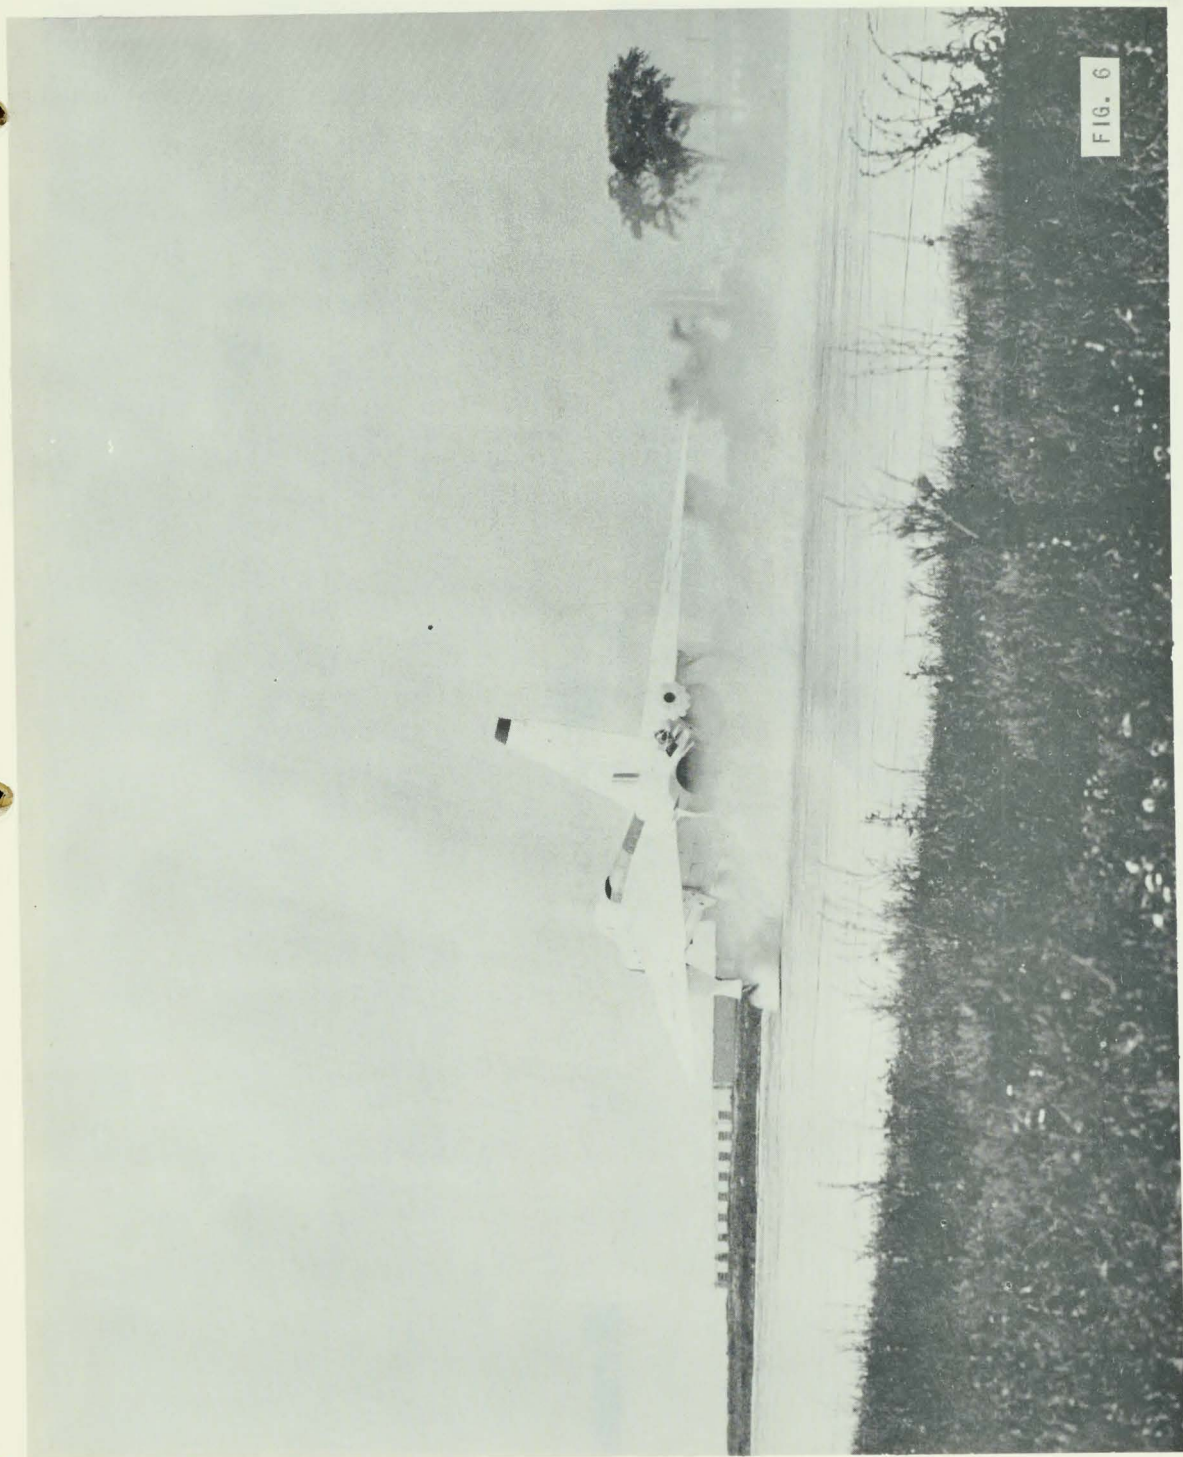
FIG. 6

Immediately after touch down (Fig. 3), the aircraft's weight caused the left-hand landing gear to turn further and assume the position which it would normally occupy when stowed in the landing gear bay (Ref. para. 3.3). The drag chute was then deployed. Figure 6 shows smoke coming from the left-hand tires, due to their misalignment with the aircraft's path. The aircraft continued to swing towards the left-hand side and corrective brake action had no effect in arresting the swing. The pilot then considered that the drag chute may be causing the swing and jettisoned the chute. Figure 7 shows the aircraft in various positions until it left the runway. When the left-hand wheel struck the soft ground, the aircraft swung violently to the left, causing the landing gear to collapse due to the excessive loads imposed on it. Figures 12 and 13 are aerial photographs taken shortly after the accident. The skid marks shown on Figure 14 are those made by the left-hand landing gear at the touchdown point, and indicates the increase in the spread of the tires, as the bogie is twisted further out of line, due to the increasing weight on the landing gear. Figure 15 indicates the point at which the left-hand tires burst. This occurred at approximately 3/5 of the total distance which the aircraft travelled (approximately 4,000 ft.).

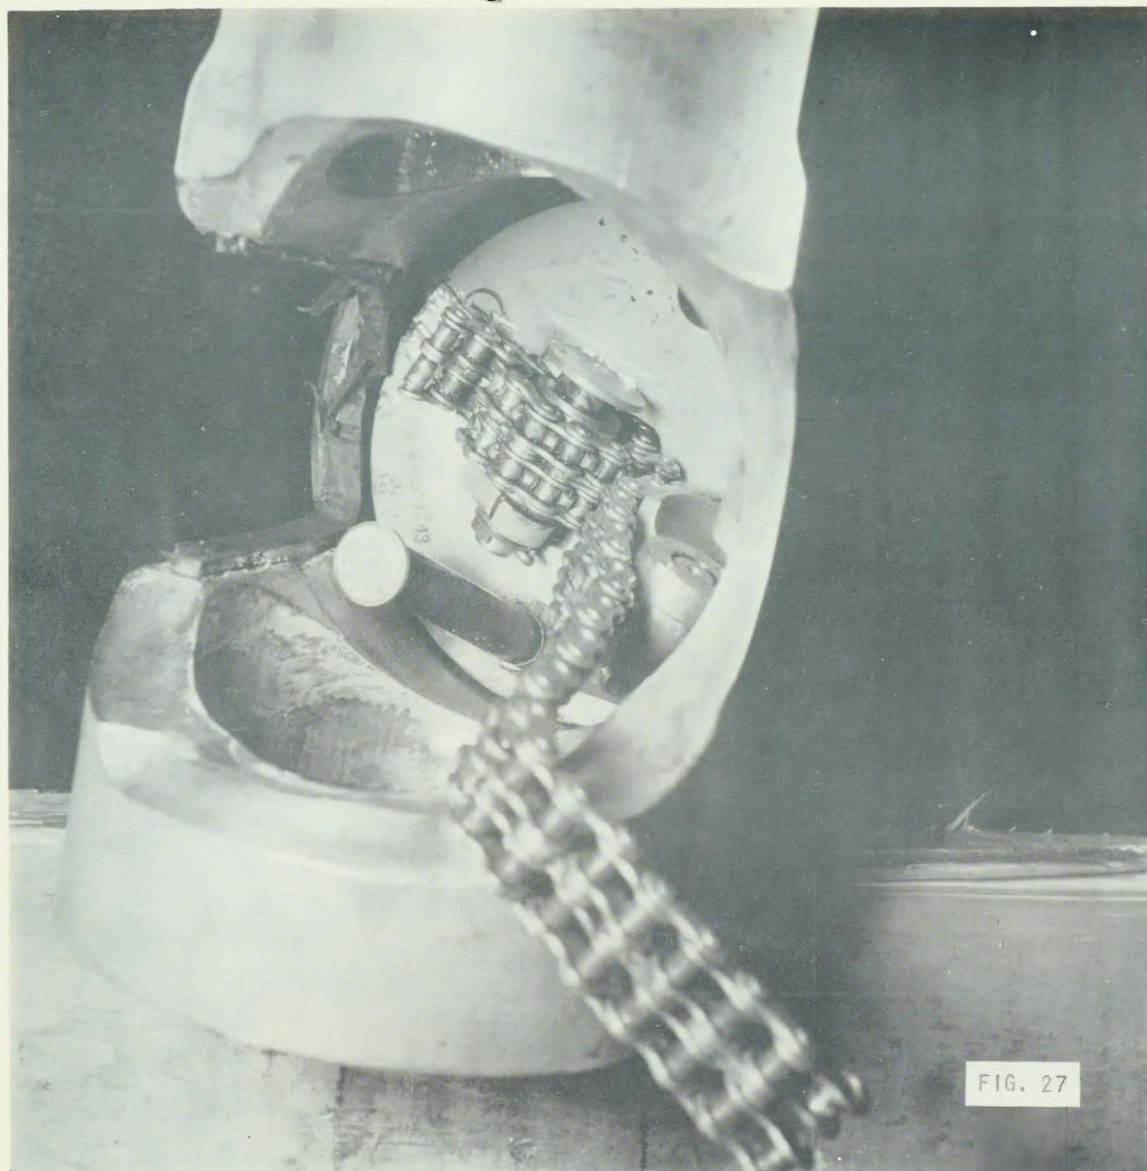
FIG. 27

Figure 27 shows the end of the leg with the dust cover removed, revealing the chain and idler sprocket. In addition, this photograph shows that a section of chain is jammed between the sprocket and the end cap, and the sprocket mounting lugs have also failed. However, the jammed chain could also have been caused by secondary damage due to the extension mechanism being pushed two inches past the fully retracted position.

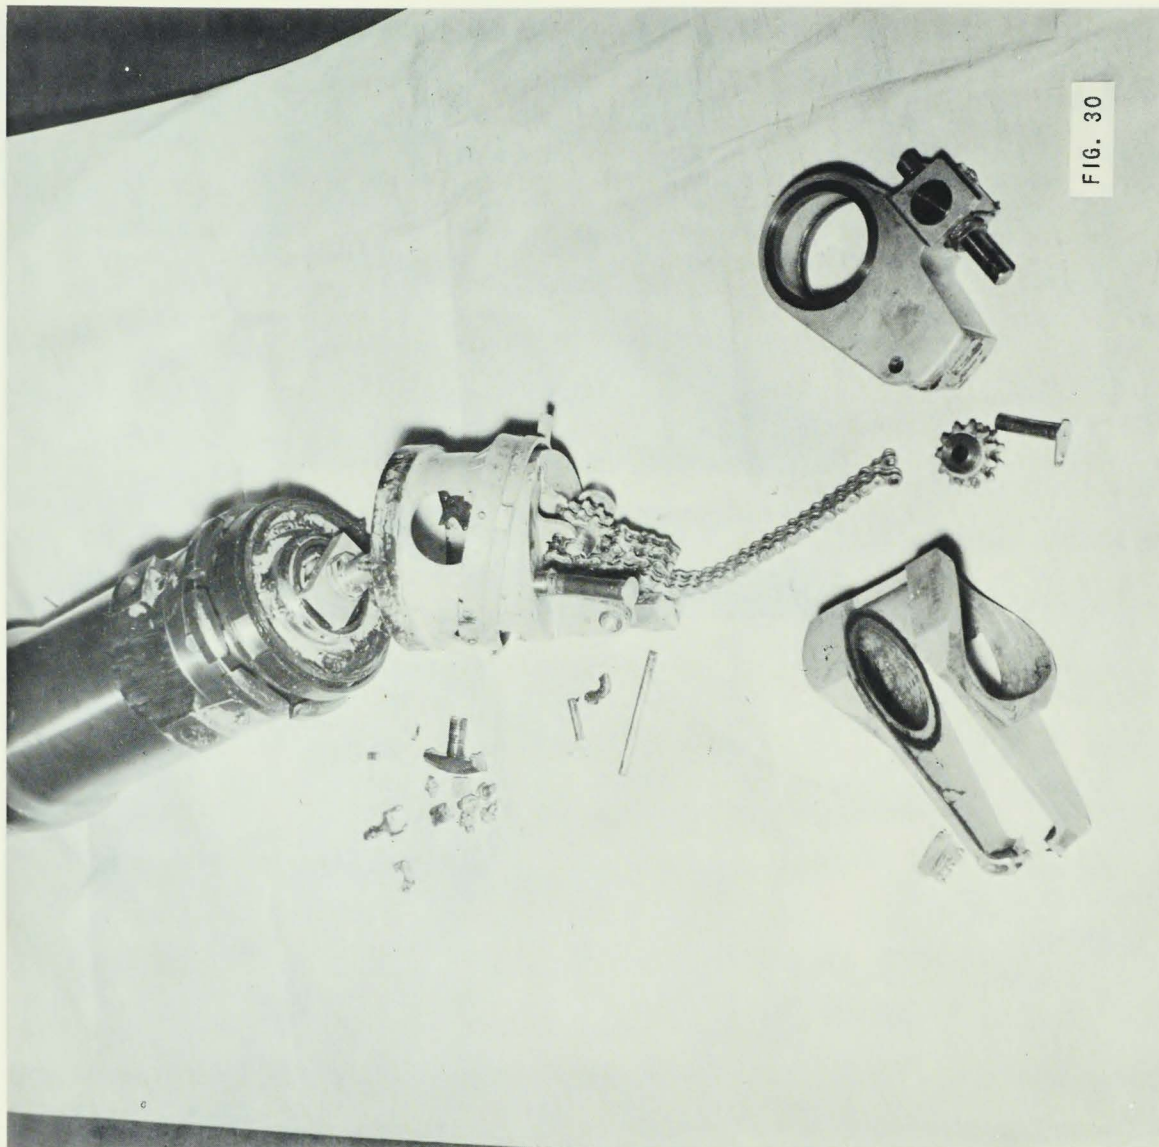
FIG. 30

Figure 30 shows the dust cover, chain and top of the extending gear after they had been withdrawn from the leg forging. Figure 30 shows the fixed portion of the dust cover along with a part of the forging which was torn out by the chain being looped between its moveable piece at the left top corner. Figure 31 shows the chain marks on the dust cover. Figure 32 is a close-up photograph of the fixed part of the dust cover showing part of the forging broken out at the extreme right-hand side. Figure 33 shows the piece of chain which had been broken off and damaged the dust cover. It should be noted that the chain breakage could have been caused when the landing gear was sheared in the final stages of the accident.

Tests were conducted at Dowty on a rig in which the friction at the extension bearing was increased. The locking band bolts were torqued to 410 lbs. ins. instead of 50 lbs. ins. The gear was then lowered, and it was found that the retraction chain looped and jammed in the dust cover, as it closed; the length of chain jamming being about 5 links. The tests were stopped before the gear was fully down in order to prevent damage to the gear. However, on one occasion, when it was thought that the chain was clear, the gear was let go and damage was caused to the dust cover similar to that shown in Figure 30.

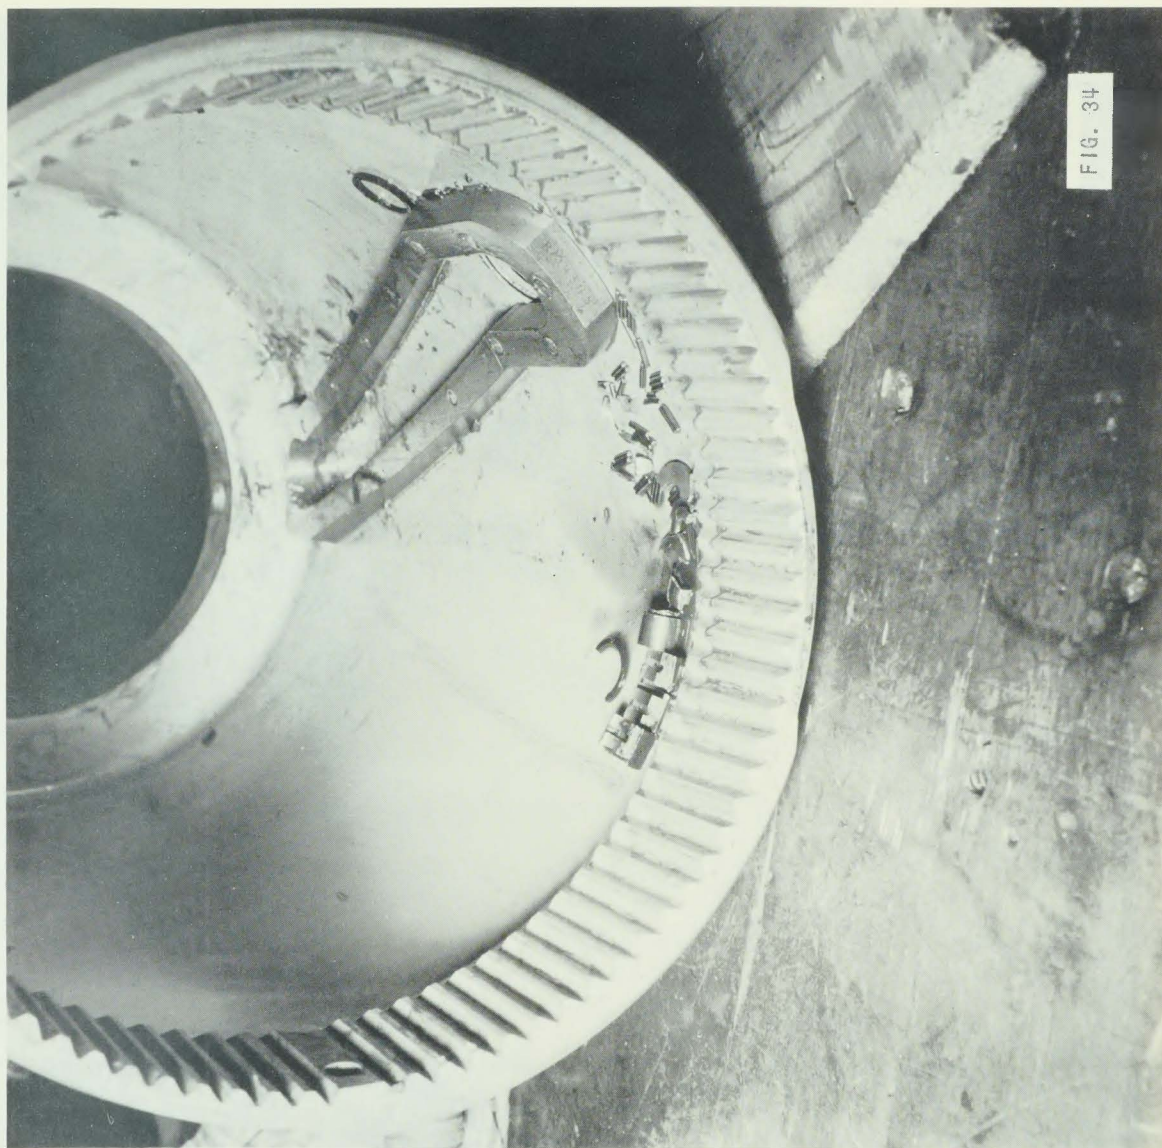
FIG. 34

Figure 34 shows one of the two cam tracks; the rollers in the bottom are broken. This is secondary damage, due to the extending portion of the leg being driven beyond the fully retracted position.

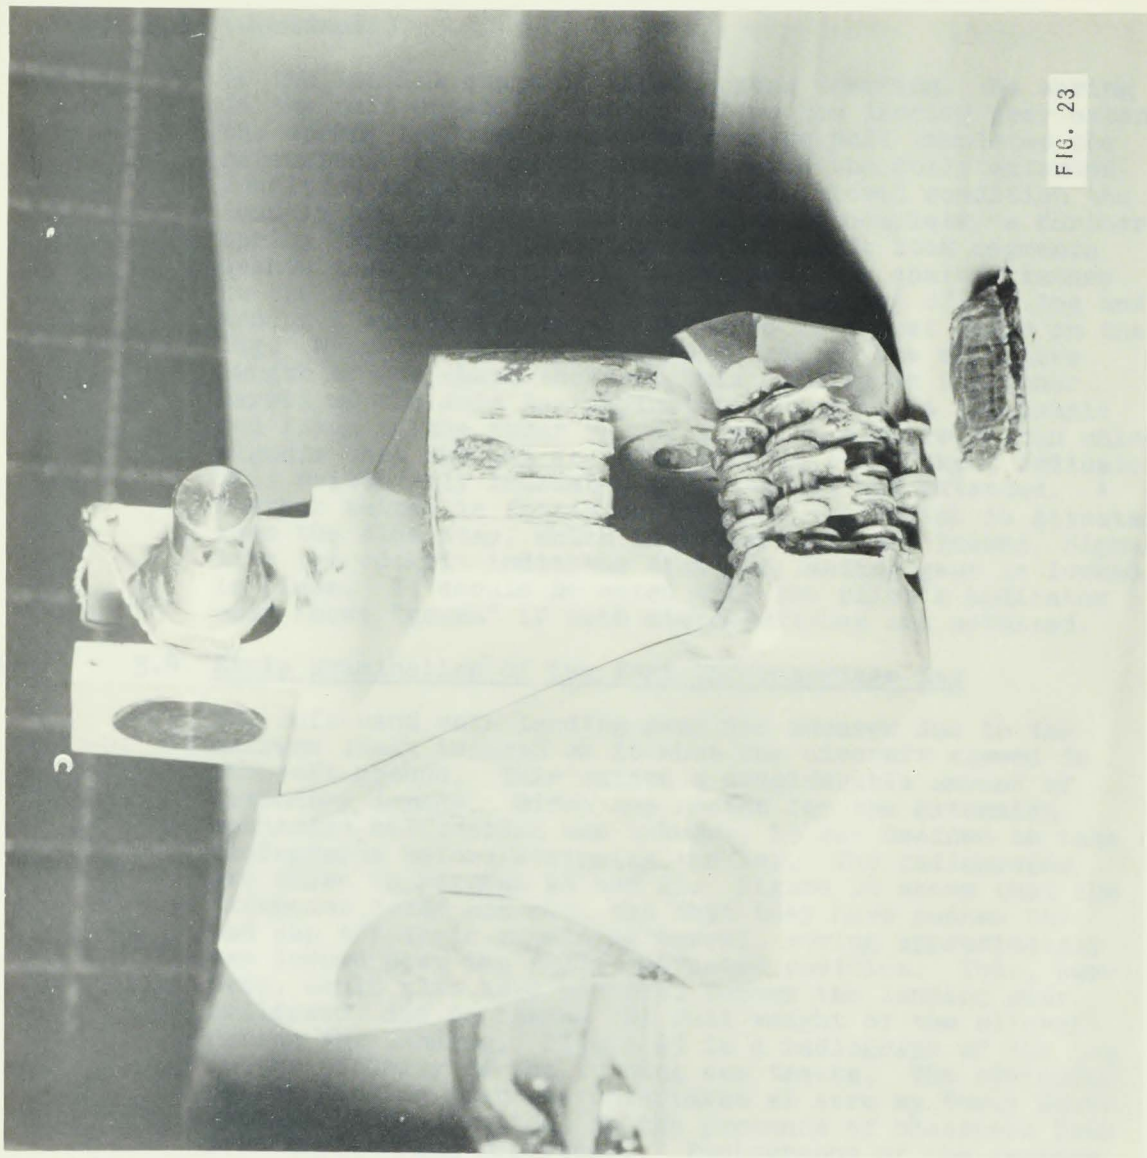
FIG. 23

Turning is accomplished by means of two cam tracks on the main leg barrel and two rollers on the extending unit. The main oleo is attached to the shortening gear, therefore, the oleo is active whether the extension is up or down. Figure 21 shows the main leg details and Figure 22 shows the shortening mechanism details lock. The dust cover is shown on Figure 23.

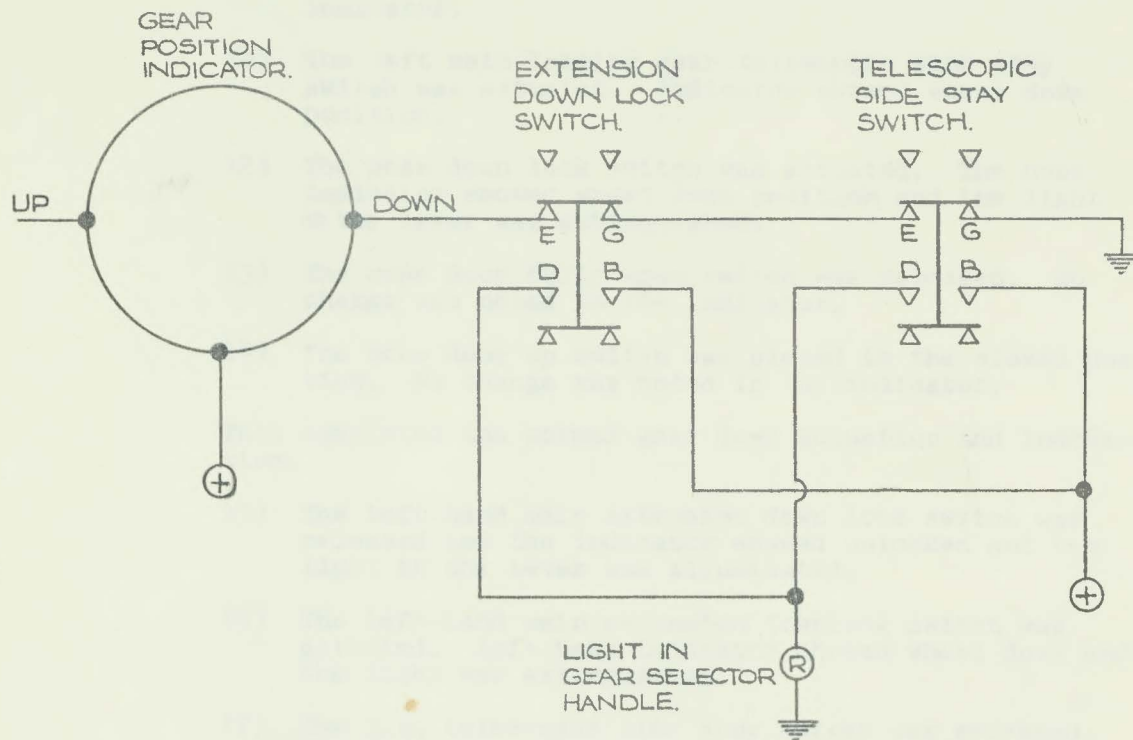
FIG. 39

Figure 39 shows the schematics of the cockpit indicator for the main landing gear. It will be noted that both micro-switches must be actuated in order to indicate GEAR DOWN - LOCKED. The working drawings were checked to ensure that the system had been correctly converted into the aircraft wiring drawings. The drawings were found to be correct. The harness from the left-hand landing gear was then re-fitted to the aircraft and circuit checks were made. The side stay micro-switch was found to be unserviceable, and a new switch was installed for the check. It is considered that the failure of this switch was due to the secondary damage, since the pilot's indicator showed the gear to be locked down. This indication would be given if both side stay and extension micro-switches are actuated and serviceable. (Ref. Figure 39.)

The above tests proved that the aircraft wiring was correct and the false indication must have been caused by micro-switch maladjustment or jamming in the wheels down position. If this switch was permanently in the actuated condition, the indication would be in order i.e. "wheels down" when the side stay was actuated and "wheels up" when the gear was retracted and the side stay micro-switch released.
