REPORT ON ACCIDENT

AVRO ARROW I 25201

June 11, 1958

MALTON

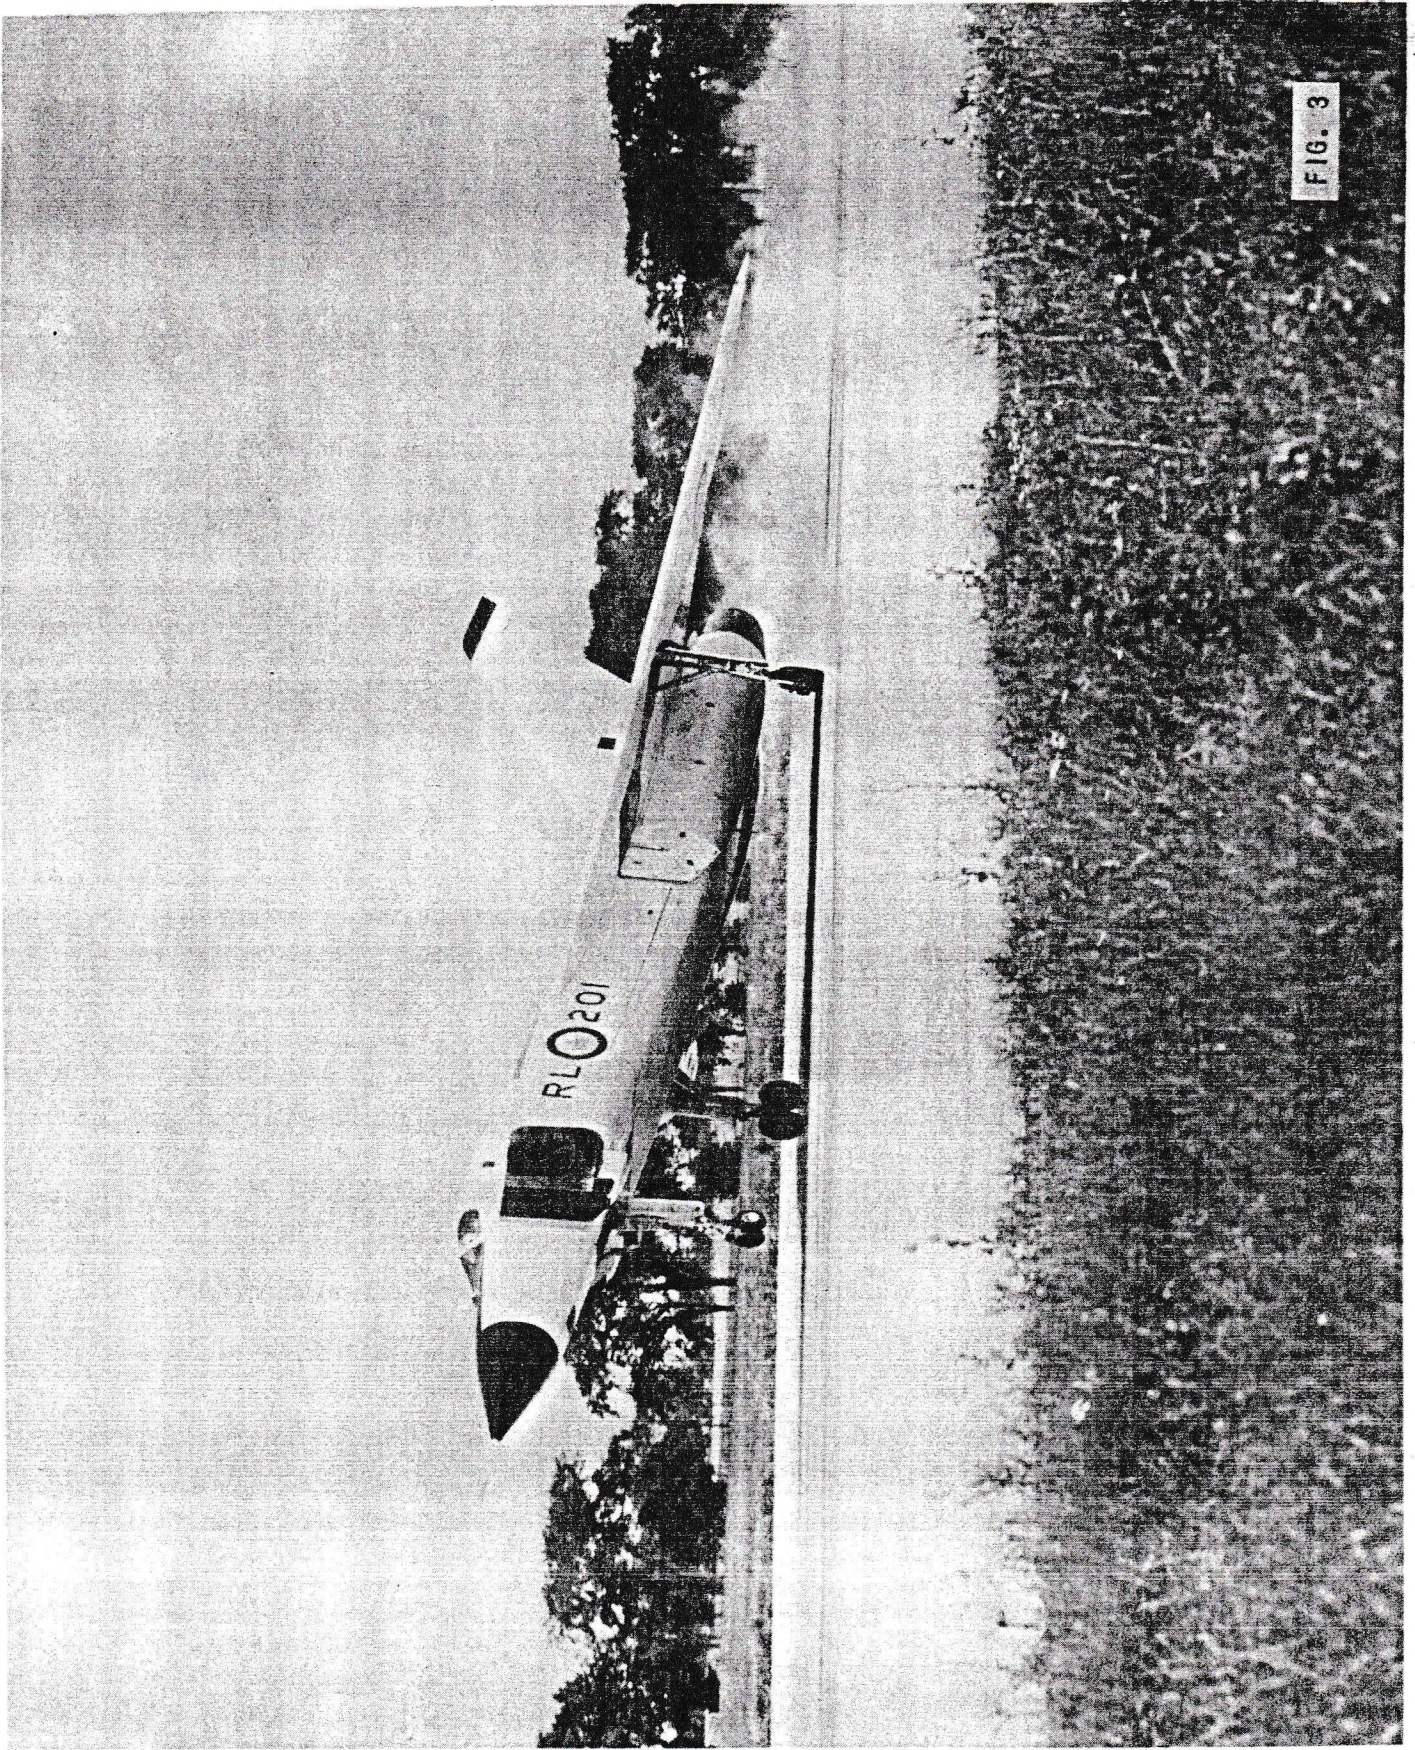
FIG. 3

Immediately after touch down (Fig. 3), the aircraft's weight caused the left-hand landing gear to turn further and assume the position which it would normally occupy when stowed in the landing gear bay (Ref. para. 3.3). The drag chute was then deployed. Figure 6 shows smoke coming from the left-hand tires, due to their misalignment with the aircraft's path. The aircraft continued to swing towards the left-hand side and corrective brake action had no effect in arresting the swing. The pilot then considered that the drag chute may be causing the swing and jettisoned the chute. Figure 7 shows the aircraft in various positions until it left the runway. When the left-hand wheel struck the soft ground, the aircraft swung violently to the left, causing the landing gear to collapse due to the excessive loads imposed on it. Figures 12 and 13 are aerial photographs taken shortly after the accident. The skid marks shown on Figure 14 are those made by the left-hand landing gear at the touchdown point, and indicates the increase in the spread of the tires, as the bogie is twisted further out of line, due to the increasing weight on the landing gear. Figure 15 indicates the point at which the left-hand tires burst. This occurred at approximately 3/5 of the total distance which the aircraft travelled (approximately 4,000 ft.).

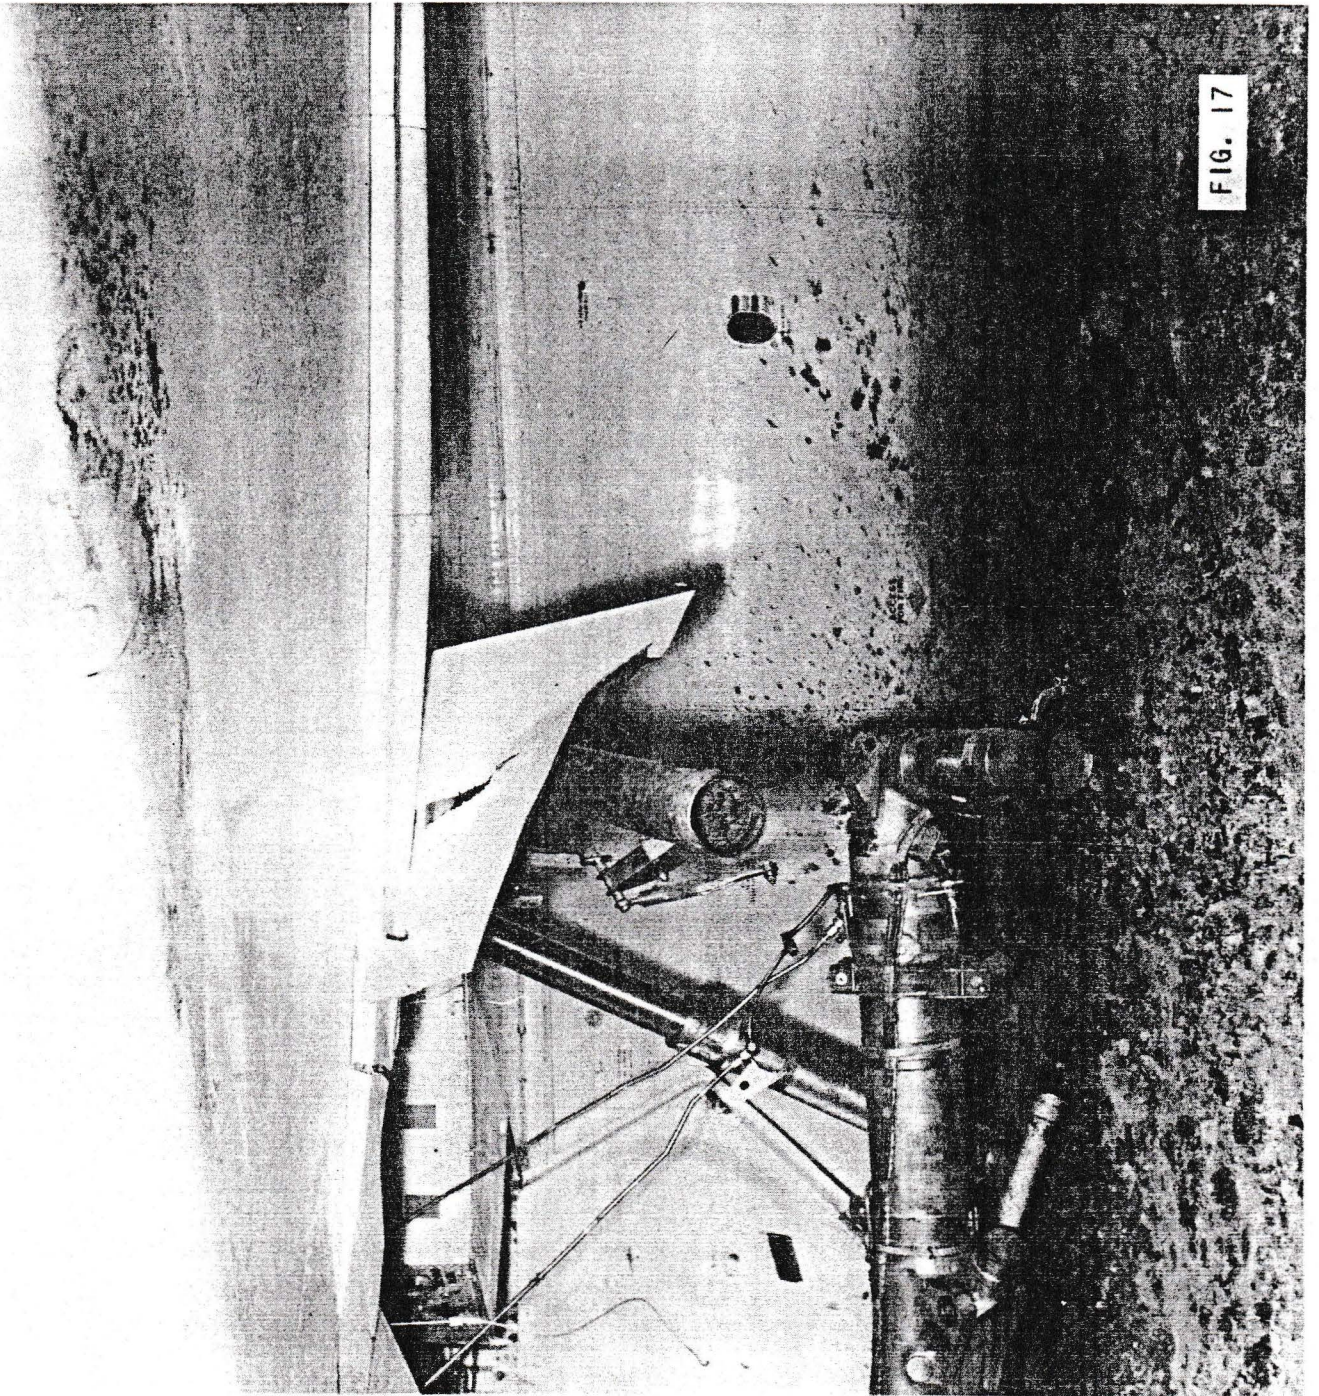
FIG. 17

Photographs taken of the left-hand landing gear shortly after the accident are shown in Figures 17, 18 and 19. Figure 17 shows the retracting chain broken off, and protruding from the dust cover.

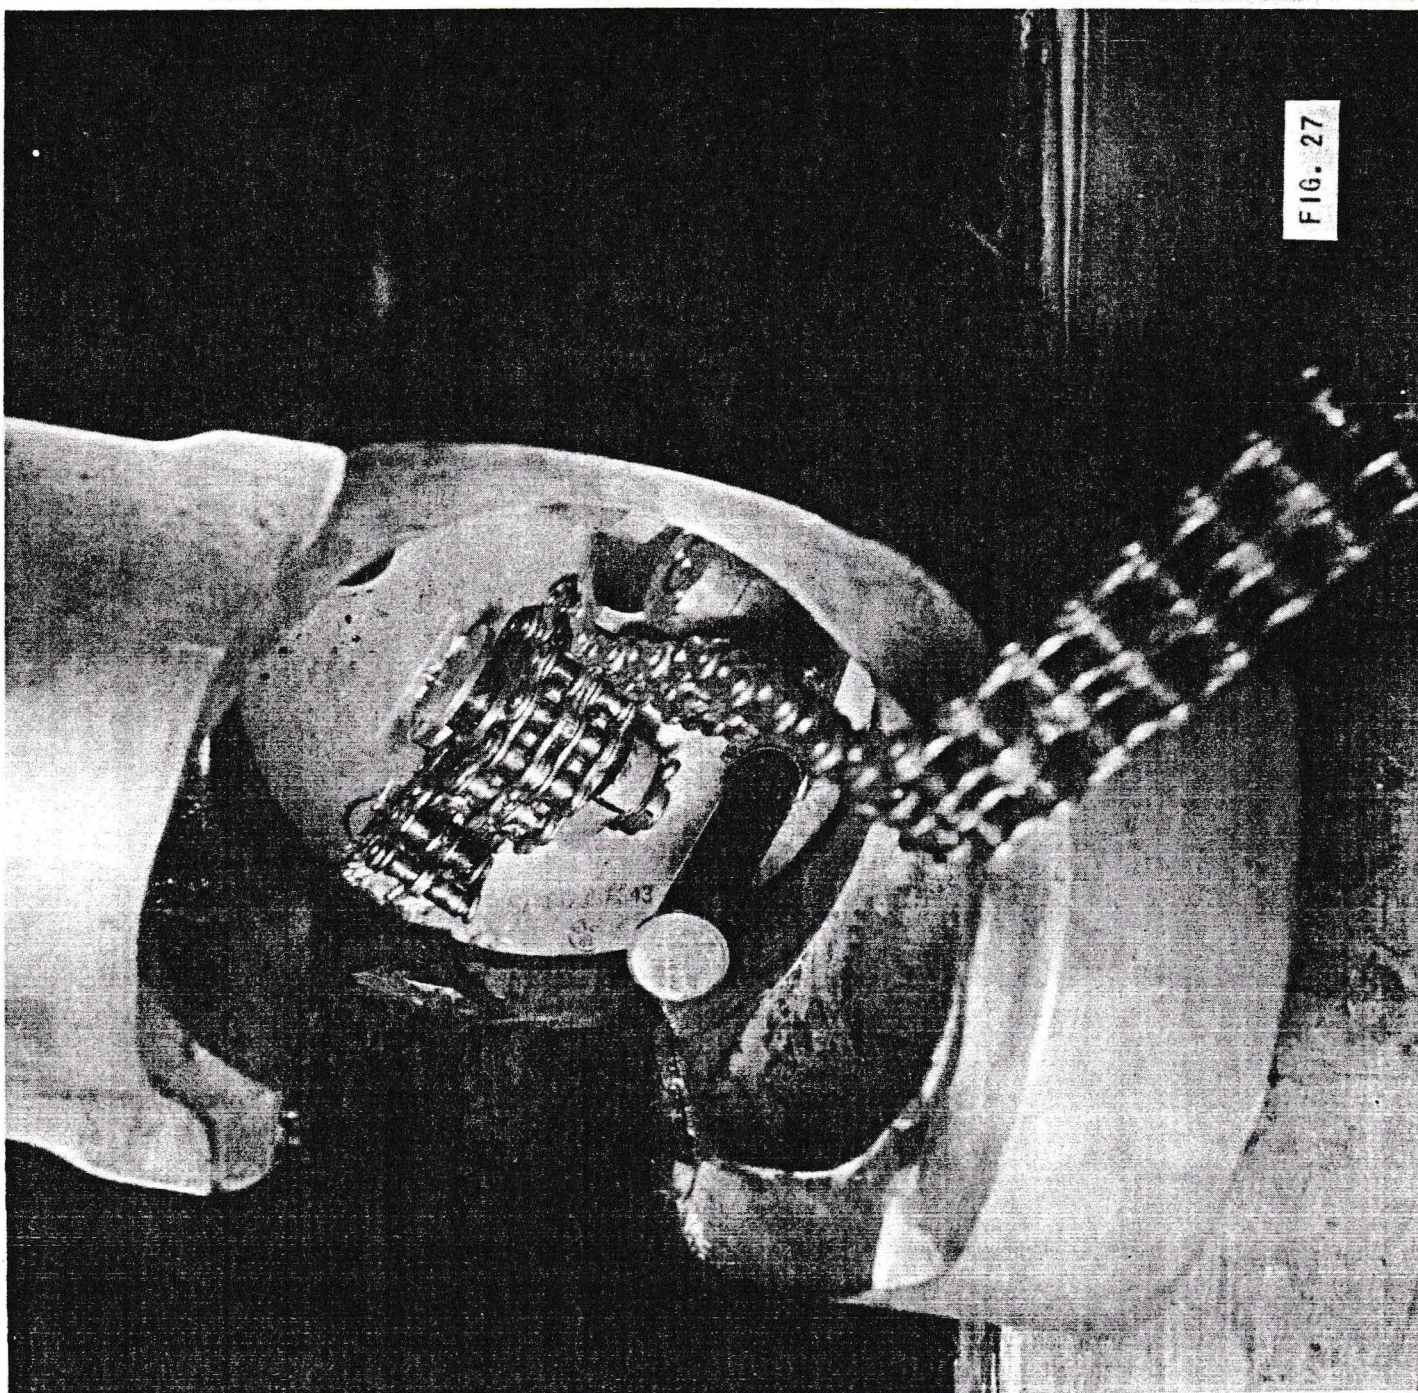
FIG. 27

Figure 27 shows the end of the leg with the dust cover removed, revealing the chain and idler sprocket. In addition, this photograph shows that a section of chain is jammed between the sprocket and the end cap, and the sprocket mounting lugs have also failed. However, the jammed chain could also have been caused by secondary damage due to the extension mechanism being pushed two inches past the fully retracted position.

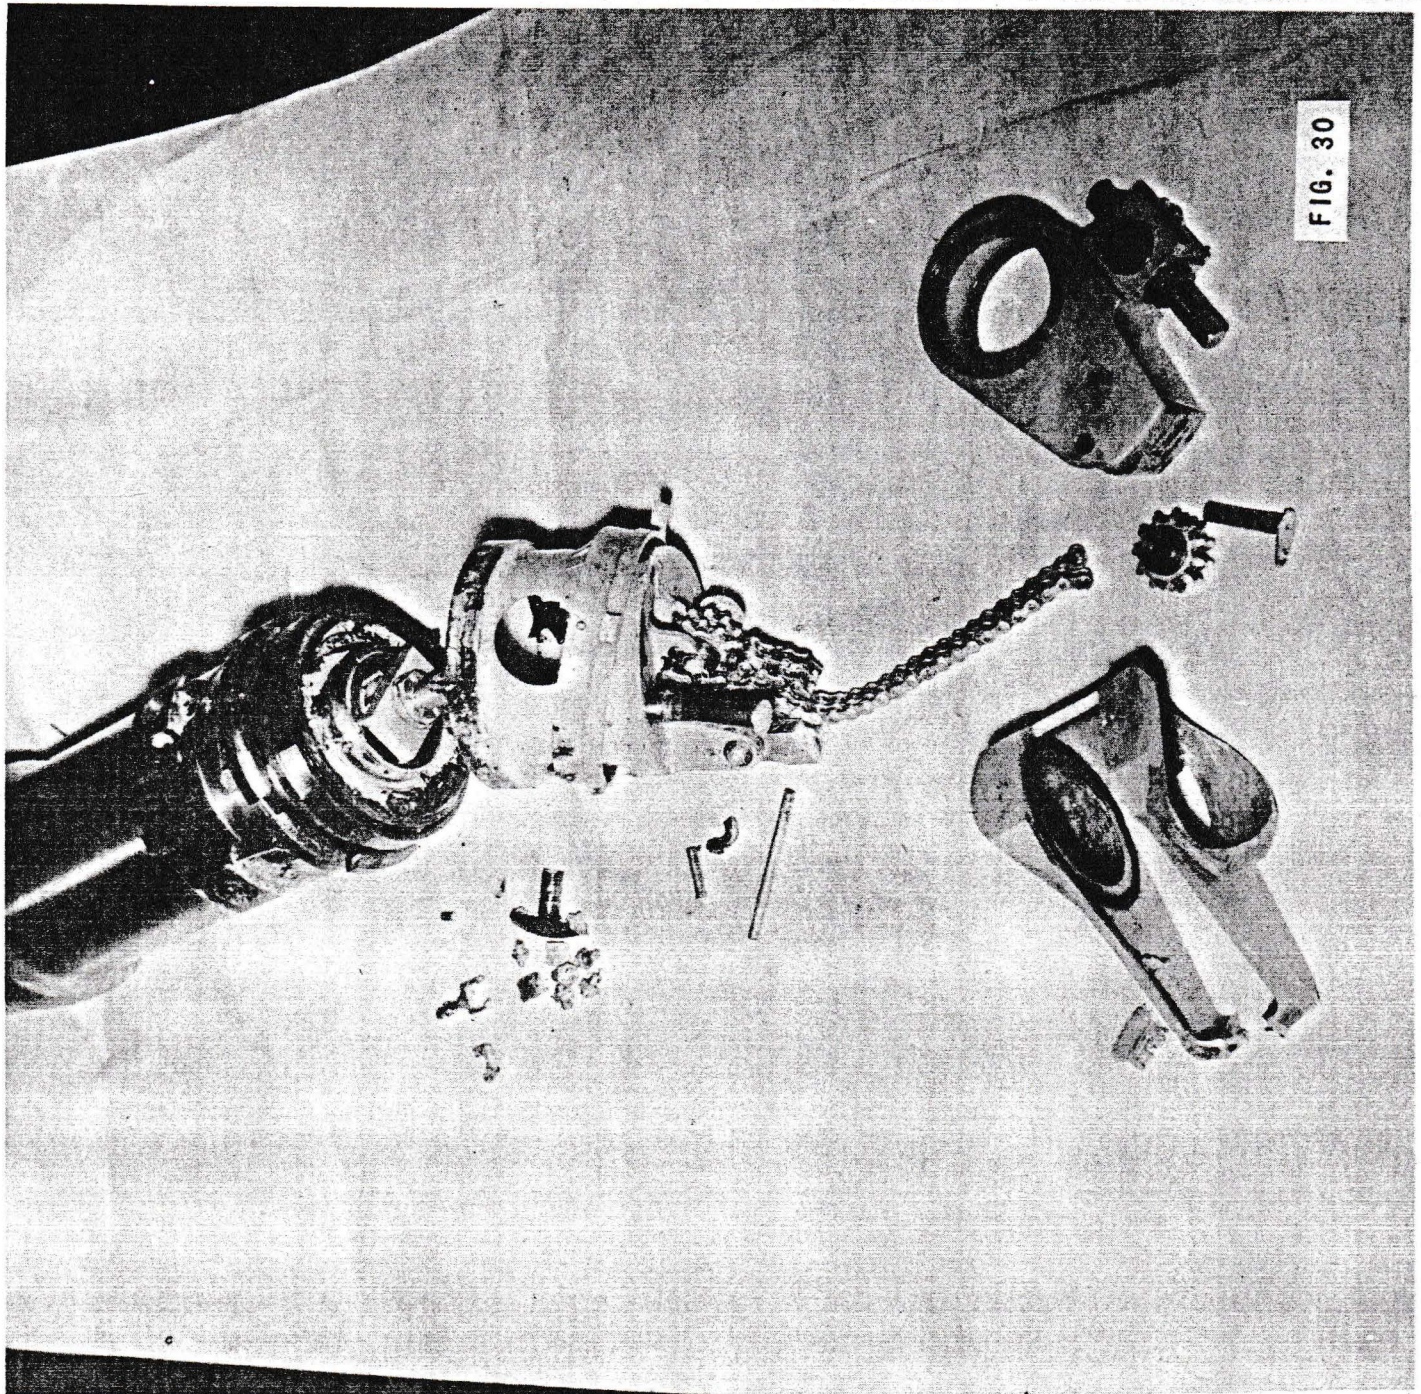
FIG. 30

Figure 30 shows the dust cover, chain and top of the extending gear after they had been withdrawn from the leg forging. Figure 30 shows the fixed portion of the dust cover along with a part of the forging which was torn out by the chain being looped between its moveable piece at the left top corner. Figure 31 shows the chain marks on the dust cover. Figure 32 is a close-up photograph of the fixed part of the dust cover showing part of the forging broken out at the extreme right-hand side. Figure 33 shows the piece of chain which had been broken off and damaged the dust cover. It should be noted that the chain breakage could have been caused when the landing gear was sheared in the final stages of the accident.

Tests were conducted at Dowty on a rig in which the friction at the extension bearing was increased. The locking band bolts were torqued to 410 lbs. ins. instead of 50 lbs. ins. The gear was then lowered, and it was found that the retraction chain looped and jammed in the dust cover, as it closed; the length of chain jamming being about 5 links. The tests were stopped before the gear was fully down in order to prevent damage to the gear. However, on one occasion, when it was thought that the chain was clear, the gear was let go and damage was caused to the dust cover similar to that shown in Figure 30.

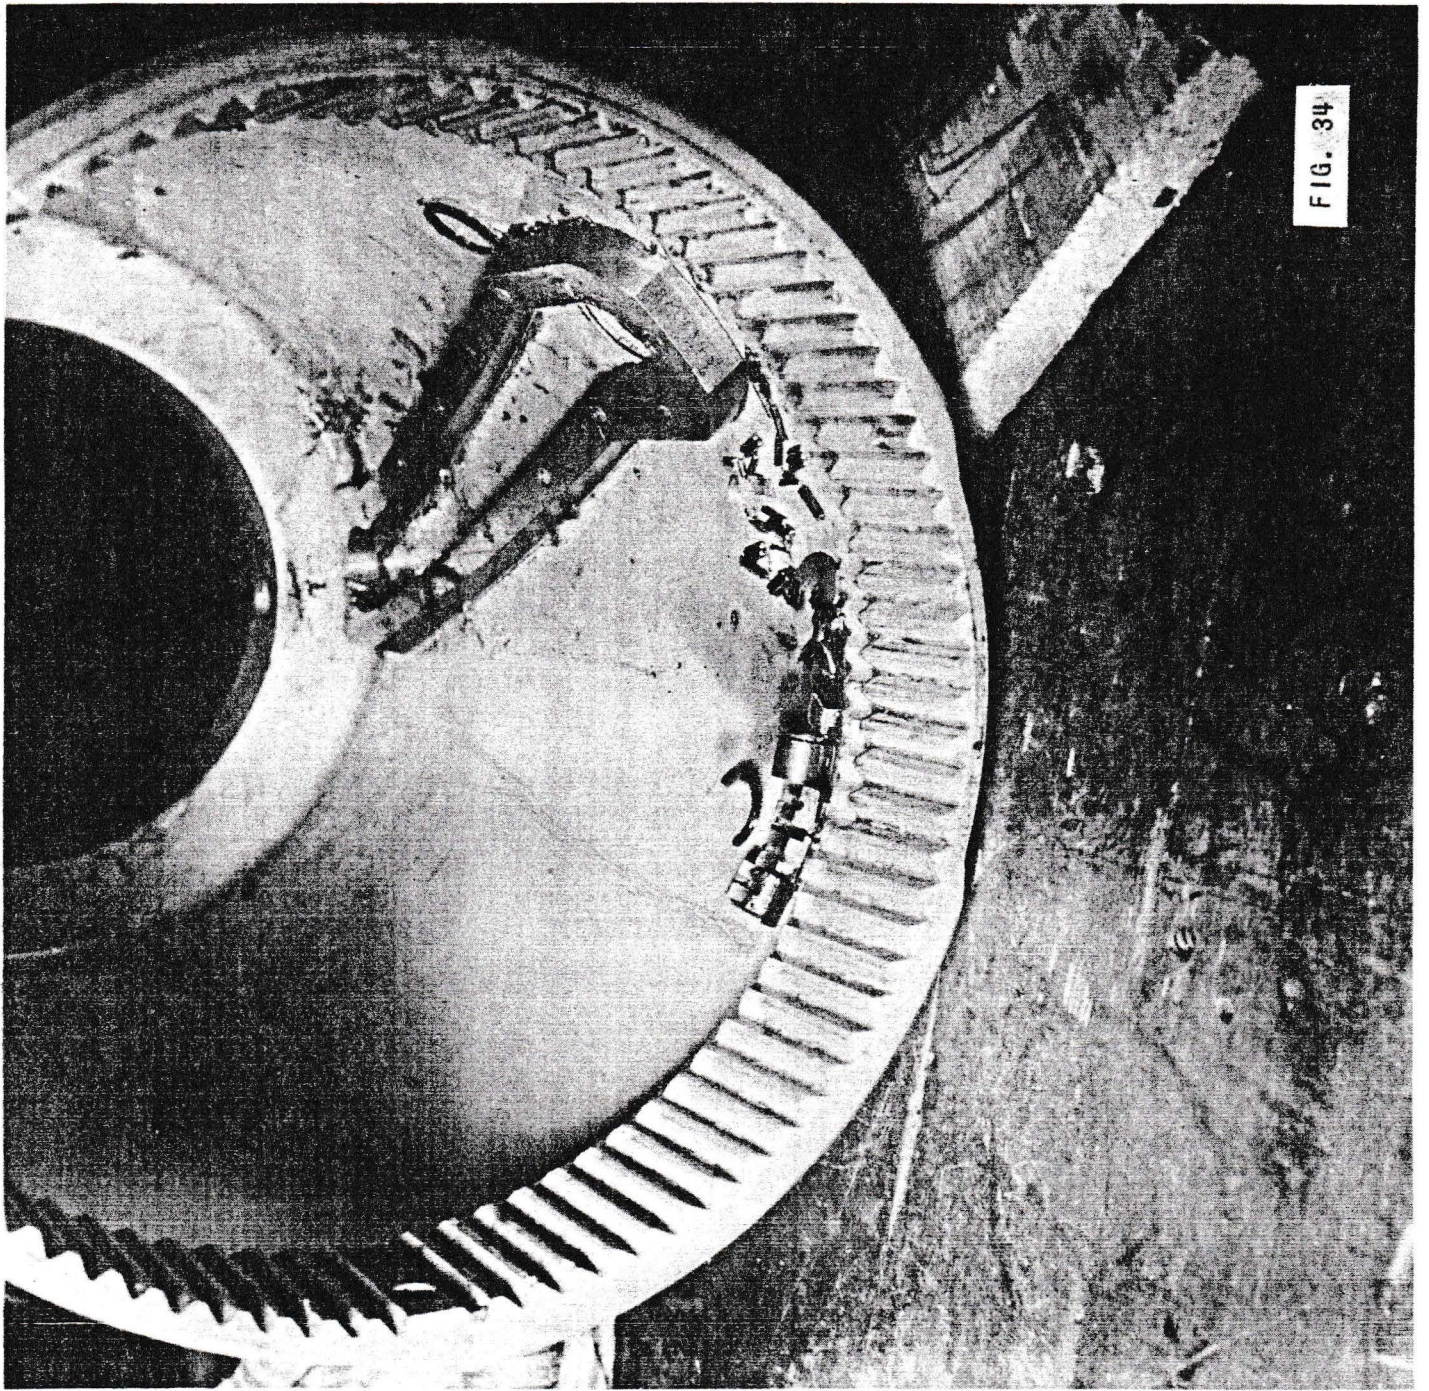
FIG. 34

Figure 34 shows one of the two cam tracks; the rollers in the bottom are broken. This is secondary damage, due to the extending portion of the leg being driven beyond the fully retracted position.

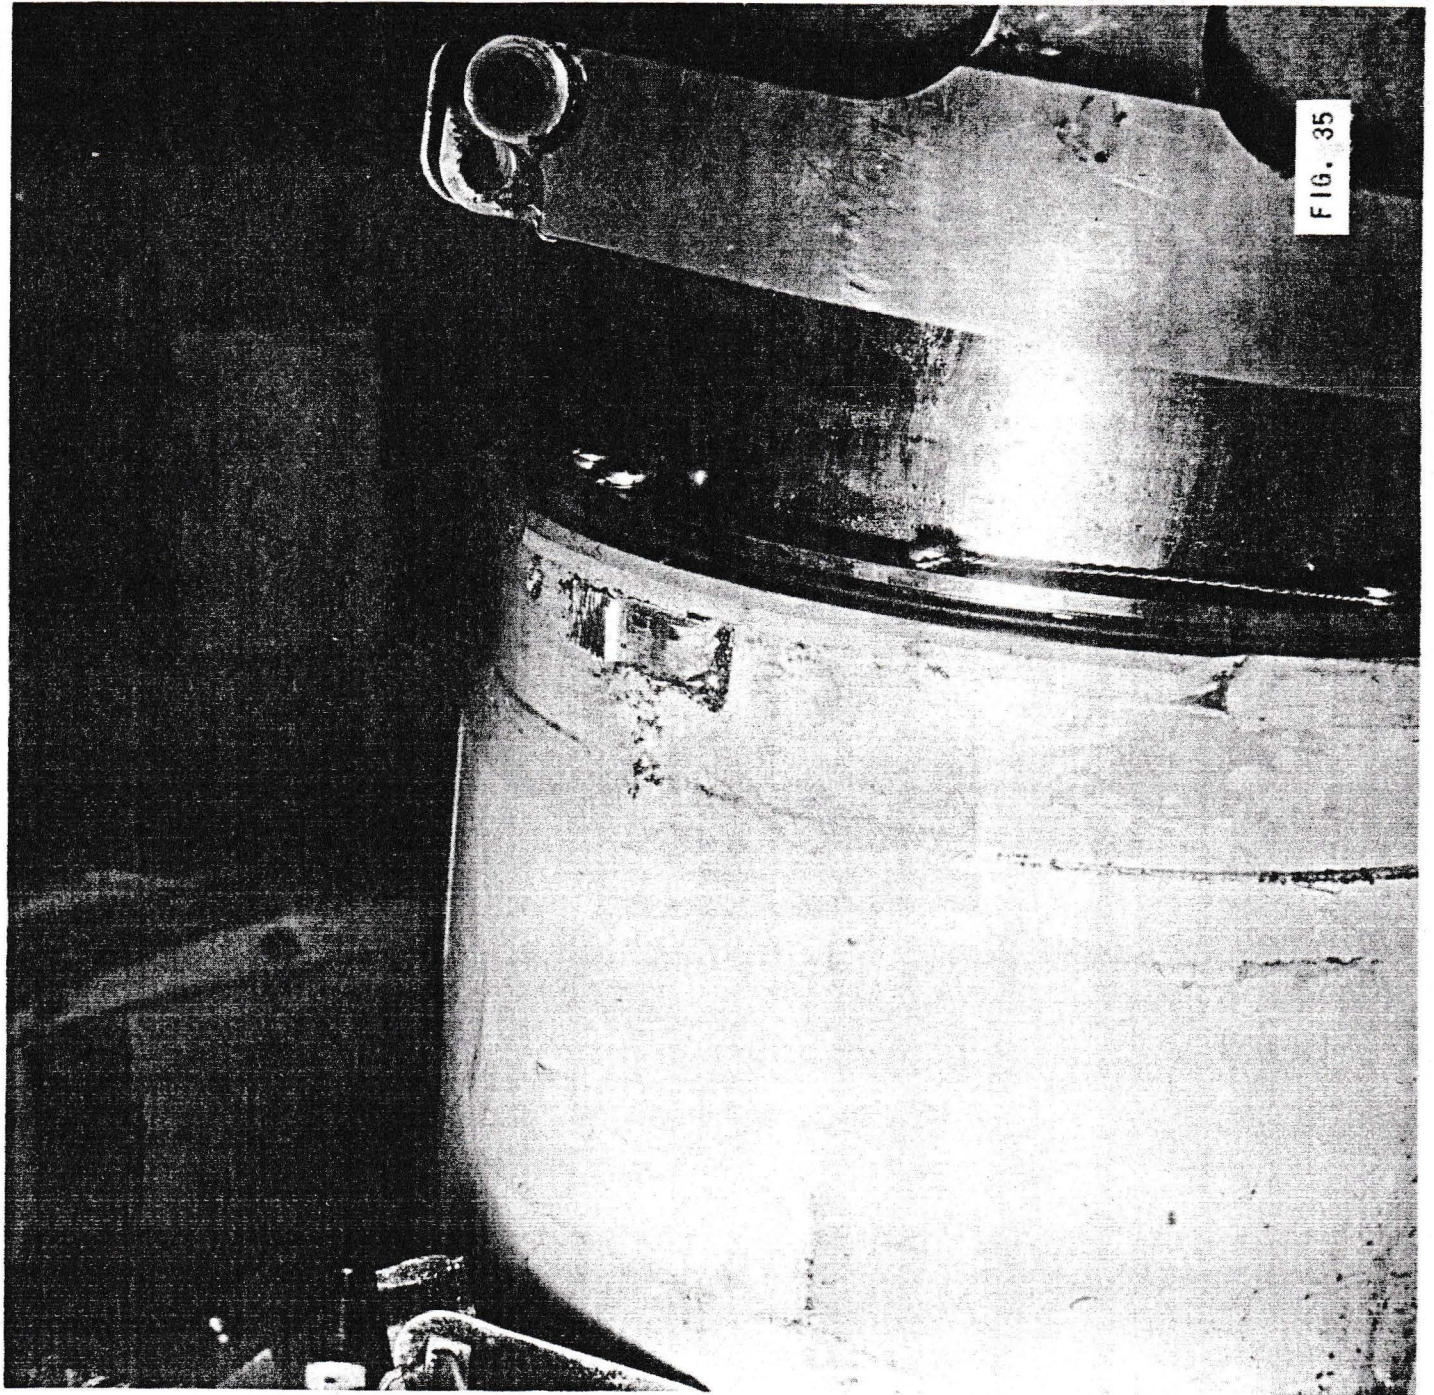
Figure 35 shows the bearing retaining clamp and the barrel. The marks on the barrel indicate that the band had rotated, and the dowel had scored the barrel. The torque to release the bolts was in the order of 350 lb. in. However, some of this high loading could be attributed to twisting during the final breakage of the leg.

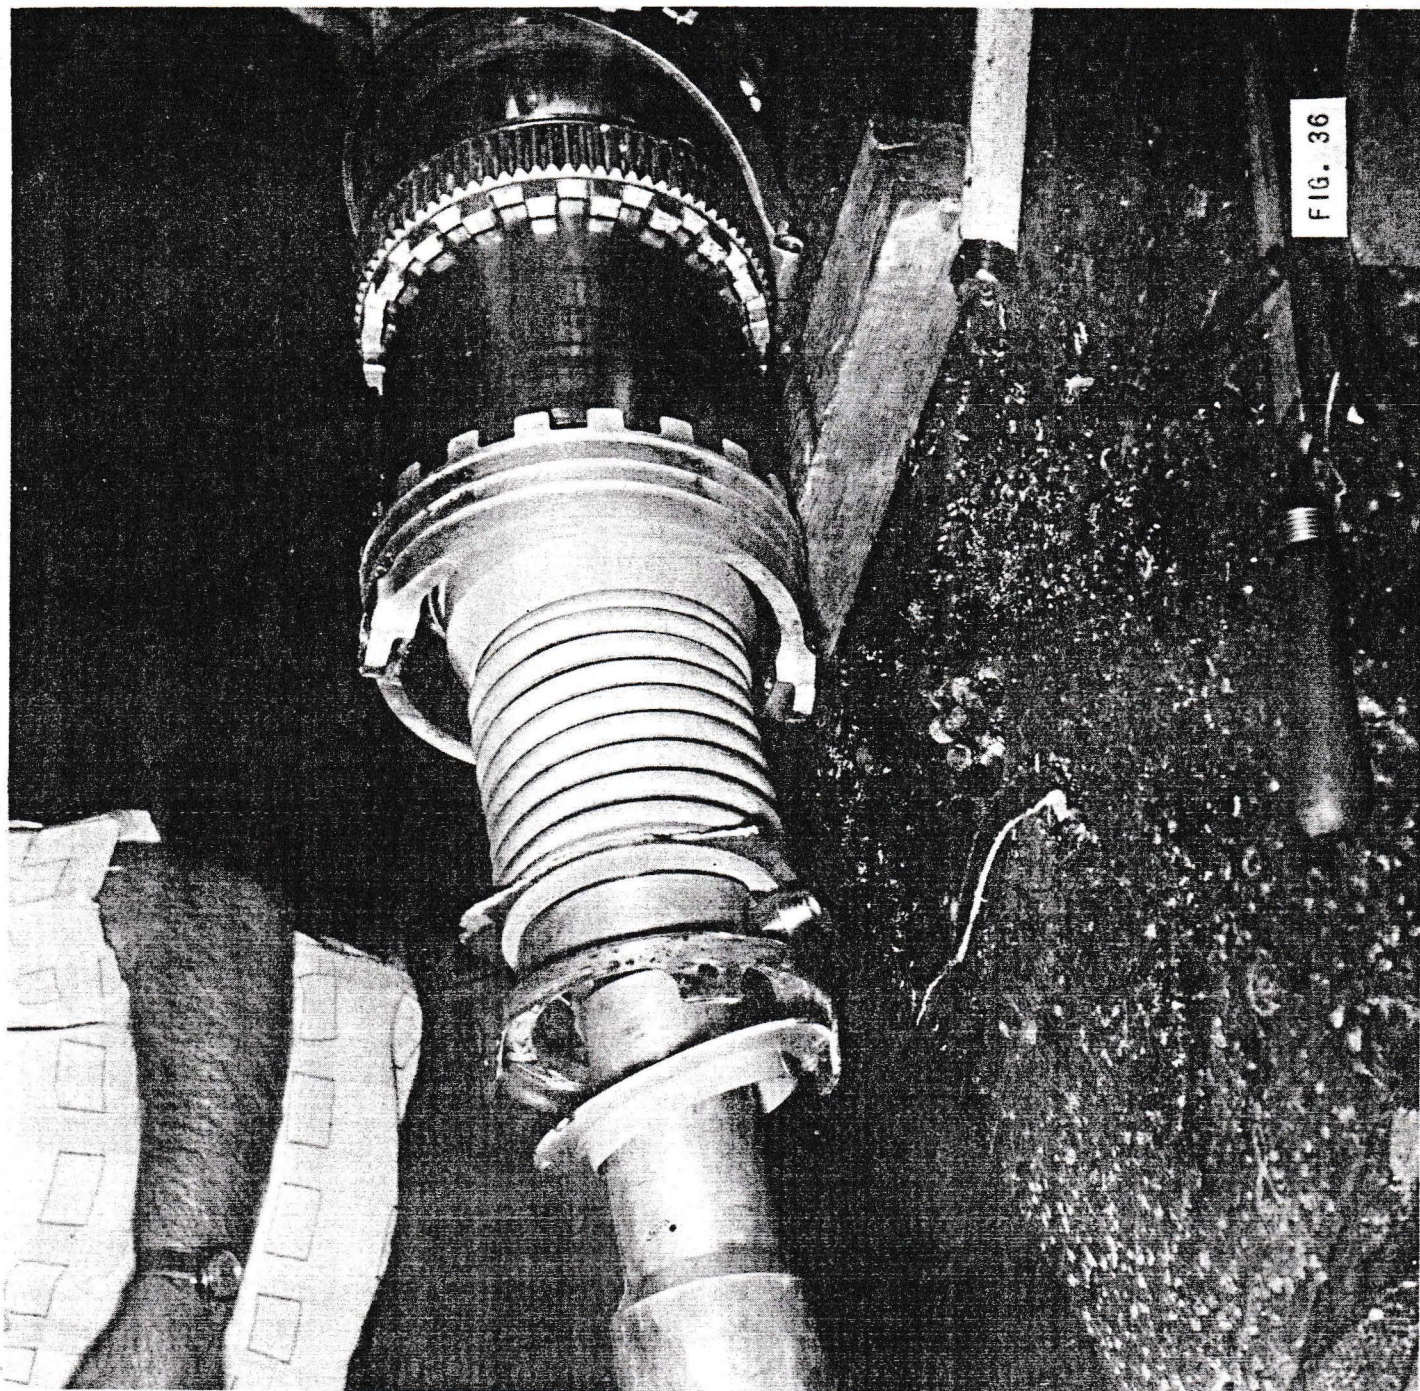
Figure 36 shows the shortening mechanism extension spring, which is almost coil bound. This is due to the locks passing beyond the normal retracted position, forcing off the end cap and then forcing the locking segments out at the top of the cylinder. A metallurgical check on the spring showed that it was according to specification, although it had a permanent set of about 1-1/2 in.

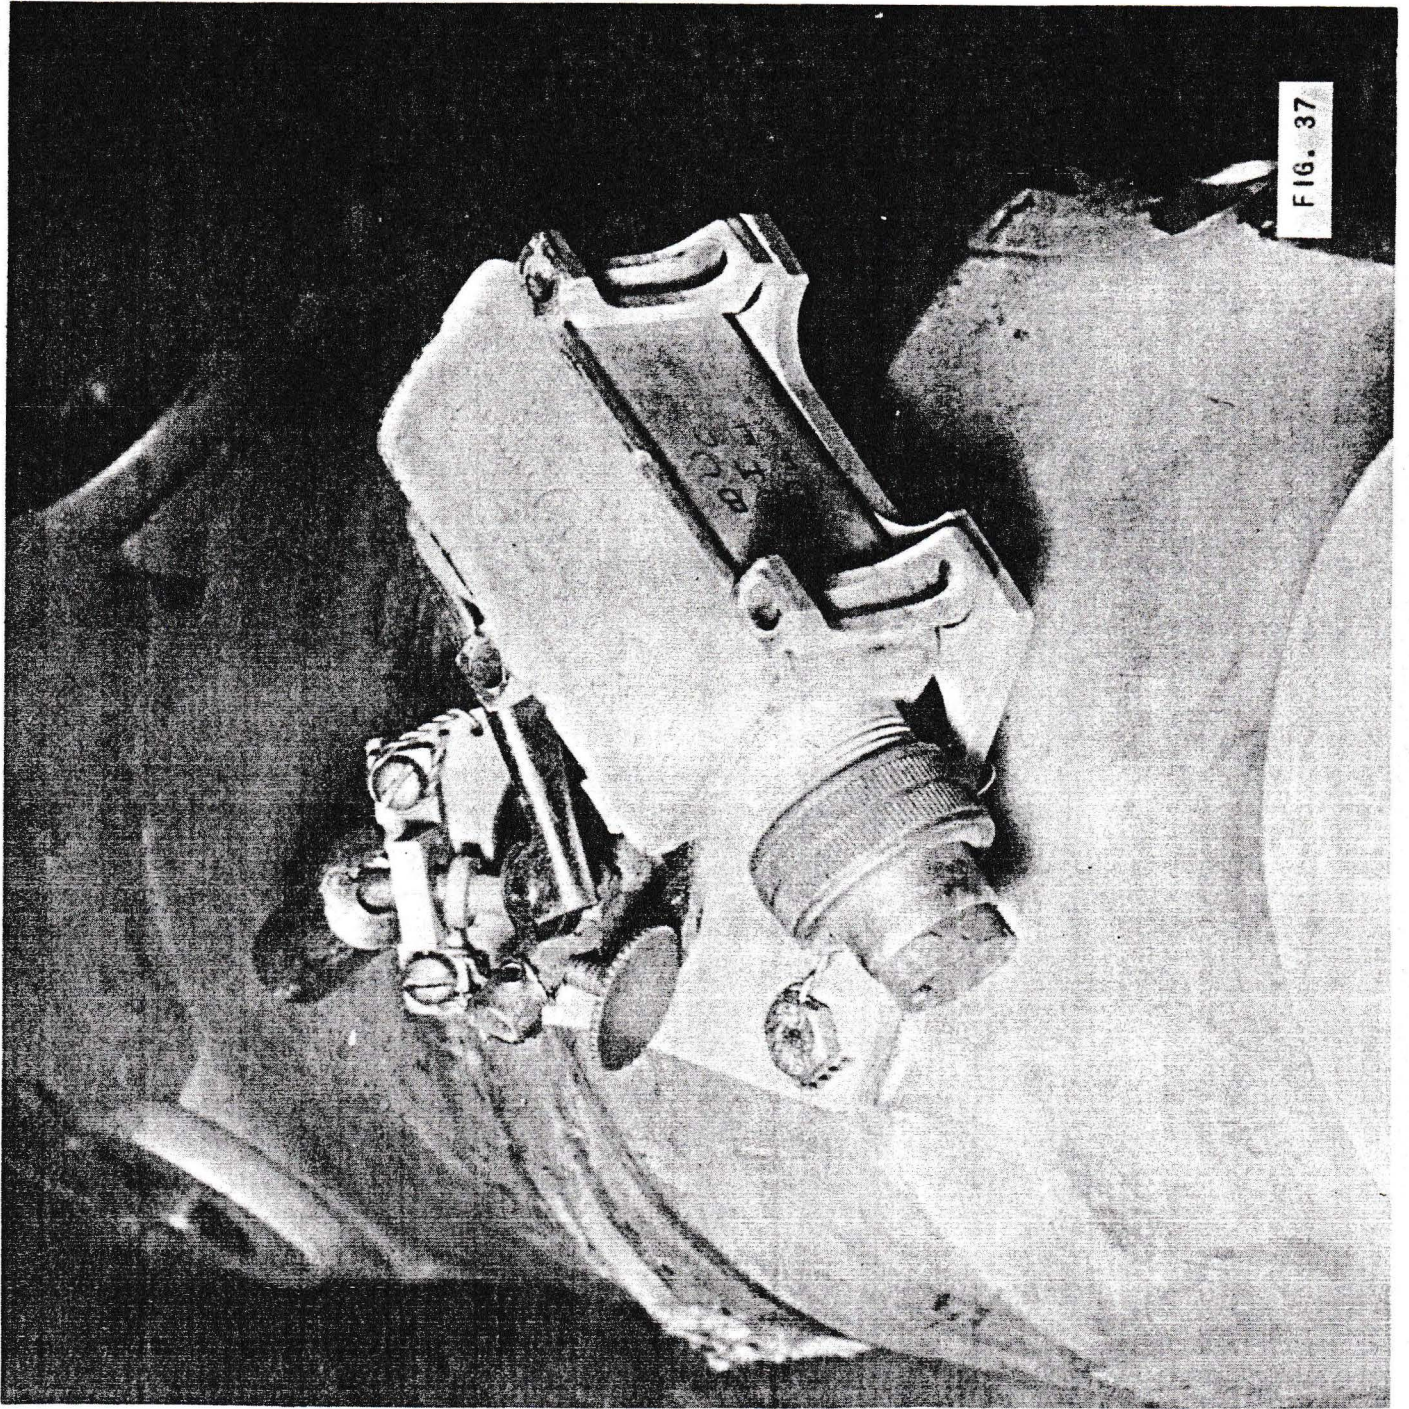
FIG. 37

Figure 37 shows the left-hand landing gear extension micro-switch and Figure 38 shows the left-hand tires.

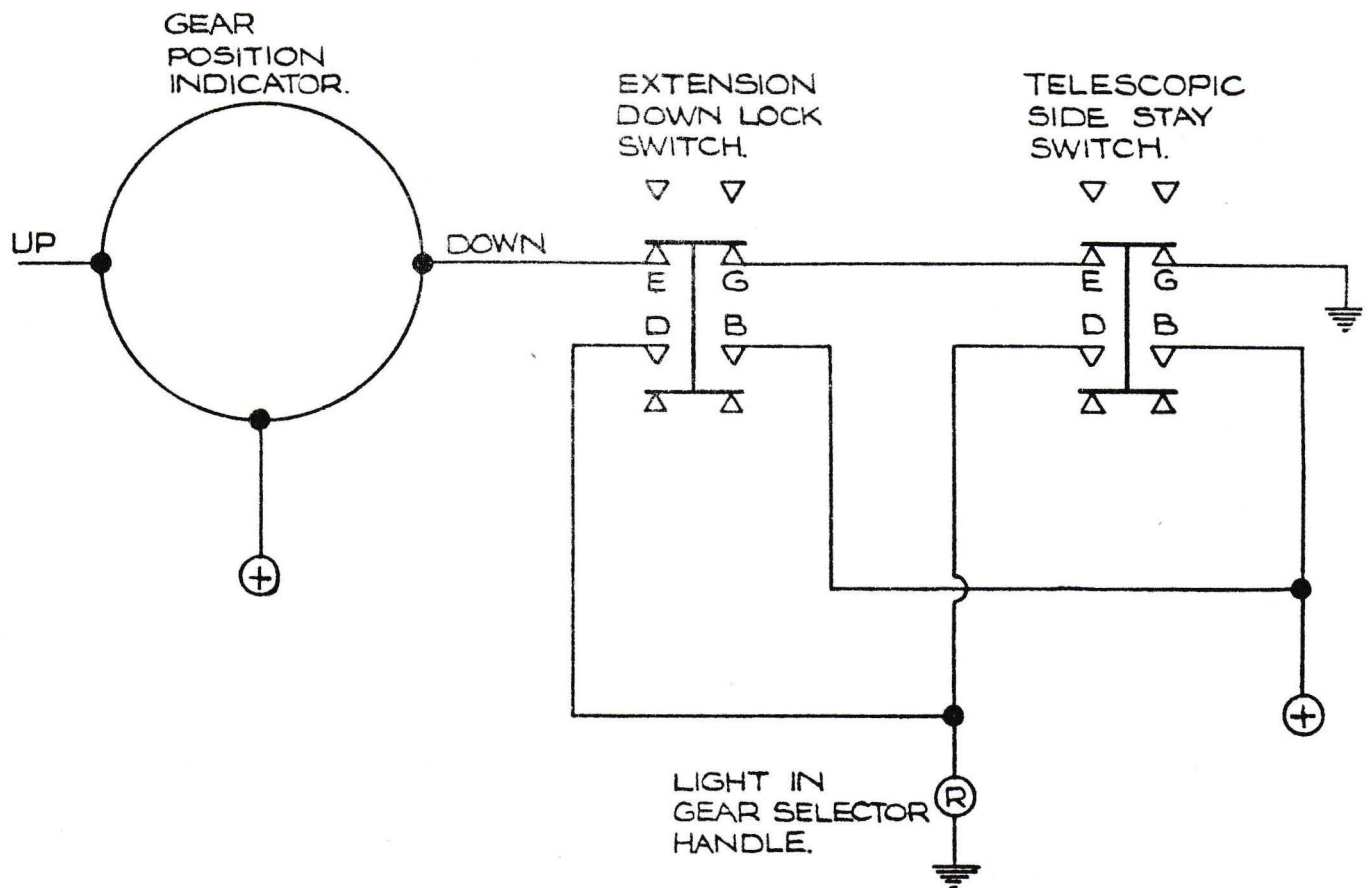
FIG. 39

Figure 39 shows the schematics of the cockpit indicator for the main landing gear. It will be noted that both micro-switches must be actuated in order to indicate GEAR DOWN - LOCKED. The working drawings were checked to ensure that the system had been correctly converted into the aircraft wiring drawings. The drawings were found to be correct. The harness from the left-hand landing gear was then re-fitted to the aircraft and circuit checks were made. The side stay micro-switch was found to be unserviceable, and a new switch was installed for the check. It is considered that the failure of this switch was due to the secondary damage, since the pilot's indicator showed the gear to be locked down. This indication would be given if both side stay and extension micro-switches are actuated and serviceable. (Ref. Figure 39.)

The above tests proved that the aircraft wiring was correct and the false indication must have been caused by micro-switch maladjustment or jamming in the wheels down position. If this switch was permanently in the actuated condition, the indication would be in order i.e. "wheels down" when the side stay was actuated and "wheels up" when the gear was retracted and the side stay micro-switch released.

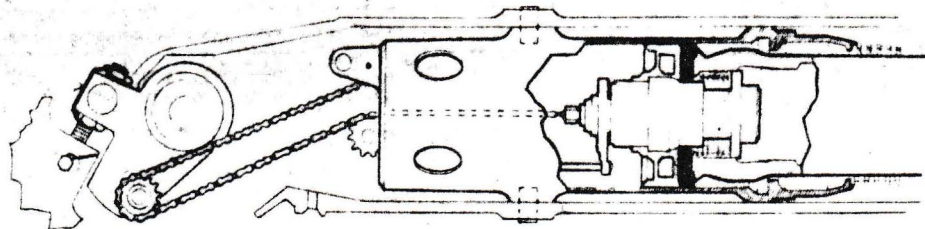
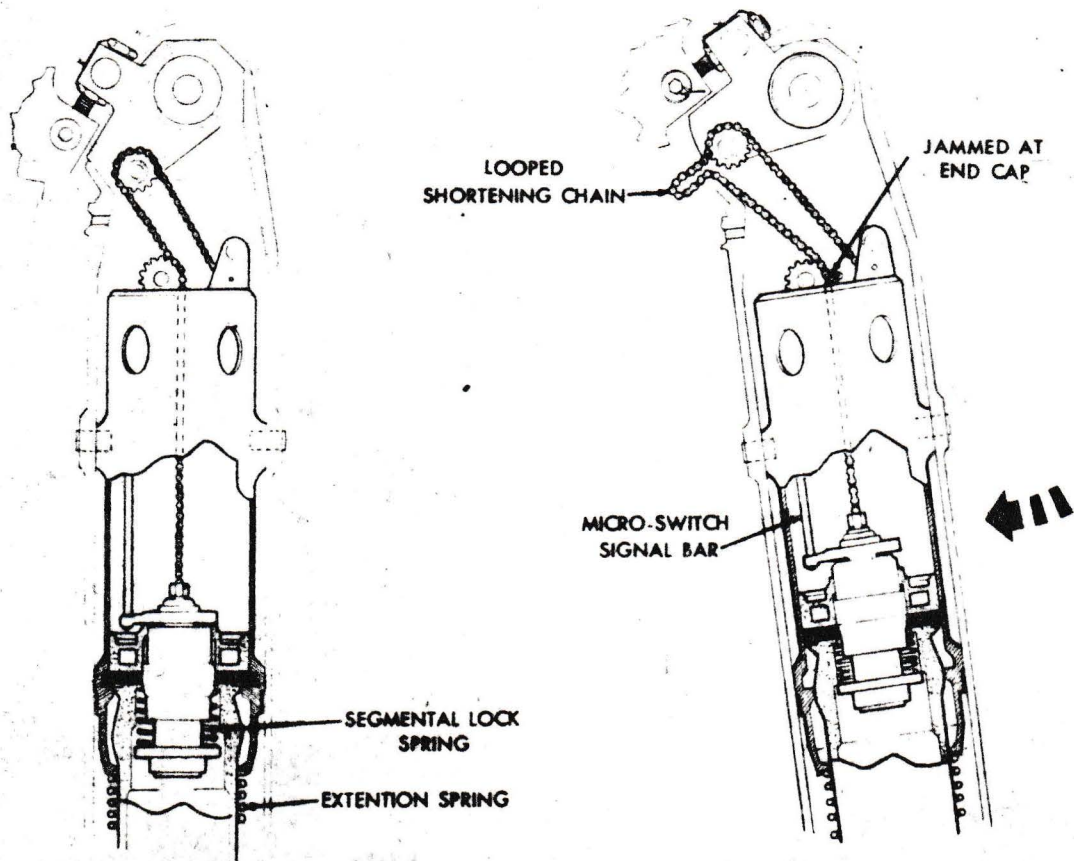
FIG. 44 DETAIL OF LEG SHORTENING MECHANISM

The main landing gear failed to extend properly. The first malfunction occurred when a "hang up" kept the extension mechanism from lowering, causing an excess amount of chain at the upper end of the gear. (See Fig. 44.)

This "hang up" cleared itself during extension, but the excess amount of chain had jammed, making proper extension impossible. Detail design of the chain mechanism is such as to make jamming almost certain if there is excess chain.
