ARROW 2 CONTROL BOXES

DEVELOPMENT PROGRAM PROGRESS REPORT

INSPECTION OF RH AILERON

REPORT NO. 71/MAINT 00/6

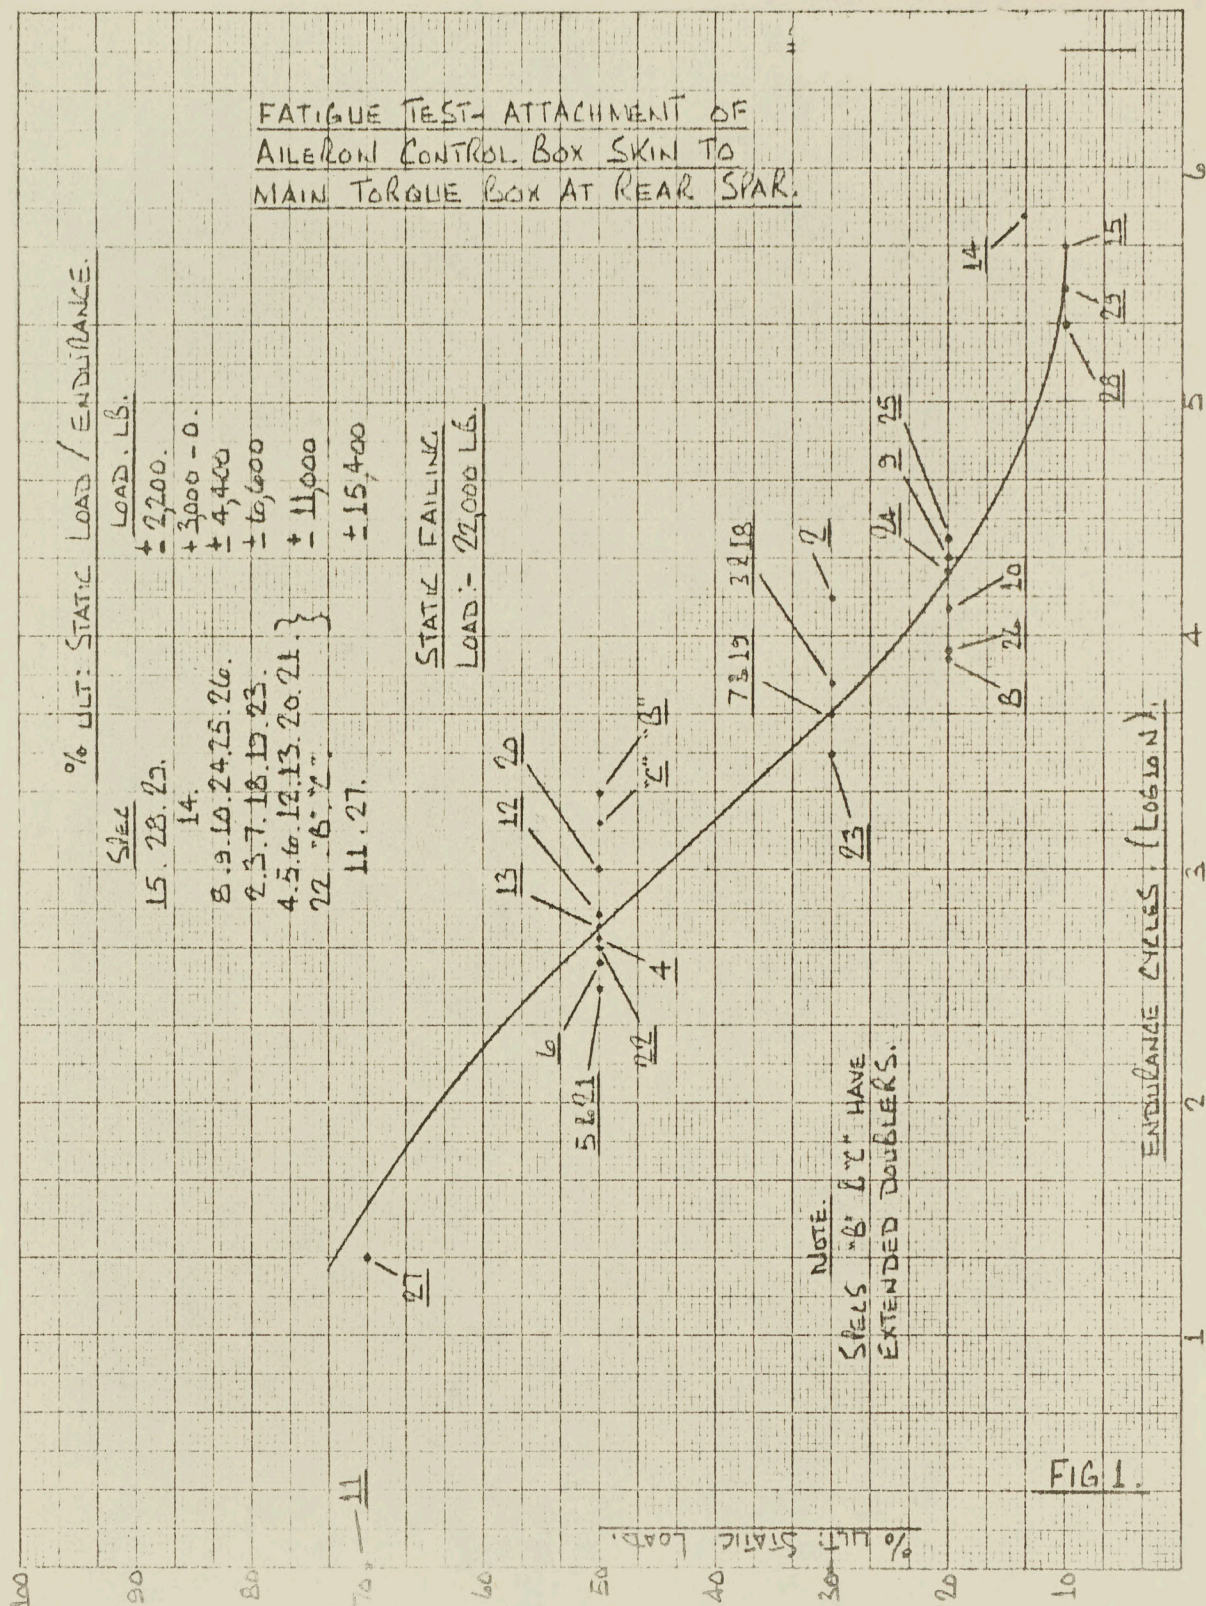
FATIGUE TEST- ATTACHMENT OF AILERON CONTROL BOX SKIN TO MAIN TORQUE BOX AT REAR SPAR.

Two specimens have been static tested (one with standard holes and one with oversize holes). and both failed at 22,000 lb thru' the thin skin at the line of bolts.

The remaining 33 specimens are at Krouse Testing Machines Inc. The results for 29 of these have been received.

Figure 1 is a plot of the results received to date (all loads are plus and minus unless noted). It has been noted that the majority of failures in these specimens were due to bolt failures. The failures recorded in Figure 1 are the first failures of bolts or skins.
