ICING IN JETS

White Menace of Aviation, Ice is Being Studied

In Jet Engine Tests by Our National Research

Council. Preliminary Report on the Experiments

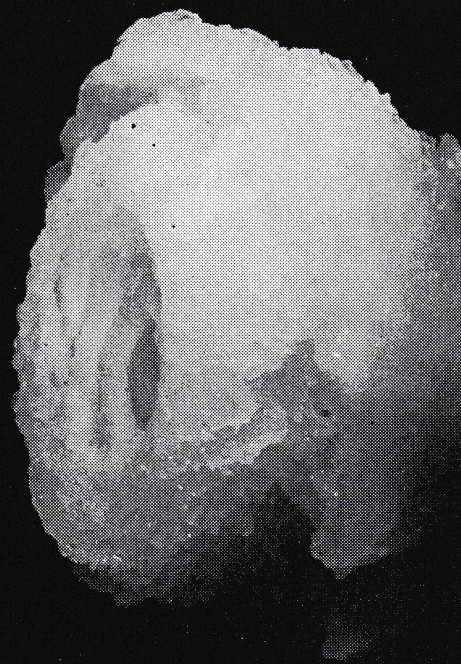
LEFT:: Side view of the ice "rose" removed from jet engine after icing run.

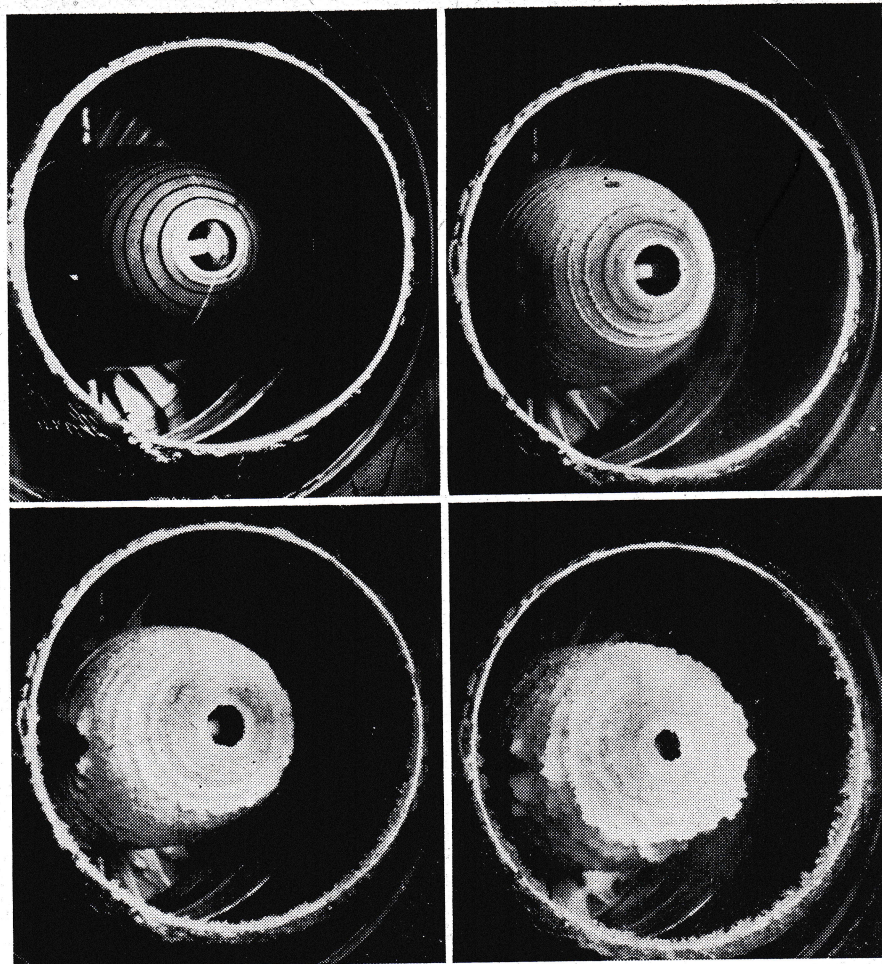
The four illustrations above show the progress of icing on the jet starter fairing and guide vanes after 0, 2, 5 and 9 minutes of water spray respectively.

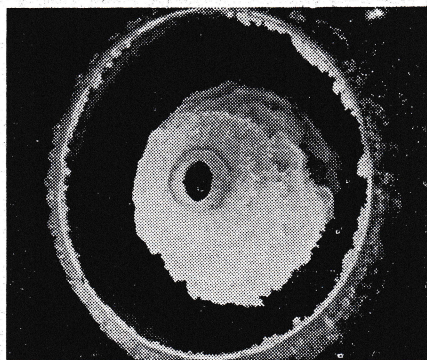
Ice "coronet" weighing 7.5 lb.

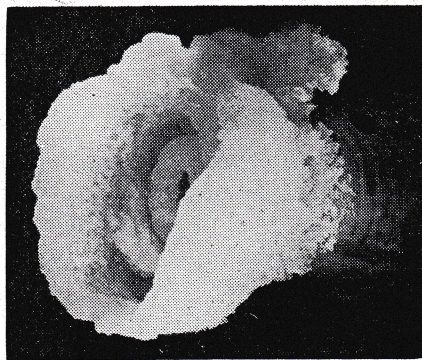
Ice "tulip" formed on jet starter fairing.

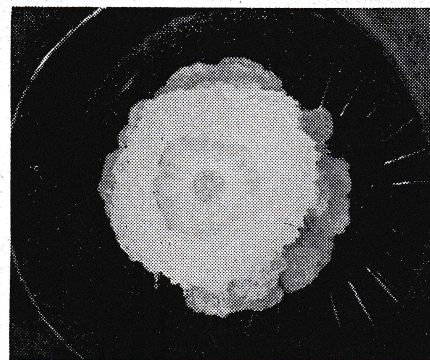
Ice "rose" formed as jet ran at 8,420 rpm.

imum continuous speed for the Jumo engine. After 25 minutes of water addition, an ice rose weighing 6.6 lb. was formed, the exhaust temperature increased only 30 deg. C, thrust dropped 60 lb. and the conditions seemed to stabilize.

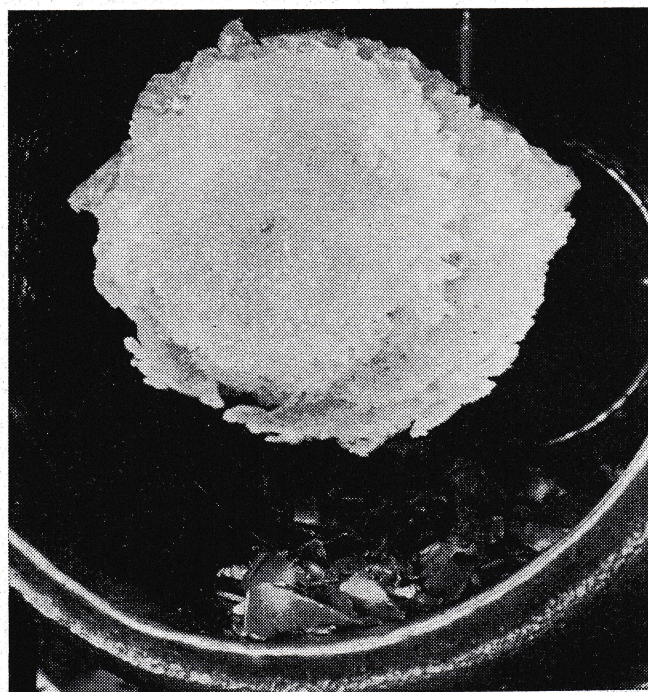
Ice "coronet" remaining after failure. Part of ice formation had broken off and demolished the compressor. Note broken blades in foreground. Weight of remaining ice was 4.7 lb.

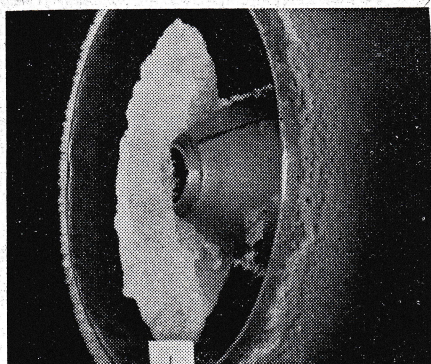
Sectioned ice "coronet" shows construction.

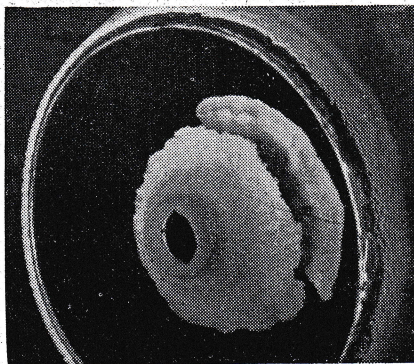
Ice "coronet" with secondary ring. Missing part broke compressor blade.

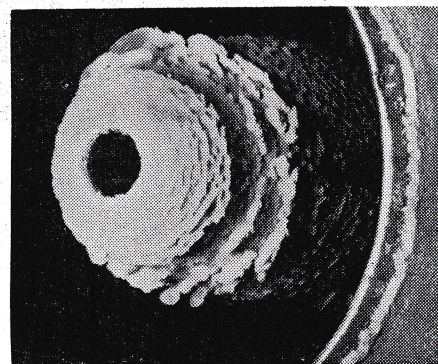
Ice "teeth formation. Separate teeth broke continuously and flew into compressor.

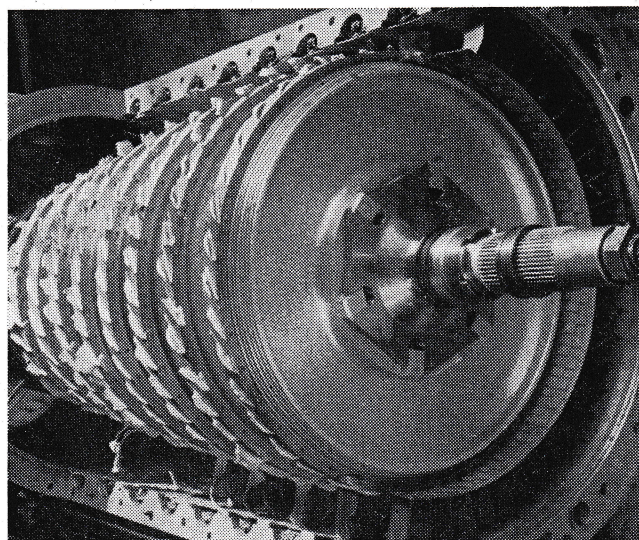
Ice breaking off the starter fairing and passing through the engine stripped all the blades from the compressor rotor as shown at right.

In another run, a part of the ice ring estimated at one pound, broke off resulting in one compressor blade in the first stage being bent. In another run, after 31.5 minutes of water addition, using an air spray nozzle at 18 feet, a large piece of ice broke loose and destroyed the compressor. The weight of the broken piece could not be exactly estimated but it is believed to have been between three and six pounds.

As the coronet built up symmetrically, it may be suspected that the structure of the ice was looser under the conditions of this test than in previous runs. All blades were stripped from the compressor rotor and the stator blades were extensively damaged. Although most of the broken blades remained in the unit, some blades and pieces of blades were thrown forward as far as 20 feet.

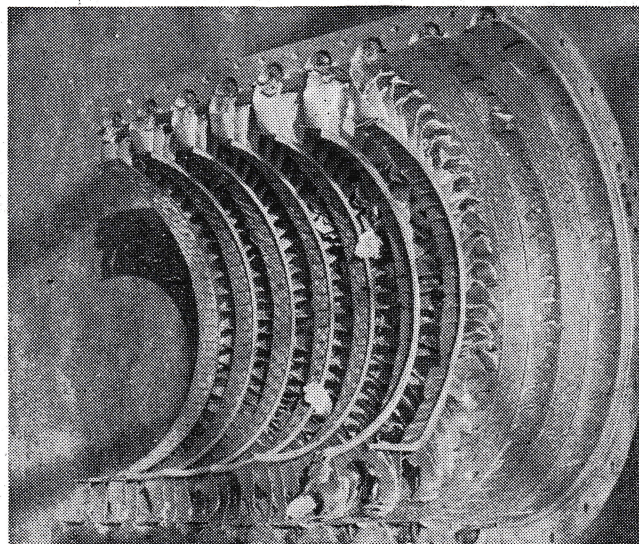
Damage to the compressor stator, right, during the same run in which the compressor rotor was stripped. The piece of ice responsible was estimated at three to six pounds in weight.
