REPORT ON ACCIDENT

AVRO ARROW 1 (25201)

PART 2

Report No. 71/ENG PUB/10

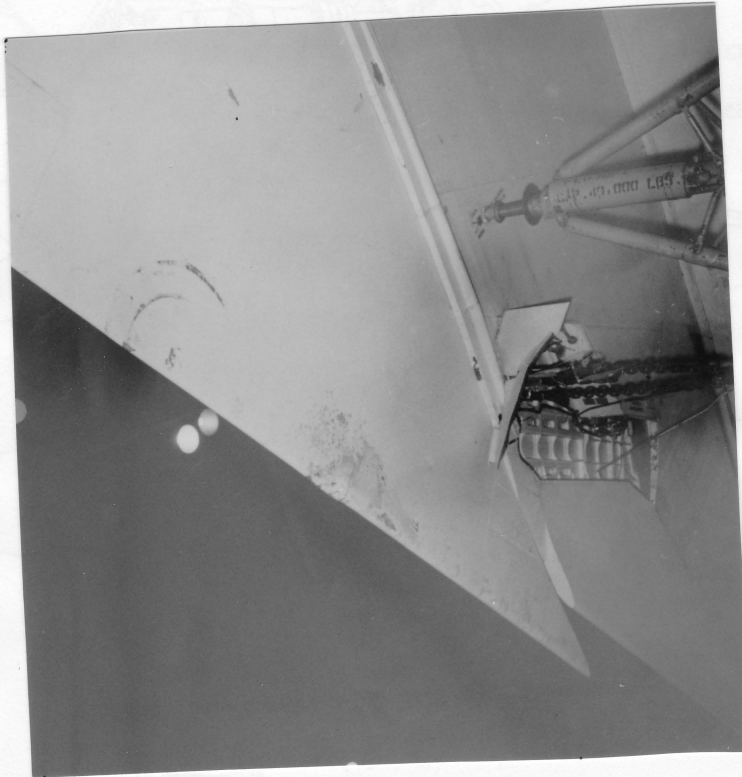
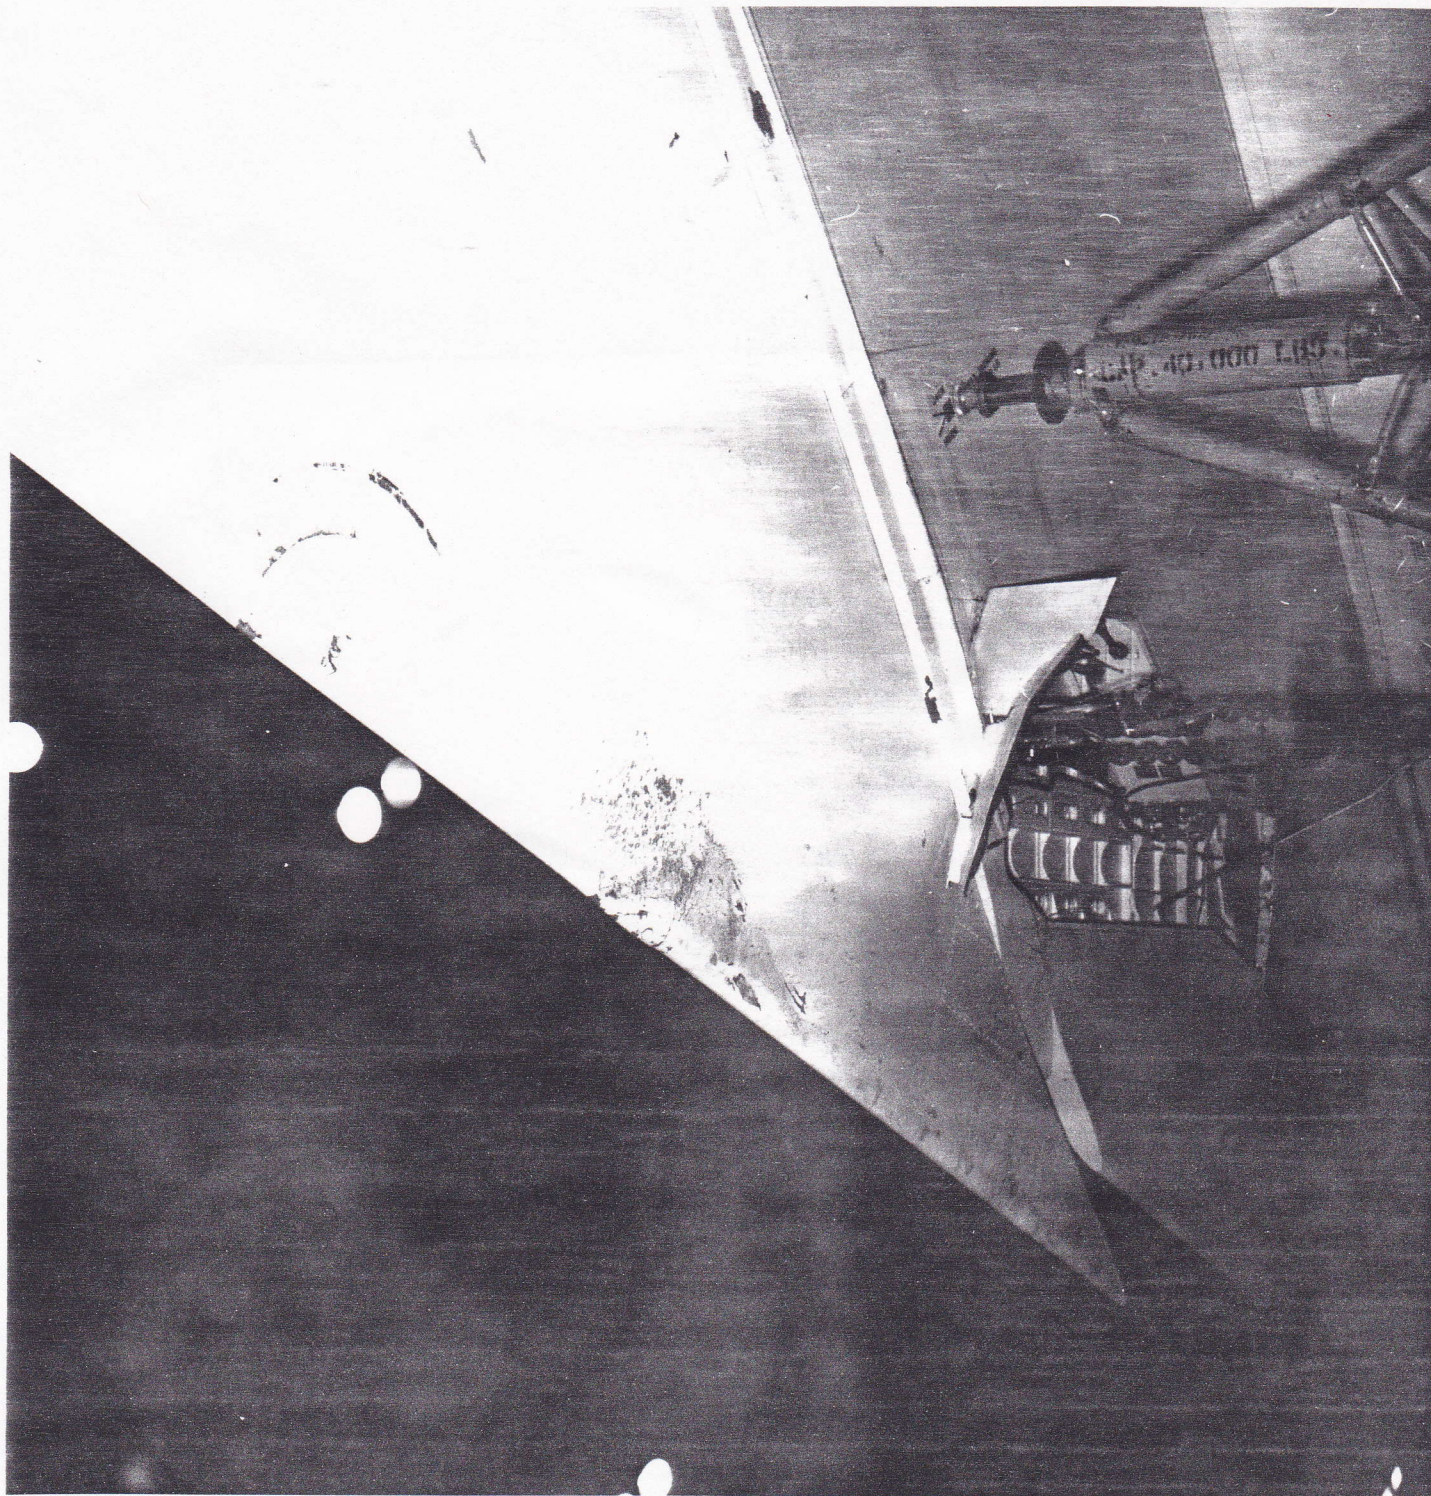
FIG. 1

Part of the outer wing leading edge and lower surface were damaged by contact with the L.H. landing gear wheels. (see Figures 1 and 2)

- (a) Nose ribs 6,7,9, 10 and 11 were replaced.
- (b) New portions of stringers 2 and 3 were spliced in.
- (c) Nose skin between ribs 6 and 14 was replaced.
- (d) New portion of nose skin spliced in between ribs 3 and 6.
- (e) Navigation light fairing and cover replaced.

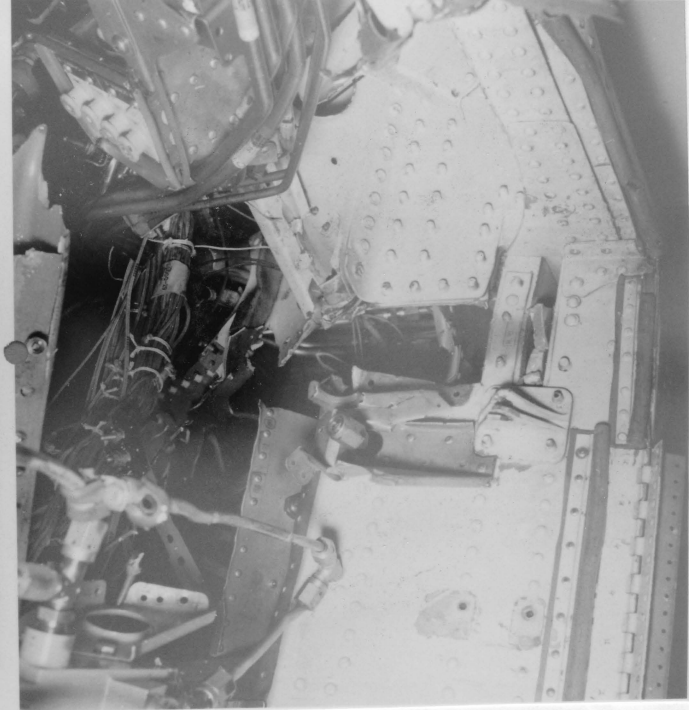
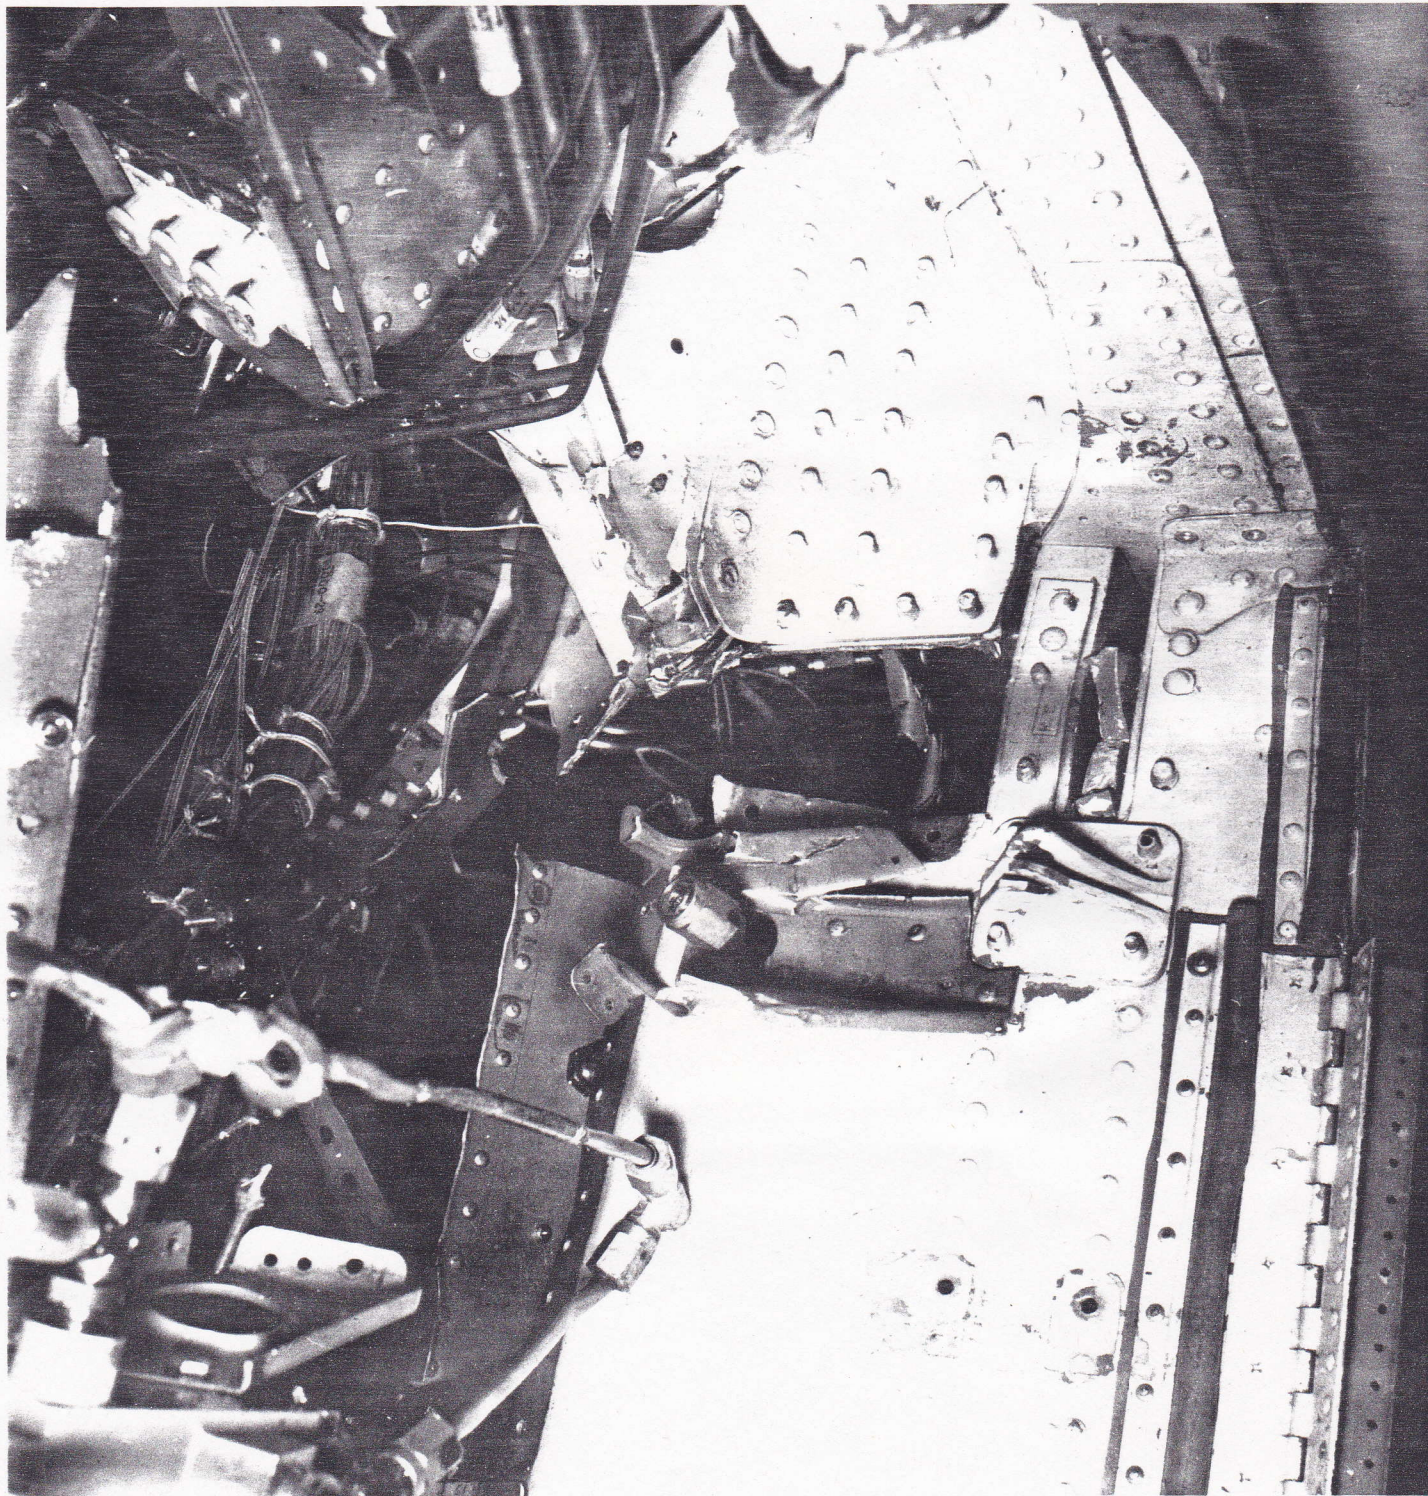
FIG.7

Major damage to the nose area was at the attachment of the nose leg pivot mountings to the flight observers bulkhead. In addition, the nose wheel bay skirt and nose wheel door were also damaged. (Ref. Figures 7, 8, 9 and 10).

Repair of the major damage to the nose area was effected by installing a new flight observer's bulkhead and cross beam assembly, below the cockpit floor. A utility jig was fabricated to position the nose leg pivot fittings. Structural repairs were made to nose wheel bay skirt, and nose wheel door.

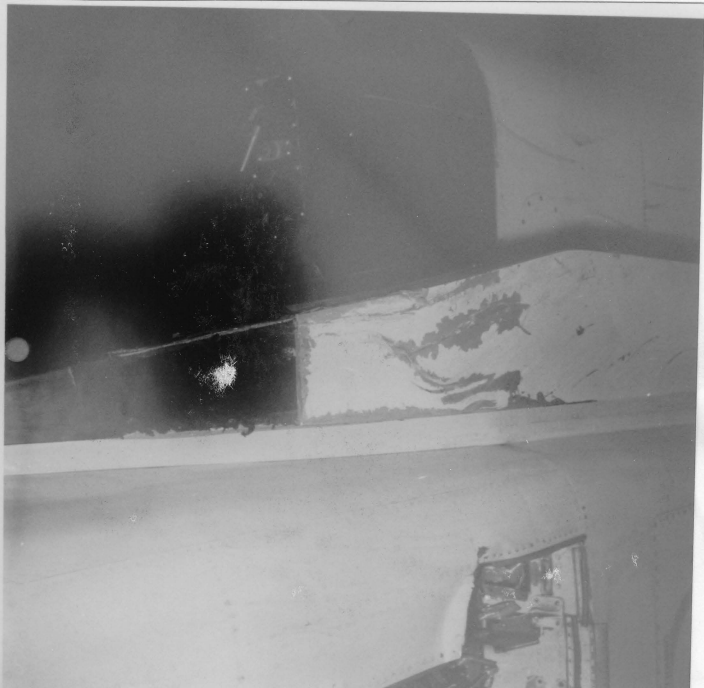
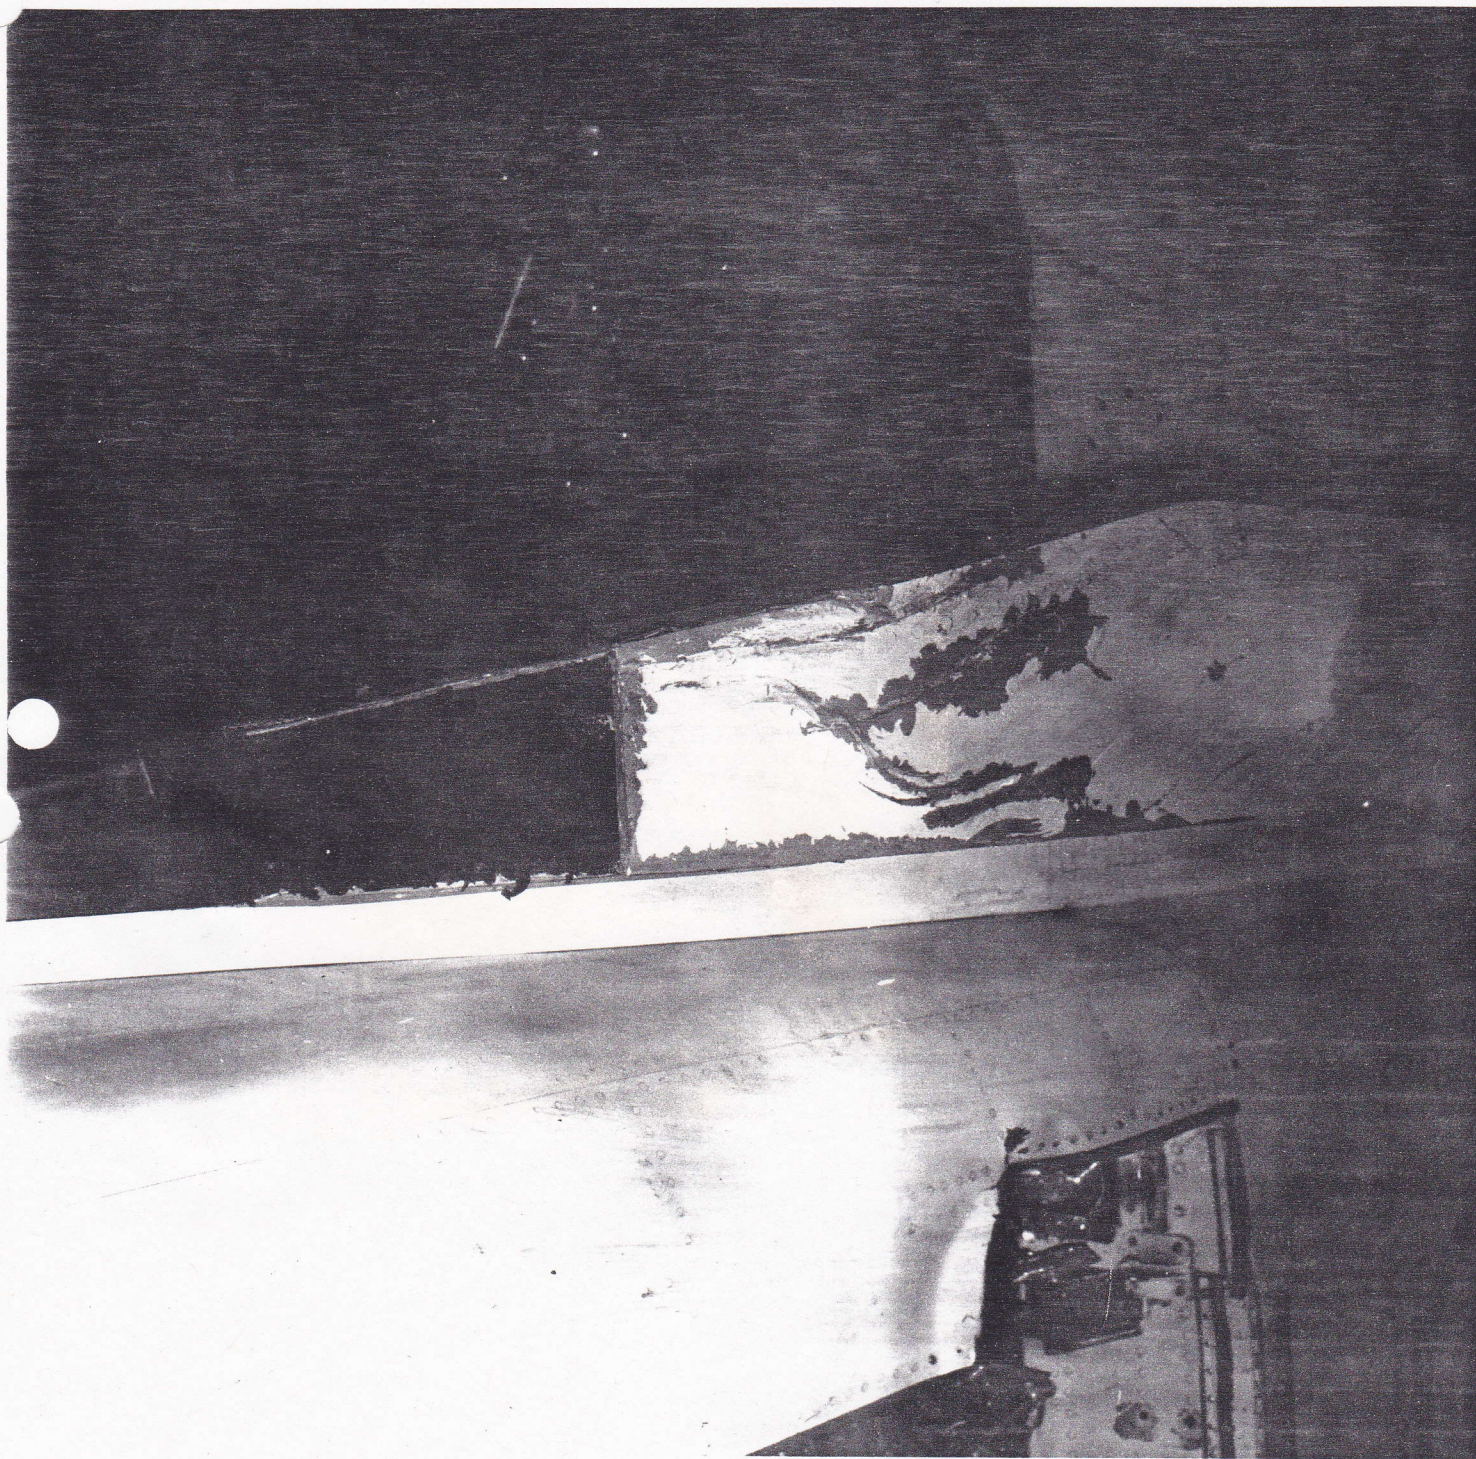
FIG. 11

The left-hand air intake ramp was buckled and cracked at the outboard web, and buckled at the inboard web. (Ref. Figures 11 and 12).

Damage to the intake ramp perforated bleed skin was determined by radiography and was repaired in situ by means of a machined patch.

- (a) De-icer boot replaced.
- (b) Bottom skin complete with attachment angle beams for the bleed skin and inner skin replaced.
- (c) Ejector scoop front guide vane replaced.

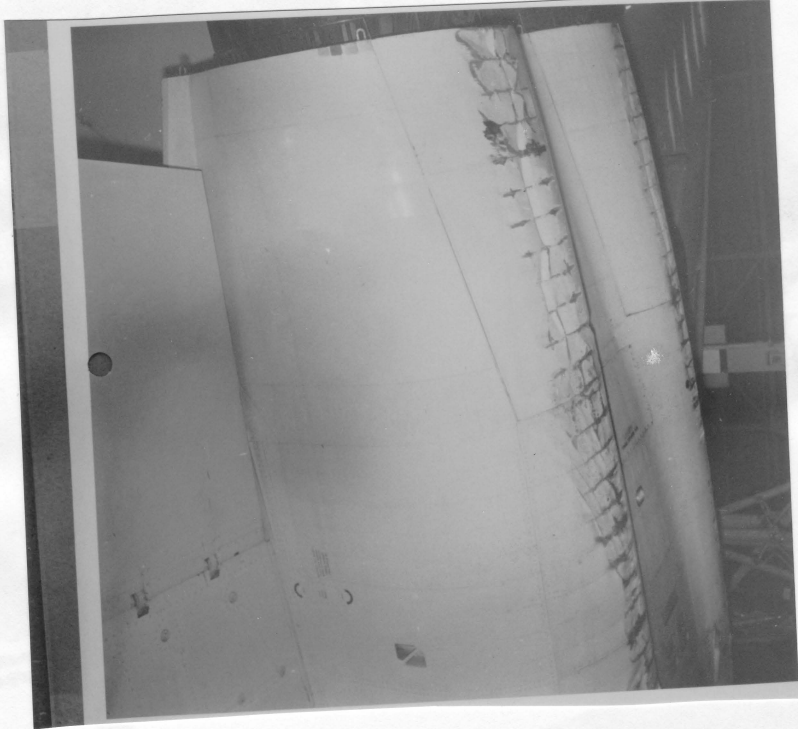
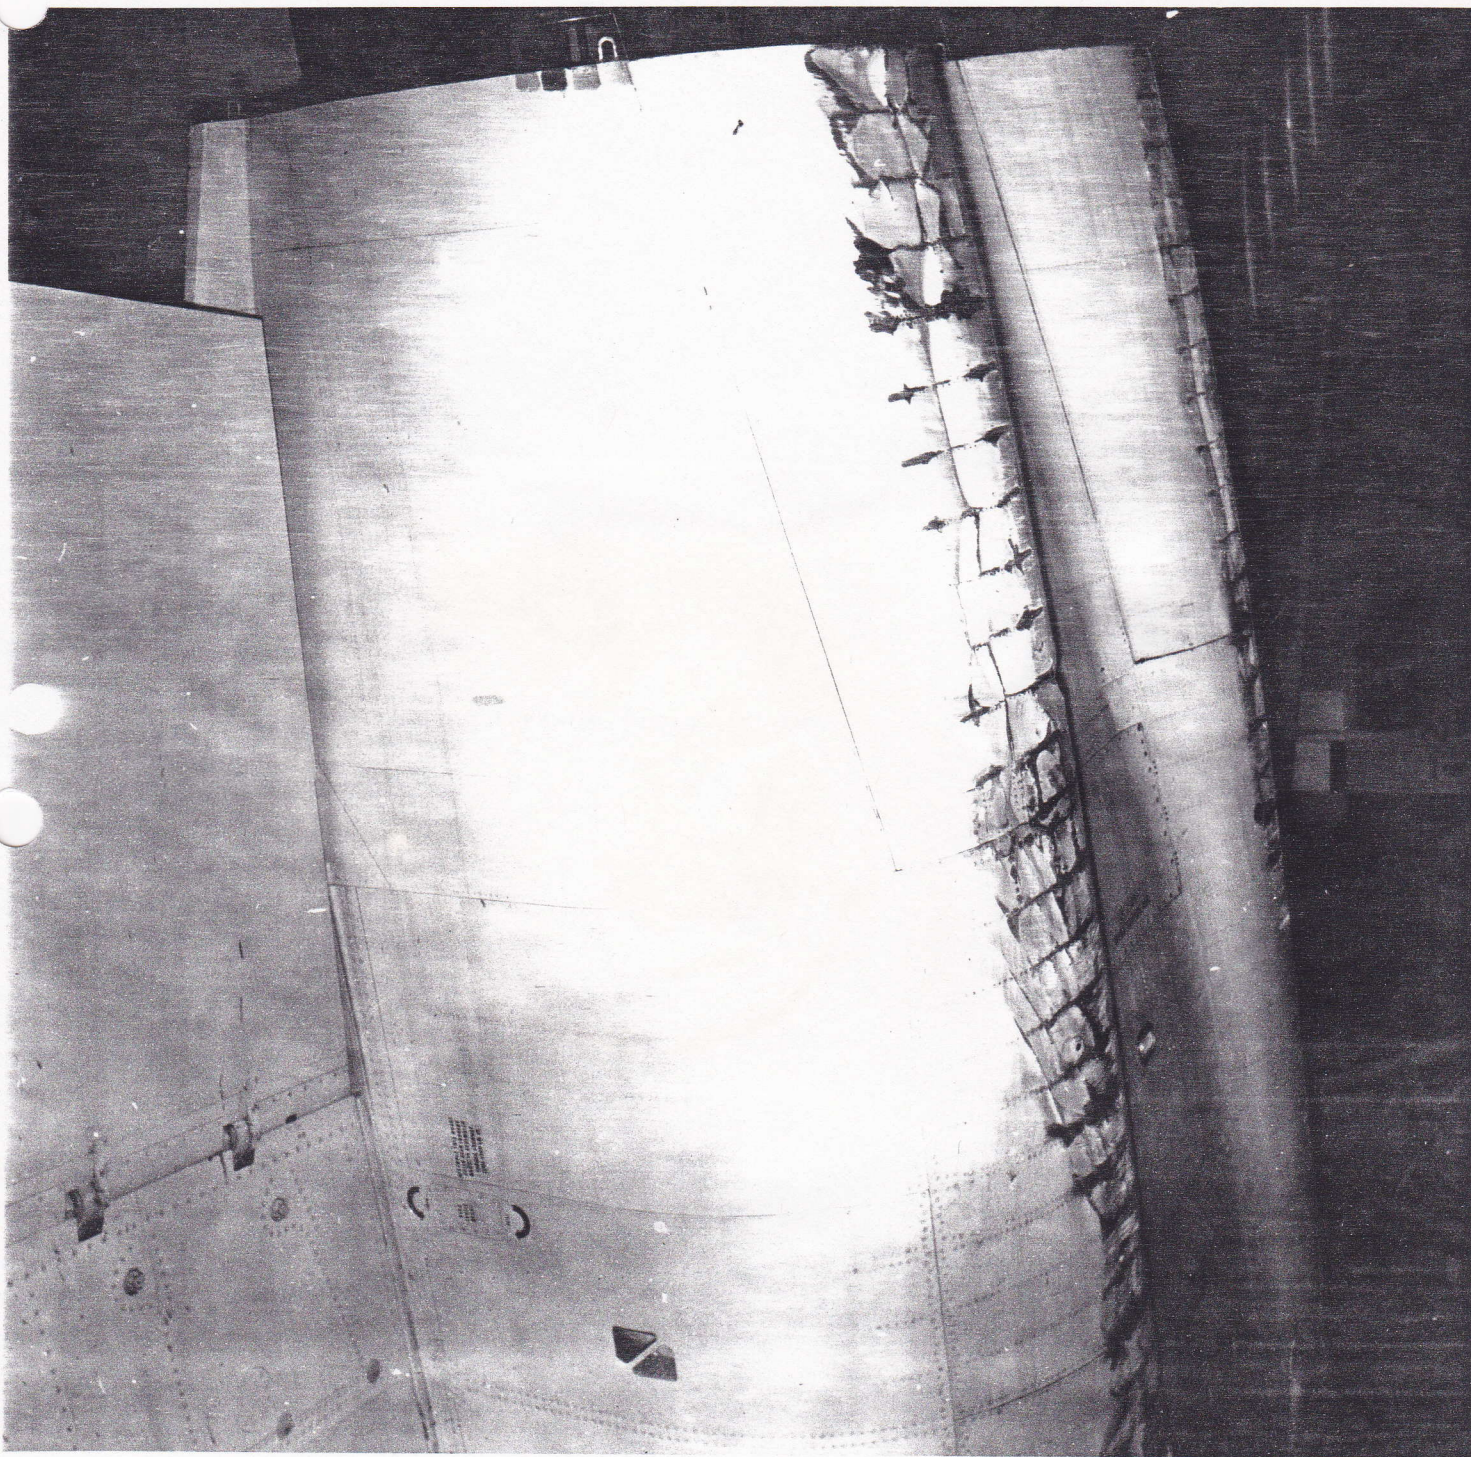
FIG.13

Damage was mainly confined to the left-hand side of the rear fuselage and engine bay. (see Figures 13 to 19 inclusive). The L.H. and R.H. rear engine doors suffered damage (Ref. Figure 13) and were replaced.

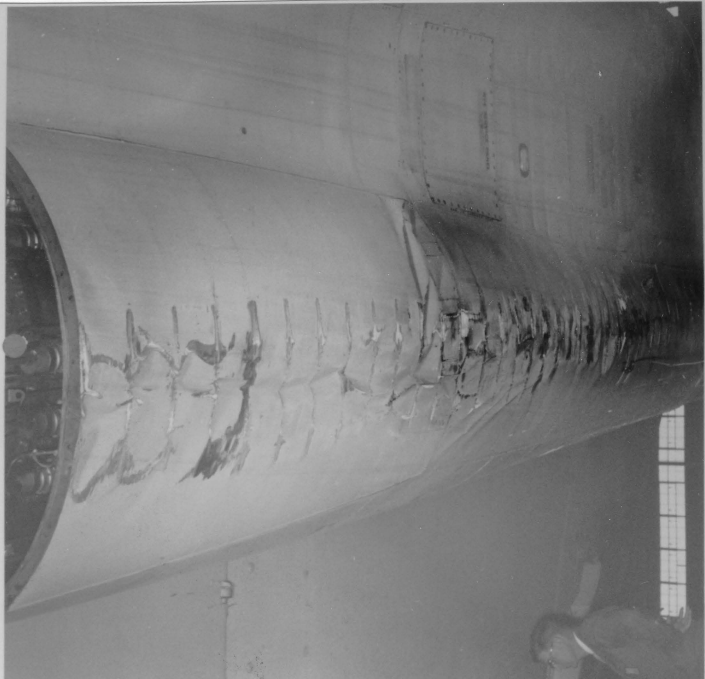
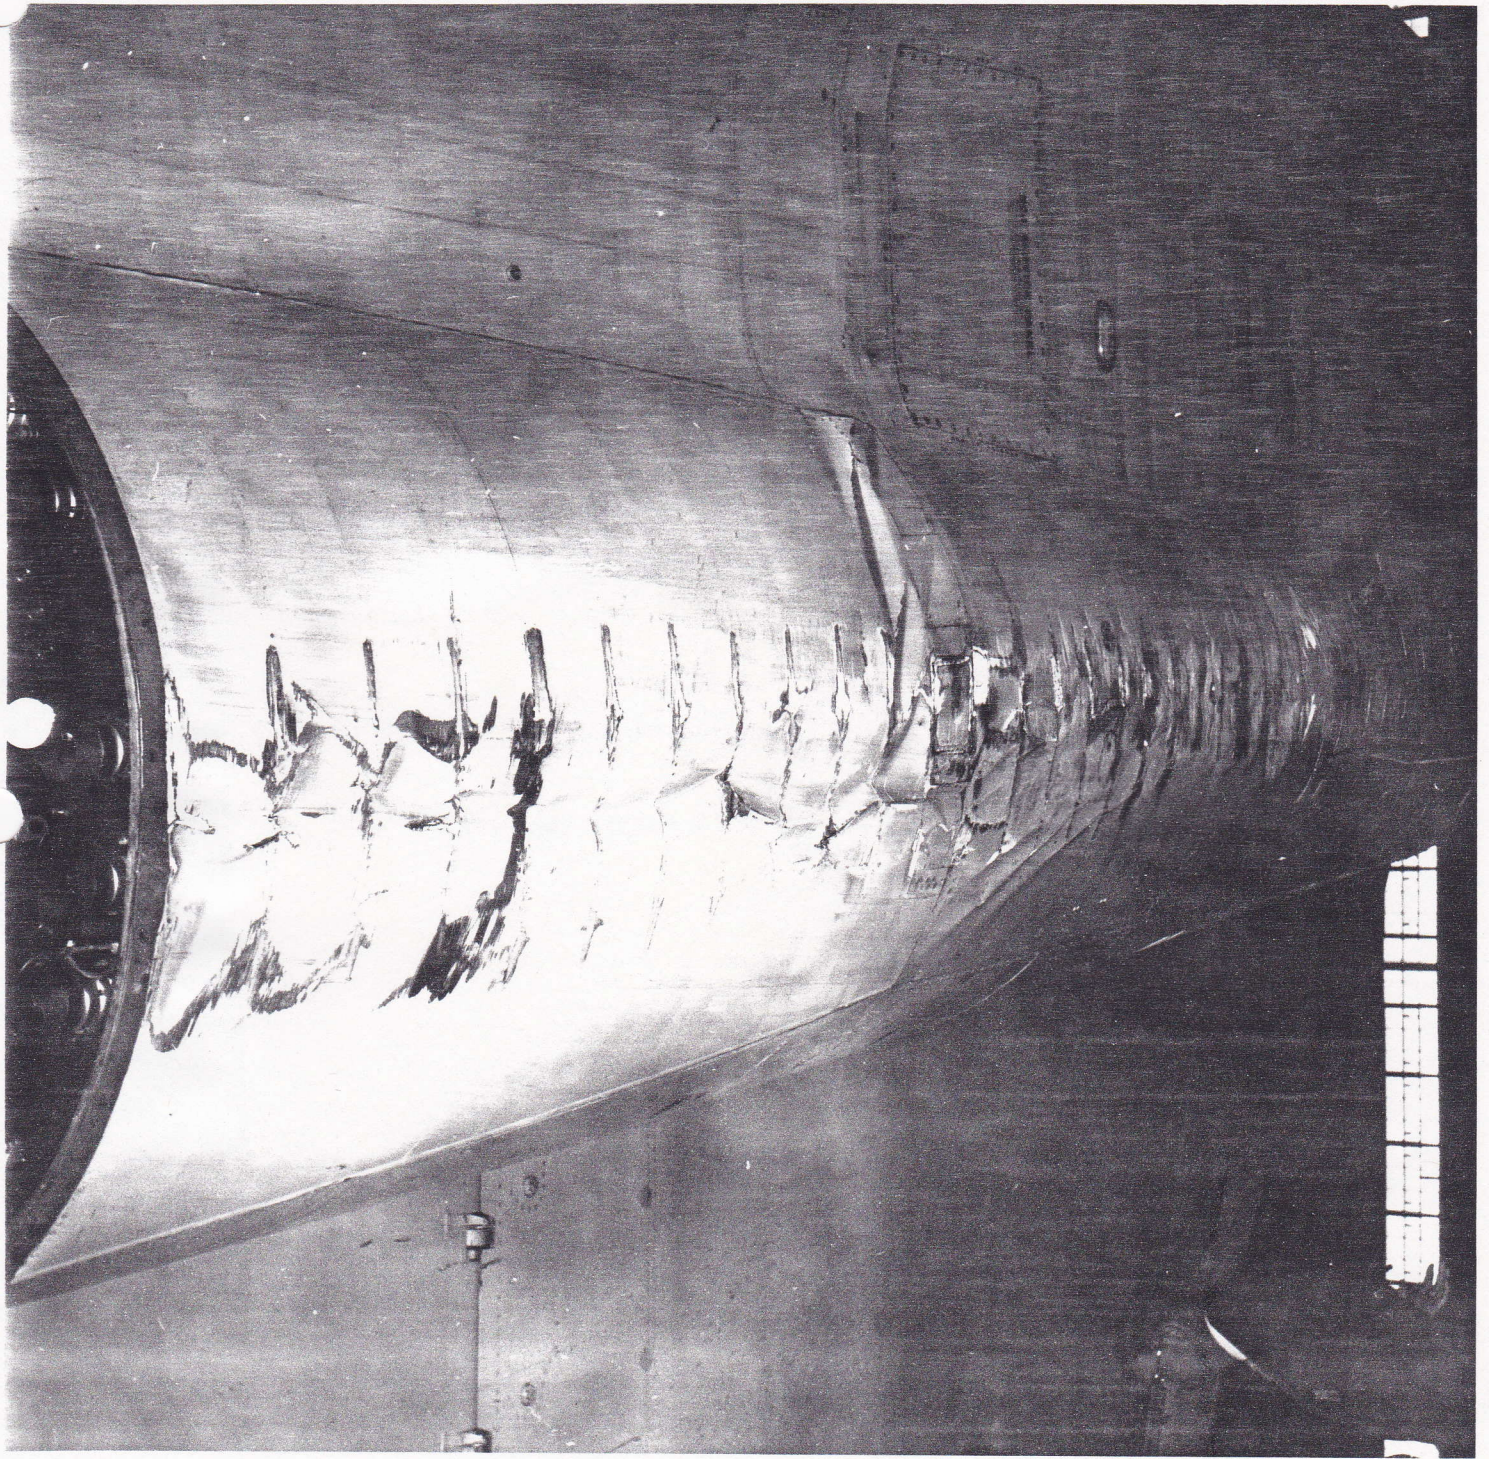
FIG.14

Figure 14 shows damage to L.H. engine access door and engine bay, just forward of the door. The L.H. engine access door was repaired and L.H. engine bay skin replaced.

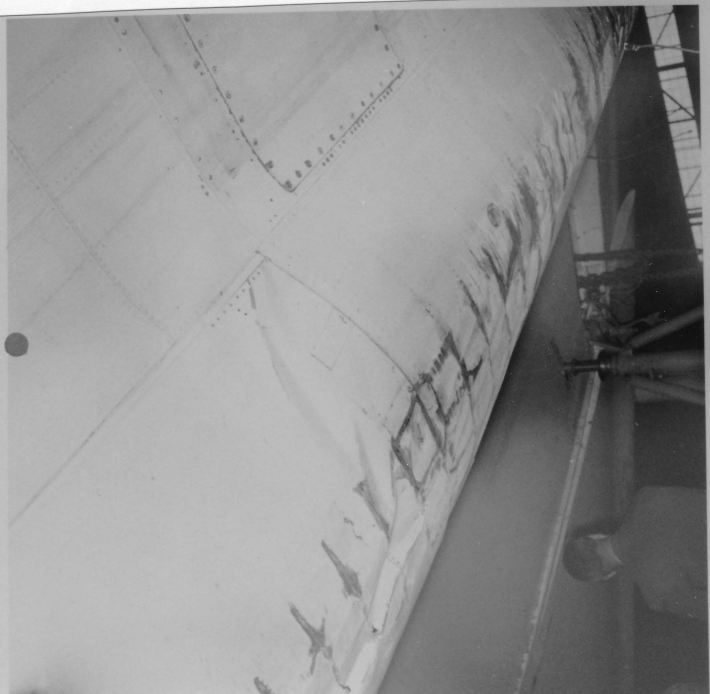
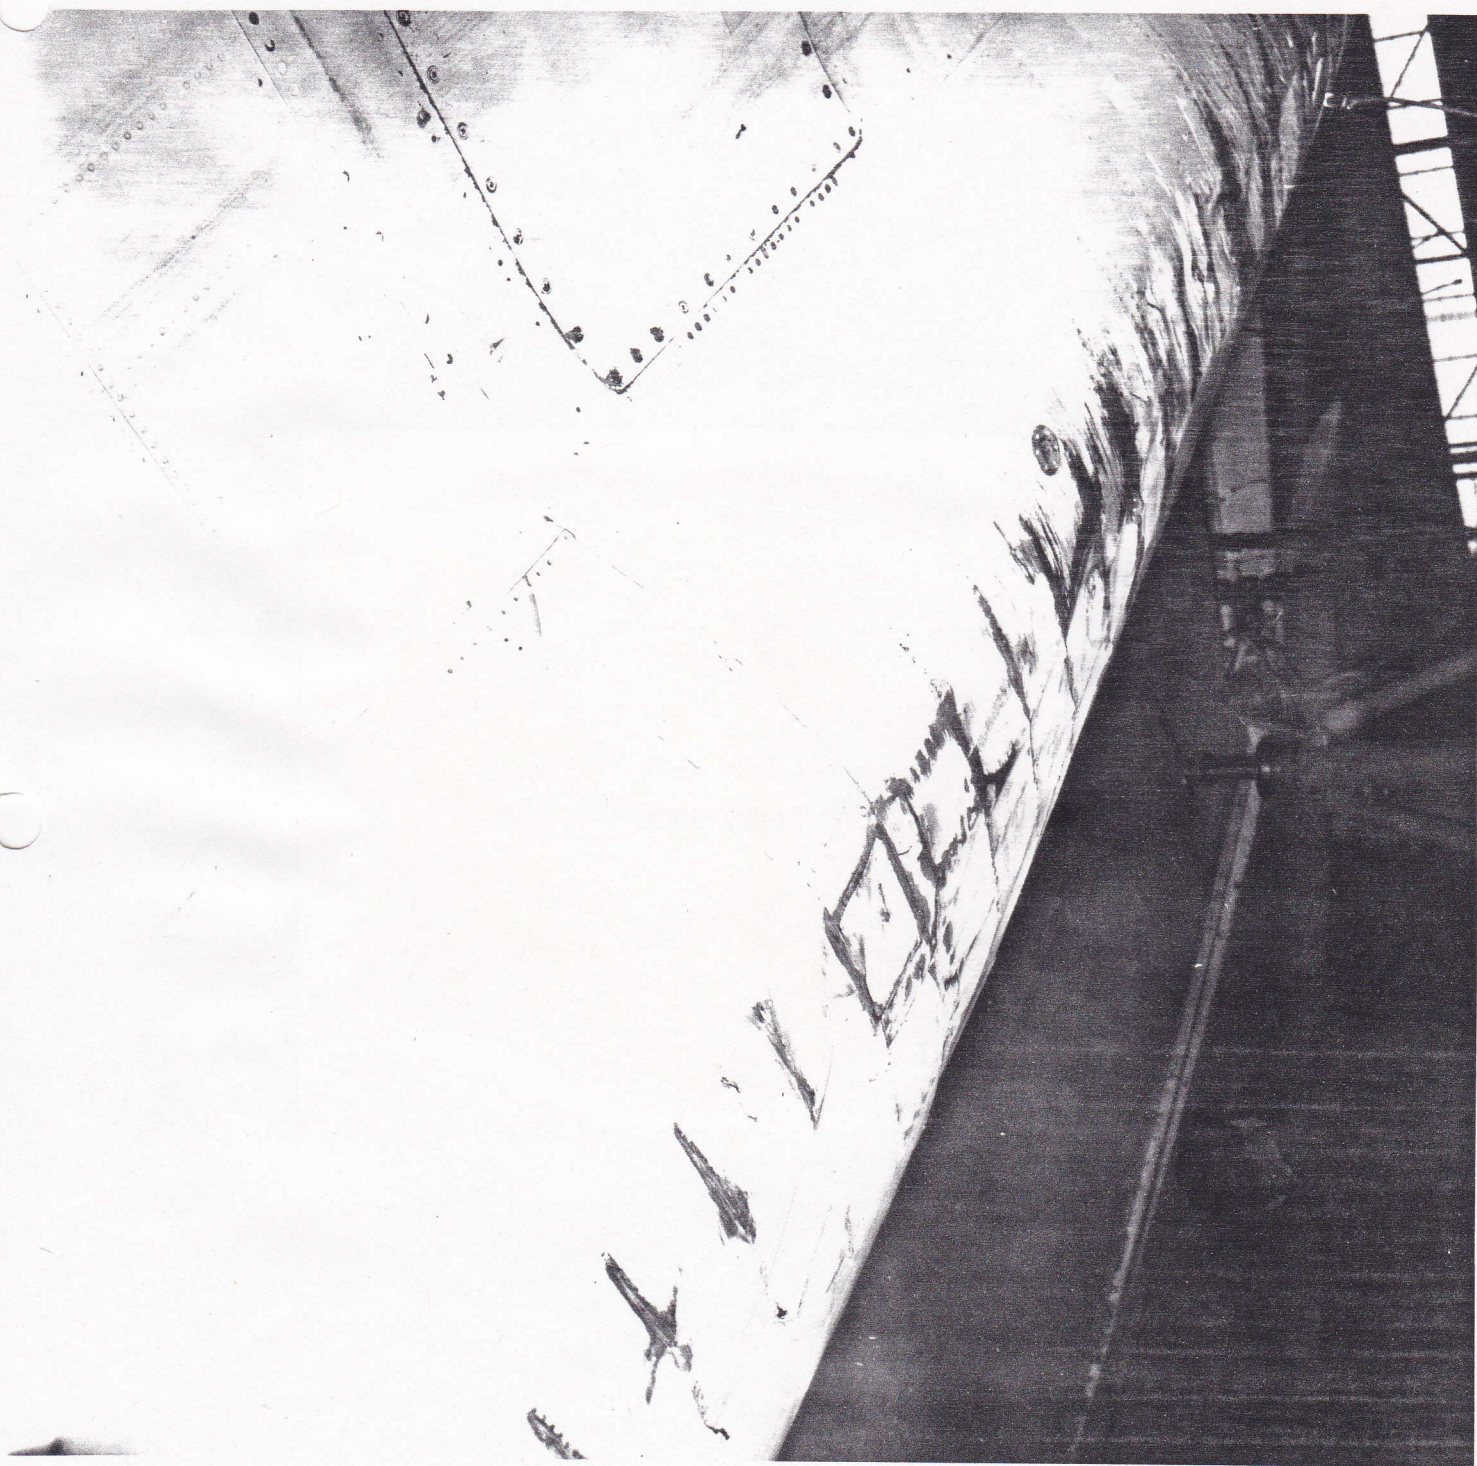
FIG.15

Figures 15 and 16 show damage to L.H. engine bay lower surface.

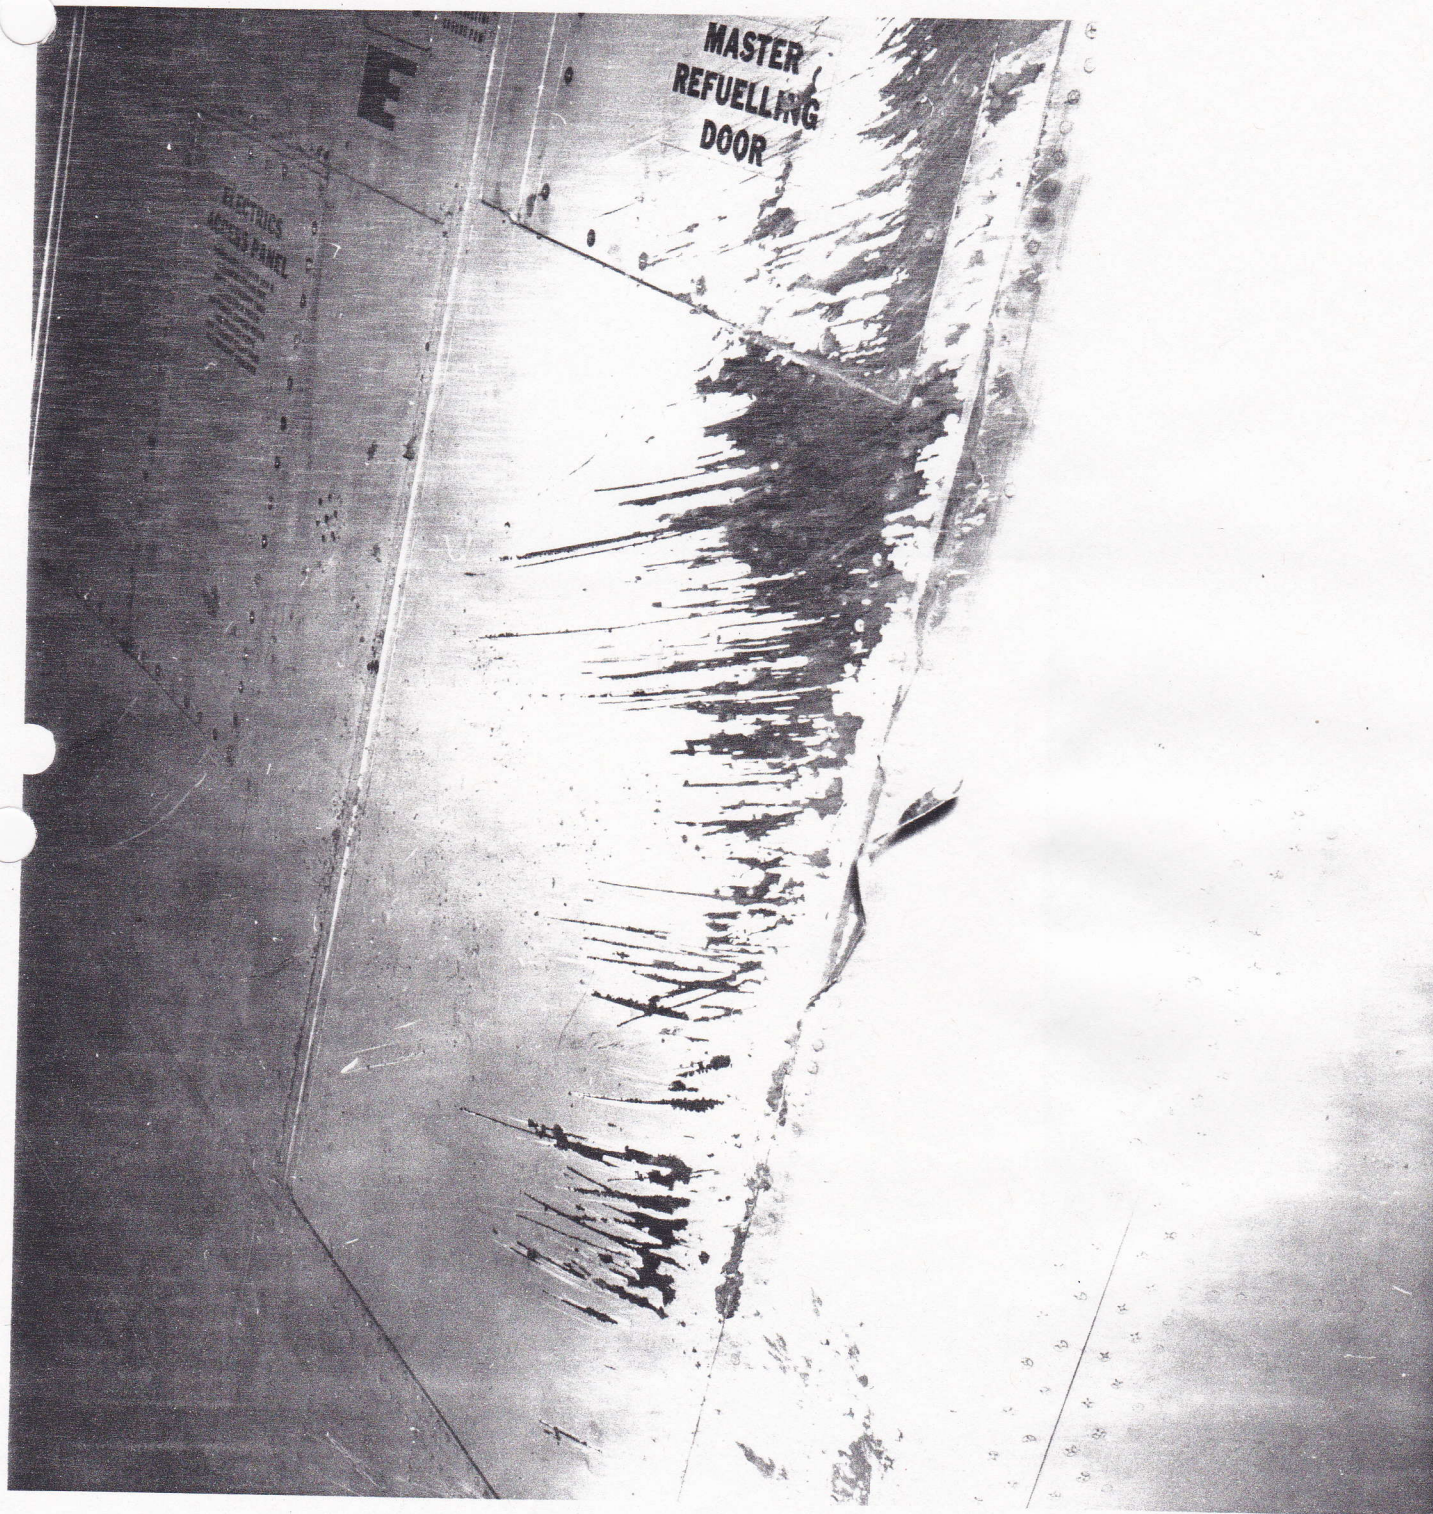
FIG.17

Figures 17, 18 and 19 show damage at forward positions of L.H. engine bay.

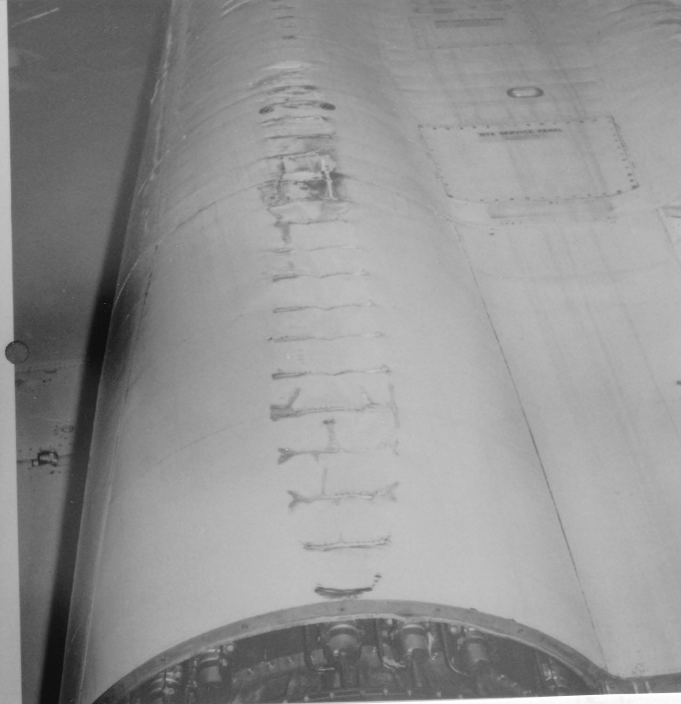
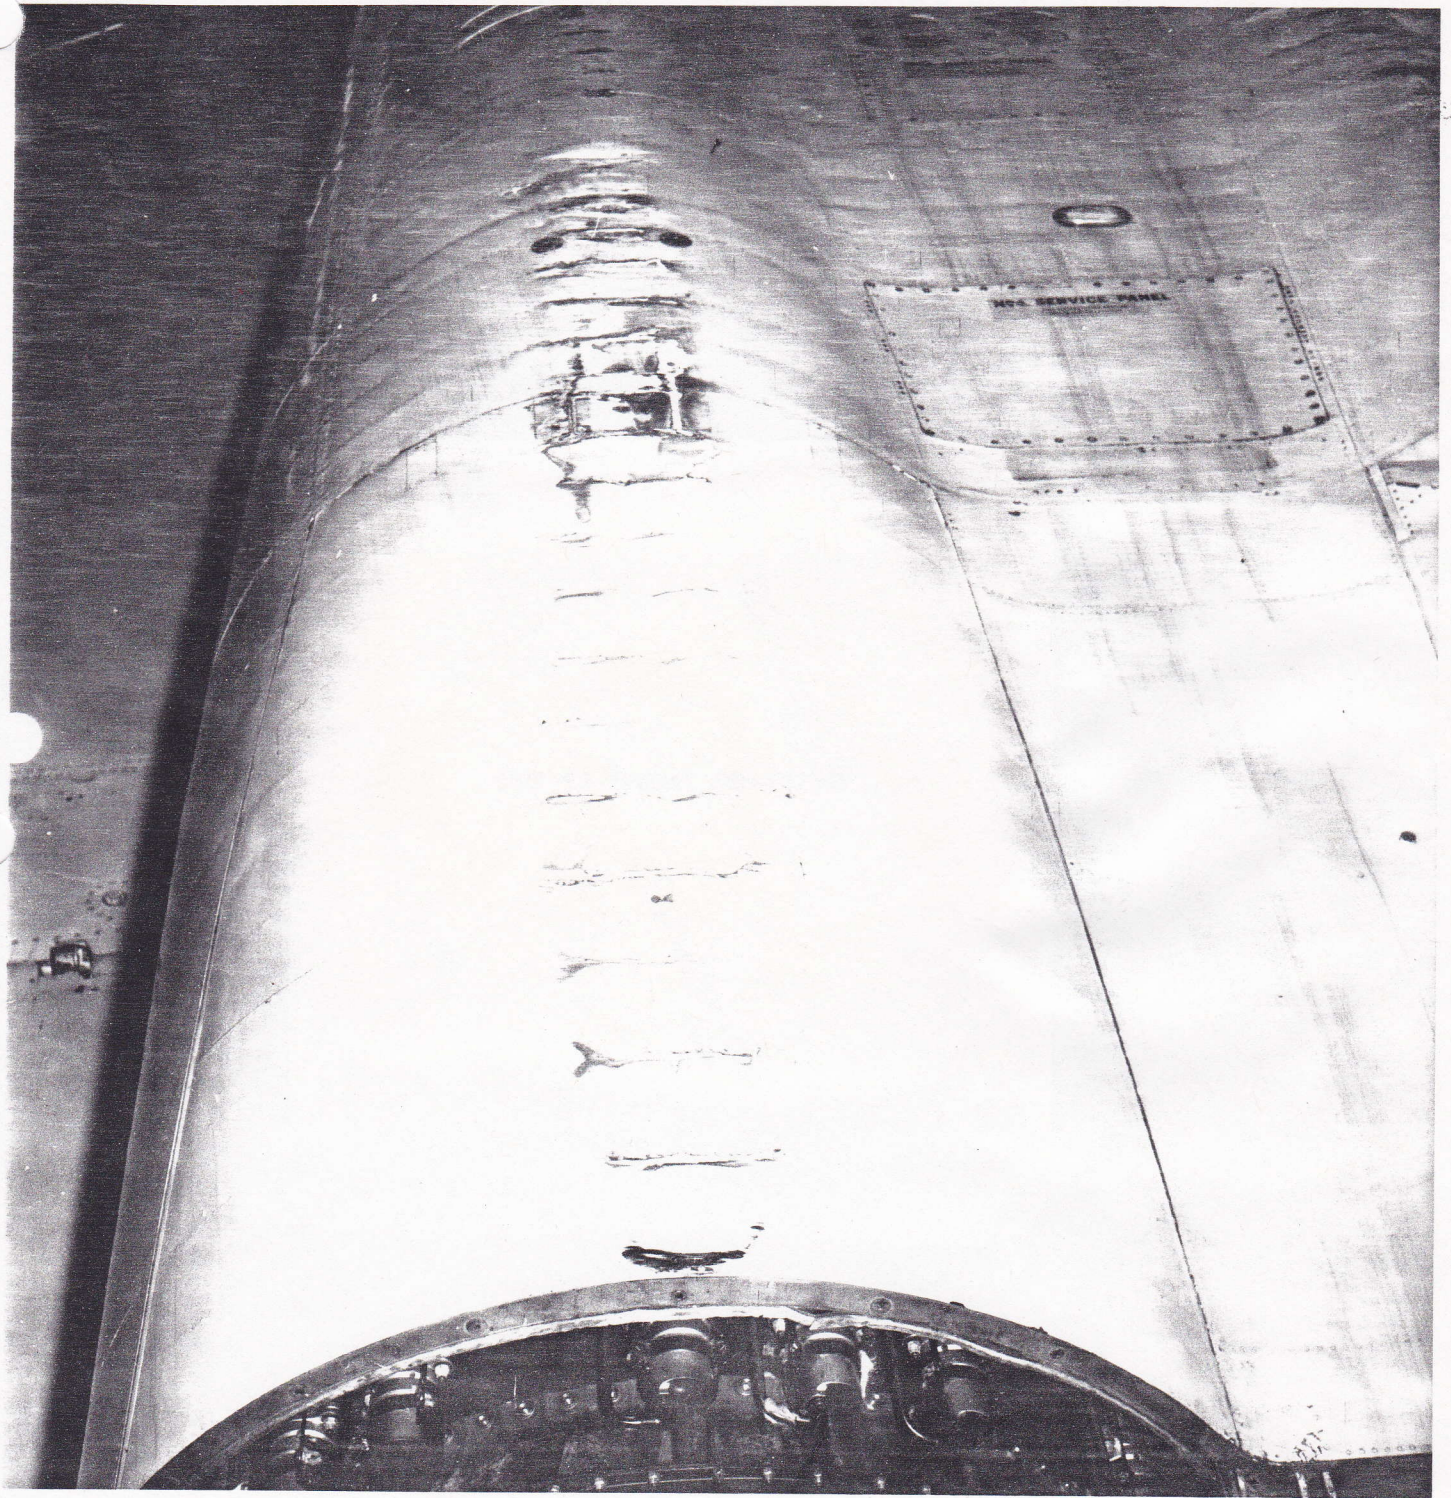
FIG.20

Figures 20, 21 and 22 show damage to R.H. engine bay. The skin in these areas was replaced.
