REPORT ON ACCIDENT

AVRO ARROW 1 (25201)

PART 2

Report No. 71/ENG PUB/10

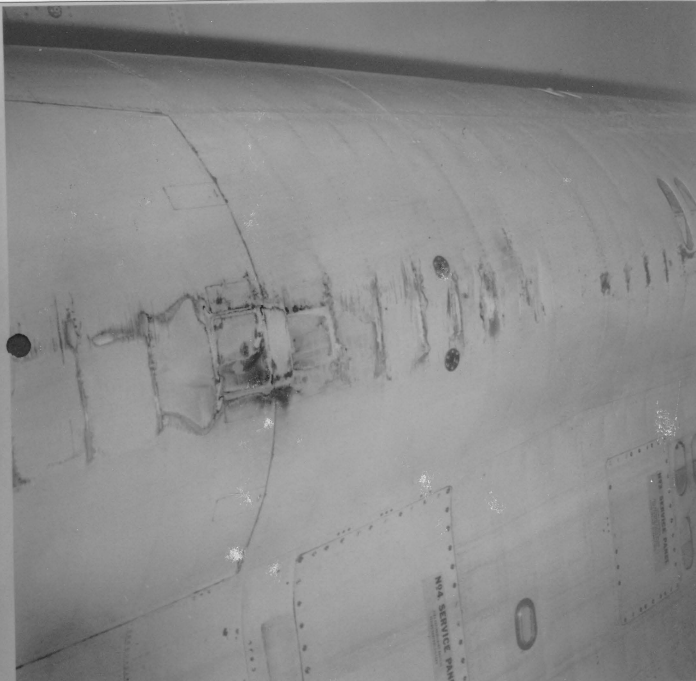
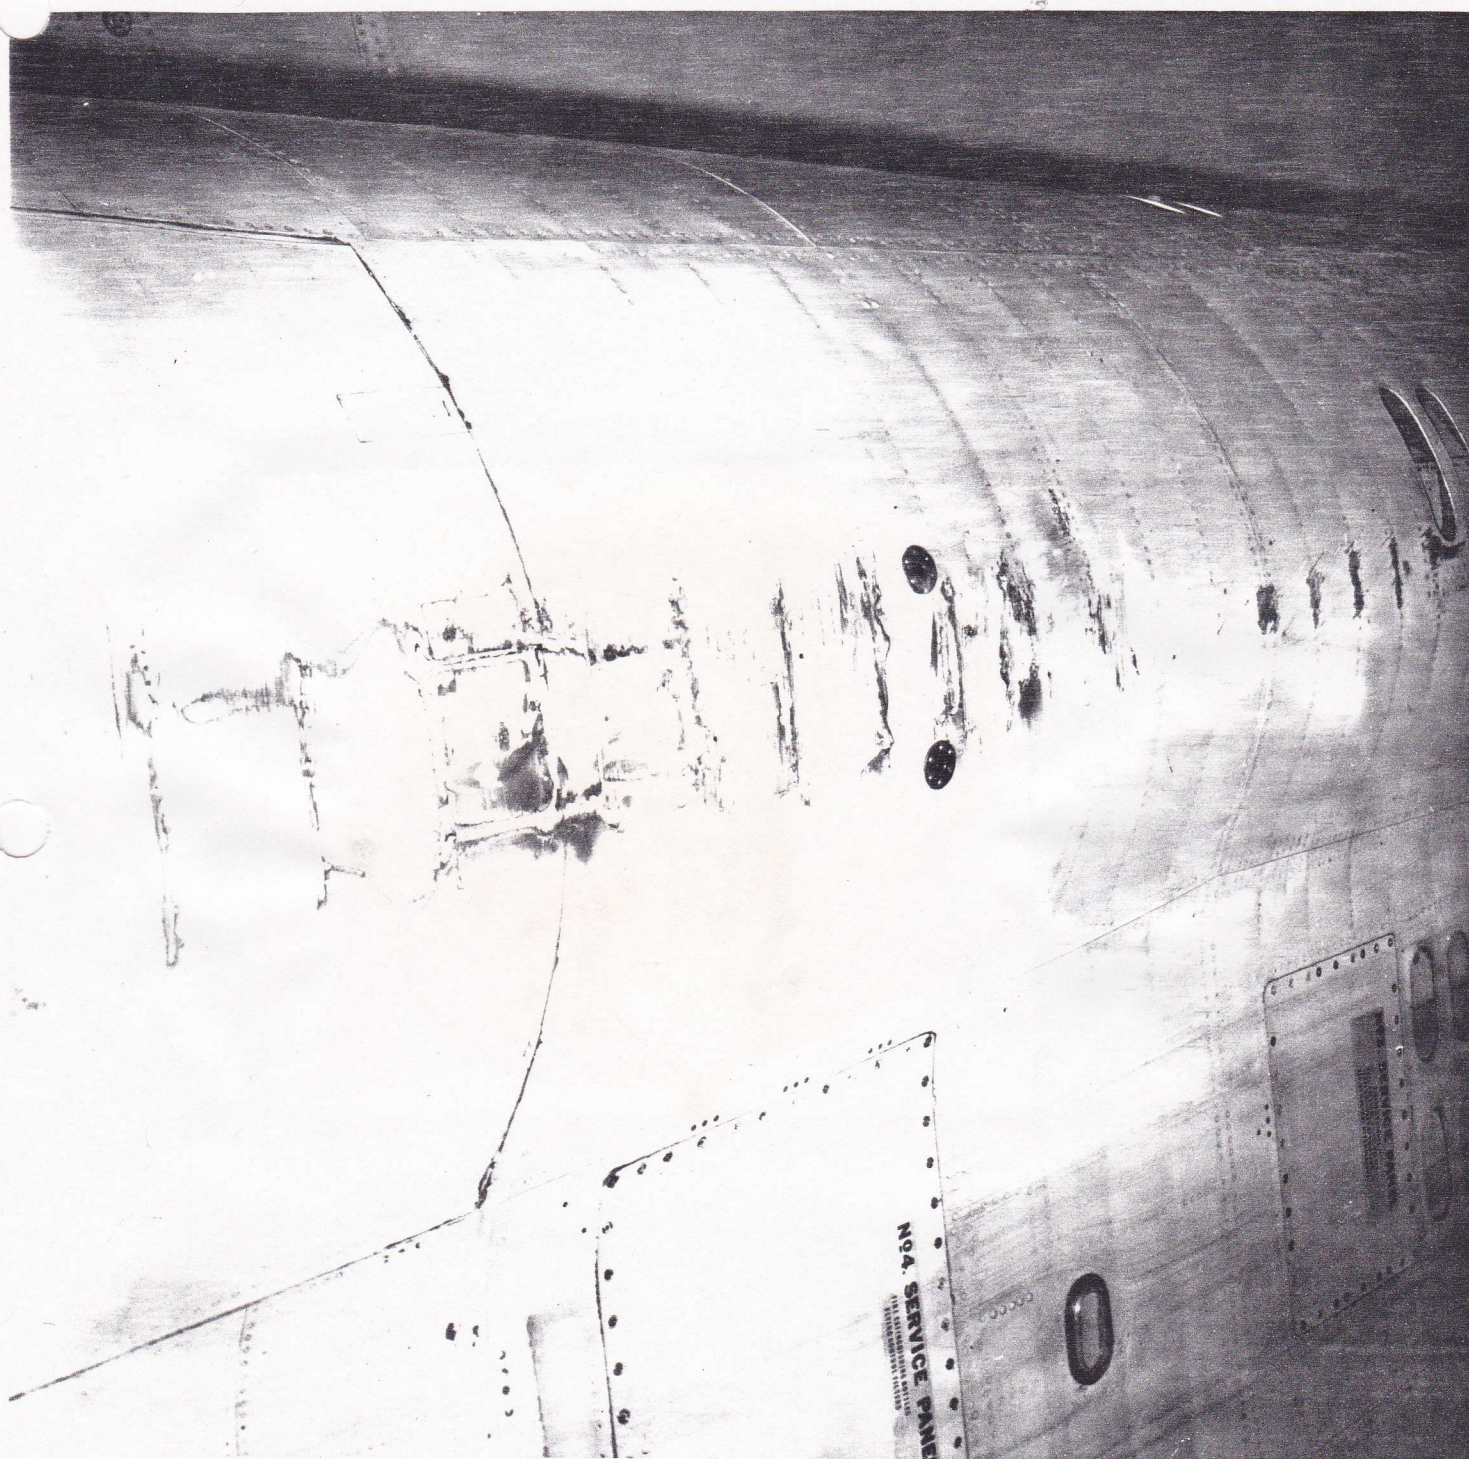
FIG. 21

Figures 20, 21 and 22 show damage to R.H. engine bay. The skin in these areas was replaced.

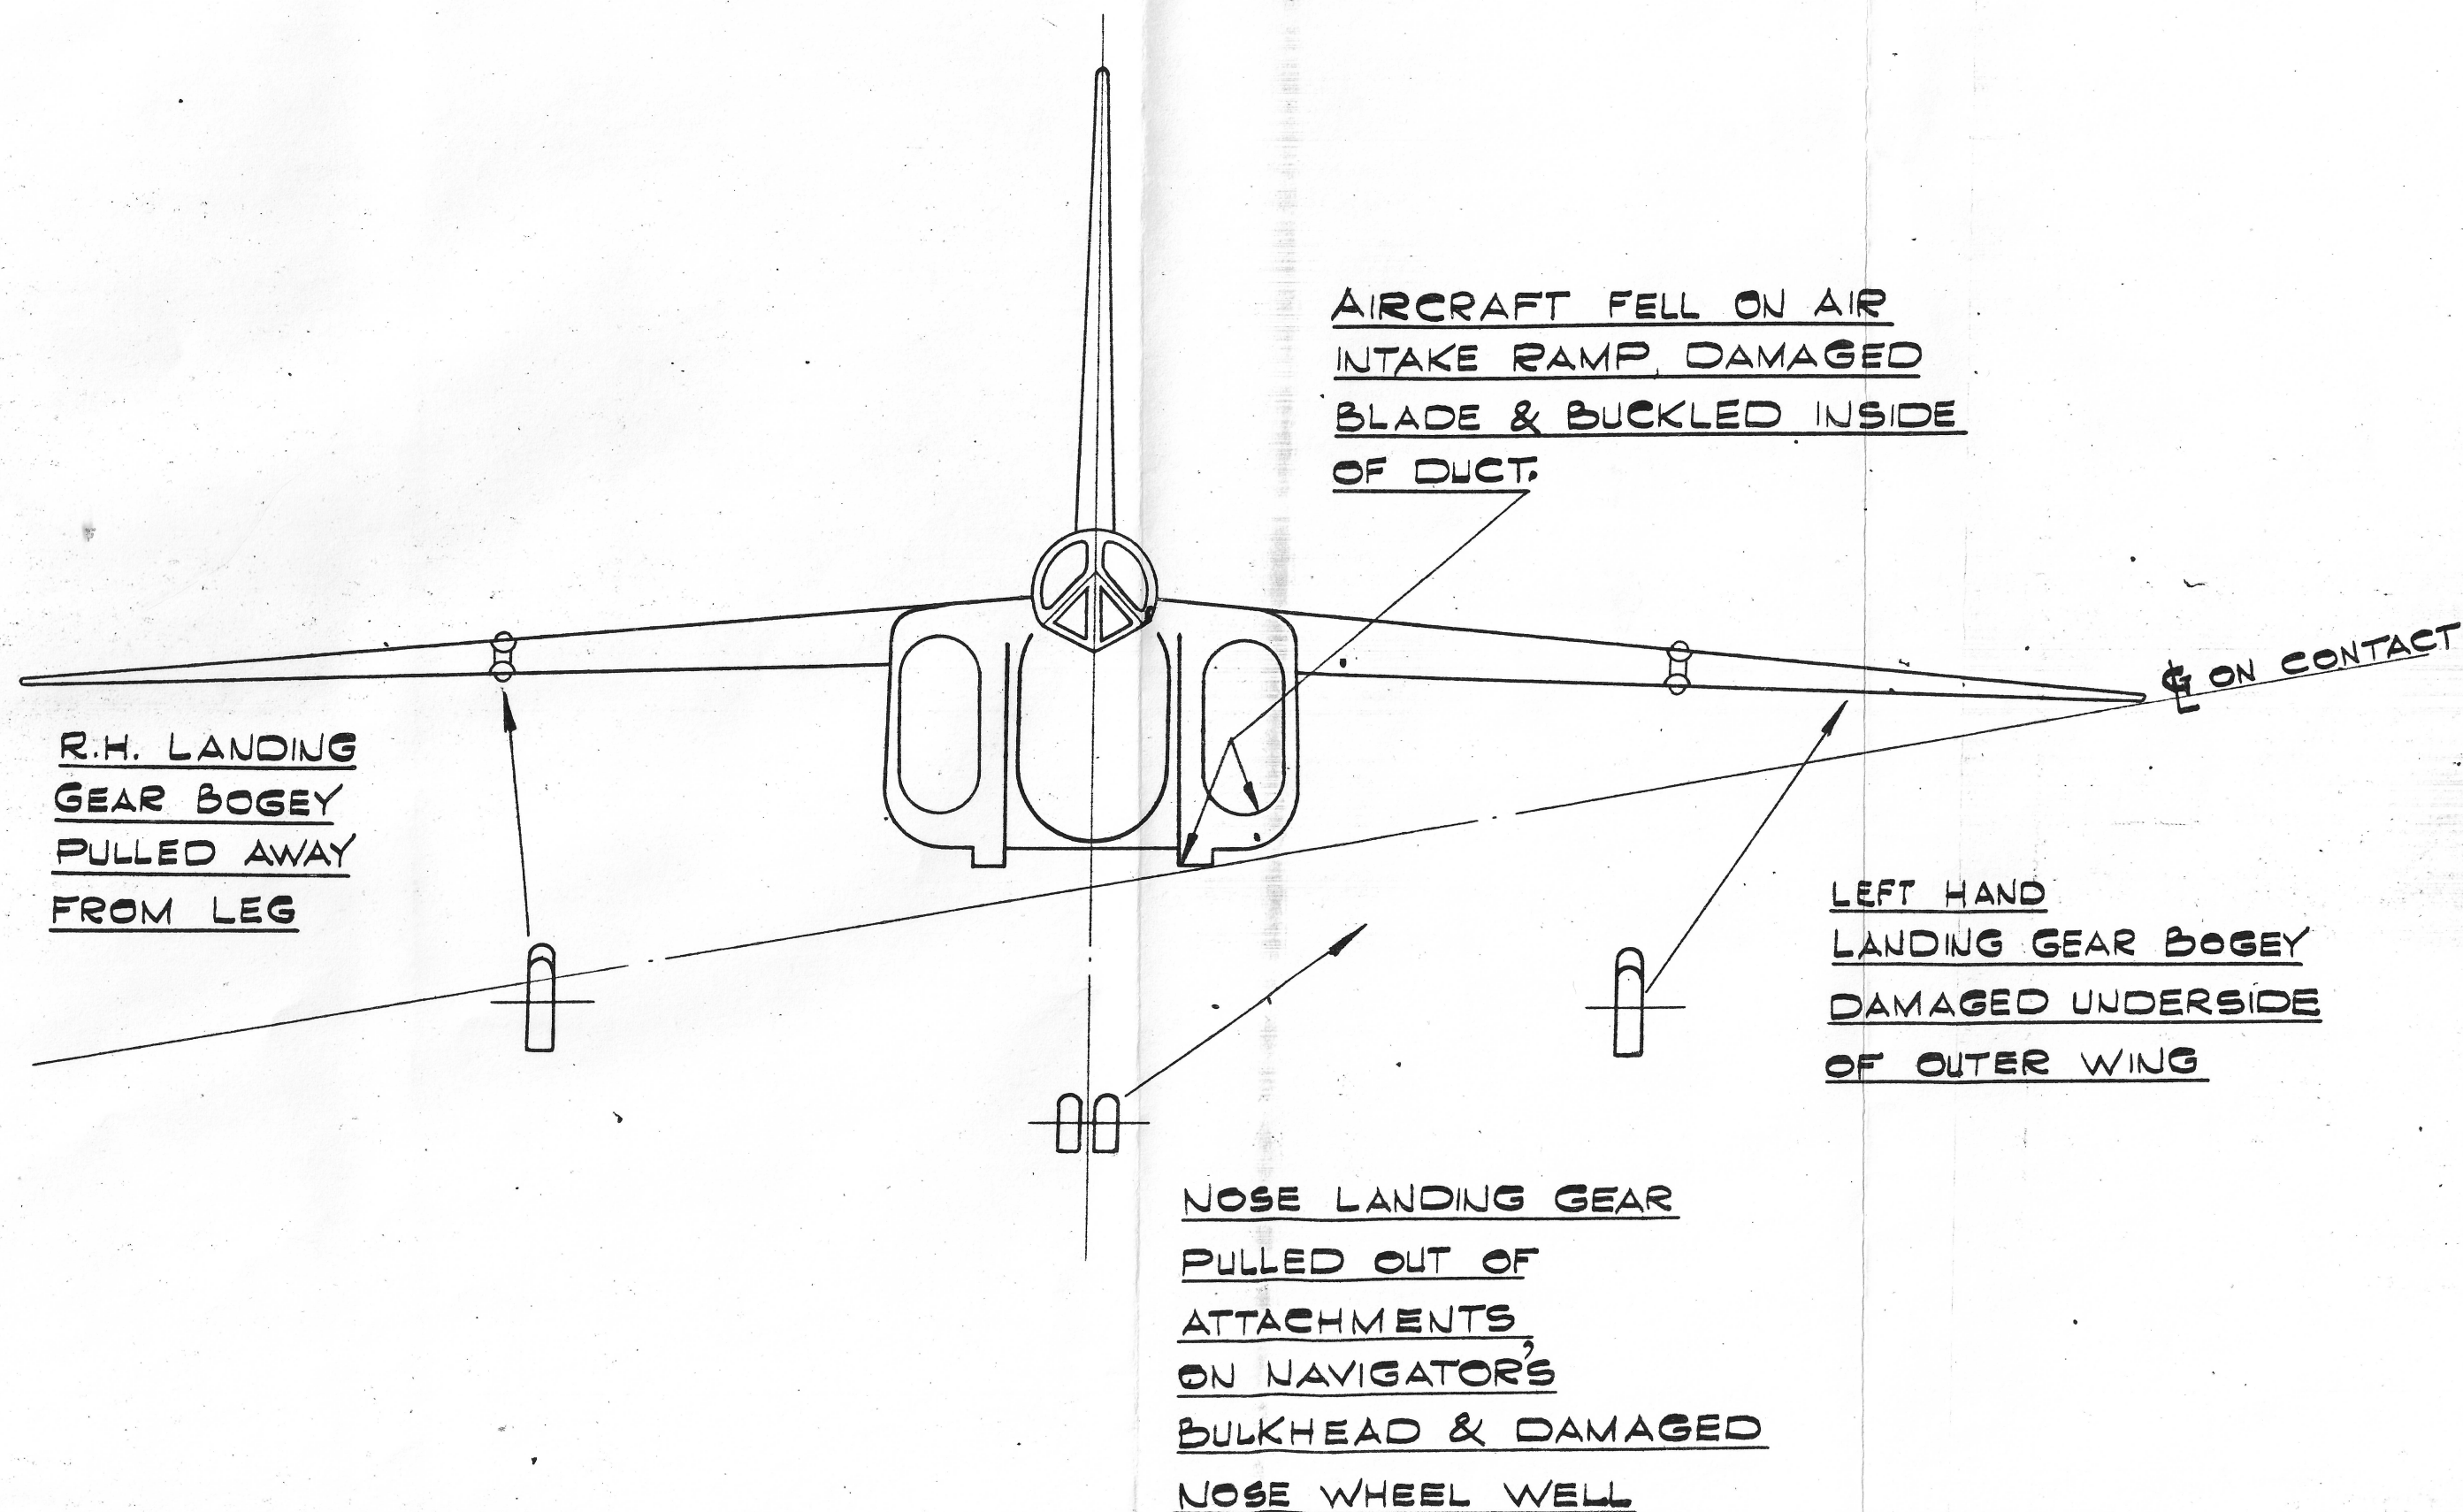
FIGURE 23

The position of contact with the ground is shown in Figures 23 and 24.

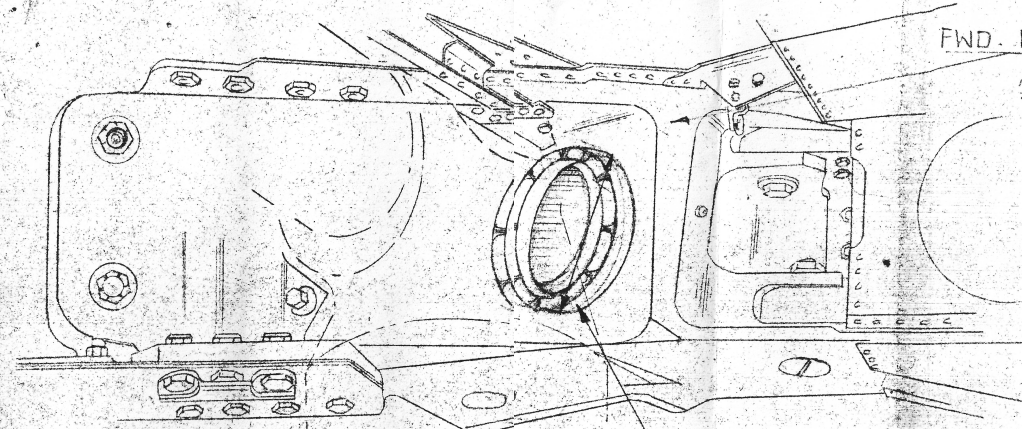
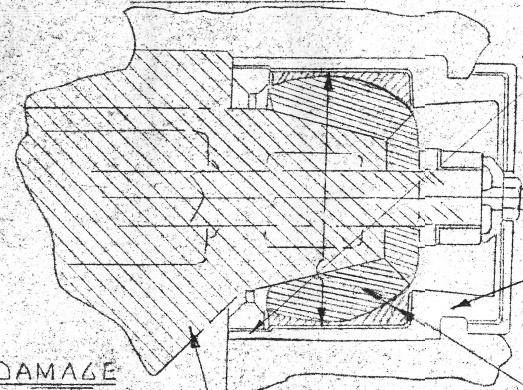
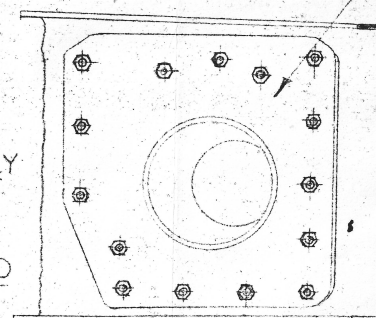
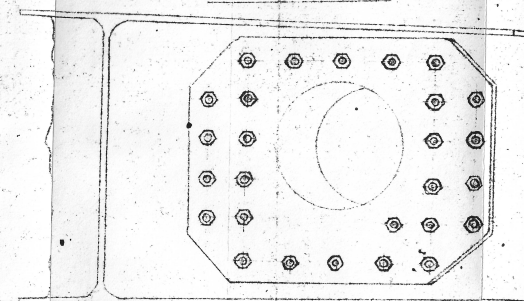
FIGURE 26

Radiography and measurement checks indicated that no damage had occurred to the right wing. Figure 26 shows the examination conducted on main landing gear leg attachments.

APPROX. .030 OVALITY
DIAM. SLEEVE AND PIVOT FITG.
L.H. SIDE ONLY

L.H. SIDE SHAFT PULLED OUT

DAMAGE
RETAINING RING THREADS
ON SLEEVE DAMAGED
L.H. SIDE ONLY

DAMAGE
BEARING BROKEN
L.H. & R.H. SIDES

REPAIR L.H. SIDE ONLY
L.H. SLEEVE REMOVED
PIVOT FITTING REBORED
NEW D/S SLEEVE FITTED
