The Orenda Story

COMPLEX PROBLEMS SOLVED IN ORENDA DEVELOPMENT

By D. W. KNOWLES

Chief Development Engineer
Gas Turbine Engineering Division
A. V. Roe Canada Ltd.

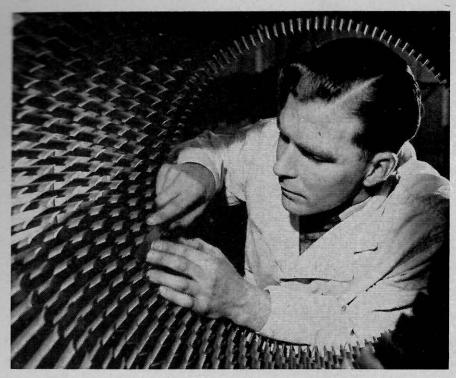
FIG. 1—Fatigue crack in a 10th-stage rotor blade. When made of steel, the blade proved satisfactory.

The failures of 10-stage stators were initially traced to fatigue cracks which were the result of intercrystalline corrosion. Other blades in the engine also were found to be subject to this form of attack. The material used in the later stages of the compressor was changed to a similar material which was more resistant to this kind of corrosion.

However, the failures, although not as frequent, continued to give trouble, appearing now as ordinary fatigue cracks FIG. 1. A study of the resonance conditions of the blade showed that it was being excited by the 10th rotor in the second flexural mode. Strain gauge tests indicated that the blade would be strong enough if made in steel. The change proved to be a satisfactory solution.
