HAYES MARINE & CONSULTING SERVICES POWER BOAT VESSEL SURVEY

1929 Chris Craft Sedan Limousine, Runabout (28ft)

Date of Survey: **March 31, 2023**

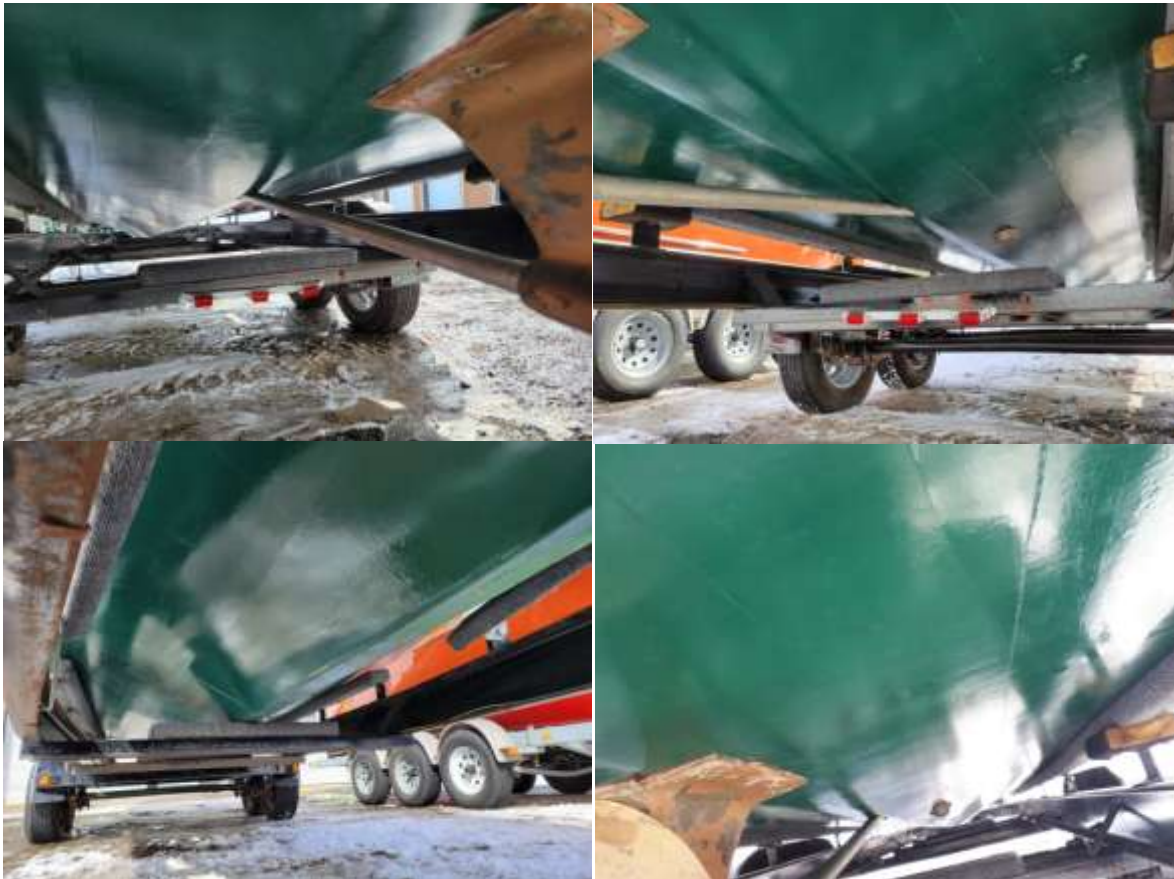
HULL BOTTOM APPEARED LIKE NEW. FAIRED AND FINISHED TO PROFESSIONAL / SHOW QUALITY. MOST ALL OF THE BOTTOM IS REPORTED TO HAVE BEEN REPLACED DURING AN EXTENSIVE RESTORATION BY A NOTABLE BUILDER/RESTORER.

THE ENTIRE HULL BELOW THE WATERLINE WAS COVERED IN A RECENT APPLICATION OF FOREST GREEN MARINE GRADE PAINT AND WAS FOUND TO BE WELL APPLIED WITH SEAMS AND CAULKING NEAR FLAWLESS.

HULL PERCUSSION SOUNDINGS SHOWED CONTINUOUS STRUCTURAL INTEGRITY AND NO VOIDS, LOOSE SUB-STRAIGHT LAYERS OR HULL STRUCTURAL PROBLEMS WERE NOTED.

MOISTURE METER READINGS ABOUT ALL AREAS OF THE HULL BELOW THE WATERLINE, AND IN AREAS OF THE KEEL AND TRANSOM, SHOWED LOW LEVEL READINGS AND BELOW LEVELS OF CONCERN.

HULL BELOW WATERLINE; OVERALL EXCELLENT CONDITION, FINISH, APPEARANCE AND CONDITION.

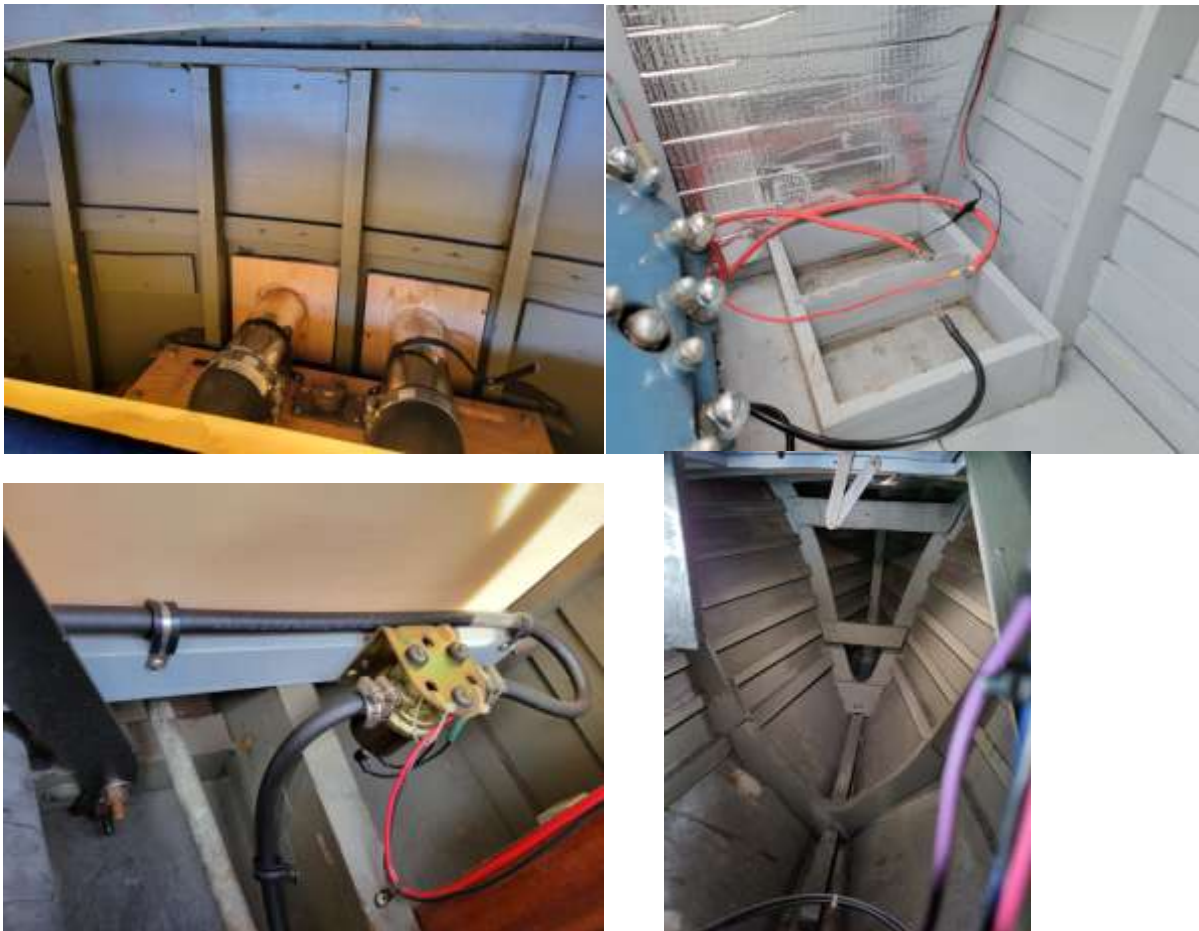
ALL LATERAL AND LONGITUDINAL STRINGERS THAT WERE ABLE TO OBSERVED, MOSTLY IN THE ENGINE BAY, AND HULL PLANKING WERE FOUND TO BE IN VERY GOOD CONDITION AS WERE ALL THE CONNECTIONS POINTS TO HULL SIDES AND FLOOR/BOTTOM STRUCTURE.

ALL HULL STRUCTURAL MEMBERS THAT WERE OBSERVED WERE FOUND TO BE IN VERY GOOD OVERALL CONDITION.

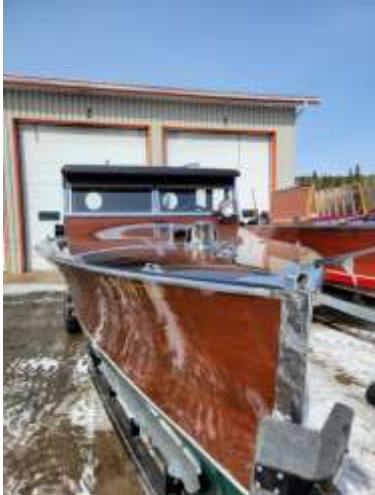
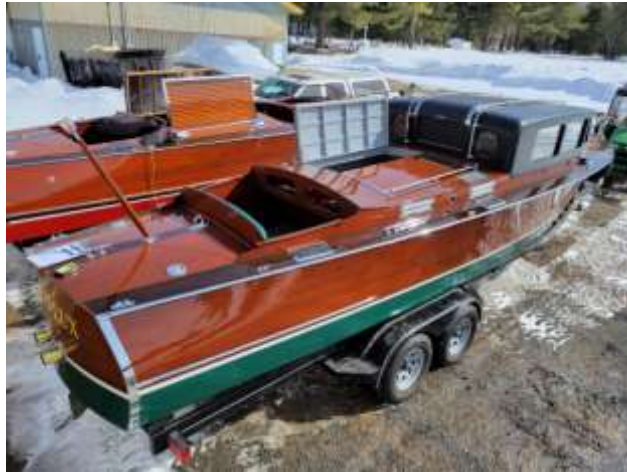
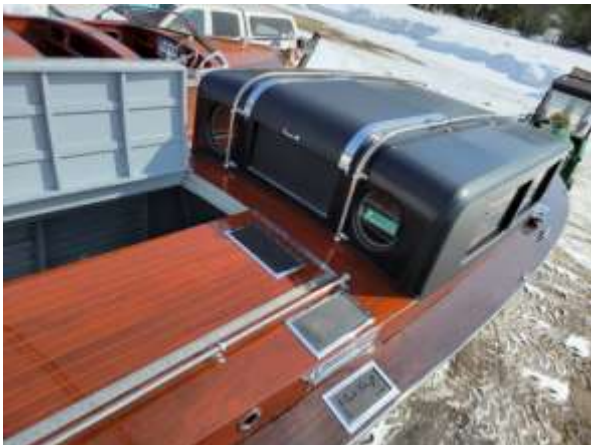
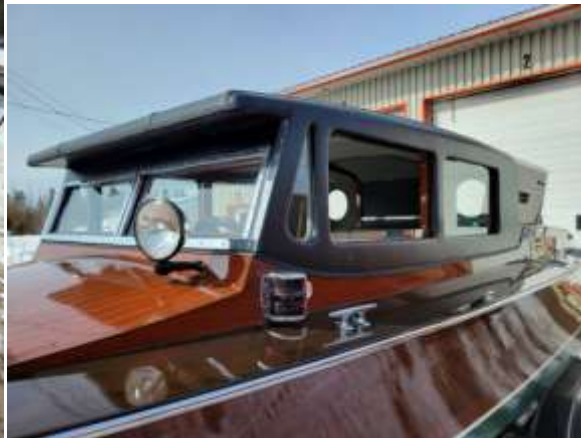
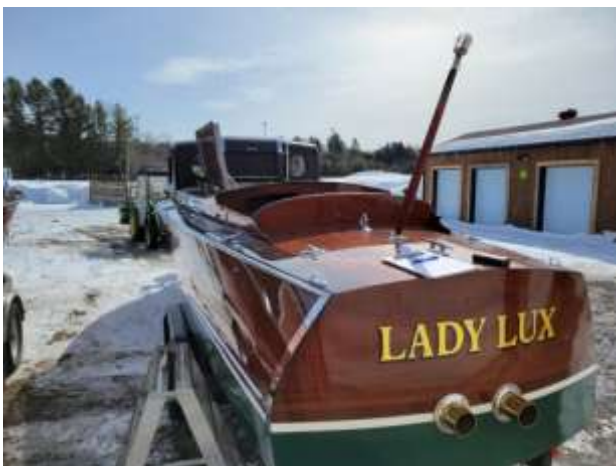
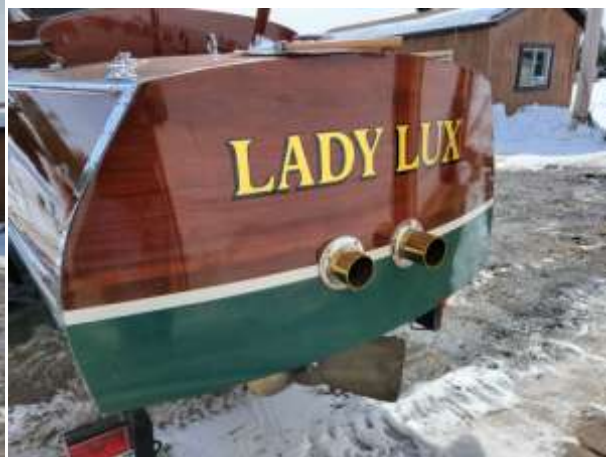
TIME AND ATTENTION WAS SPENT ON THE TOPSIDES AND EXTERIOR OF THE HULL WITH FORE, AFT DECKS AND GUNNELS AREAS SHOWING IN EXCELLENT CONDITION WITH SEVERAL COATS OF HIGH GLOSS VARNISH IN EVIDENCE.

ALL DECK AREAS WERE FOUND TO BE SOLID, WITH NO VOIDS AND ALL MOISTURE READINGS WERE VERY LOW AS EXPECTED BEING A NEW RESTORATION. MUCH OF THE TOPSIDES PLANKING WAS SEEN TO BE NEW. DECK SEEM CAULKING, EXCELLENT. NO PROBLEMS NOTED.

FORE - AFT-DECK CLEATS AND DECK FITTINGS, INCLUDING CLEATS, VENTS, LIGHTS, HINGES, EXTENSIVE TRIM PIECES, GRAB RAILS, INCL BOW CUTWATER/FAIRLEAD WERE INSPECTED. NO PROBLEMS NOTED. CHROME; VERY GOOD. ONE COPPER EXHAUST PIPE EXTENDS SLIGHTLY FURTHER THAN THE OTHER. (COSMETIC).

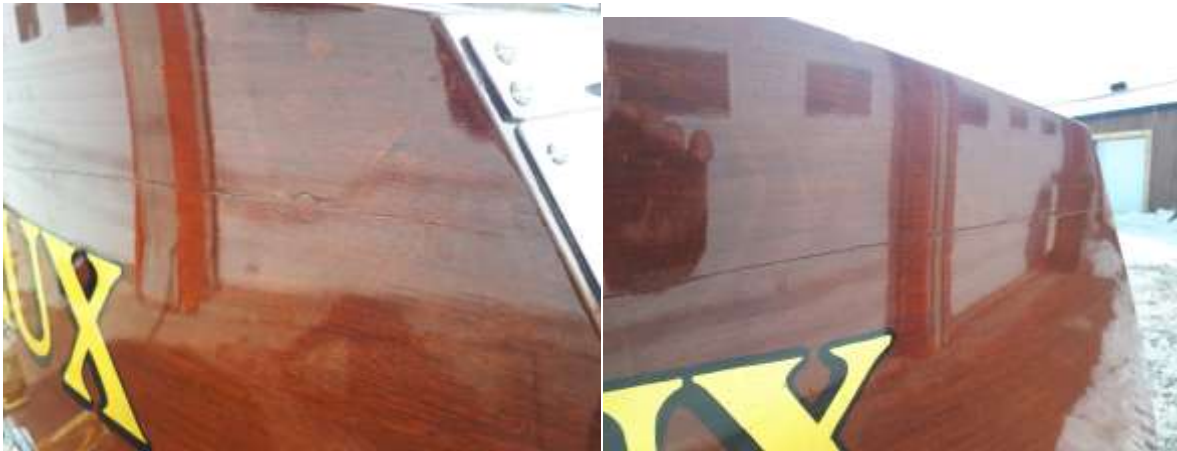
TRANSOM: SOUND. TOP AFT PLANK, TO STARBOARD, HAS SLIGHT SPLIT/CRACK. WELL ABOVE WATERLINE, EASILY ADDRESSED. ONLY BOARD ON THE ENTIRE BOAT WITH ANY NOTABLE COMMENT.

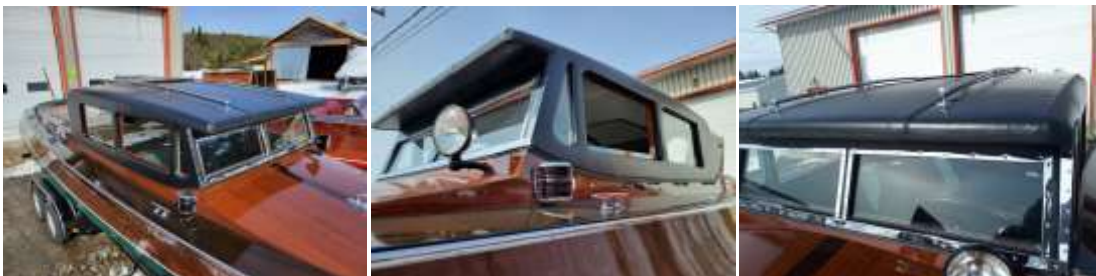
TOP: RARE OPTION OF THIS VESSEL WITH MANY UNIQUE FEATURES, INCLUDING FOUR OPENING, ROLL UP SIDE WINDOWS, AND TWO FRONT OPENING WINDOWS WHICH ROLL UP (RATHER THAN DOWN) AND RETRACT VERTICALLY INTO UPPER SLEEVES. ADDITIONALLY, REAR FACING ROUND “OPERA” WINDOWS AT THE REAR OF THE HARDTOP COMPLETE THE 10 WINDOW LAYOUT, OF WHICH ONLY 32 WERE REPORTED TO HAVE BEEN MADE. FAR FEWER HAVE SURVIVED TO THIS DAY. ENTIRE INTERIOR OF TOP IS COVERED IN PERIOD CORRECT GREY FABRIC, GIVING THE FEELING OF AN ANTIQUE FUNERAL COACH OF THE HIGHEST ORDER. CABIN INTERIOR A BIT DIFFICULT TO ENTER, WITH THE ONLY MEANS VIA THE CENTRAL REAR SLIDING ROOF/AFT HATCH. A LONG STEP DOWN TO THE AFT BENCH SEAT MAKES TRAVERSING FROM ONE AREA OF THE VESSEL (FORE AND AFT) SOMEWHAT CUMBERSOME IN RELATION TO DESIGNS OF TODAY. PERIOD CORRECT AND IN EXCELLENT CONDITION BOTH INSIDE AND OUT.

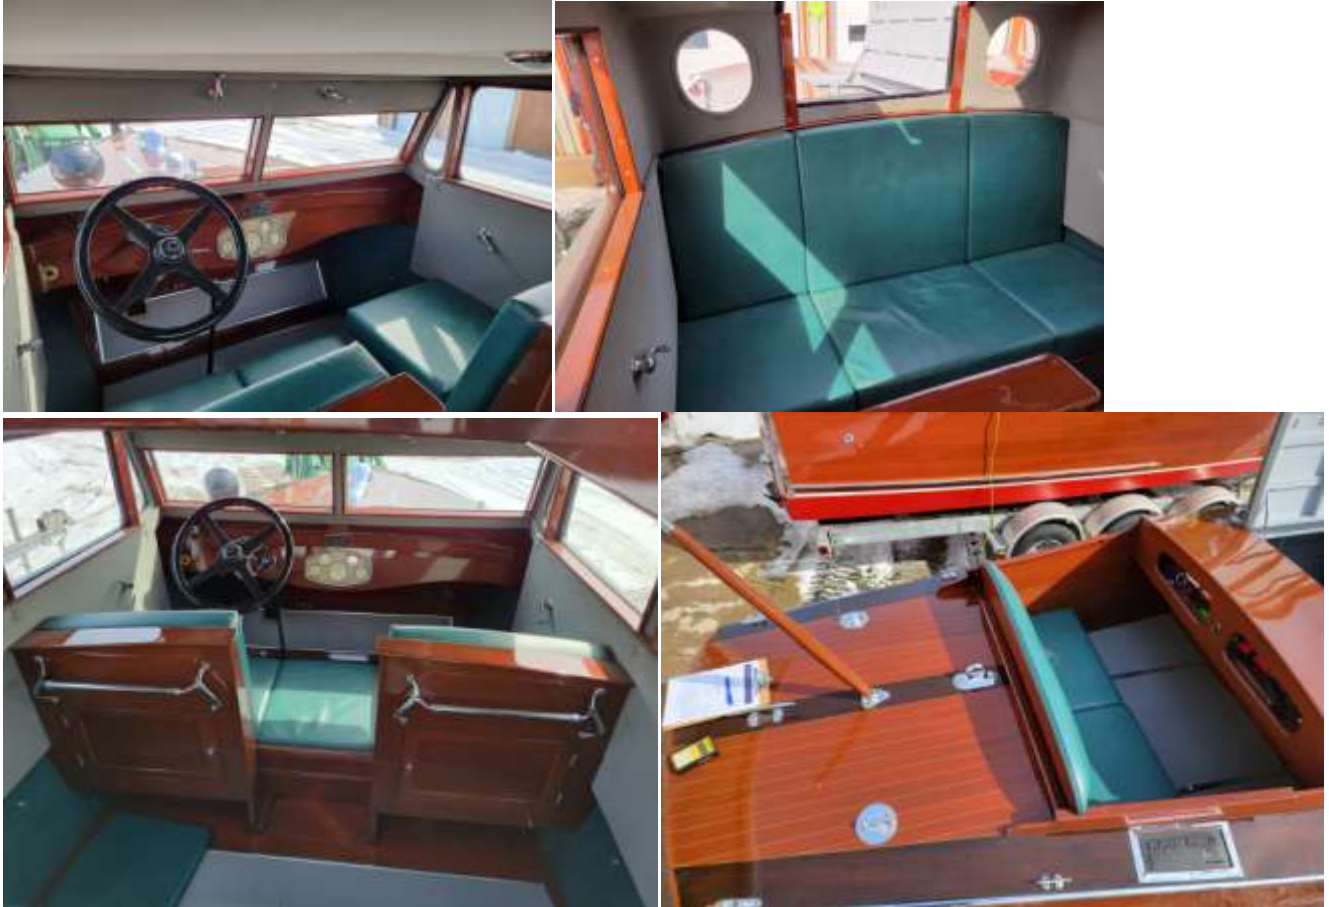
UNDER THE HARDTOP; THE LAYOUT FEATURES A REAR BENCH AND SPLIT FRONT BENCH WITH REMOVABLE CENTRE SECTION. ALL SEATING SURFACES COVERED IN GREEN LEATHER. FLAWLESS.

ALL INTERIOR WOODWORK INCLUDING WINDOW TRIM, UPHOLSTERY AND FITTINGS WERE FOUND TO BE PERIOD CORRECT AND IN EXCELLENT (LIKE NEW) CONDITION.

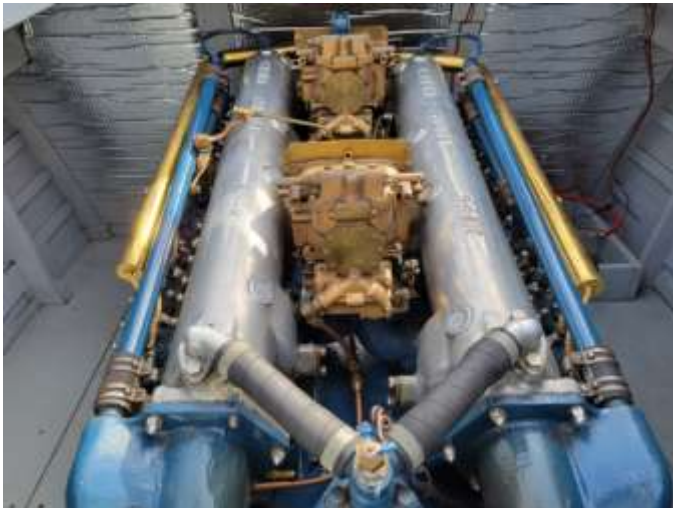
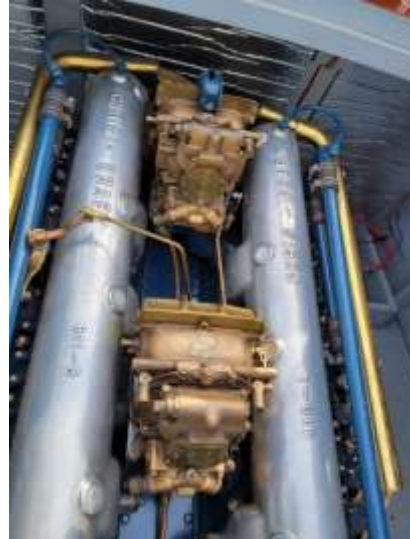
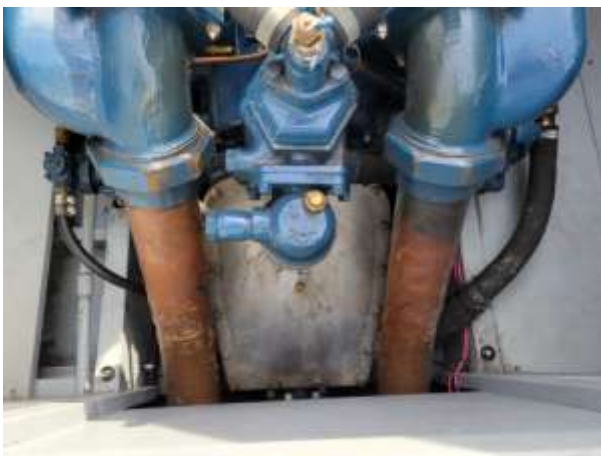
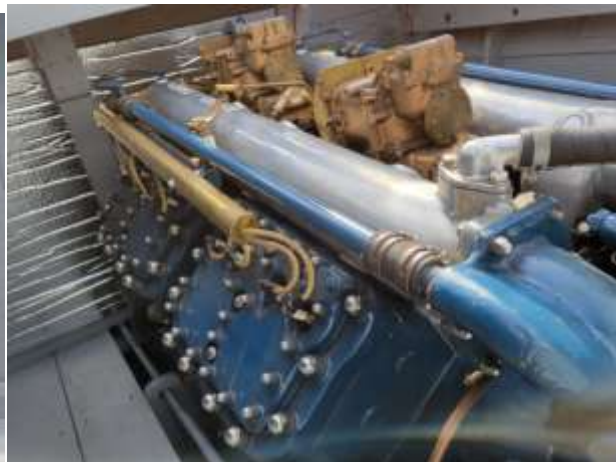
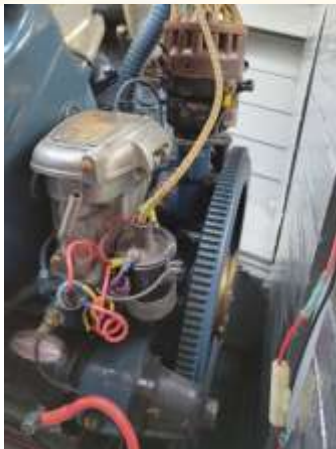
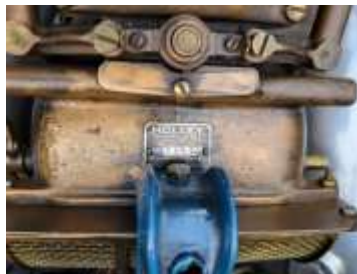
ENGINE REPORTED TO HAVE BEEN RESTORED BY KNOWN, REPUTABLE BUILDER AND HAS FEW HOURS SINCE REBUILD. HOURS UNKNOWN.

MANIFOLDS SOUND. ALL HOSES, BELTS AND CLAMPS AND WIRING WERE INSPECTED AND FOUND TO BE NICELY AND PROPERLY ROUTED AND APPEARED TO BE IN PROPER WORKING ORDER.

ENGINE AND ENGINE BAY CLEAN, UNCLUTTERED AND VERY PRESENTABLE IN APPEARANCE.

ENGINE MOUNTS: SOUND. ALL ENGINE MOUNTS, ENGINE SUPPORT STRINGERS AND EQUIPMENT FITTINGS IN EXCELLENT CONDITION.

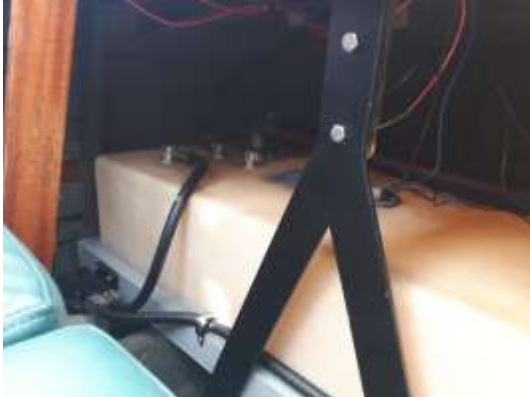
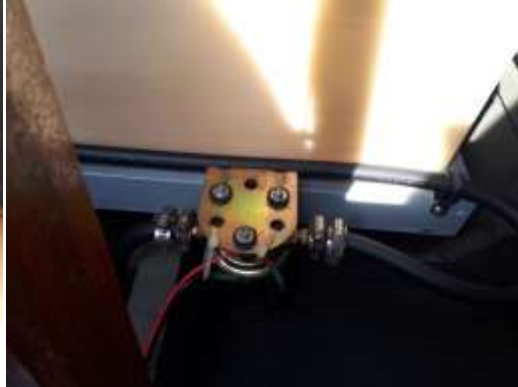
ENGINE BAY / OBSERVATIONS: ORGANIZED, WELL EQUIPPED. CLEAN NO PROBLEMS NOTED.

SHAFTS AND RUNNING GEAR: STAINLESS STEEL SHAFT; VERY GOOD. STUFFING BOX AND PACKING GLAND; VERY GOOD. SHAFT STANCHION; SOUND. NO PROBLEMS NOTED.

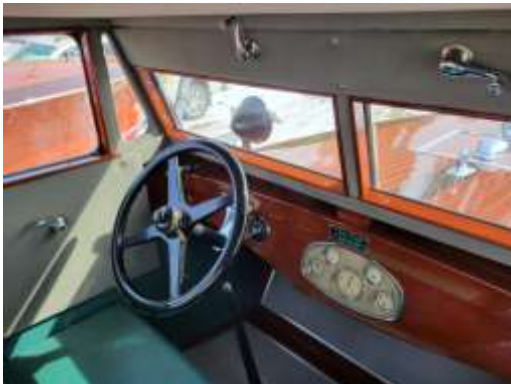
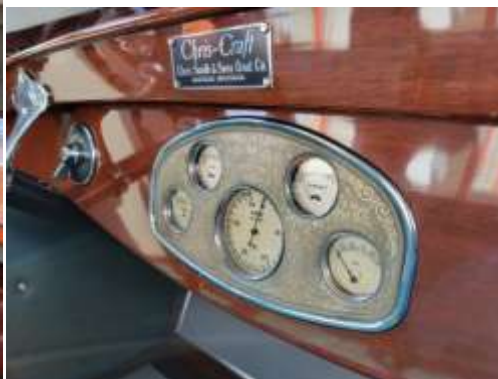
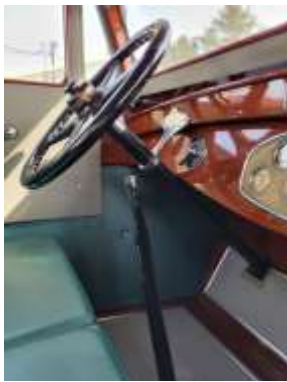
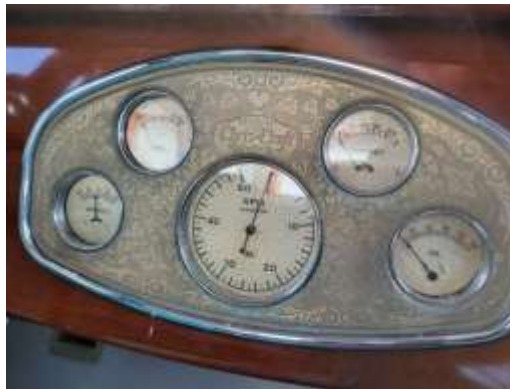
HELM: LOCATED TO PORT, UNDER THE HARDTOP IN THE COCKPIT AREA. HELM FEATURES THE ORIGINAL LAYOUT AND EQUIPMENT INSTRUMENTATION. GAUGES HAVE BEEN RESTORED. VINTAGE, ORIGINAL WHEEL, GAUGES AND CLUSTER. WIRING IS NEWER, OF PROPER SIZE, ADEQUATELY BUNDLED AND ROUTED. MAHOGANY DASH AND TRIM; EXCELLENT.

THE WHEEL MOUNTED THROTTLE AND FLOOR MOUNTED GEAR SHIFT LEVERS WERE FOUND TO BE IN VERY GOOD OPERABLE CONDITION WITH NO “PLAY” OR MECHANICAL OBSTRUCTIONS NOTED. MAHOGANY DASH/HELM IS EXCELLENT CONDITION. GAUGE CLUSTER; A SHOWPIECE.

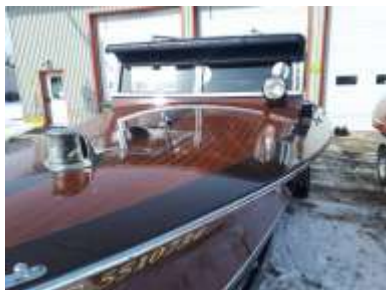
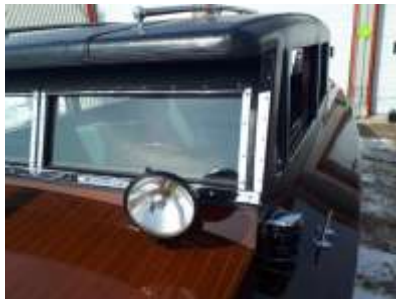
RUNNING LIGHTS: THE NAVIGATION LIGHTS (PORT AND STARBOARD, ONE EACH MOUNTED TO SIDES OF WINDSCREEN COWLING), AND THEIR HOUSINGS WERE FOUND TO BE ORIGINAL TO THE VESSEL. STERN LIGHT IS POST MOUNTED. ALL WERE PROPER SIZE AND IN PROPER LOCATIONS AND IN VERY GOOD CONDITION. VINTAGE / PERIOD CORRECT, CHROME AND LENSES ALL VERY GOOD. VESSEL ALSO FEATURES WHITE FOREDECK MOUNTED BOW LIGHT AND GIMBALED SPOT LIGHT. ALL FITTINGS EXCELLENT CONDITION.
