## Condition & Value Survey Report

File # 23182

Acting at the request of Carlo Ferriera, 250 Pilot Road Suite 150, Las Vegas, NV 89117, attending surveyor proceeded to Bergersen Boat Company, 334 Interchange N, Lake Geneva, WI 53147 under the date of June 17, 2023 and there did survey the 23' antique runabout while resting on her trailer. The purpose of the survey was to ascertain the condition and value of said vessel for purchase. The vessel will reportedly be used for pleasure purposes.

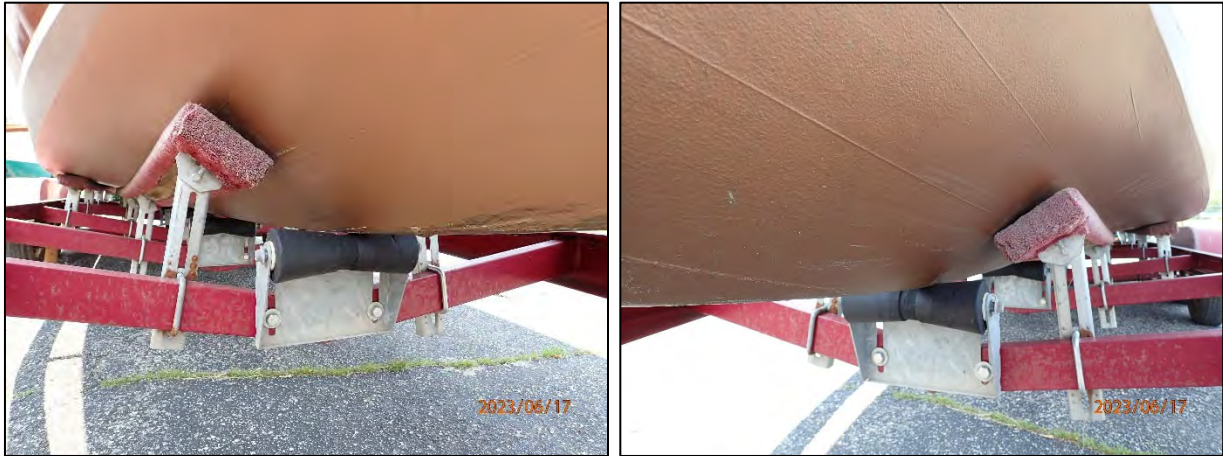
We began our survey by sounding the undersides and transom with a phenolic hammer, testing for moisture using a Tramex Skipper 5 moisture meter, and by performing visual inspections. No signs of collision or grounding damage were observed. The antifouling paint presented in a good and serviceable condition. Moisture meter readings (Wood Scale) gained from the undersides registered in the Level 1/“Dry” range.

*Starboard & Port Undersides*

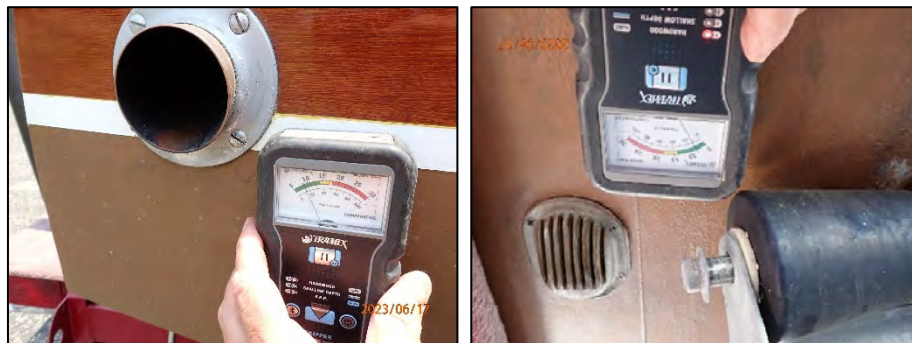
*Obtaining Moisture Readings From Transom & Hull Undersides*

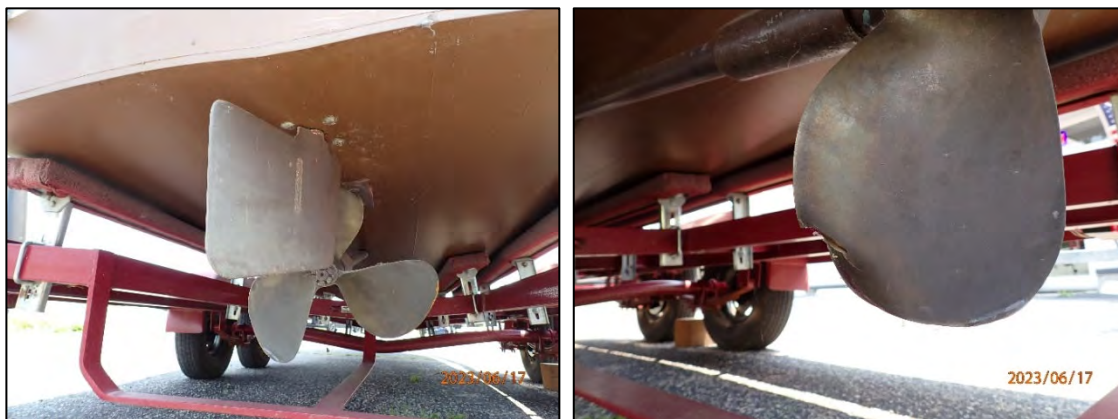
Survey of the underwater running gear showed one propeller blade to be curled and torn. Abrasions were noted in the other 2 blades. The rudders and struts were free of any visible damage. Small amounts of wear were observed while inspecting the visible surfaces of the cutlass bearing. A small amount of lateral “play” was noted when we applied light pressure to the rudder.

*Running Gear*

*Damaged Propeller Blade*

6. We recommend installing non-conductive boots on the ends of the high-tension/spark plug wires.
7. Repair the propeller. Anytime significant propeller damage is present, we recommend checking the trueness of the propshaft.

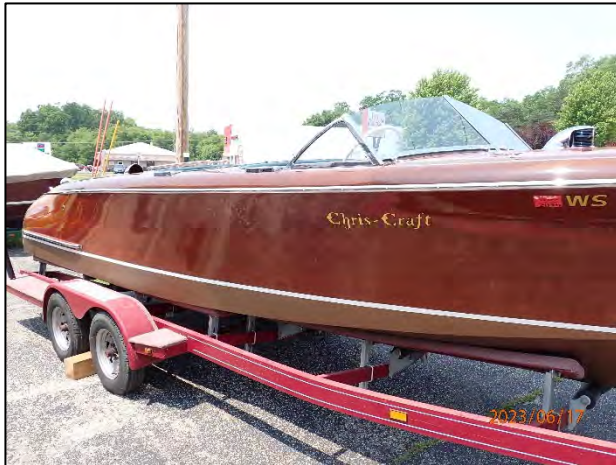
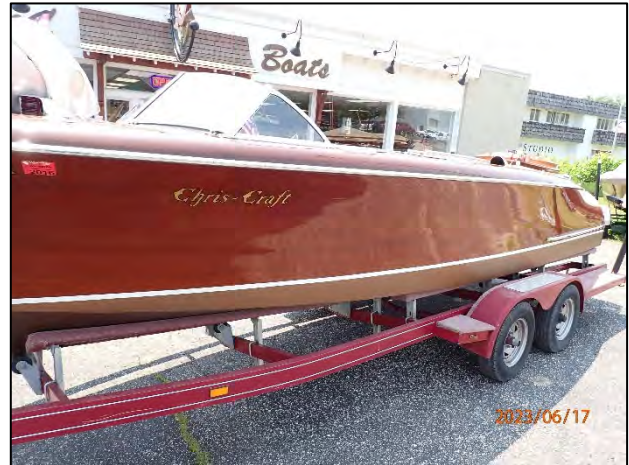
Survey of the topsides showed the surfaces to present in a well-maintained condition. An approximate 3” shallow scratch was noted in the starboard hullside, near amidships. A couple of faint scratches, covered with varnish, were noted in the opposite side, also at amidships. Percussion testing didn’t reveal any indicators for loose planking and or fasteners. Moisture readings gained from the topsides registered in the Level 1 range.

*Starboard & Port Topsides*

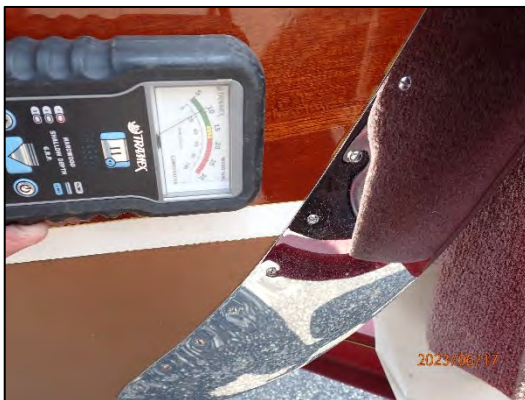
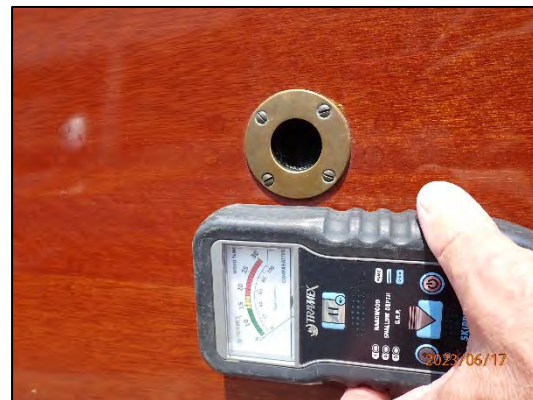
*Obtaining Moisture Readings From Topsides*

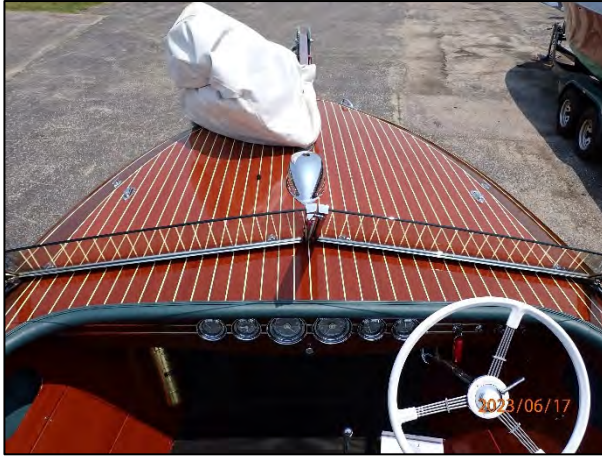
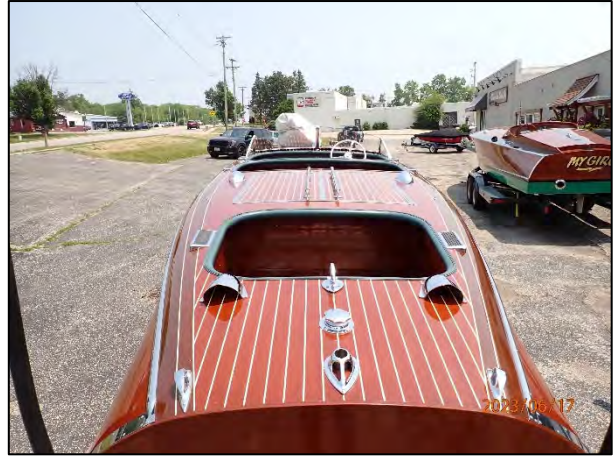
Our visual inspections of the deck surfaces showed all to have a brilliant appearance. Percussion testing was negative for indicators for loose fasteners and or planking. All moisture meter readings registered in the Level 1 range.

*Deck And Attachments*

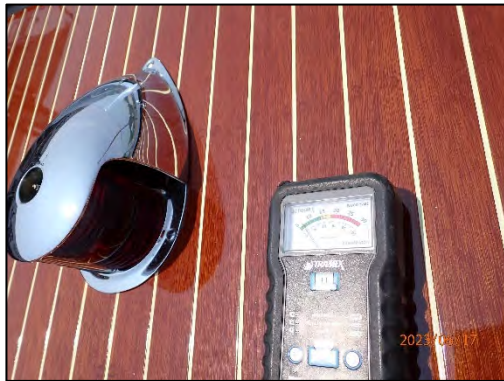
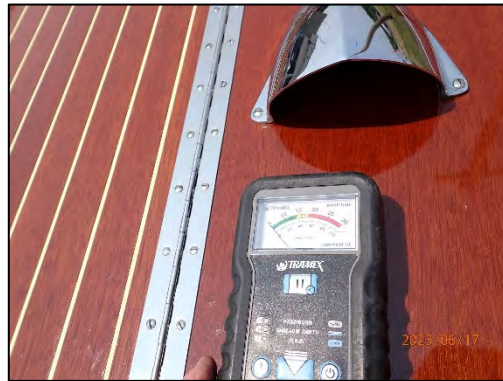
*Obtaining Moisture Readings From Deck Surfaces*

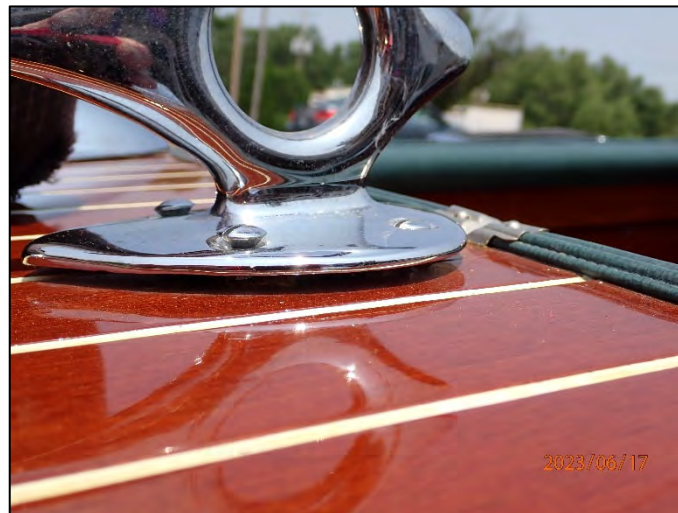
The stern lifting eye was not mounted flush to the aft deck.

*Stern Lifting Eye*

10. Ensure the stern lifting eye assembly is properly secured.

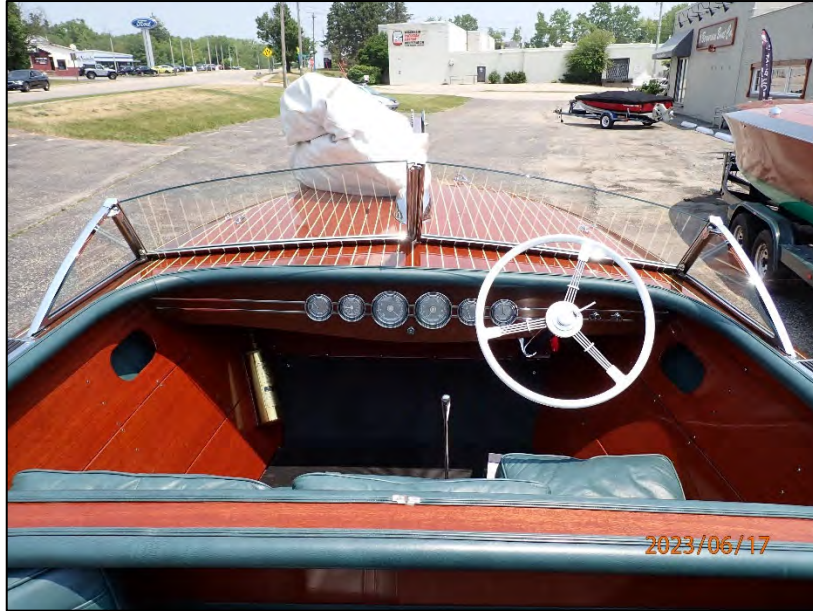
The vessel is a triple cockpit runabout. Survey of the forward cockpit and helm position showed the vessel to be equipped with standard engine monitoring gauges. Shifting and steering were from the original, mechanical systems.

*Forward Cockpit & Helm Position*

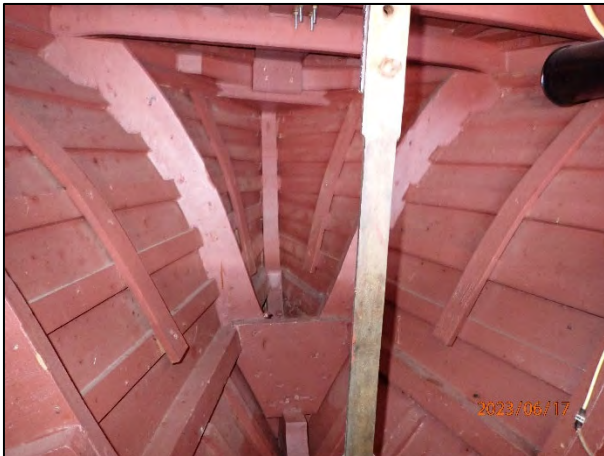
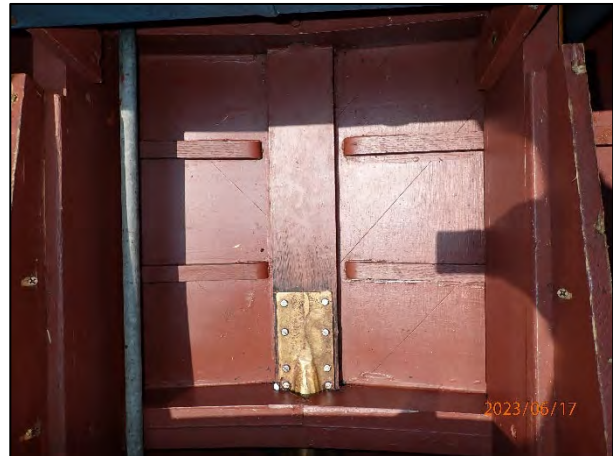
The attending surveyor opened every hatch, access panel and other that could be accessed without tools, finding all accessible primary and secondary hull frames to be free of any visible damage or measurable deterioration.

*Primary And Secondary Frames*

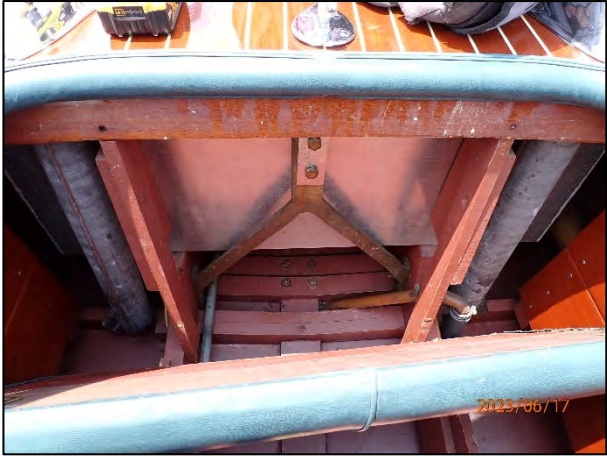
A replacement, aluminum fuel tank was mounted at the stern. Where visible, we didn't observe any fuel leaks or odors. The feed line was of the copper tube type. The deck plate was not labelled.

*Fore Side Of Fuel Tank*

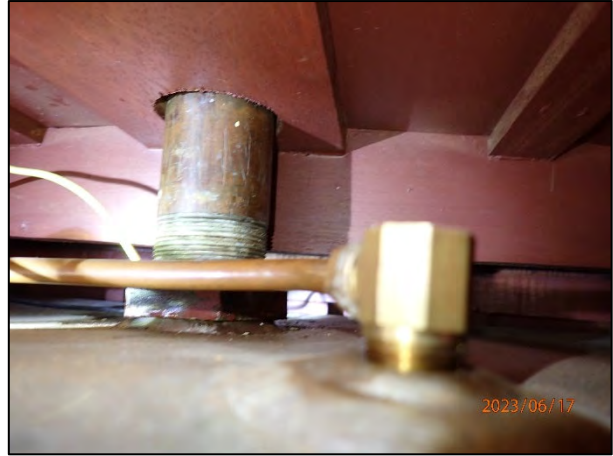
*Fill Pipe And Vent Tube*

4. Deck plates or permanently attached caps shall carry a permanent identification of the fuel type, e.g. DIESEL or the ISO symbol (ABYC H-33.12.3). The fuel deck plate should be marked accordingly.

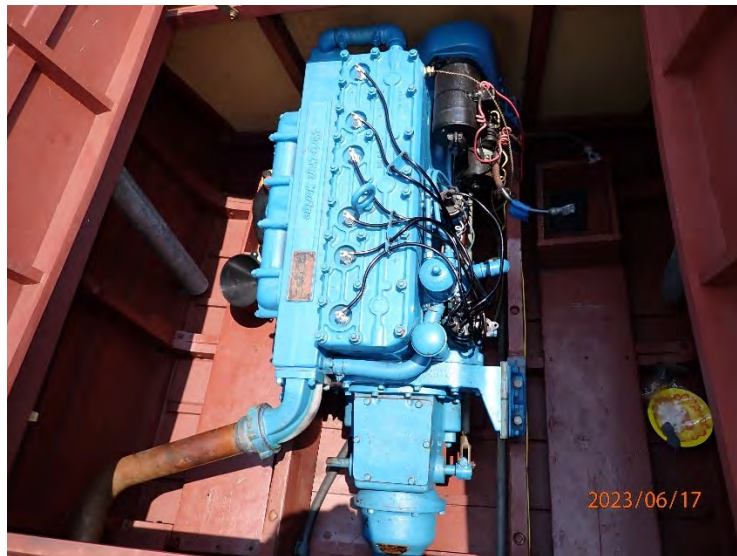
Our next inspections were of the engine compartment and engine. The engine appeared to be original. The engine showed signs of having been previously removed and repainted, and to have undergone some degree of overhauling. All engine mounts were properly secured. The flame arrestor was clean and properly secured. The sparkplug end of each high-tension lead lacked an insulative boot. The same was found while inspecting the high-tension lead attached to the ignition coil. The continuously-energized positive terminal on the starter solenoid was exposed.

*Engine*

1. Each ungrounded terminal or stud that is continuously energized must have a non-conductive cover installed so as to prevent accidental short-circuiting at the terminal or stud (33CFR 183.445 & ABYC E-11.5.2.7.5). Install a non-conductive cover over the noted continuously energized positive terminal on the starter relay solenoid. When the battery is installed, its positive post should also be insulated (33CFR 183.420).

3. Each metallic fuel line that is mounted to the boat structure must be connected to the engine by a flexible fuel line (33CFR 183.562). Install a flexible section of fuel feed hose between the engine and copper feed tube.
