## Condition & Value Survey Report

File # 25107

Acting at the request of Carlo Ferreira, 6985 South Pecos Road, Las Vegas, NV 89120, attending surveyor proceeded to a private residence at 1201 Holiday Drive, Somonauk, IL 60552, under the date of January 23, 2025, and there did survey the 19' antique runabout while resting on her trailer. The purpose of the survey was to ascertain the condition and value of said vessel for insurance application. The vessel will be used for pleasure purposes.

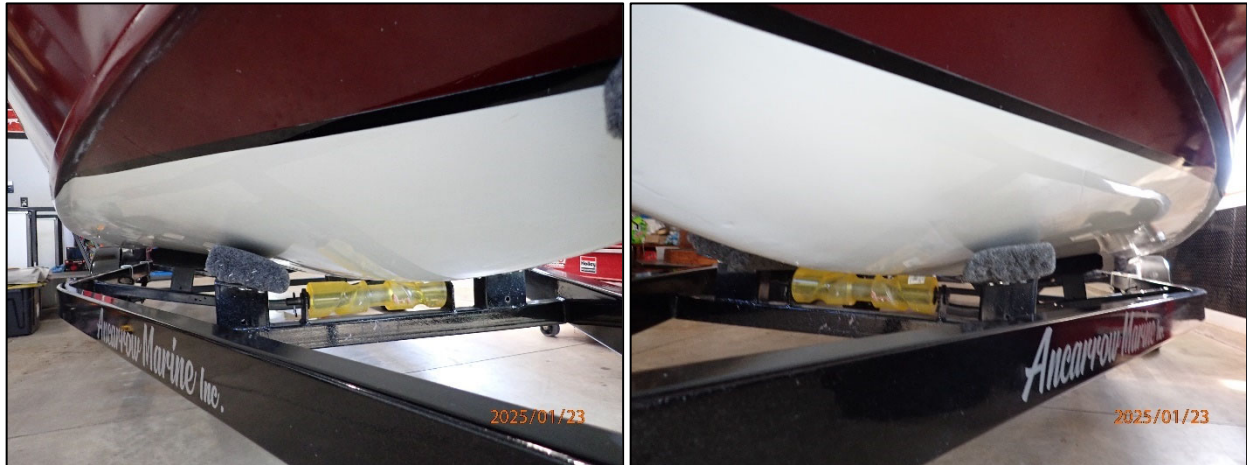
We began our survey by sounding the undersides and transom with a phenolic hammer, testing for moisture using a Tramex Skipper 5 moisture meter, and by performing visual inspections. No signs of collision or grounding damage were observed. The bottom paint presented very well. Percussive testing did not reveal any indicators for soft planking and or loose fasteners. Moisture meter readings (Wood Scale) gained from the undersides registered in the Level 1 – 3 ranges.

*Starboard & Port Undersides*

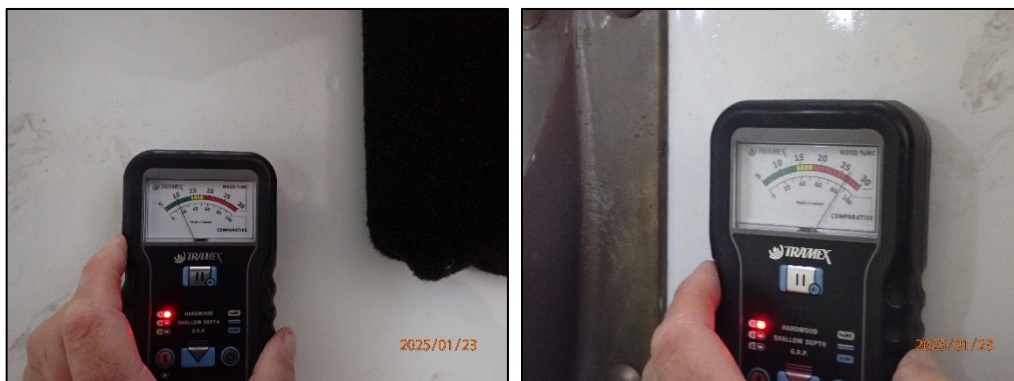
*Level 1 \* 3 Readings Gained From Underwater Surfaces*

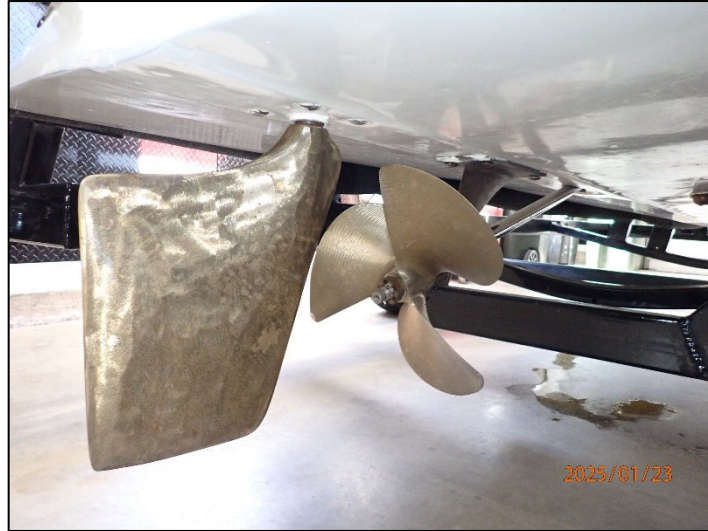
Survey of the underwater running gear showed the propeller, rudder and strut to present in a good and serviceable condition. The cutlass bearing displayed minor amounts of even wear.

***Running Gear***

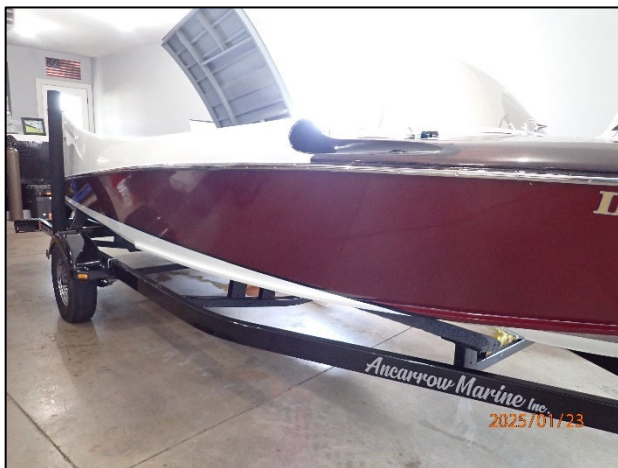
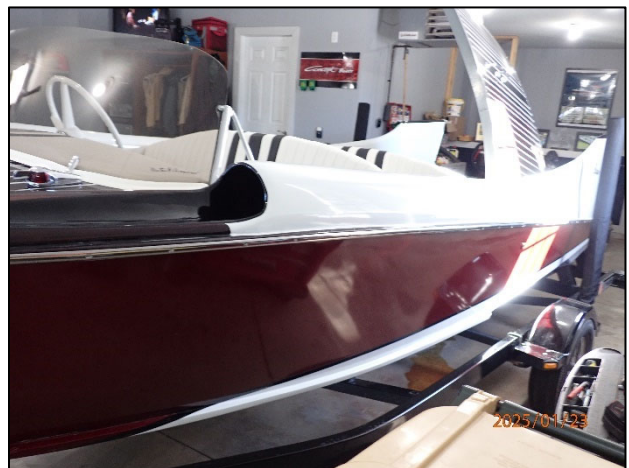
Our next inspections were of the topside and deck surfaces. The mahogany planking had a high-gloss finish. Percussive testing did not reveal any indicators for loose planking and or fasteners. Moisture readings gained from the noted surfaces registered in the Level 1 range.

***Starboard And Port Topsides***

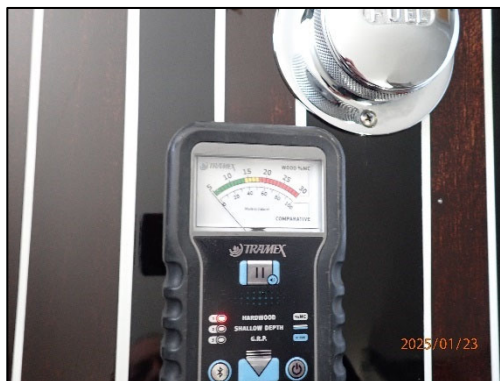
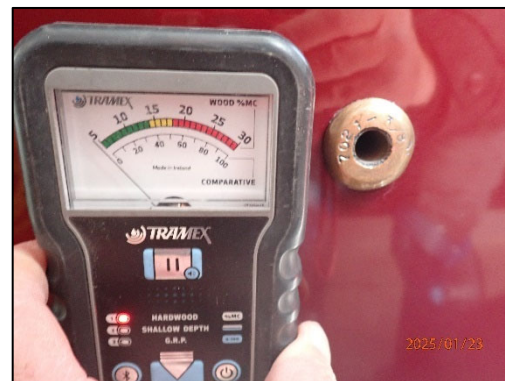
***L-1 Readings Gained From Deck & Topsides***

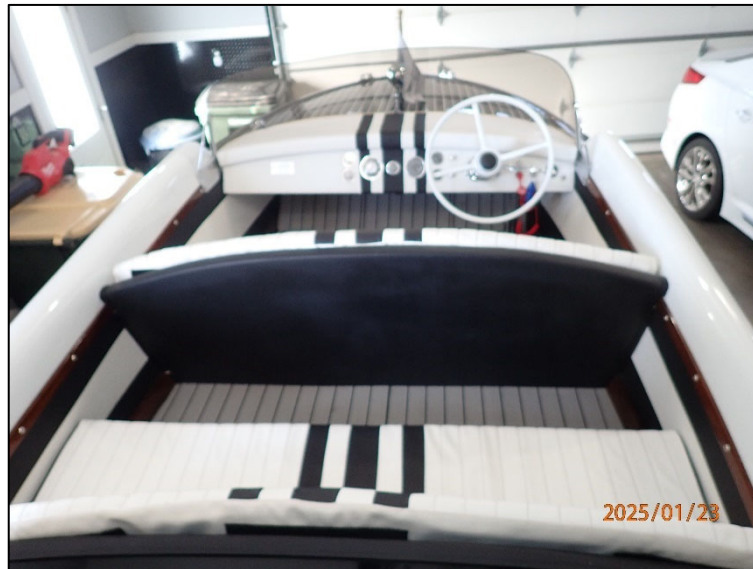
Our next inspections were of the cockpits. All seat cushions presented in a like-new condition.

*Cockpits*

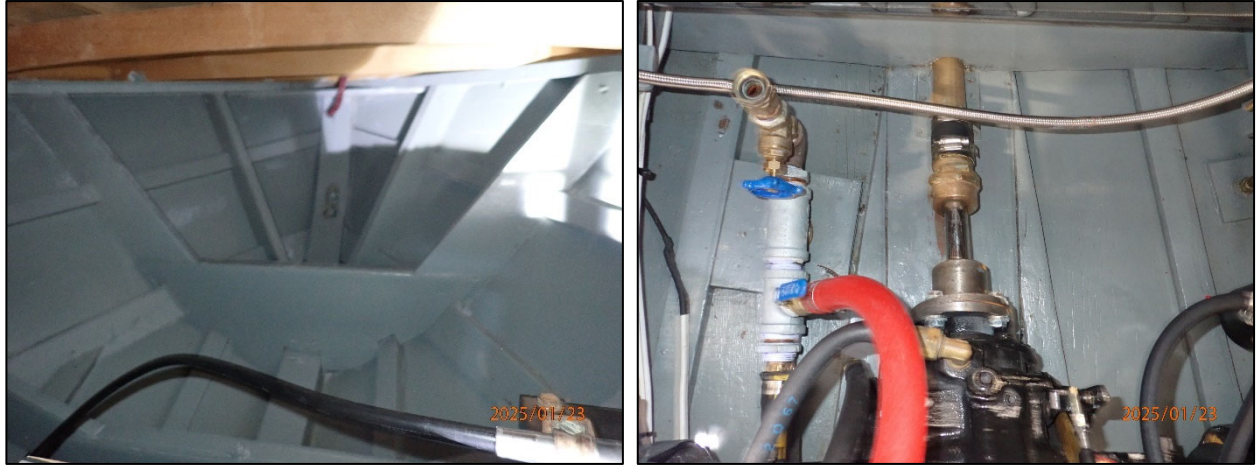
The attending surveyor opened every hatch, access panel and other that could be accessed without the use of tools, finding all accessible primary and secondary hull frames to be free of any visible damage or measurable deterioration. Moisture readings gained from the accessible frames registered in the Level 1 range.

***Fore And Aft Bilges***

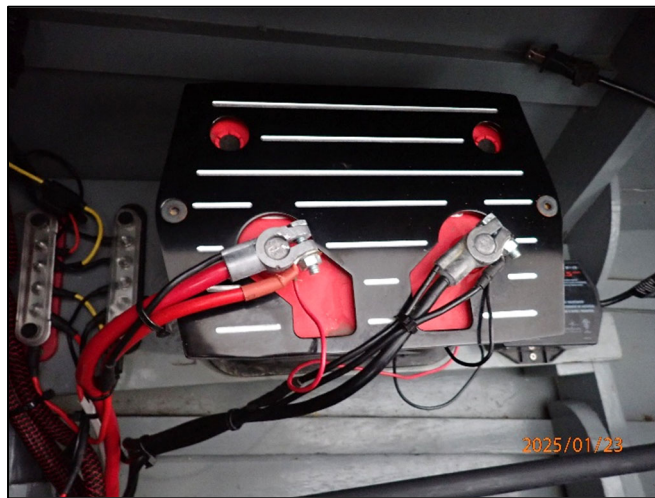
***Battery***

The battery was properly secured. However, its positive post was exposed or non-insulated.

2. Each battery must be installed so that metallic objects cannot come in contact with the ungrounded battery terminal (33CFR 183.420). Install a non-conductive boot or cap over the positive battery terminal.

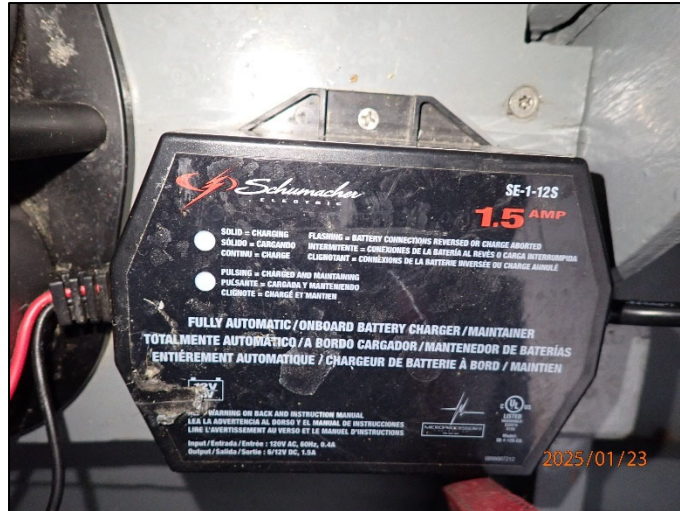
*Battery Charger*

The onboard battery charger was not labeled as being approved for marine application.

1. Have a qualified technician verify if the battery charger is approved for marine application. If not, the charger should be removed (33CFR 183.410 regulation & ABYC E-11 recommendations)

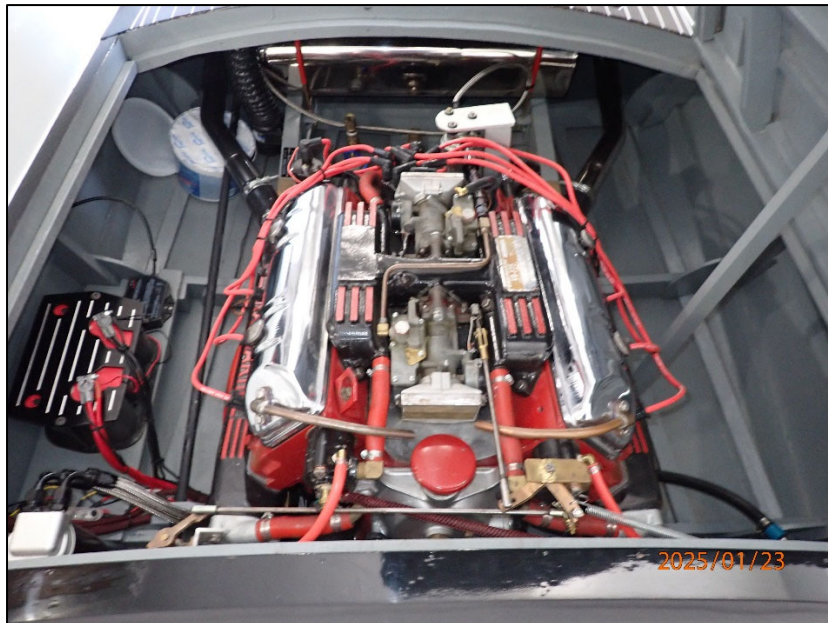
*Engine Compartment & Machinery*

Our next inspections were of the engine compartment and engine. The engine compartment was exceptionally clean.

Visual inspections showed the engine to be free of any measurable corrosion. All engine mounts were properly secured. Both flame arrestors were clean, plus they were properly secured. The belts and hoses presented in a good and serviceable condition.

The continuously energized positive terminal on the starter solenoid was exposed.

3. Each ungrounded terminal or stud that is continuously energized must have a non-conductive cover installed so as to prevent accidental short-circuiting at the terminal or stud (33CFR 183.445 & ABYC E-11.5.2.7.5). Install a non-conductive cover over the noted continuously energized 12v+ terminal on the starter solenoid.
