Buchanan Marine Appraisal Services Limited

REPORT OF MARINE SURVEY

**Insurance Underwriting Condition & Value
of the vessel**

Chris Craft 27' Custom Runabout, model 936

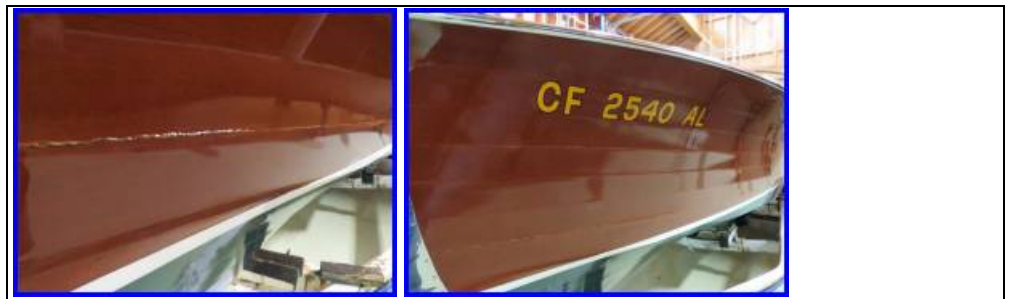
Hullside Finish: The exterior hullsides have a professional quality varnish finish applied, starting to sink into the grain, with seams standing proud. **RECOMMENDATION:** Prep and refinish at the owner's discretion.

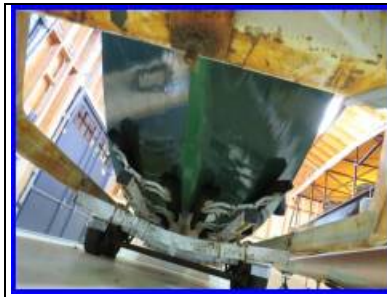
The bottom paint had minor areas of flaking and peeling present at the time of the inspection. **RECOMMENDATION:** Remove loose flaking paint, spot sand areas and touch up peeling / flaking areas as required prior to next launch or during the next haul-out period.

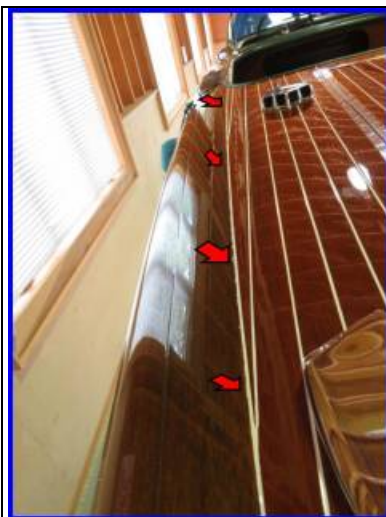
Construction material: Strip planked in mahogany timber, laid over sawn timber frames, secured with mechanical fasteners. All frames checked sound where accessible. Planking is well secured with surfaces smooth and fare. Deck grouting is cracking along the outboard port side of the engine compartment deck, running over the length of the deck at various areas. **RECOMMENDATION:** Remove loose seam compound and apply new compound as required, protecting with varnish.

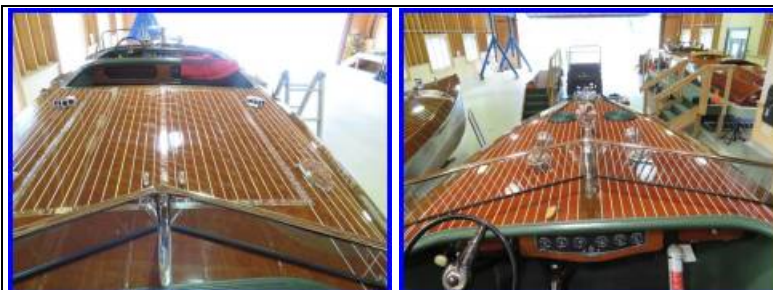
Deck Finish: A varnish finish is applied, showing well with isolated areas standing proud along seams, noted solely for information purposes. **RECOMMENDATION:** Prep and refinish at the owner's discretion as preventative maintenance.

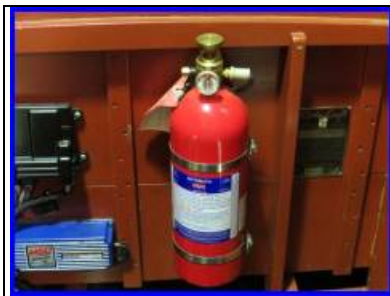
Automatic FE241 Clean Agent Extinguisher(s): Located in the engine compartment area. The gauge reads full, having no recent service tag attached. Extinguisher has outdated or no certification tag(s). A monitor is not installed at the helm. NOTE: ABYC A-4 recommends that fixed fire protection systems be checked and re-weighed at one year intervals and tagged accordingly. This is especially important when no gauge is installed. Recommend compliance.

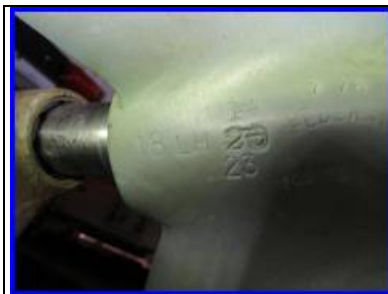
Minimal damage to tip of one blade, not expected to result in vibration. **RECOMMENDATION:** Send prop for repair and balance as preventative maintenance.

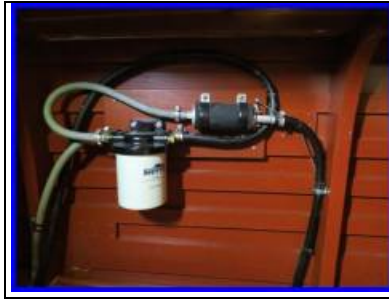
Fuel pump(s): Engine is equipped with a electronic fuel injection system (EFI / MPI), having a 12V electric fuel pump installed, mounted on the inner hullside, to port of the engine. **RECOMMENDATION:** Ensure fuel pump is ignition protected and rated for marine use. Standards call for the fuel pump to be mounted within 12" of the engine with a maximum delivery hose length of 48". **RECOMMENDATION:** Ensure compliance with standards.

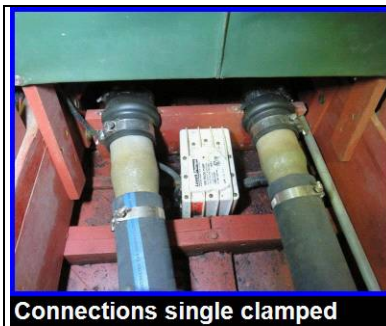
Connections single clamped

- Discharge location(s):** Through the transom, with the flanges well bedded.
- Piping/Clamps:** Cast metal and appropriately rated "wet marine exhaust" flex hose is run for the exhaust system. Exhaust system is not double clamped. RECOMMENDATION: All Exhaust Hose connections should be secured with two non-overlapping clamps at each end to produce a secure, liquid and vapour tight joint in order to comply with TC TP1332 and ABYC recommendations.

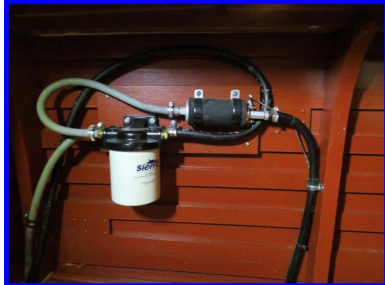
Engine is equipped with a electronic fuel injection system (EFI / MPI), having a 12V electric fuel pump installed, mounted on the inner hullside, to port of the engine. RECOMMENDATION: Ensure fuel pump is ignition protected and rated for marine use. Standards call for the fuel pump to be mounted within 12" of the engine with a maximum delivery hose length of 48". Ensure compliance with standards.

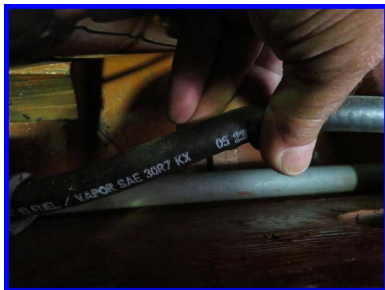
Type 30R7 flex hose is run for the fuel supply system, along with runs of Type A1-15. The Type 30R7 hose is sub-standard, not appropriate for the application. RECOMMENDATION: Replace all runs of sub-standard hose at this time.

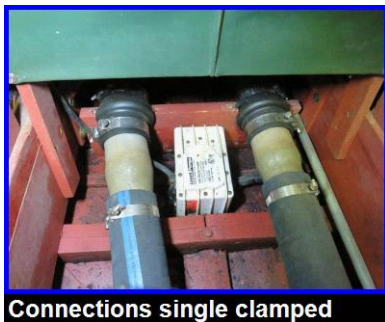
Cast metal and appropriately rated "wet marine exhaust" flex hose is run for the exhaust system. Exhaust system is not double clamped. RECOMMENDATION: All Exhaust Hose connections should be secured with two non-overlapping clamps at each end to produce a secure, liquid and vapour tight joint in order to comply with TC TP1332 and ABYC recommendations.

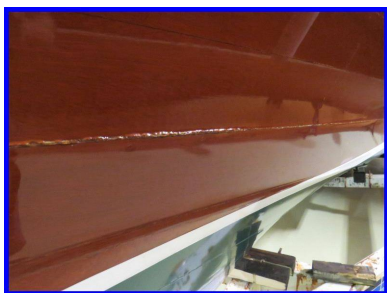
The exterior hullsides have a professional quality varnish finish applied, starting to sink into the grain, with seams standing proud. RECOMMENDATION: Prep and refinish at the owner's discretion.

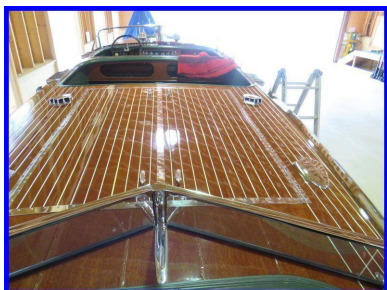
A varnish finish is applied, showing well with isolated areas standing proud along seams, noted solely for information purposes. RECOMMENDATION: Prep and refinish at the owner's discretion as preventative maintenance.

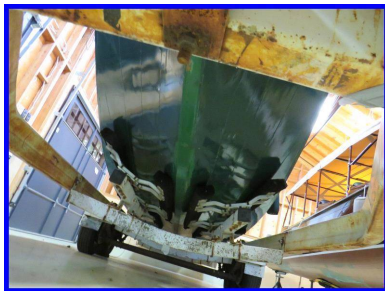
RECOMMENDATION: Remove loose flaking paint, spot sand areas and touch up peeling / flaking areas as required prior to next launch or during the next haul-out period.

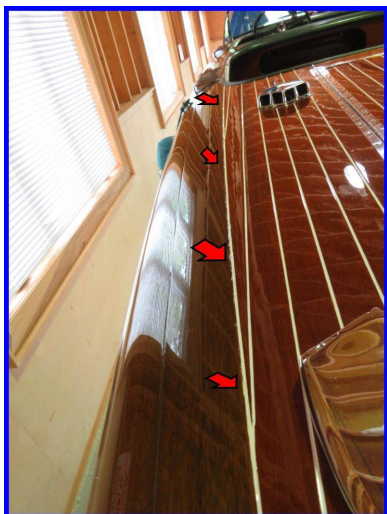
Strip planked in mahogany timber, laid over sawn timber frames, secured with mechanical fasteners. All frames checked sound where accessible. Planking is well secured with surfaces smooth and fair. Deck grouting is cracking along the outboard port side of the engine compartment deck, running over the length of the deck at various areas. RECOMMENDATION: Remove loose seam compound and apply new compound as required, protecting with varnish.
