1942 Chris-Craft 16' Special Race Boat, Model # 42-4

"SCRAPPY"

Report of Marine Survey

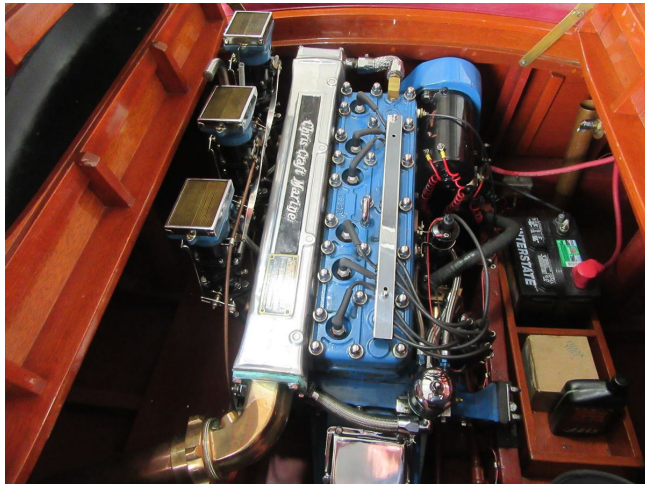
Chris-Craft KB in-line six cylinder, triple downdraft carburetors

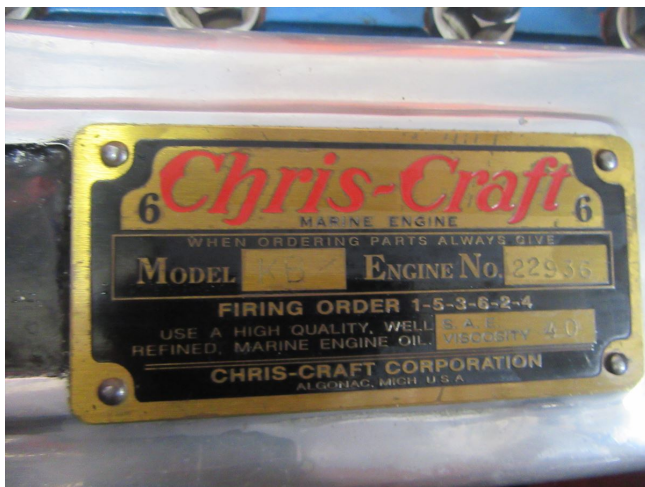
KB22936

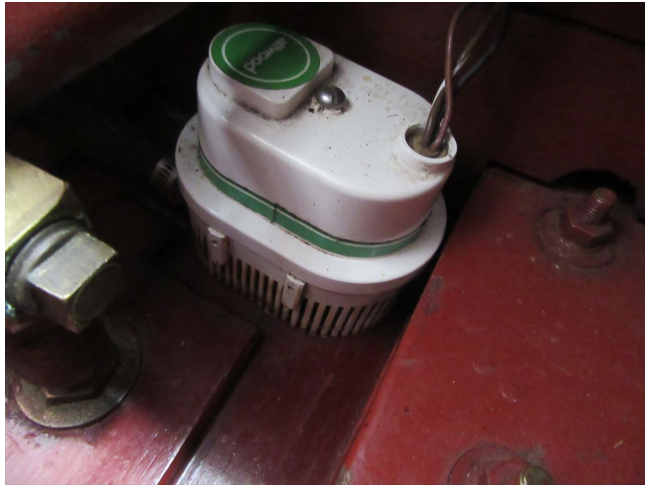
One (1) Attwood 4172 12 volt DC bilge pump, serviceable condition, securely installed, and functioned as intended.

Highly recommend weekly testing of bilge pump operation, adequate dewatering ability and removal of any bilge pump debris.

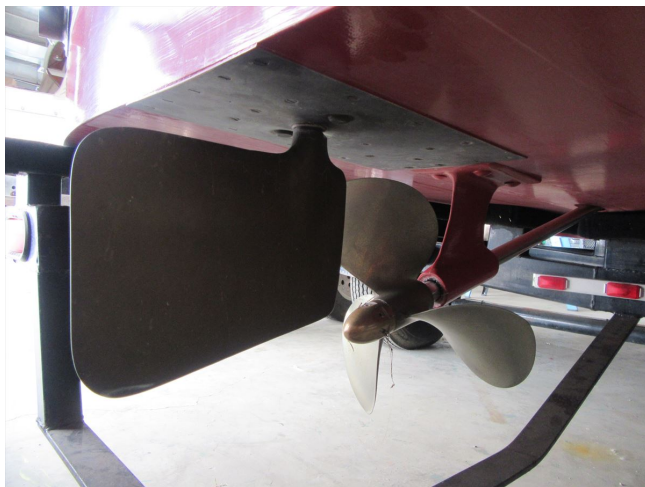
One RH cupped Nibral three blade Michigan Wheel 13" x 14P, in serviceable condition and securely installed, spun without excessive force.

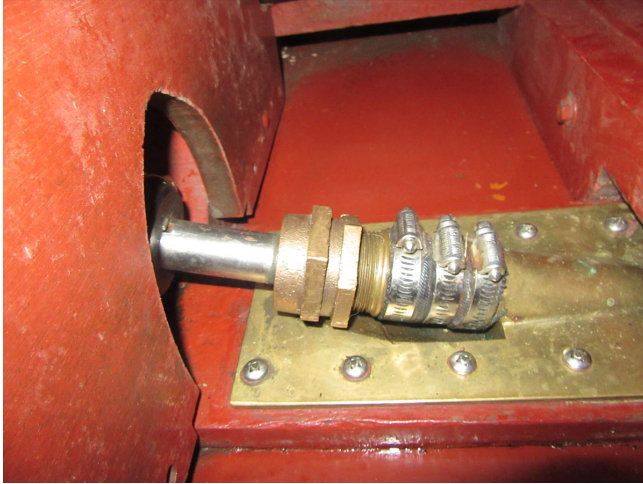
Bronze-alloy wax infused flax packing gland seal assembly; hose, clamps, and packing gland assembly were securely installed with no significant visual signs of defect
