Report of Marine Survey

"Joyride"

1965 21 ft. Chris Craft Capri

TYPE OF SURVEY REQUESTED: Pre-Purchase Condition and Value
DATE AND TIME OF SURVEY: 5-29-23
FILE NUMBER: 1172
VESSEL TYPE: High speed inboard runabout with a wood hull and deck
VESSEL BUILDER: Chris Craft Corp., Pompano Beach, FL ,& Algonac, MI.
HIN (HULL IDENTIFICATION NUMBER): CP-21-005. The hull ID number of the vessel was found located on the builder's plate on the engine hatch.
YEAR BUILT: 1955
STATE REGISTRATION NUMBER: CF 3616 KA sighted on hull sides with 2023 tags.
STATE REGISTRATION DECAL NUMBER: F-158439
STATE REGISTERED VESSEL OWNER: Ken Peter 95404
VESSEL MATERIAL: Wood hull and deck.
LENGTH OVERALL (LOA): 21 ft.
LOCATION OF SURVEY INSPECTION: Santa Rosa. CA, at owner's home.
PERSONS IN ATTENDANCE DURING SURVEY: Owner and surveyor.
WEATHER CONDITIONS PRESENT: Overcast, damp.

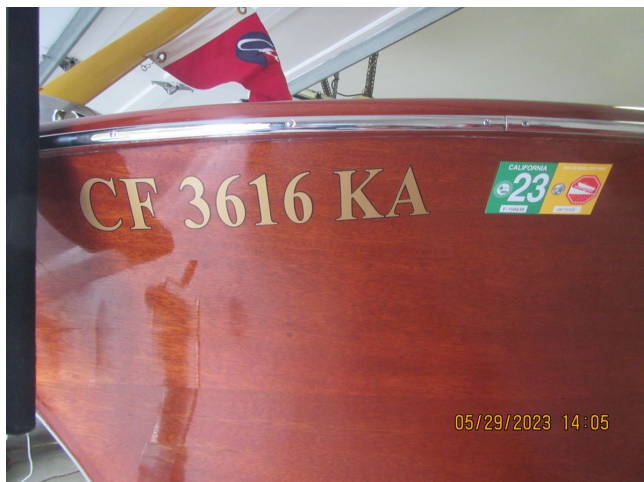
Solid, with no cracks on external inspection. Towing eye appeared secure.

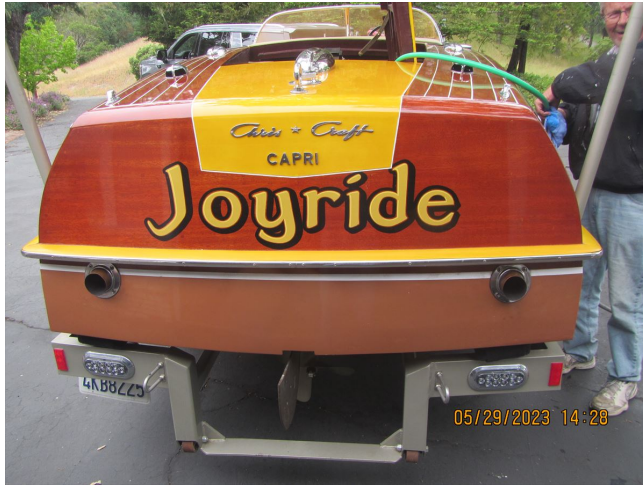
Transom surface condition was also excellent--the same as the topsides. Curved mahogany framing and knees were secure.

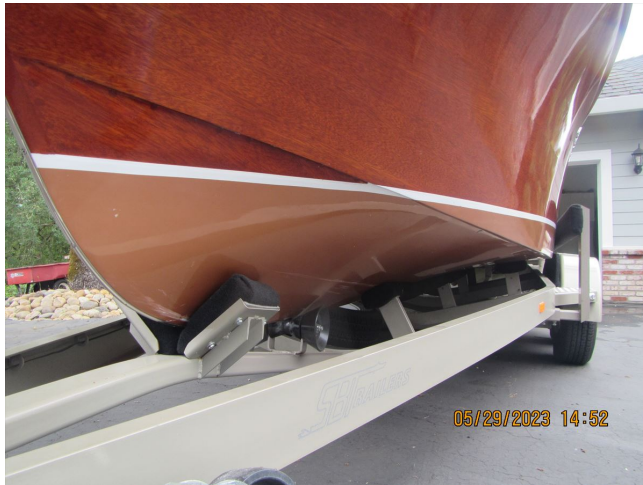
Bottom was clean and free of scratches or impact areas except as noted. Limited access due to trailer pads. There are two areas on the forward bottom and small spot on starboard aft side near transom showing minor scratches to the paint from previous impact. No structural damage to hull sighted. No access to forward interior to inspect.

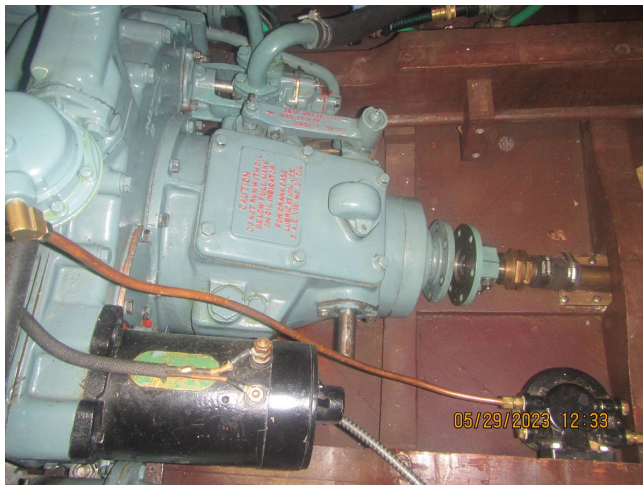
FINDING A-2

Copper fuel lines are original type copper tubing. Tubing was not secured and will work harden and fail from vibration if not secured. These boats originally had small copper straps using two small screws. Recommend replacing tubing using proper period straps. Recommend long neck nuts for marine applications.

Service, repair or replace as necessary. Secure every 18" or closer as required by ABYC H-33 and 24. Use approved metal brackets in engine space. Provide chafe gear at bulkhead openings and corners as needed. Provide flexible connection to engine from secured copper. Use long neck type end fittings on copper tubing. 33CFR USCG.

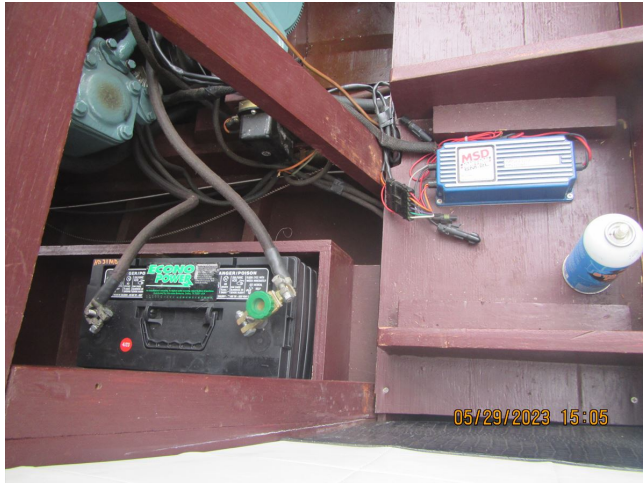
FINDING A-3

Group 27, 12 volt wet battery with 990 CCA. Battery was not secured in place and appeared nearly new.

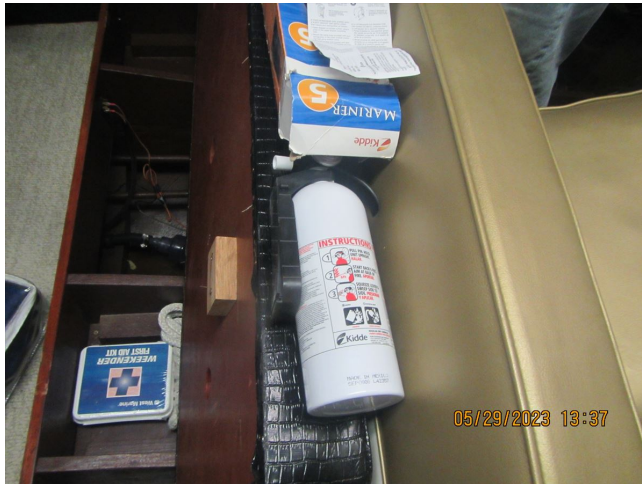
FINDING A-4

One expired sighted below seat, (recalled Kidde ABC 2.5). One vintage original extinguisher mounted in cockpit.

Provide currently certified fire extinguishers and mount in prominent locations to comply with ABYC and NFPA recommended standards for fire protection.
