GLENWOOD CEMETERY

To: Dick Ambrus
From: Martha Peterson
Subject: Estrada Monument Restoration Work
Date: October 12, 2005

MONUMENT RESTORATION PROJECT

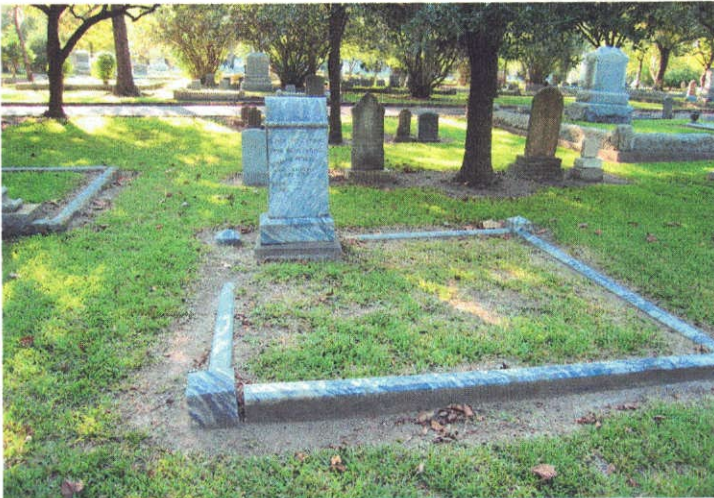
Section Lot No. Description	D 135 SE¼			
Work Performed	<p>The marble coping had sunk and was buried on the southwest corner. The beam of the coping was cracked behind the monument and a section approximately 2' long was missing.</p> <p>The missing piece of coping was found buried on the lot and was recovered. The four corner posts and the reassembled coping were leveled and reset on a new foundation.</p>			
Work To Be Completed	<p>A marble monument, 52" high x 20" x 10" is relatively plumb (1° north), but it is sliding on its base and overhanging it by approximately 1" on the northwest corner.</p>

BEFORE: The marble coping has sunk and is buried on the southwest corner. The beam of the coping is cracked behind the monument and a section approximately 2' long is missing.

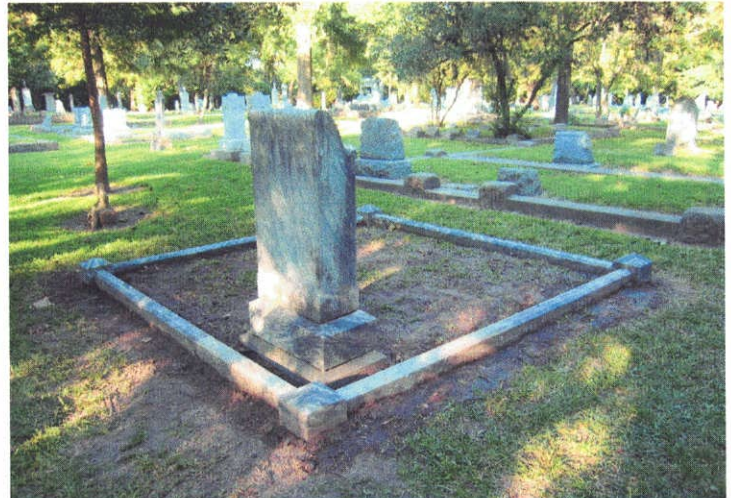
AFTER: The missing piece of the coping has been recovered and the four posts and the entire coping has been leveled and reset on a new foundation.

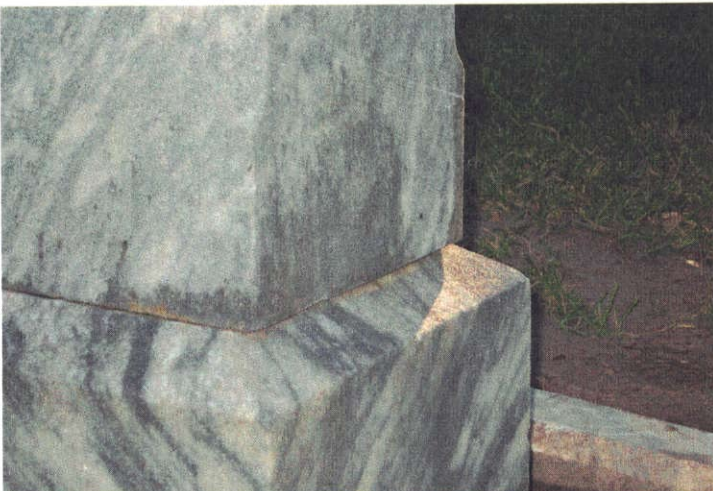
BEFORE: The monument is sliding on its base and overhanging the northwest corner approximately 1".

To be scheduled

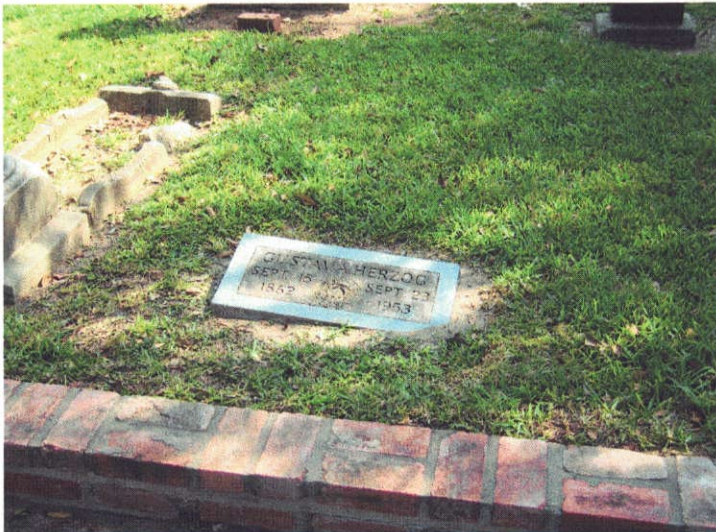
BEFORE: An in-ground granite marker had begun sinking.

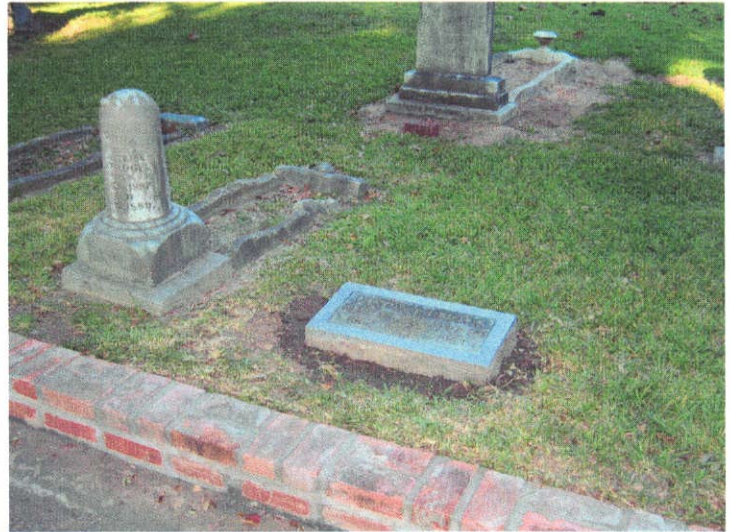
AFTER: The marker has been raised, leveled and reset on a new foundation

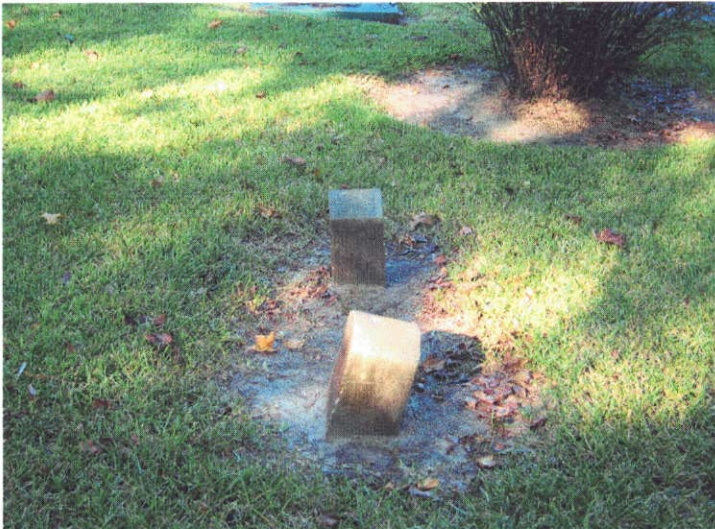
BEFORE: The two small marble markers are sunken and tilted.

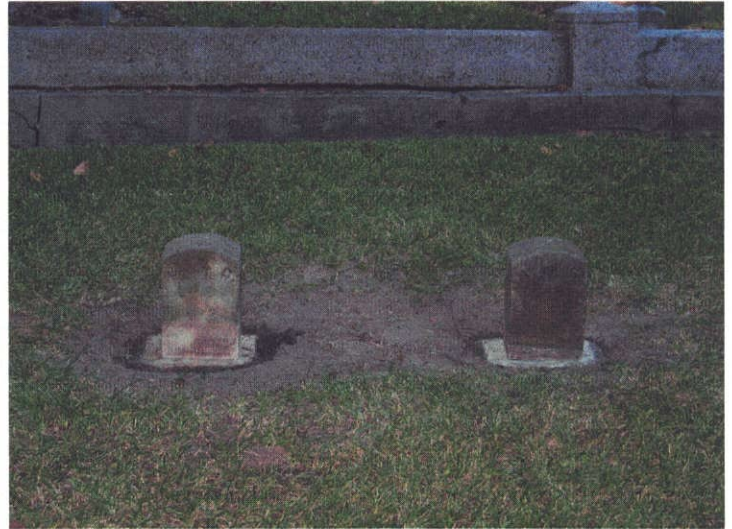
AFTER: The two small markers have been raised, leveled and reset on new foundations.

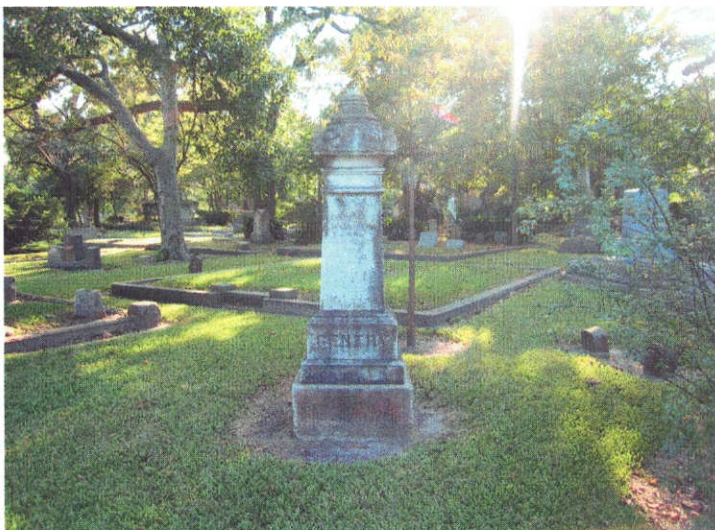
BEFORE: The large marble monument will be checked for stability and, when any necessary leveling work is completed, the entire lot will be cleaned.

To be scheduled

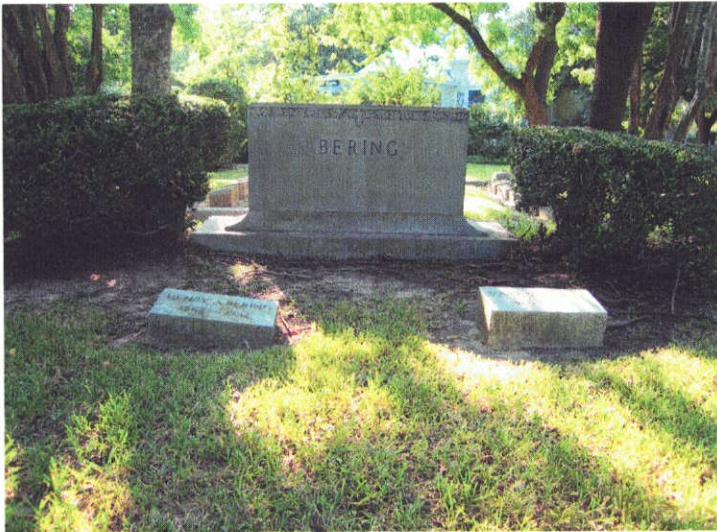
BEFORE: A raised, flat granite marker for Henry Bering was sinking 4° north.

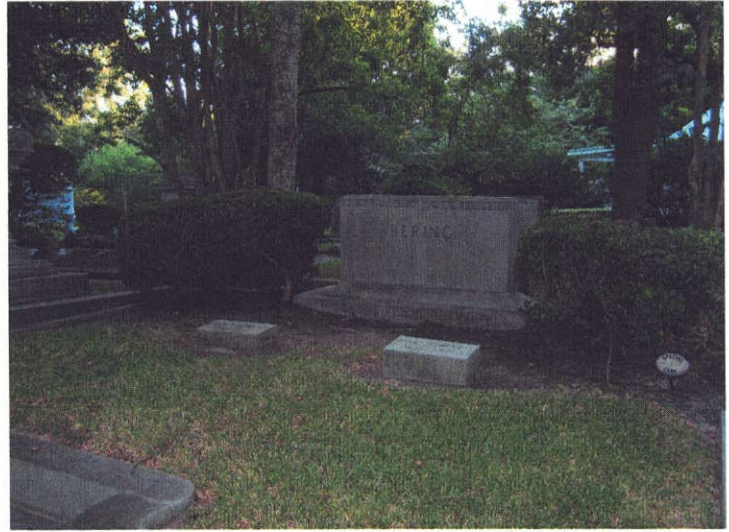
AFTER: The marker was raised level with the other marker on the lot and reset on a new foundation.

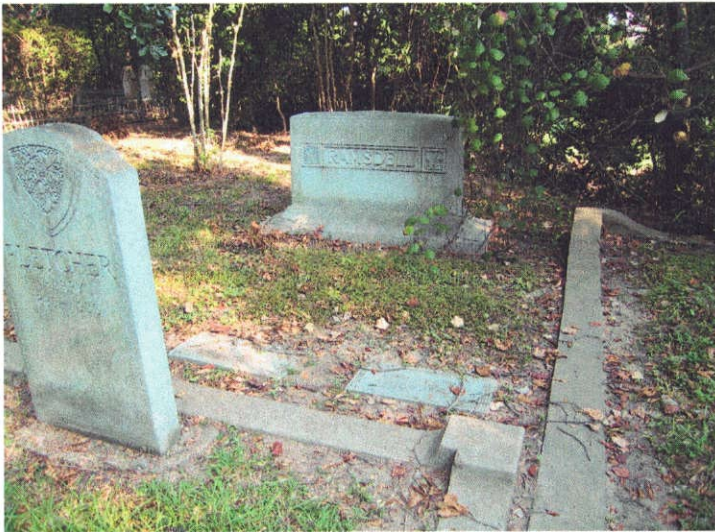
BEFORE: Two in-ground markers are sinking.

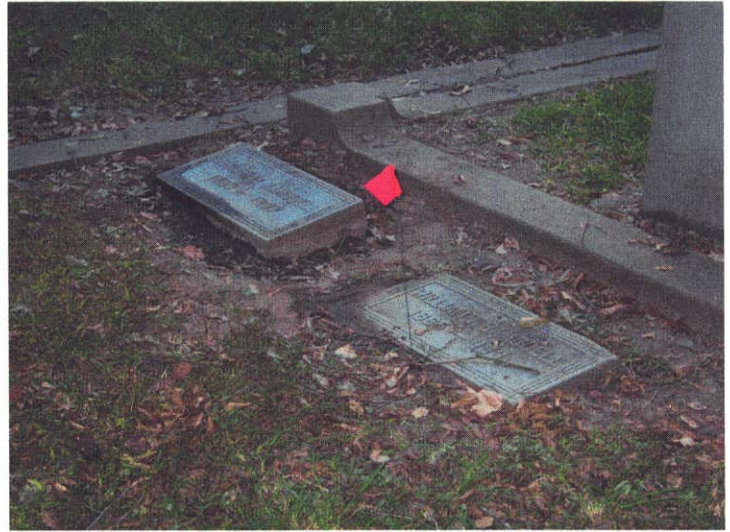
Section	F	Purchase Date	1931	
Lot No.	092	Deed of Perpetuity	Yes	
Description	NE¼	Contact	None	
		Last Burial	1937	
Work Performed	Two in-ground markers were sinking. The two markers were raised, leveled and reset on new foundations.			
Work To Be Completed	THE SECOND MARKER HAS NOT BEEN DONE. RETAKE "AFTER" PHOTO.

AFTER: The markers have been raised, leveled and reset on new foundations.

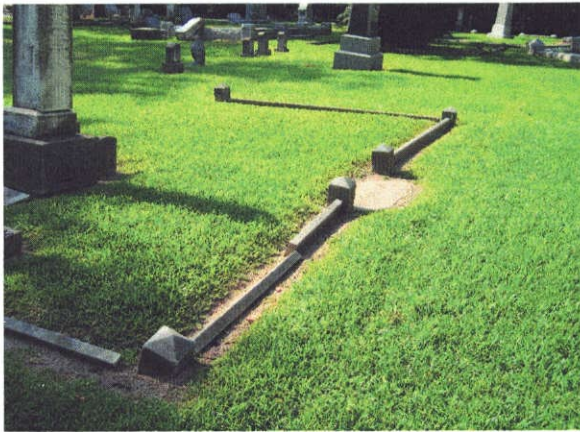
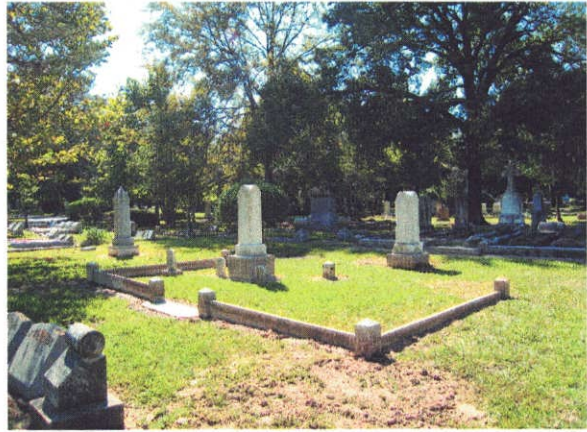
D-150 E½

D-150 E½: Six marble posts, 40' marble coping, and entrance threshold were leveled and reset on poured foundation. 36 man hours; cost to Glenwood, \$869.45.

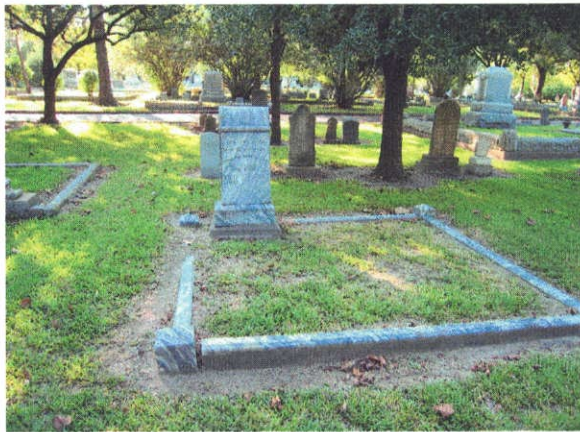
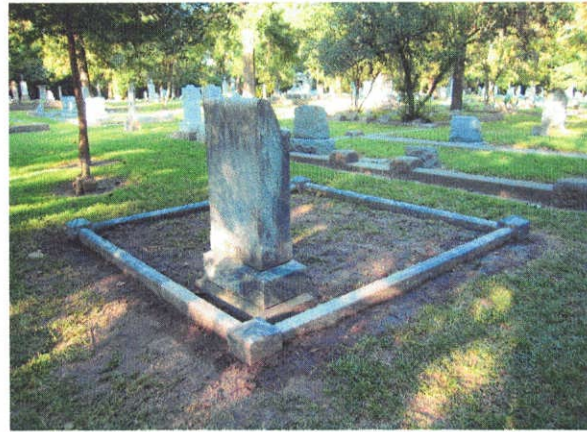
D-135 SE¼

D-135 SE¼: Four marble posts, 40' marble coping (24" found buried beneath surface) were leveled and reset on a dry foundation. There was no entrance threshold. 12 man hours; cost to Glenwood, \$185.40.
