## GLENWOOD CEMETERY

### PHOTOGRAPHS OF THREATENED GRAVE SITES

### **PHOTOGRAPHS OF PROGRESS OF EROSION**

### **FAILED ATTEMPT TO ARREST EROSION**

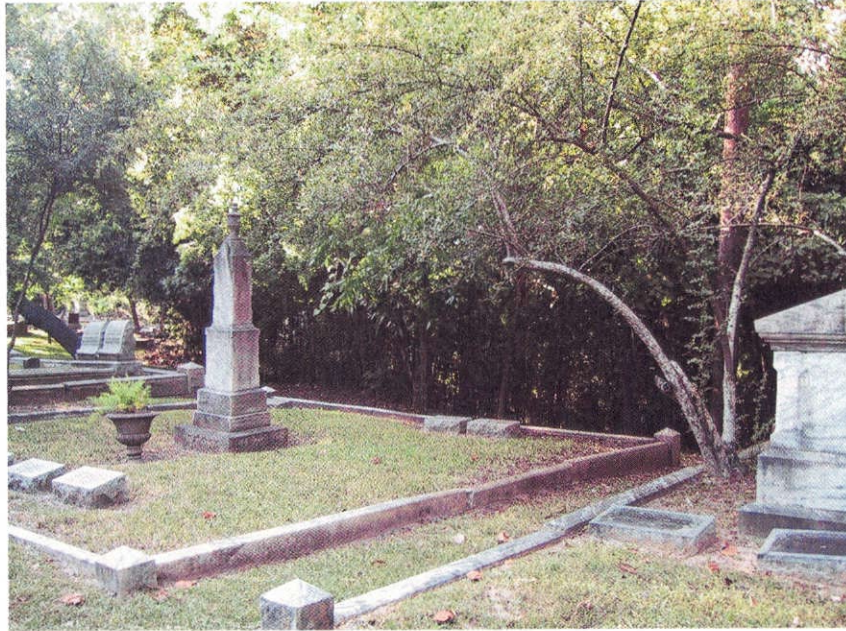
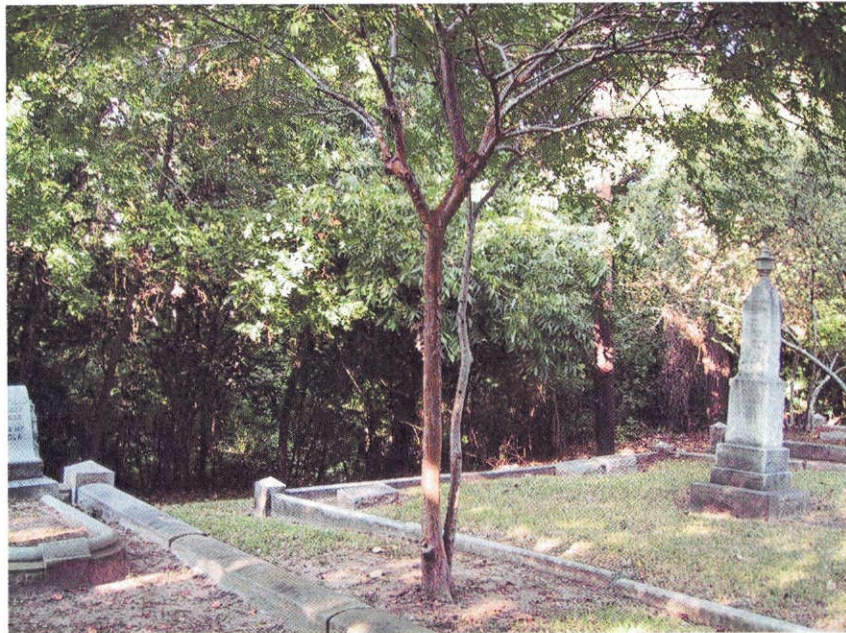
The photographs above show how close the edge of the eroding embankment has come to historic gravesites in the East Avenue Section, this one being the grave of the Loeffler family. Major Gustav A. Loeffler (d.1877), an agent of the "Nobility Verein," the German group chartered to colonize Texas and headed by Prince Solms-Braunfels. Maj. Loeffler served in the Confederate army and became assistant land commissioner and colonization agent for Texas. His wife, Julia Loeffler (d.1930) is reputed to be the first white girl whose birth was registered in Houston. Her father Henry Fisher, brought 25,000 Swiss, German and Austrian colonists to early Texas.

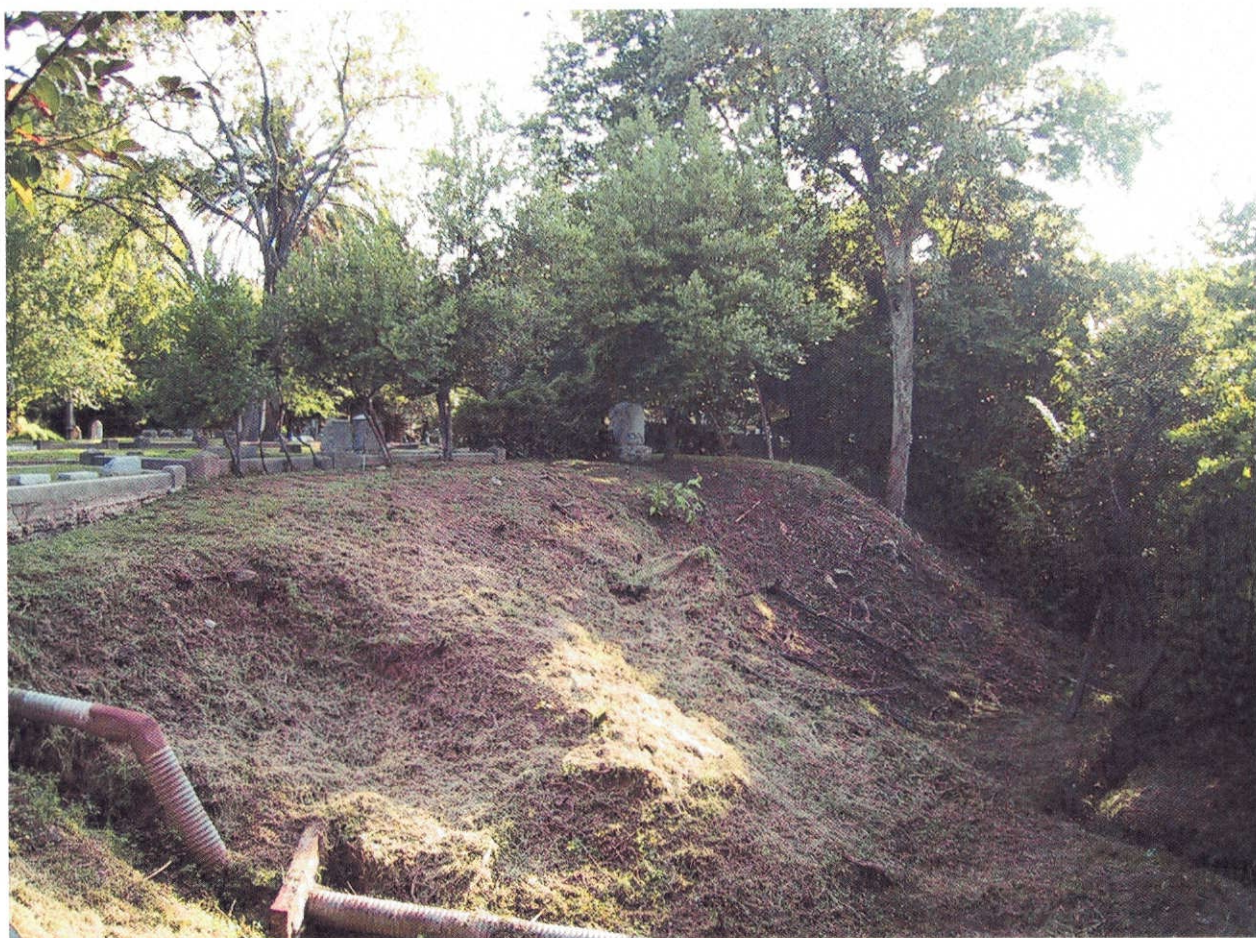
The photograph above shows the eroding bank of the gully in the West Avenue Section. Land and gravesites are also threatened in Section M and Section J.
