GLENWOOD CEMETERY HISTORIC PRESERVATION FOUNDATION

**RODRIGUEZ MONUMENT RESTORATION PROJECTS**

(Identified, Not Scheduled)

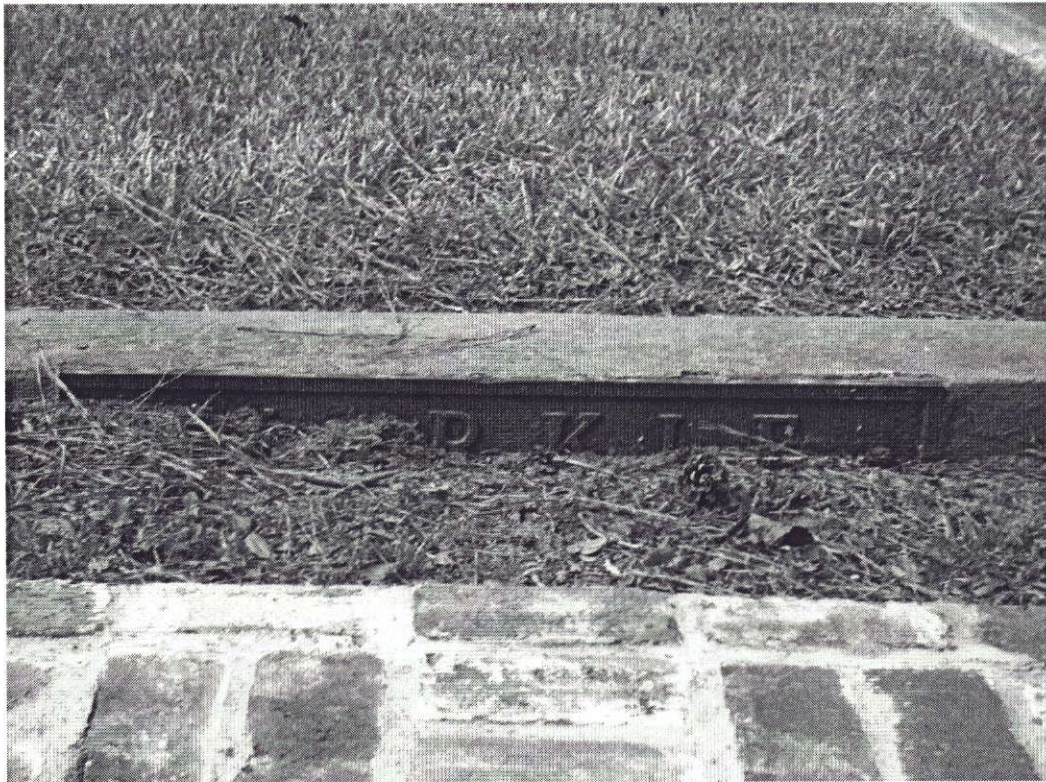
Markle, C.N.  
D-107 W 1/2  
1940  
DOP yrs  
Contact in Houston  
(since 2003)

*Coping  
surk*

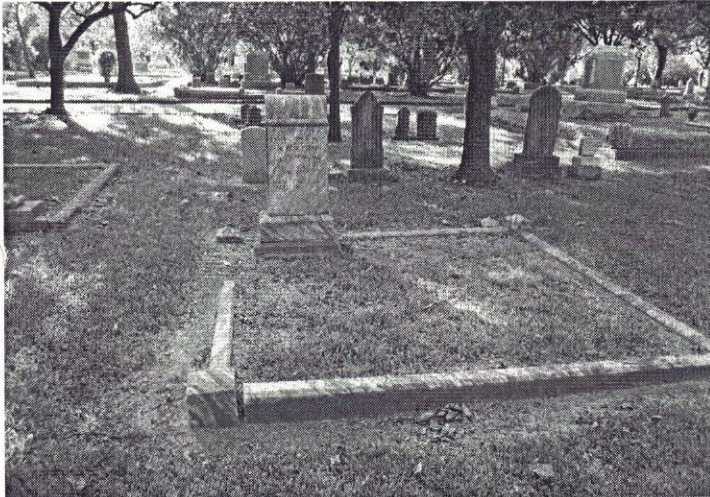
| <b>Work Performed</b> | <p>The marble coping had sunk and was buried on the southwest corner. The beam of the coping was cracked behind the monument and a section approximately 2' long was missing.</p> <p>The missing piece of coping was found buried on the lot and was recovered. The four corner posts and the reassembled coping were leveled and reset on a new foundation.</p> | | |

**BEFORE:** The marble coping has sunk and is buried on the southwest corner. The beam of the coping is cracked behind the monument and a section approximately 2' long is missing.

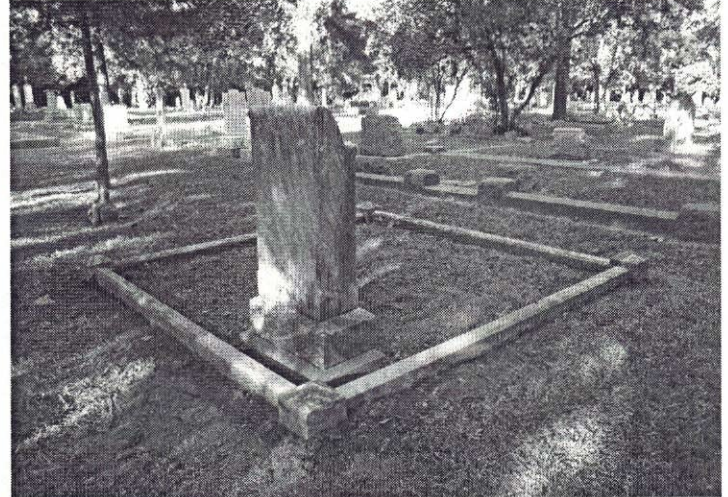
**AFTER:** The missing piece of the coping has been recovered and the four posts and the entire coping has been leveled and reset on a new foundation.

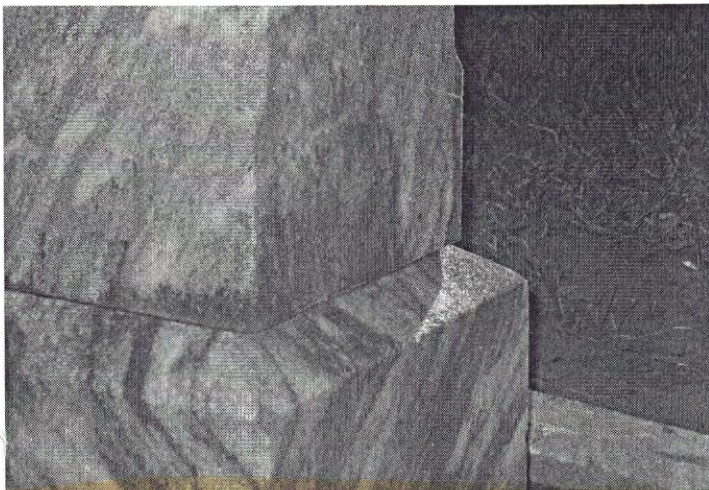
| <b>Work To Be Completed</b> | A marble monument, 52" high x 20" x 10" is relatively plumb (1° north), but it is sliding on its base and overhanging it by approximately 1" on the northwest corner. | | |

**BEFORE:** The monument is sliding on its base and overhanging the northwest corner approximately 1".

To be scheduled

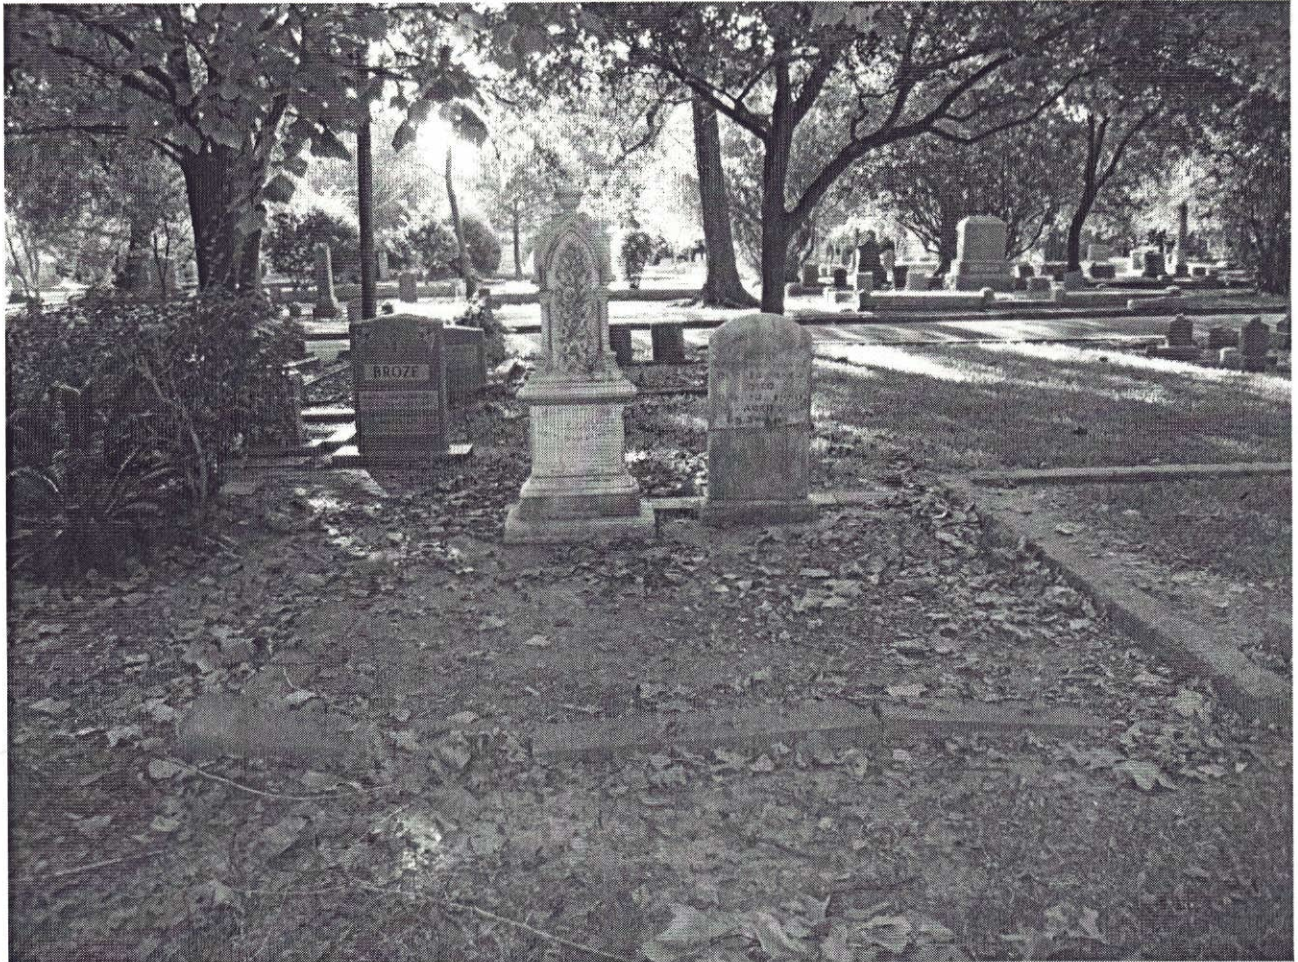
Borgsleet  
D-136 SW 1/4

Coping

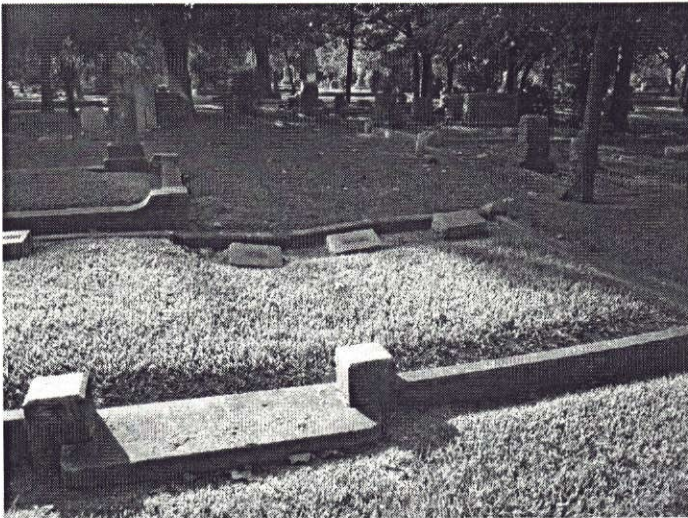
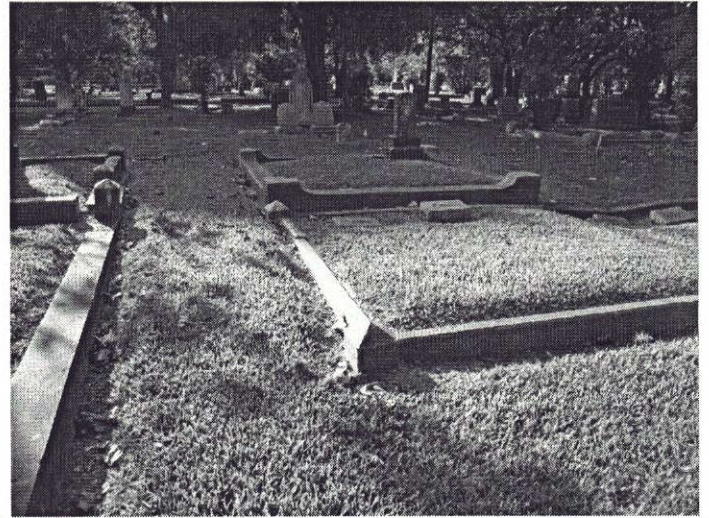
Williams, Charles B  
D-175 (200 sf)  
1905  
no DOP  
no contact

Level lot + markers

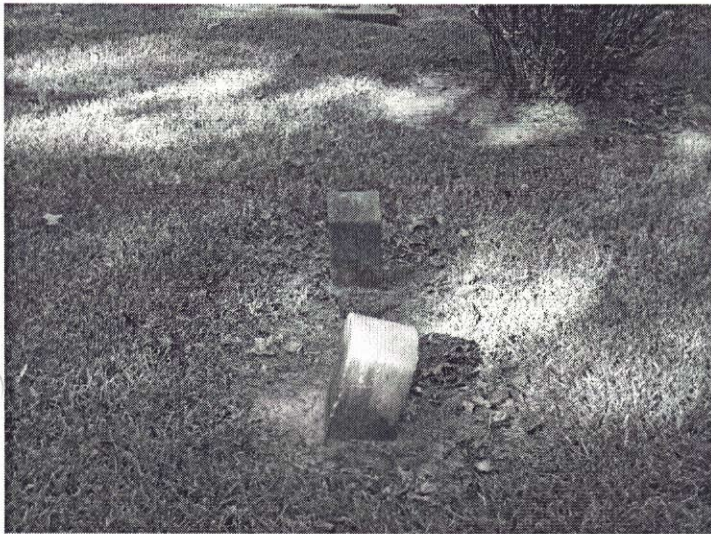
| <b>Work Performed</b> | <p>The two small marble markers were sunken and tilted.</p> <p>The two small markers were raised, leveled and reset on new foundations.</p> | |

**BEFORE:** The two small marble markers are sunken and tilted.

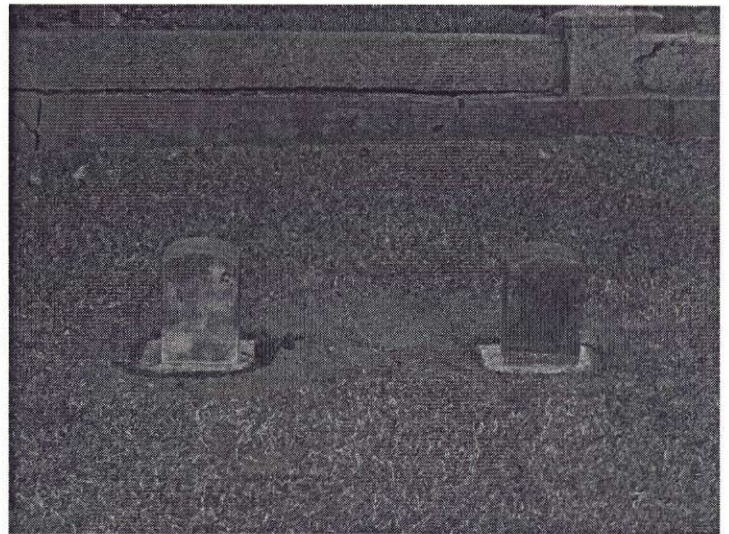
**AFTER:** The two small markers have been raised, leveled and reset on new foundations.

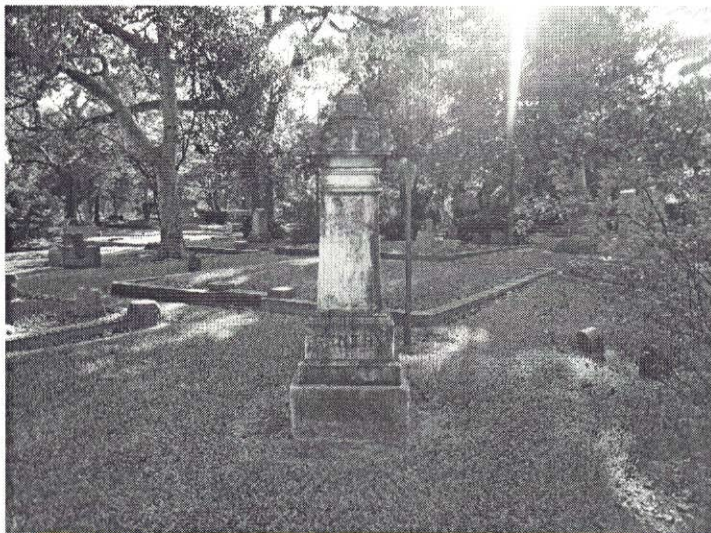
**BEFORE:** The large marble monument will be checked for stability and, when any necessary leveling work is completed, the entire lot will be cleaned.

| <b>Work To Be Completed</b> | The large marble monument will be checked for stability and, when any necessary leveling work is completed, the entire lot will be cleaned. | |

To be scheduled

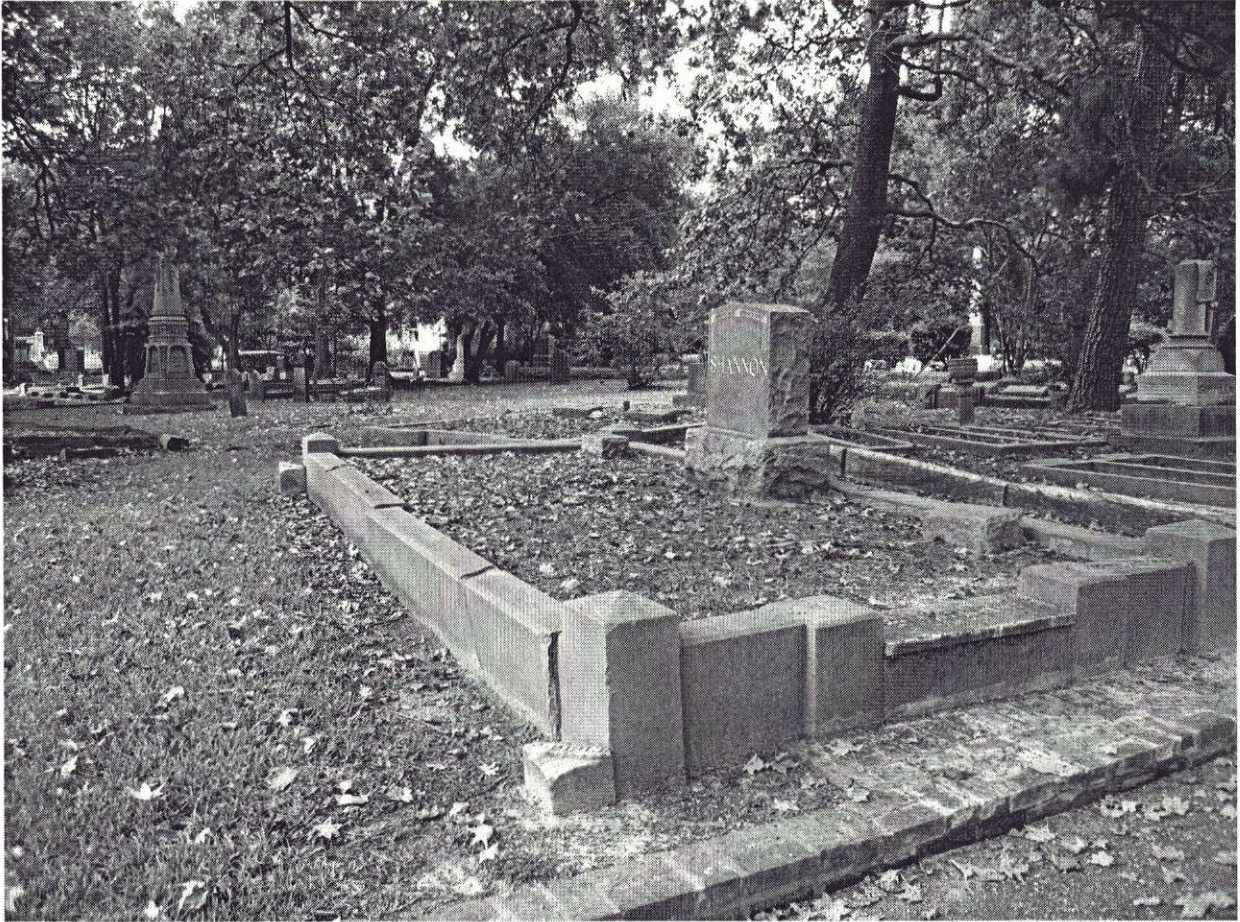
Shannon, Joe  
F-019 NW 1/2  
1886  
DOP Yes  
no contact  
Last 1938

only east side of  
concrete coping.

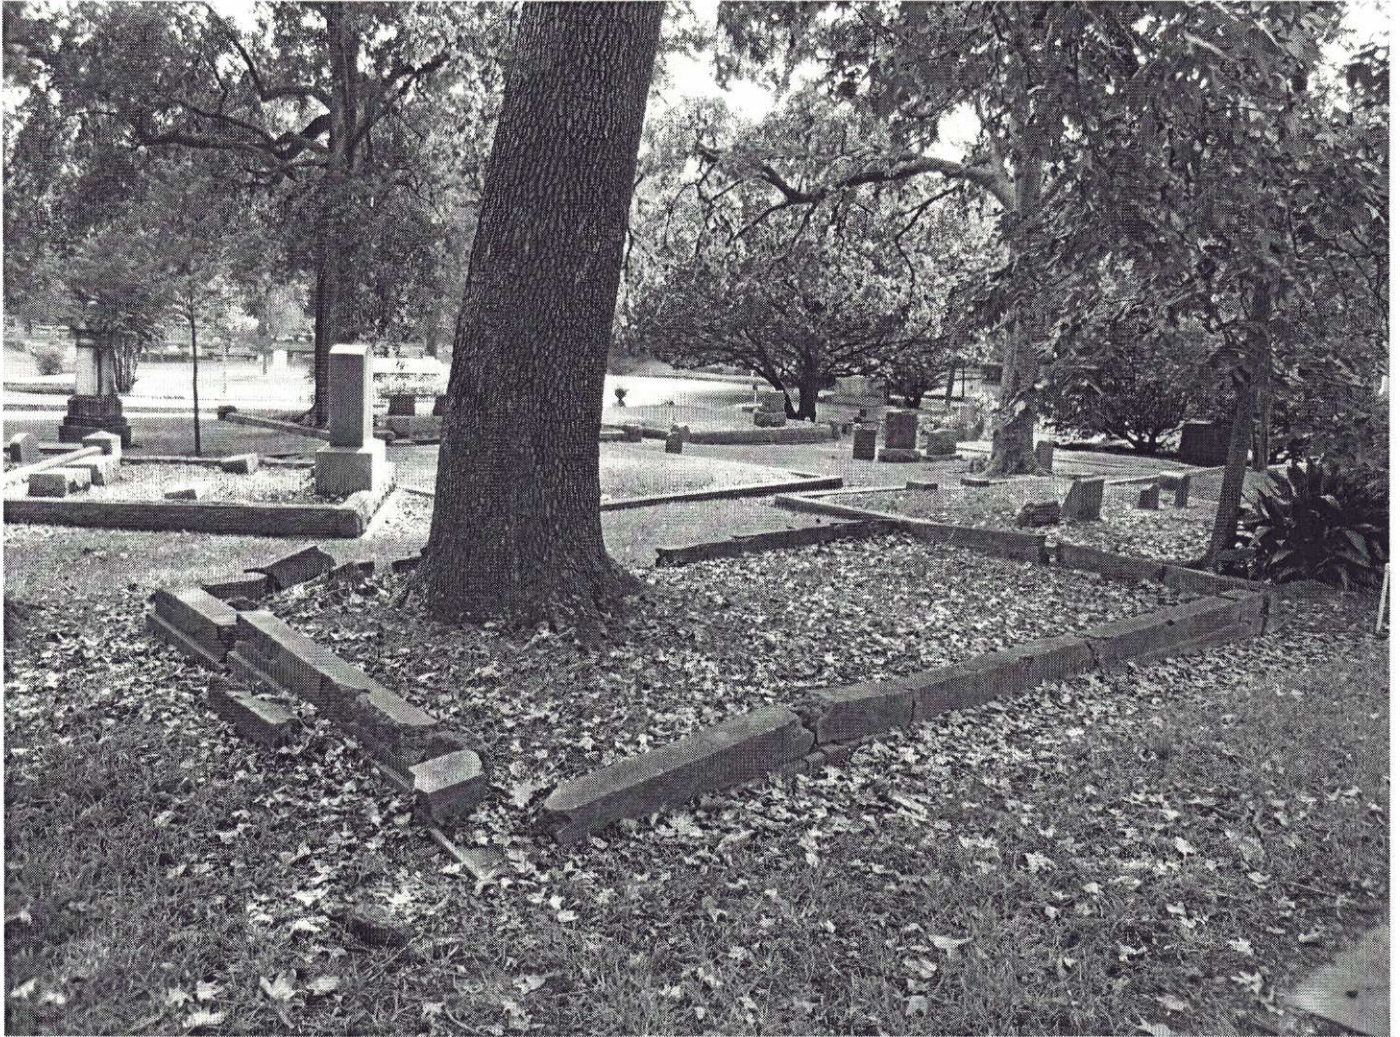
Small, Mrs. A.B.  
F-043 (500 sf)  
1879  
DOP 10  
no contact  
Last 1889

Four ~~unmarked~~ unmarked graves in  
S-Sp. Probe for markers.

Replace or remove coping.

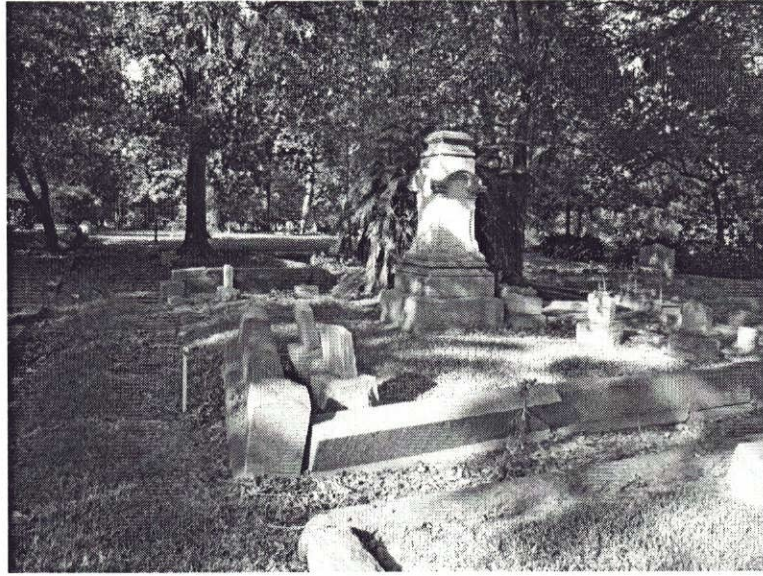
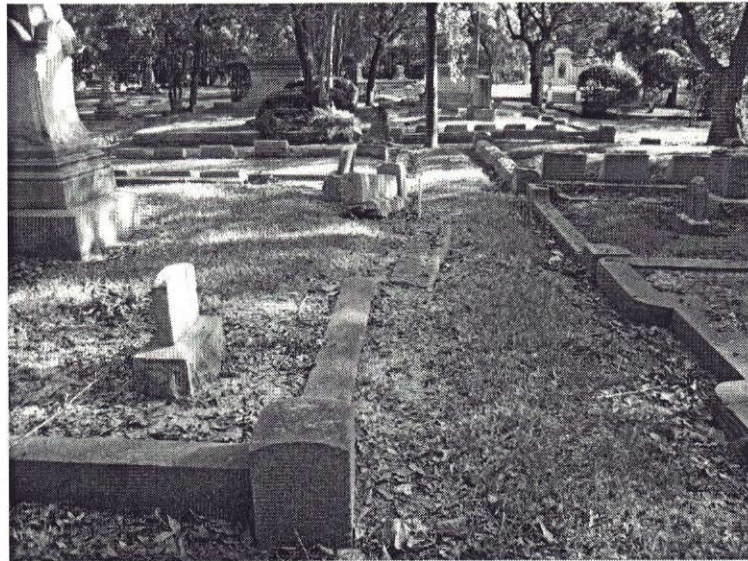
Perry, W.G.  
F-057  
1879  
No DOP  
No contact

Copies  
made  
1'+  
(no roots  
evident)

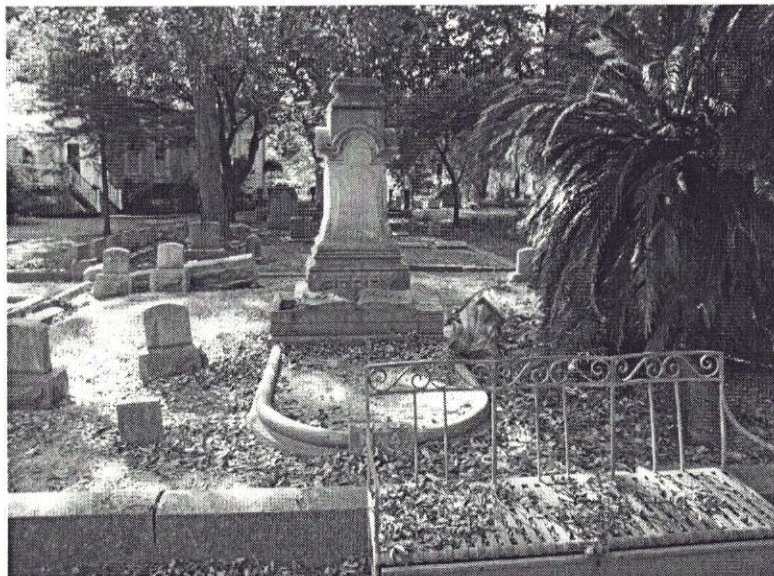
Broken  
statue

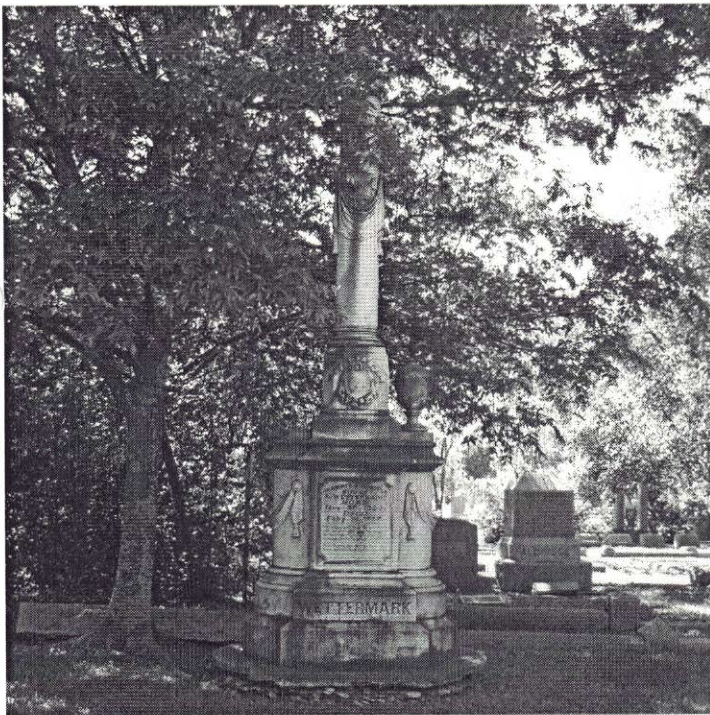
| <b>Work To Be Completed</b> | A white marble monument, approximately __' tall, is set on a rubble foundation and is tilting __° __ and __° __. One of two urns approximately ____" tall is missing from monument and may be buried on lot.<br><br>Monument will be leveled on a new foundation and cleaned. An effort will be made to find the missing urn. | | |

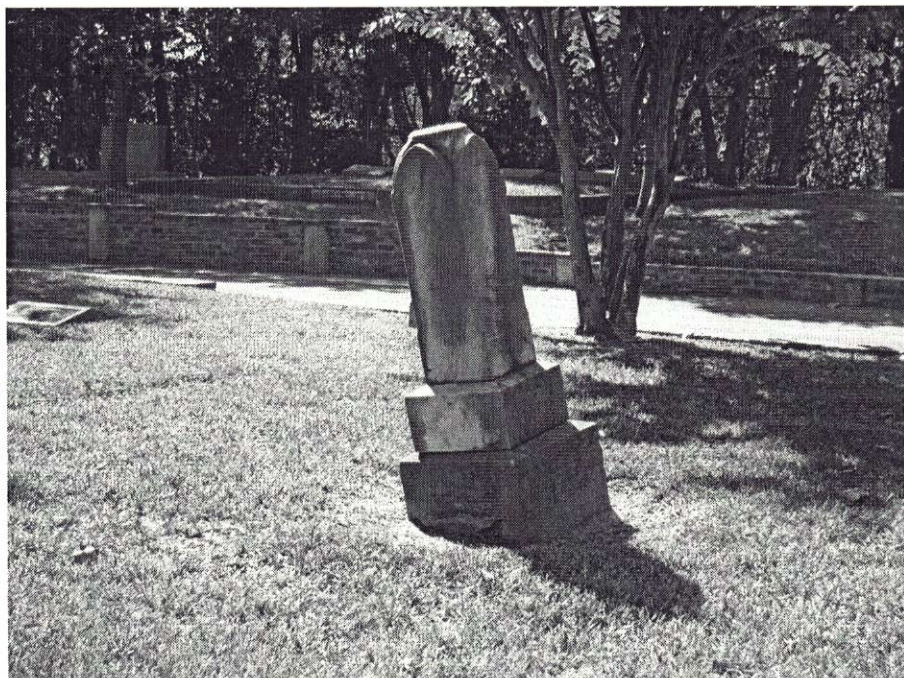
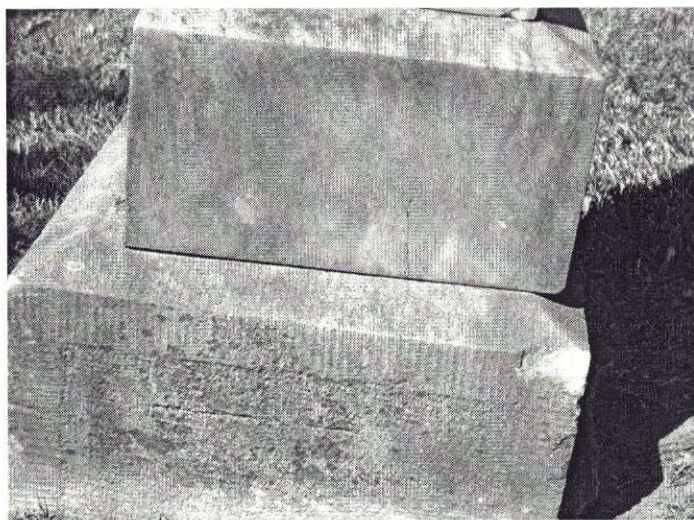
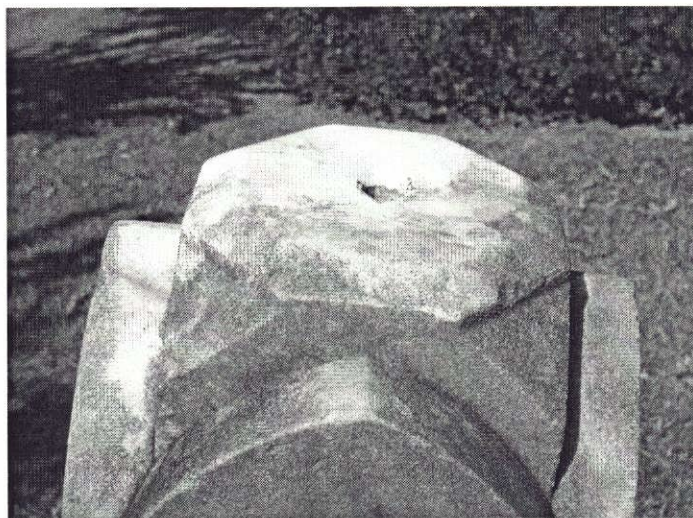
Sullivan, M.A.

Marker for Edward

P. Larkin (1900) is

leaning 10° S + 10° E.

Marble - 51" tall on

18 1/2 x 18 1/2 base

Gravestone is missing
