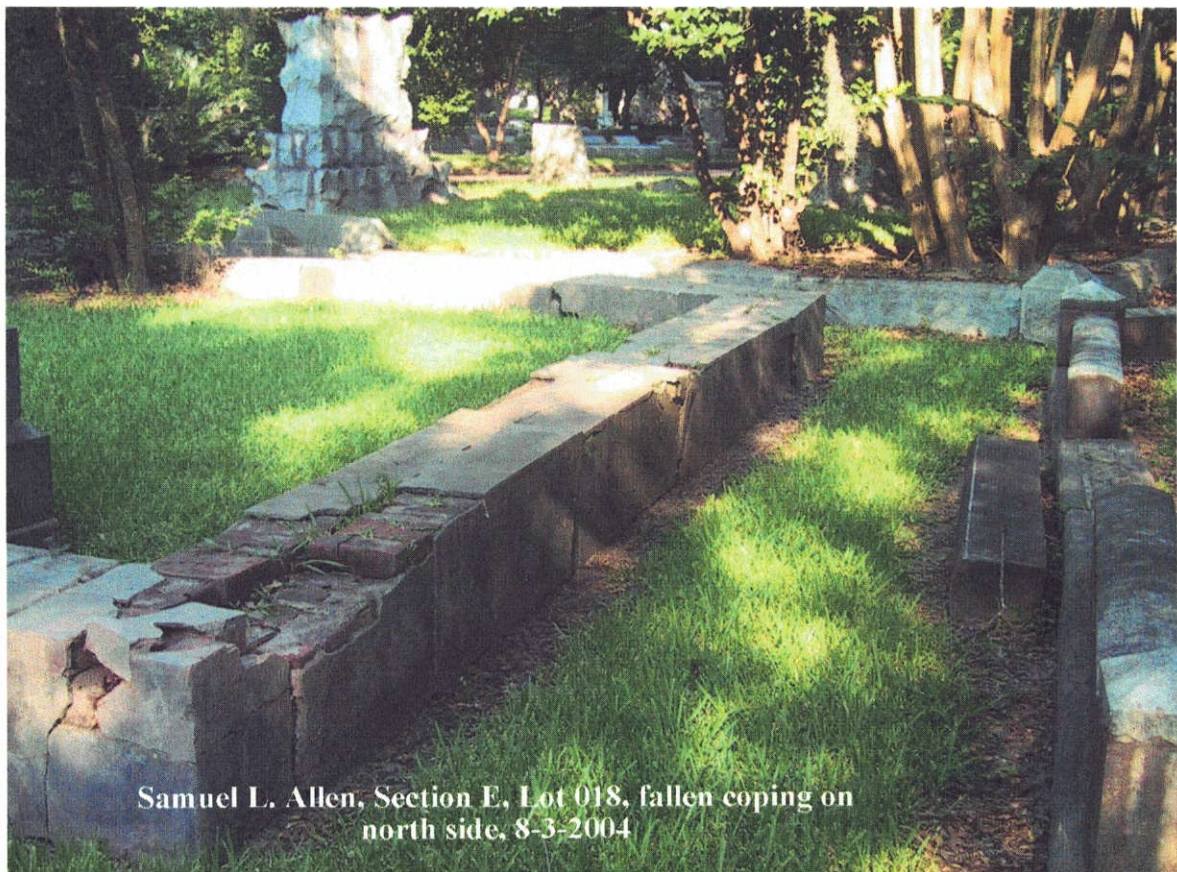
Samuel L. Allen, Section E, Lot 018, fallen coping on  
north side, 8-3-2004

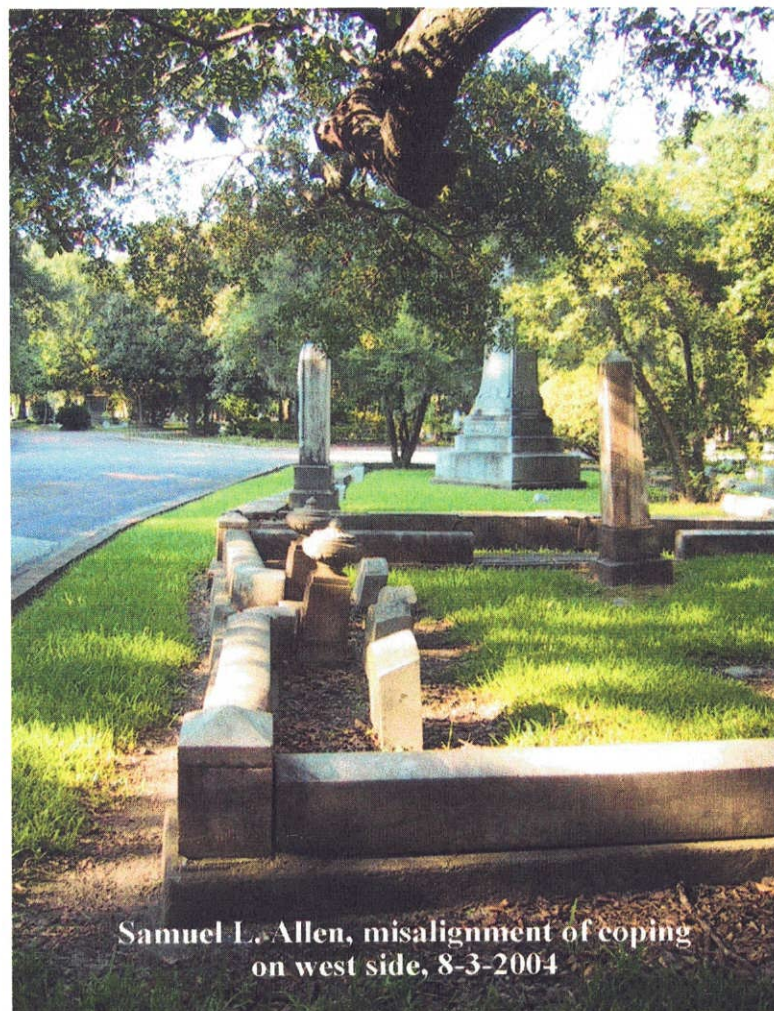
Samuel L. Allen, misalignment of coping  
on west side, 8-3-2004

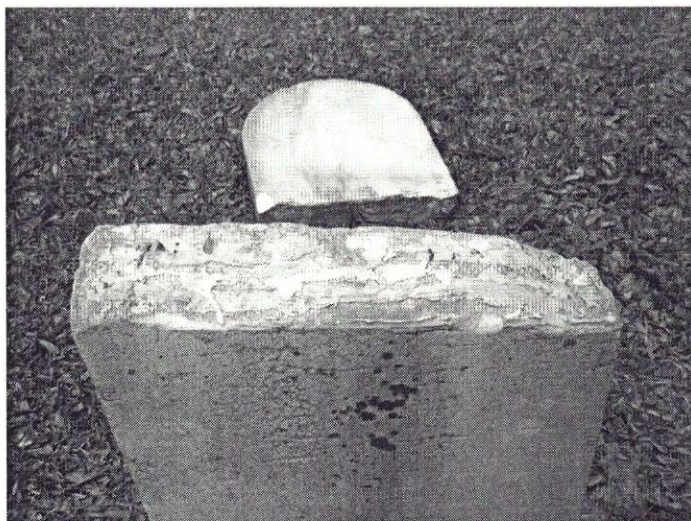
E-095 see above

(shows previous attempt to repair.)

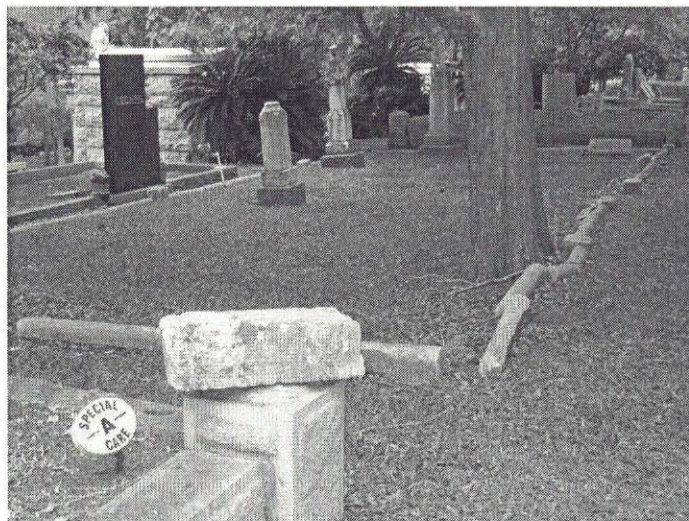
E-135 ?

Piece of stone has been sitting there a long time. May be piece of coping or corner post from another lot.

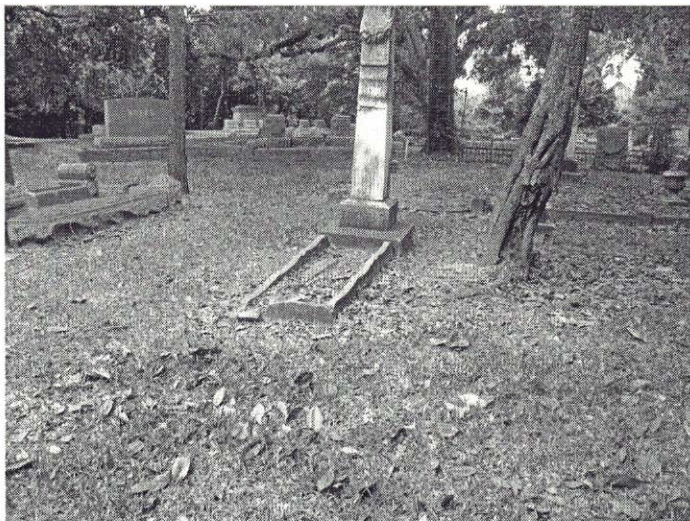
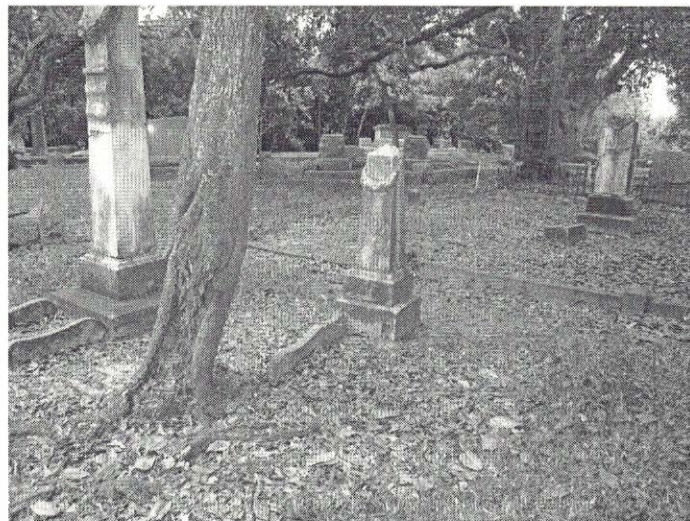
← E-067 →  
Lobdell  
E-067  
80 - no DOP  
no contact.

Cradle pieces  
buried or  
missing.

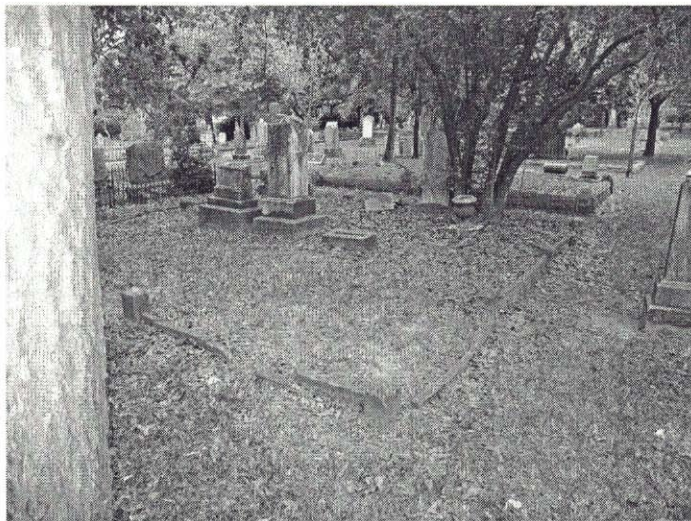
E-065 see above  
coping broken, sunken.  
marker? (washed)

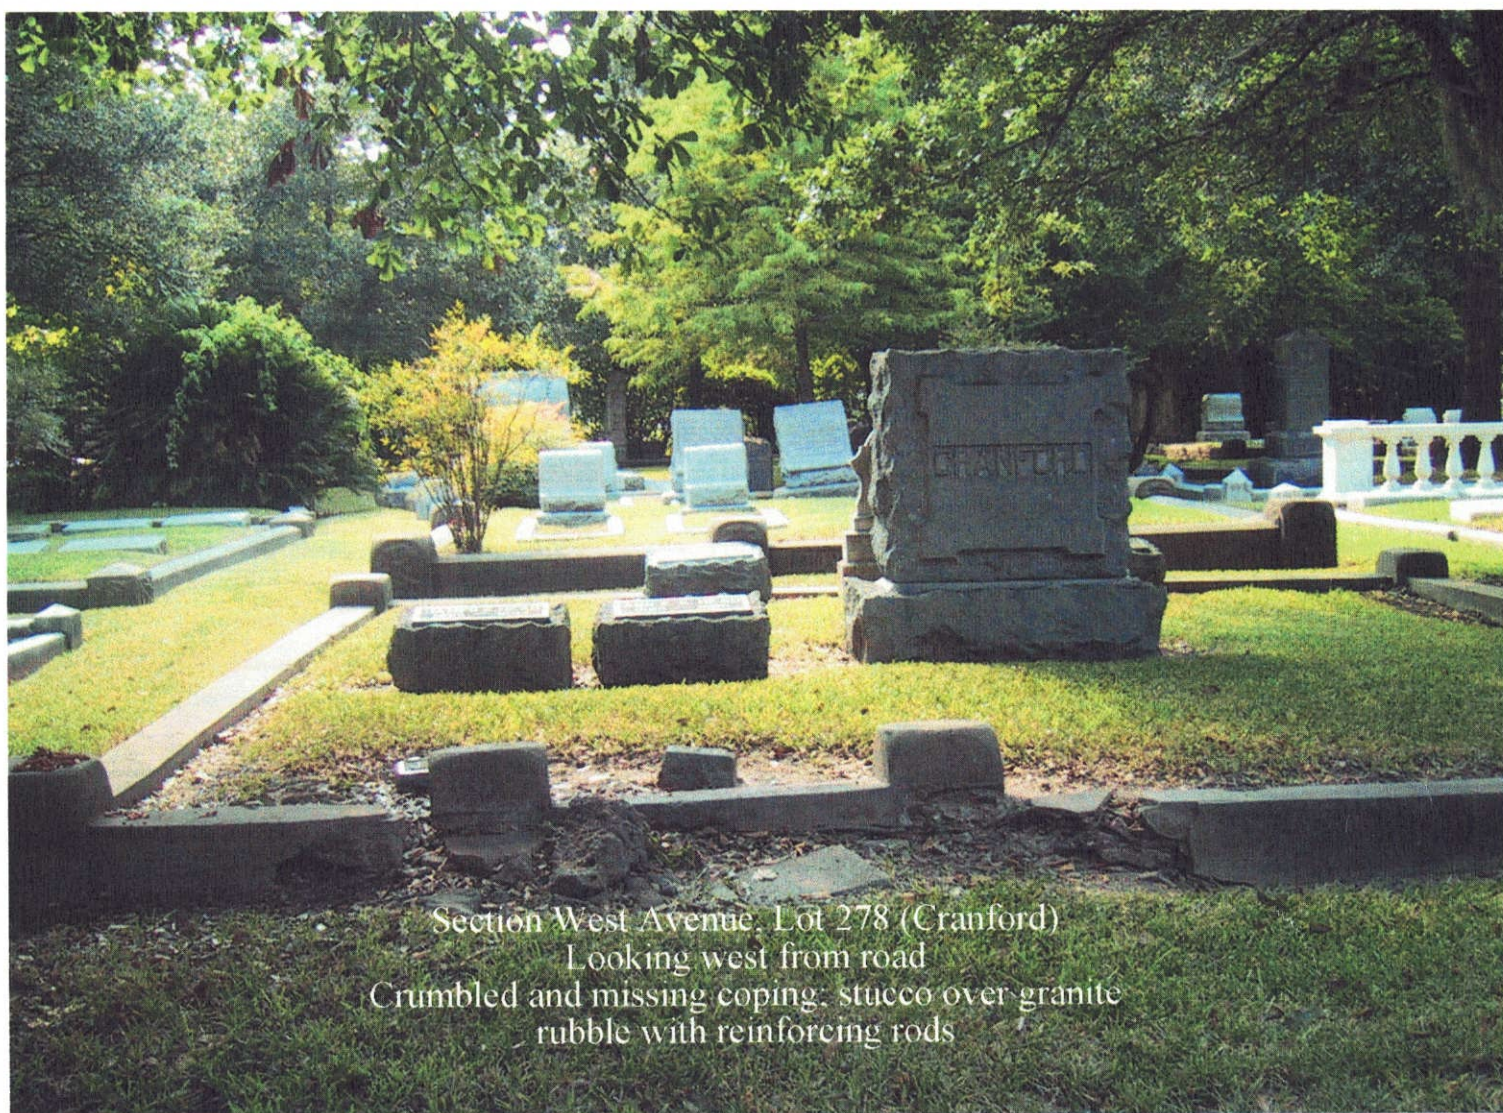
Section West Avenue, Lot 278 (Cranford)  
Looking west from road  
Crumbled and missing coping; stucco over granite  
rubble with reinforcing rods

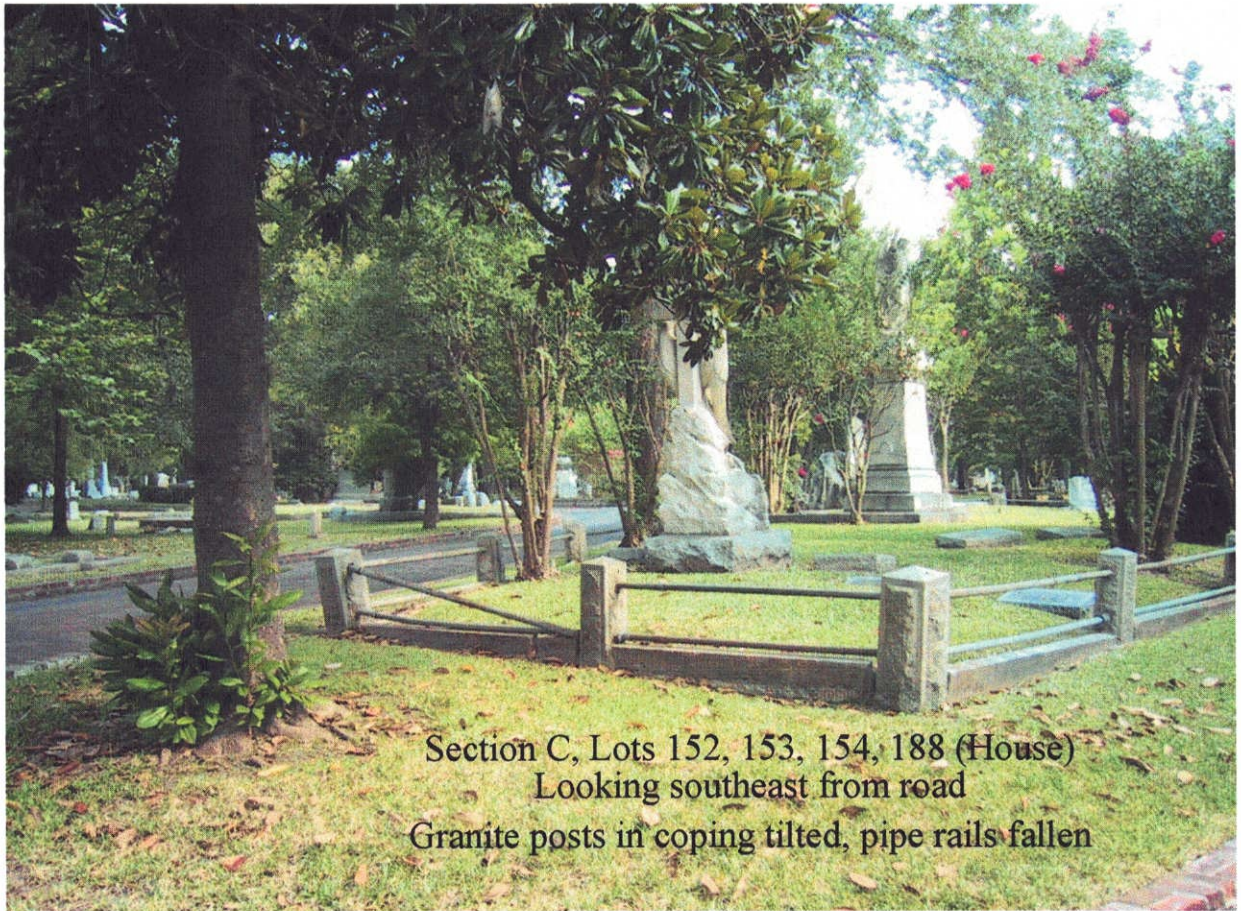
Section C, Lots 152, 153, 154, 188 (House)  
Looking southeast from road  
Granite posts in coping tilted, pipe rails fallen

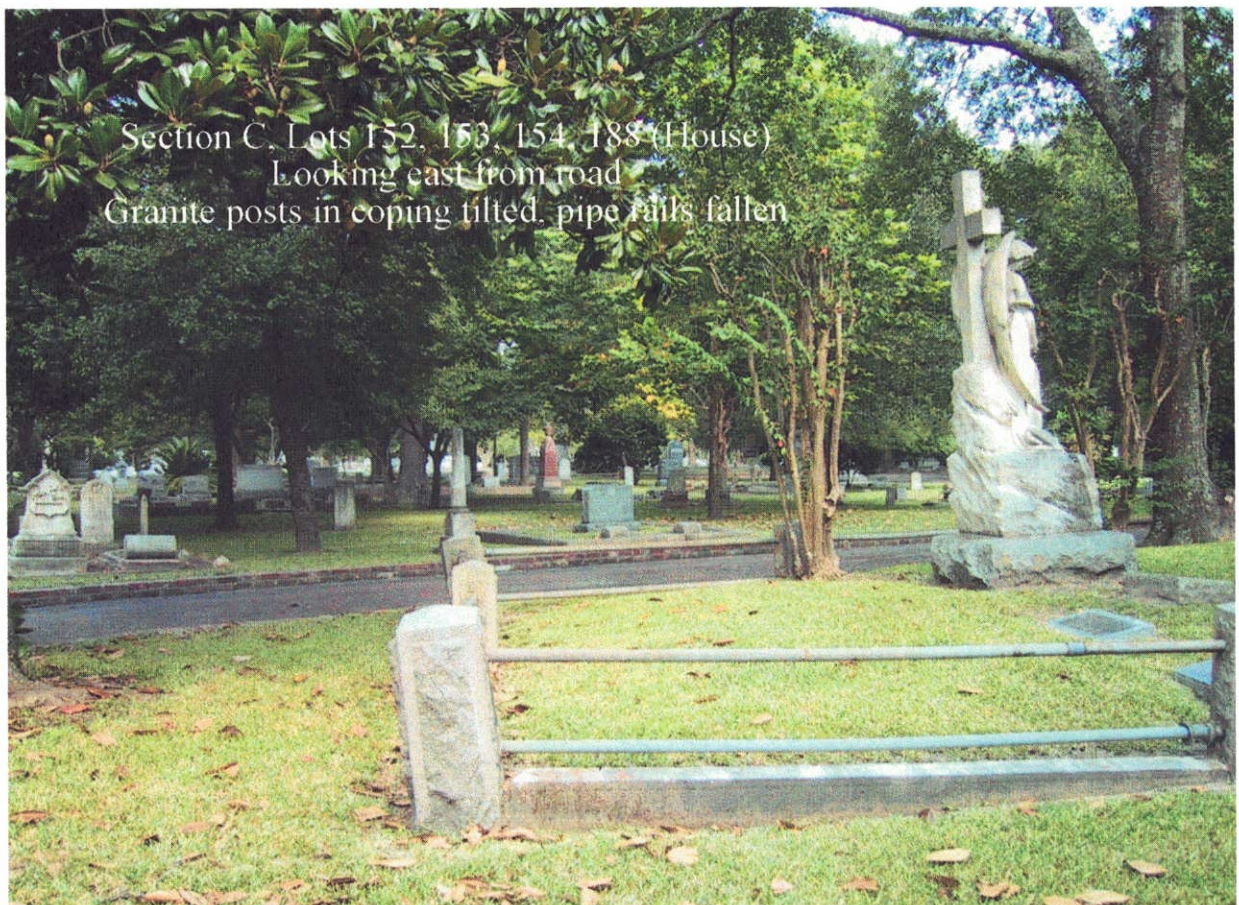
Section C, Lots 152, 153, 154, 188 (House)  
Looking east from road  
Granite posts in coping tilted, pipe rails fallen
