## **THE OLDEST HOUSE/ WRECKER'S MUSEUM**

**FIELD INVESTIGATION - July 8, 1992**

Linda D. Stevenson, AIA

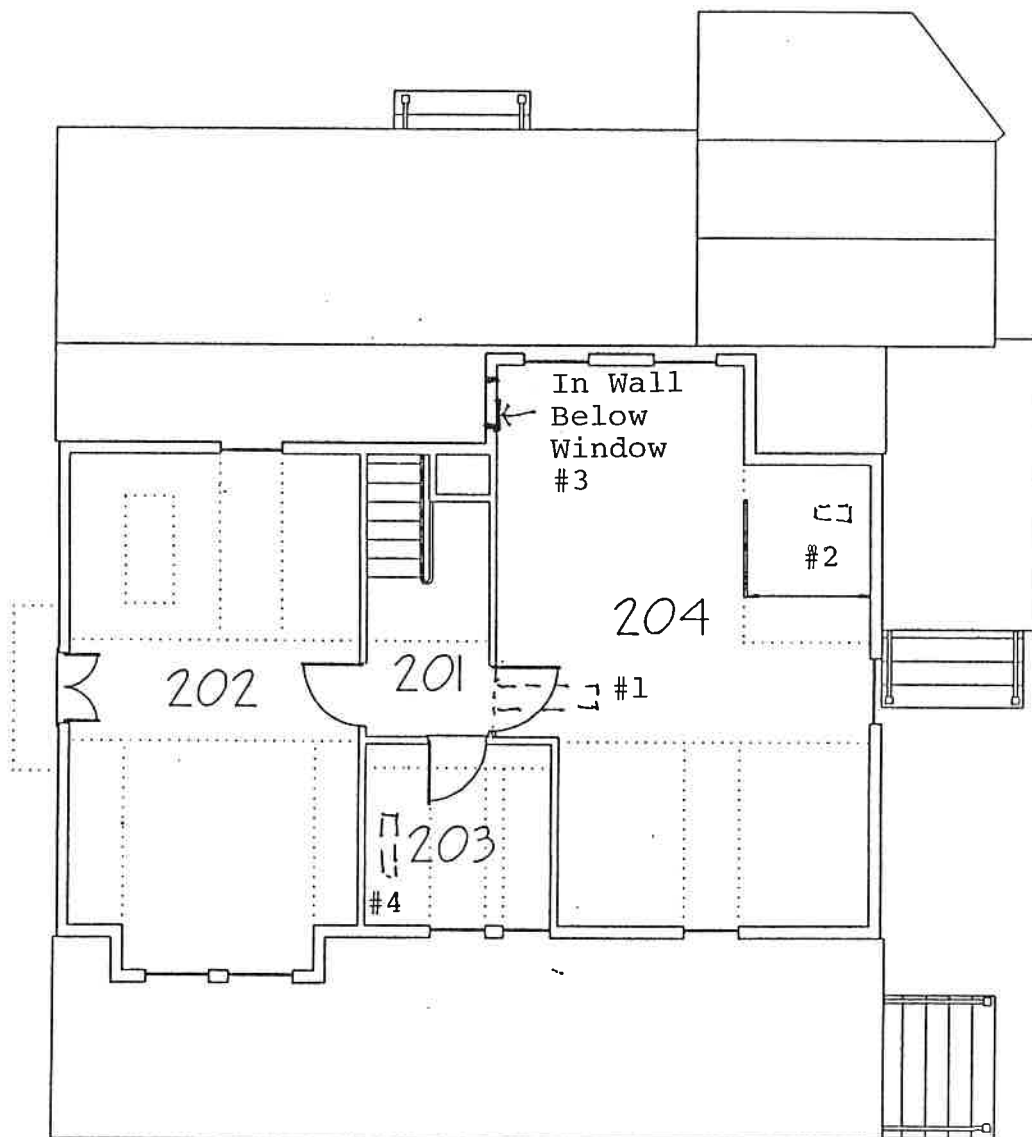
# SECOND FLOOR PLAN THE OLDEST HOUSE

Location #1: Under the main gable of the house, in the area of flat ceiling just west of the door into room 204.

Location #2: In the sloped ceiling in the display area, adjacent to the west gable end of the house.

Location #3: In the wall, below the window in the east wall of the large rear dormer.

Location #4: In the sloped ceiling of the roof just to the west of the middle dormer, in Room 203.

Location of Exploratory Openings in Existing  
Walls/Ceilings. 7/8/92
