The Proposed Renovation of
The Oldest House

322 Duval Street
Key West, Florida

Perpared for the
Historic Key West Preservation Board

May 1975

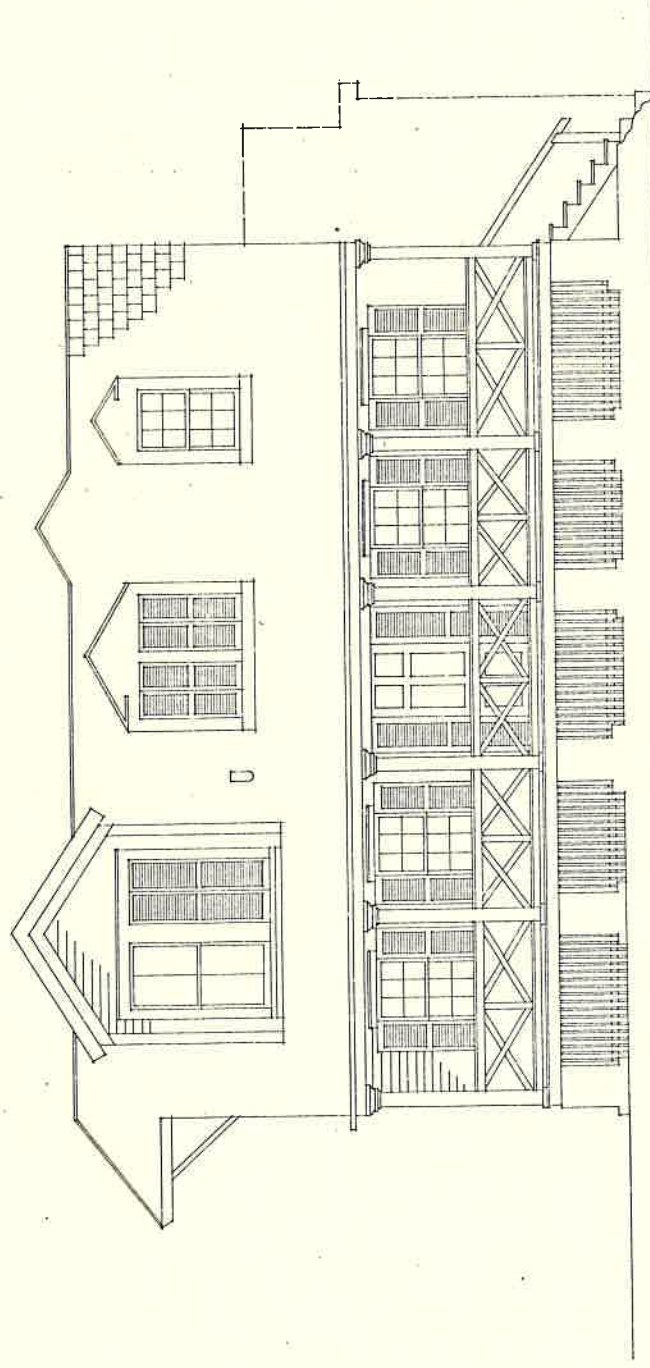
THE OLDEST HOUSE - AS EXISTING MAY 1975 - FRONT ELEVATION

The three interior bays of the house are echoed by three roof dormers. The five bays of the front porch reflect this in an AB-C-BA pattern. Window openings are not centered on the porch bays.

The porch foundation is white-washed masonry. Its continuation as the base for a picket fence to the property lines on both sides of the house (as seen in photographs) is mostly destroyed.

White painted wood foundation slats are in disrepair, some pieces broken, missing, or improperly replaced.

The stairs to the front porch are wood: grey painted treads, white risers. Their concrete base is crumbling.

The porch floor, now painted grey, is half new (the right side) and half old, with many coats of paint.

The porch railing is wood painted white, with grey top horizontal member. The existing diagonal members are a replacement for original spindles, traces of whose improper removal can still be seen on the bottom horizontal member.

Six square wood columns are painted white. The first two from the right appear to have been repaired at the base. Square base extensions are later additions; the original columns were flush to the porch floor. Column capitals are deteriorated, in some cases partially missing.

The beam at the front of the porch roof is deteriorating.

The porch ceiling, originally finished with plaster, is currently dropped with board and moulding.

The silver painted metal shingle roof was preceded by asphalt shingles (photograph), also possibly by wood shingles.

Originally, two symmetrical single dormers bracketed the central double dormer. After the turn of the century, the left dormer was enlarged to the oversize double window form it keeps today.

Large left dormer: Left face - clapboard deteriorating at juncture with roof; some plywood repairs, shutters deteriorating. Front face - two four-pane windows are unique (the rest of the house windows being 12-pane sashes); one pair wooden shutters missing, wood deteriorating at connection with roof. Right face - same as left.

Middle dormer: Left face - clapboard deteriorating. Front face - wood between sash and roof deteriorating, shutters in disrepair, right section of broken pediment is missing. Right face - good condition.

Right dormer: Left face and right face both in good condition. Front face - one pair of shutters missing, sash unpainted, left section of broken pediment missing.

The foundation wall should be extended to the property lines. Sharpen all masonry edges.

The foundation slats should be replaced in their entirety.

A new picket fence should be installed along the foundation wall to the edges of the property.

On the right side of the house, provide a pedestrian entrance: a picket gate and two steps. Newel posts flanking this gate should be detailed similarly to those of the side porch of the house. A vehicular entrance, if needed, should be located on the left side of the house.

The front beam of the porch probably should be replaced, as should the left half of the porch floor.

The original spindles of the porch railing should be restored. If none of the originals are in existence, new ones should be patterned after those of the John Lowe House on Southern Street.

The left end of the porch needs a complete new railing.

The steps at the right side of the porch should be rebuilt

with bannisters detailed like the porch railing and newel posts like those on the left porch.

The existing porch ceiling should be removed and the original plaster finish restored.

Repair, replace, and repaint all other missing and damaged elements.

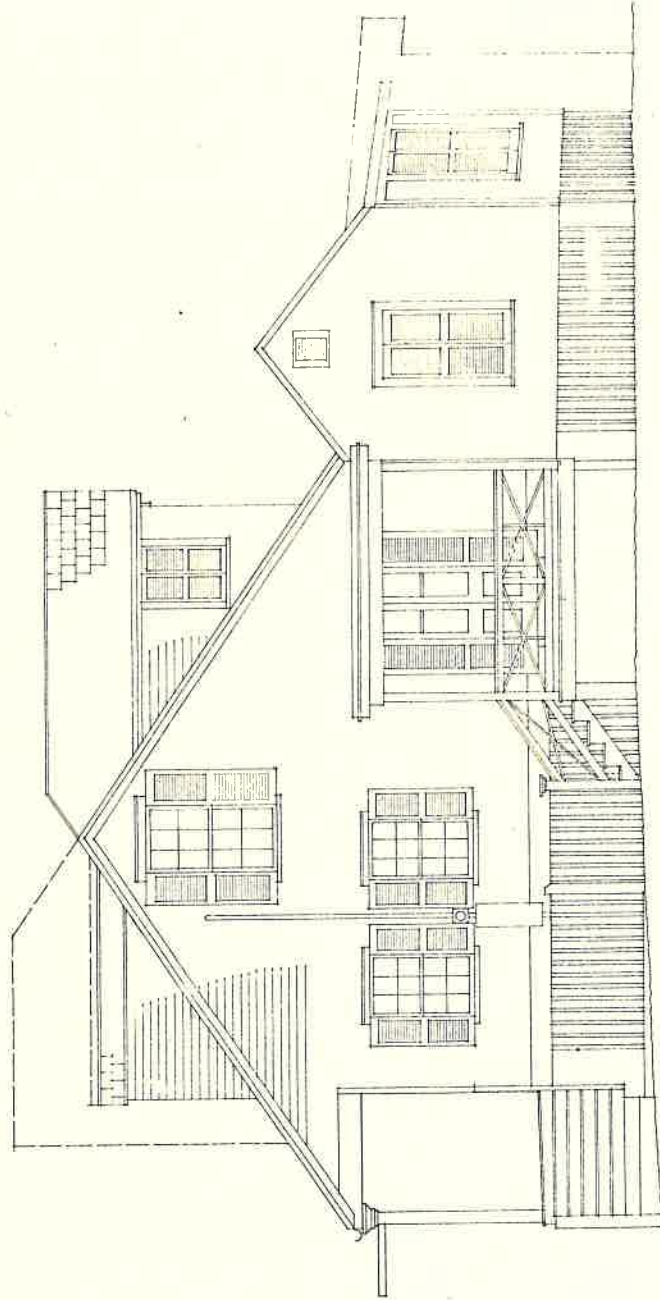
THE OLDEST HOUSE - AS EXISTING MAY 1975 - RIGHT ELEVATION

The right facade consists of the original house, added side porch, and a one story room (hence referred to as Captain Watlington's Office) at the back of the house.

A recently installed picket fence and driveway gate are set back from the original location of a fence at the front foundation wall.

The electric meter is currently located between the original house's two windows.

The foundation slats are in bad condition, partially missing.

A water pipe drops from under the side porch floor to underground of the present parking area.

The side porch rests on original wood point, and more recent temporary block, foundations. The stairs and floor of the porch are new and well restored. Two white stop-chamfered columns support the porch roof. Diagonally crossing members of the porch

Both doors opening to the porch are partially glazed, with porcelain knobs, and deteriorated full-length shutters.

The clapboard is similar to that of the front of the house. It is generally in good condition, with only a small amount of deterioration around the porch door.

The one story rear addition, Captain Watlington's Office, has similar clapboard, and two windows generally in poor condition.

The temporary porch foundation should be removed and replaced with a wood point foundation. The foundation slats should be replaced under the porch.

It is not architecturally necessary to replace the missing porch cornice.

The electric meter should be moved to a less conspicuous location - perhaps to the level of the foundation slats. The exposed electrical wiring which clutters the rear addition should be consolidated.

The existing fence should be removed.

The existing driveway should be removed.

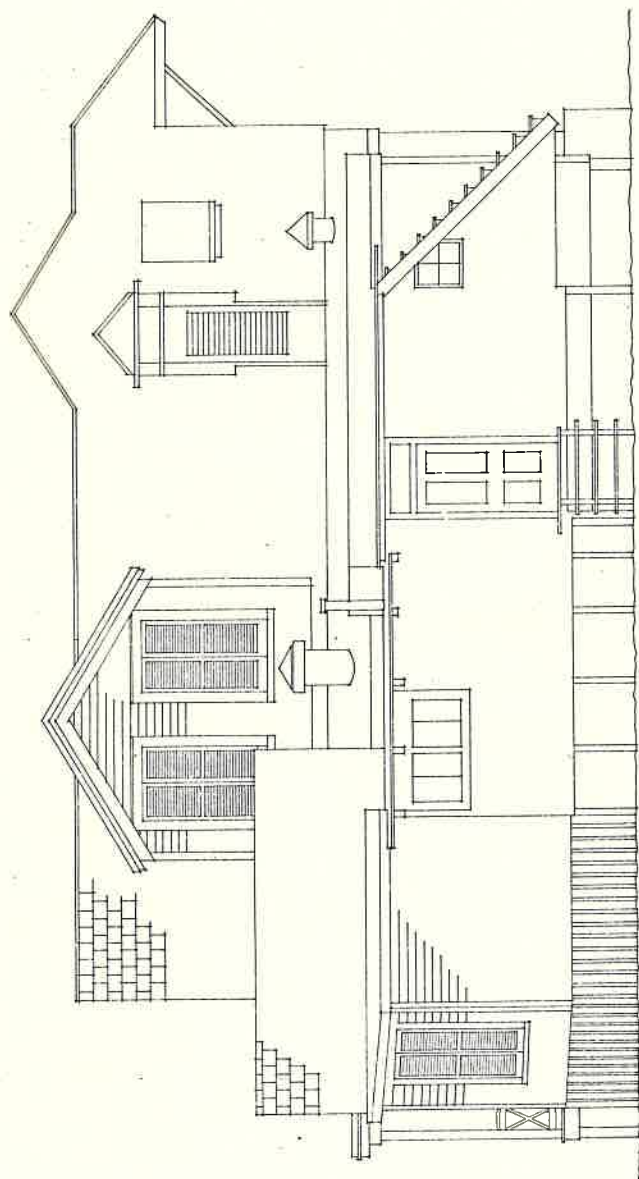
THE OLDEST HOUSE - AS EXISTING MAY 1975 - REAR ELEVATION

The left section (Captain Watlington's office) dates to the 1890's. The white clapboarding is in good condition; the foundation slats are unpainted; green asphalt roofing overhangs this section's cornice.

The middle section consists of five bays of wood foundation supports, and five bays of roof joists. The lower portion of the facade here is good clapboard. Above the siding are two double pane windows. Between the windows and the roof is a narrow unfilled slot, exposing the interior of this addition to the elements. A sheathing of random pieces of plywood and board covers the remainder of the middle section.

The right section includes the back entrance to the house. Four steps above ground level replace a ramp from the interior kitchen to the backyard dining room, now removed. The back door (with porcelain knob) is from the original house. The rest of this portion of the facade consists of random scrap boards, screens, a broken-pane sash, and an exterior stair to the roof, whose bottom risers are missing.

The various heights of the rear addition roofs are covered by green asphalt sheets improperly applied. Two vertical vents protrude and signal the locations of past kitchens. On the left, is a large dormer, similar to its contemporary on the front facade; to the right, is a small dormer, recently converted to a

full length door. At the extreme right of the rear roof, is a ventilating scupper, the last of six original to construction of the house. The condition of the metal roof and these dormers is similar to that described for the front elevation.

The remaining back elevation will be resting on wood point foundations and the original cistern.

The door in the small dormer should be removed and replaced by a window, similar to that of the small dormer on the front facade.

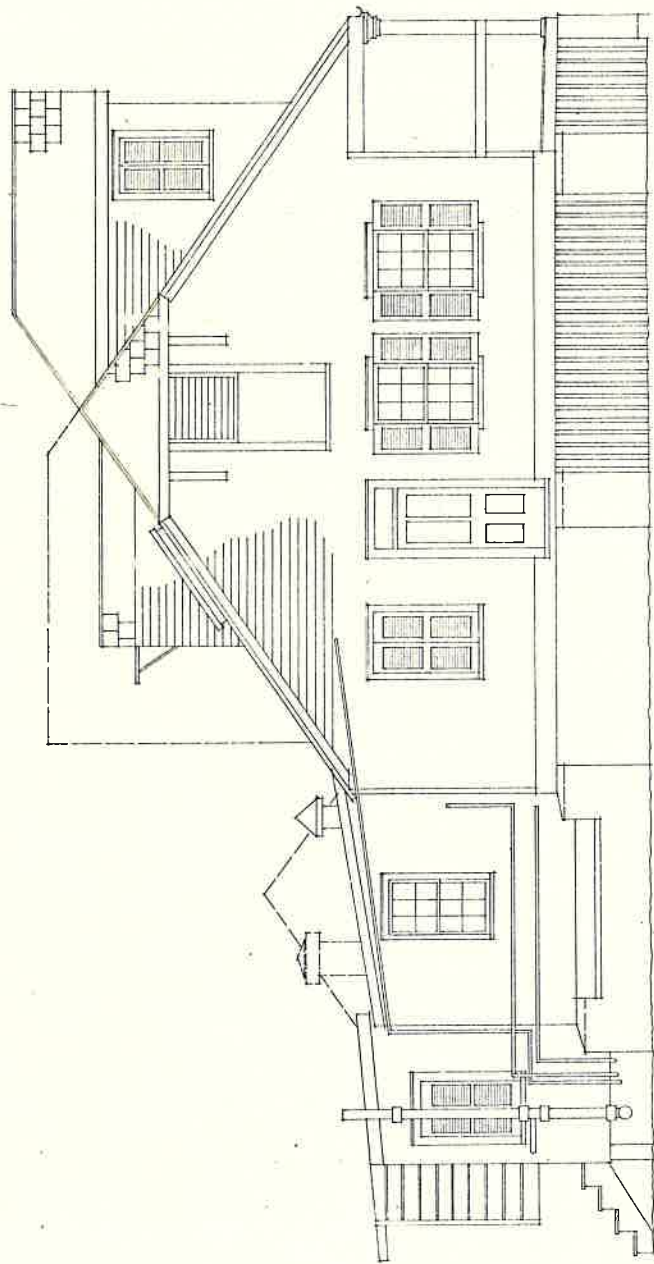
THE OLDEST HOUSE - AS EXISTING MAY 1975 - LEFT ELEVATION

The right portion is the original house. The old point foundations are limestone. Supplementary supports are un-mortared concrete block and stacked lumber sections. Here, the crawl space is exposed; few foundation slats remain, occasionally replaced by scrap. The clapboard is deteriorating in some areas; a board is missing where the balcony was removed. Two shuttered windows are in good condition, consistent with other original house first floor fenestration. A third window frame is boarded up. The glazed door is a modification of the original facade, added with the no longer existing porch. At the center of the gable, the original window has been substituted with a door (now boarded up) which opened onto a balcony. The balcony and the porch have been recently removed. The cantilever roof of the balcony remains, in good condition.

The middle portion of this elevation is an addition to the original house, formed by the partial enclosing of the back porch. The base walls of the cistern are exposed at the foundation of this addition. Plumbing pipes are exposed. The window is in poor condition; the twelve pane sash is painted green. The workmanship and condition of this addition is generally inferior to that of the original house.

The left portion is the most recent and shoddiest addition. Foundation slats are uneven and missing. The clapboard is of

Foundation slats should be replaced.

The clapboard needs repair, especially above the left window, which itself needs to be replaced.

The missing porch and balcony have no photographic records available for their faithful reconstruction. Three options for restoration are available:

1. hypothethical reconstruction of both porch and balcony;
2. restoration to the house's original condition, which would demand the removal of both doors and the roof overhang; or
3. removal of the first floor door, and the hypothetical reconstruction of the balcony only - using detailing from the porch on the opposite side of the house.

The latter is the option recommended. By giving functional meaning to the excellent roof overhang, it represents the best
