Ten-Tec Argonaut V (Model 516) Low Output Repair

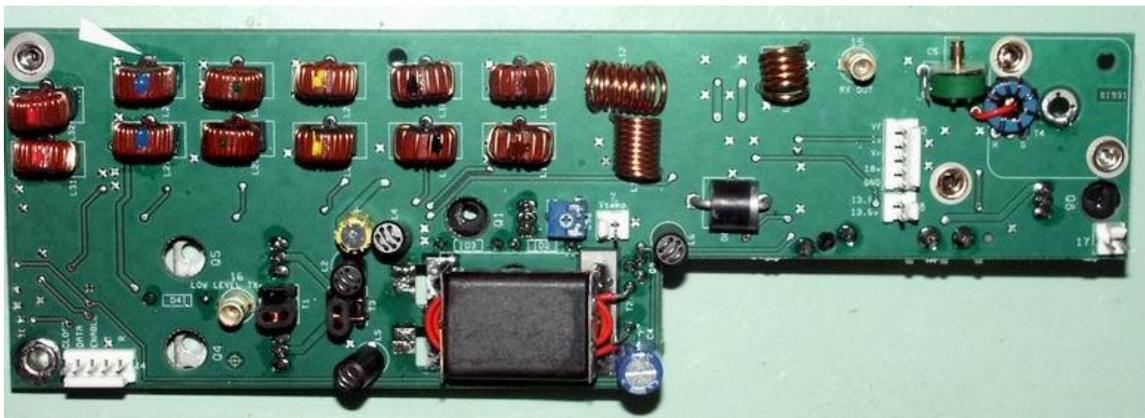
Figure 1: Test points (PA board removed from rig)

With the top off of the rig you can access all the necessary test locations to determine if the band switch circuitry is functioning properly (*use caution*). A series of coils are located on the circuit board (see figure 1) that is attached to the heat sink. These coils are a part of the various band-switching stages and are connected to the **Bandout** rail. They are identified as 160 metres (L32) at the left, L28, L24, L21, L18, L15 and end with the 15 through 10 metre coil (L12) at the right. (The latter coil is air wound all others are wound on ferrite cores.)

top of the PC board (see arrow on 80 meter coil). The measurement is made with the rig in key down CW at full power into a dummy load. All coils should have approximately -150 volts **except** the selected band, which should read approximately +8 volts. Check all bands and all coils.

In my tests the voltages when the rig was on 80 metres were correct. That is +8 volts on the 80 metre coil and -150 on all other coils. However, when other bands were selected the voltages were quite different. For example, when 40 metres was selected there was +8 volts on the 40 metre coil, +6 volts on the 80 metre coil and -75 volts on all the others (see table below). This suggested that the 80 metre circuitry was turned on at all times - likely the result of a shorted switching diode or faulty transistor feeding the diodes.

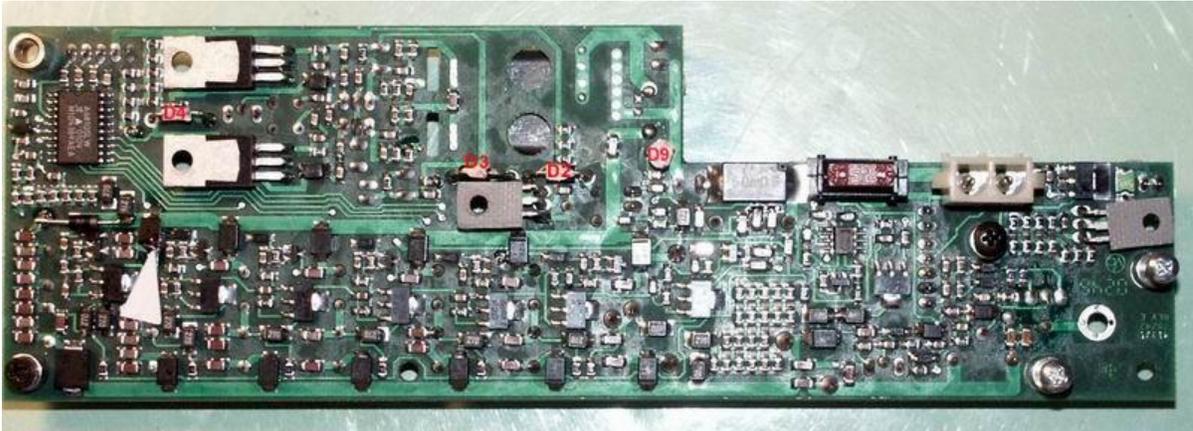
Figure 4: Diode side of PA/LP Filter Board

16. Test the diodes with a DVM. A faulty diode will have a resistance of 100 or 200 ohms or less. The board with the offending 80 metre diode, marked with a white arrow, is shown in the figure 4.

17. Carefully note the polarity and then unsolder and lift the faulty diode. Test it again to be sure!
18. Replace the faulty diode with a new 1N4007 or surface mount equivalent (ensure that the polarity is correct) and recheck all the diode resistances. They should be similar. (If they are not similar, the problem **may** be the transistor feeding the switching diodes and the transistor will need to be tested and, if faulty, replaced.)
19. Re-assemble the radio in reverse order. (**Note:** Do not forget to apply heat sink compound to D2, D3, D4 and D9 – see red identification in figure above.)
20. Test the Argonaut into a dummy load and reinstall it back into service.
