Engineer's report

In re 184 Ashley Avenue
Cannonboro Inn
Inspection Report

HISTORIC CHARLESTON FOUNDATION
HURRICANE HUGO DAMAGE ASSESSMENT FORM

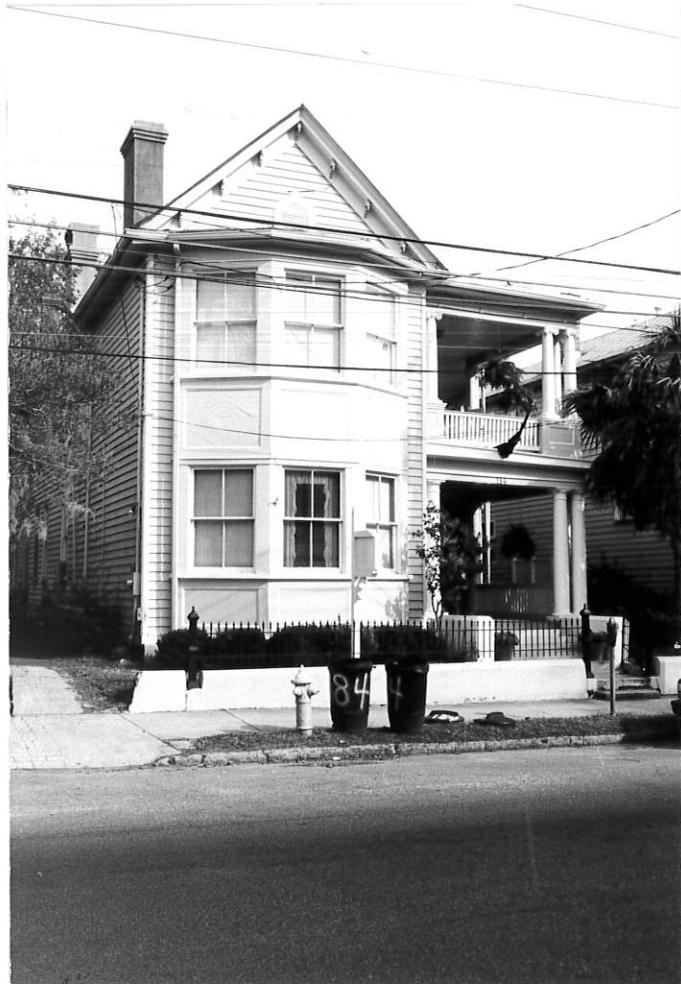
Hugo survey photo

Lost quite a bit of their roof covering
on portico. 100% replacement
