HISTORIC PRESERVATION CERTIFICATION APPLICATION

REQUEST FOR CERTIFICATION OF COMPLETED WORK

241 East Bay Street

Charleston, South Carolina

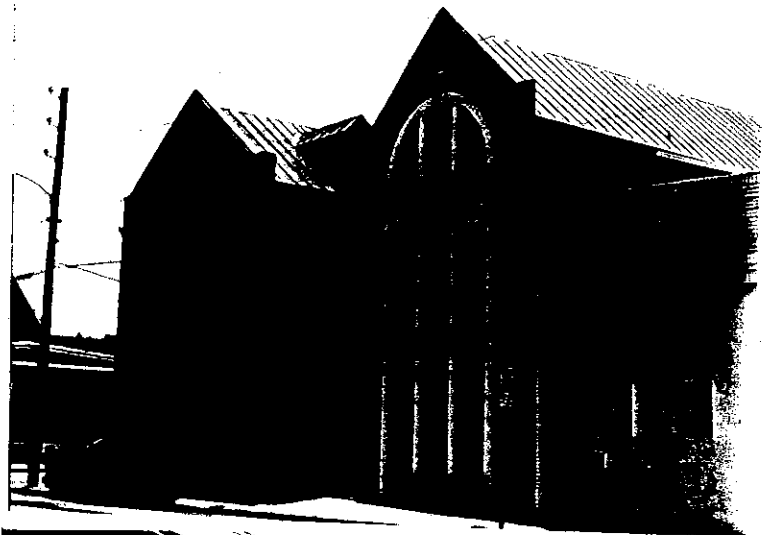
2

East Facade, Facing Southwest

Compatible contemporary addition constructed as per approved HPCA Part 2; the site had a building whose mass and size is suggested by the new structure

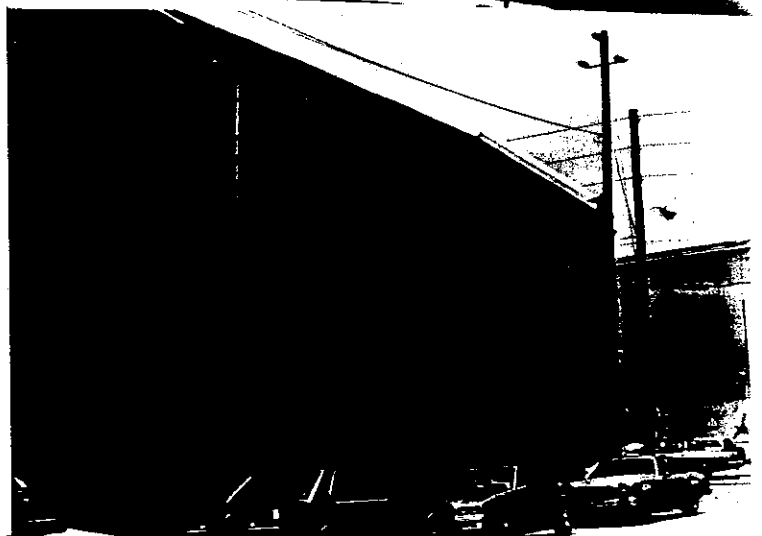
3

South Elevation, Facing Northeast

Gable metal roof and 2nd floor openings were retained; 1st floor openings were rehabilitated as per the amended HPCA Part 2

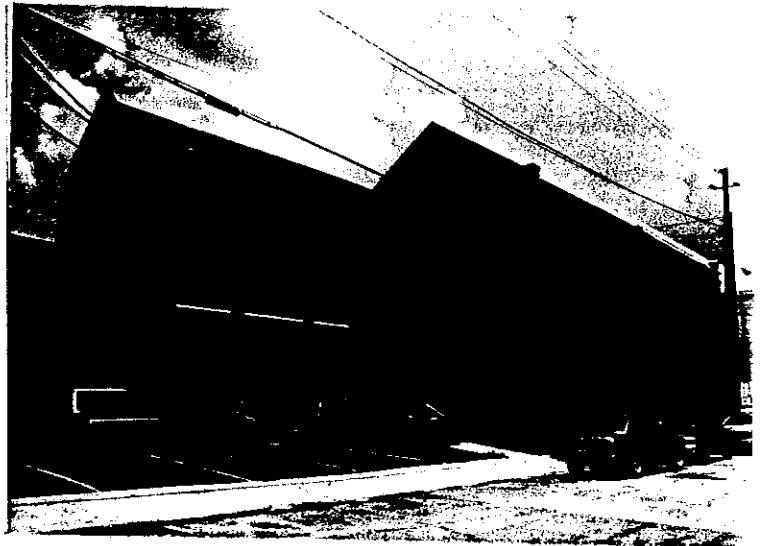
5

West Elevation, Facing Northeast

Compatible contemporary addition constructed as per
approved HPCA Part 2

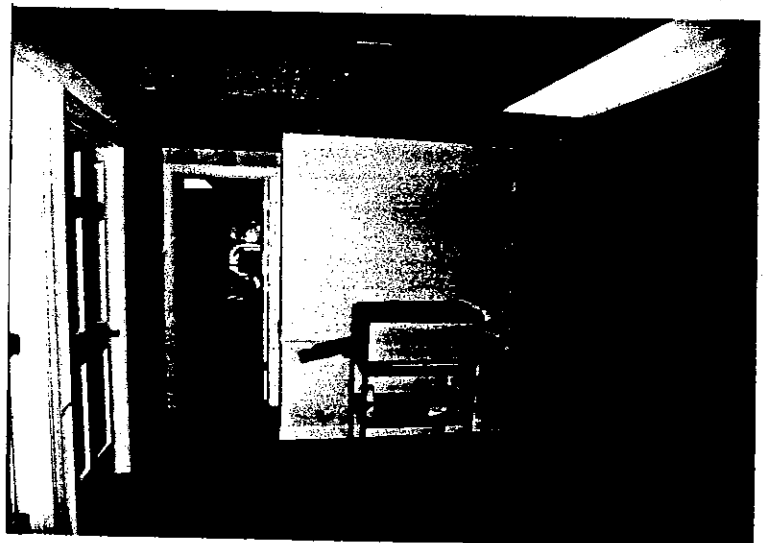
6

First Floor, Facing West

Interior was rehabilitated as per the approved HPCA Part
2

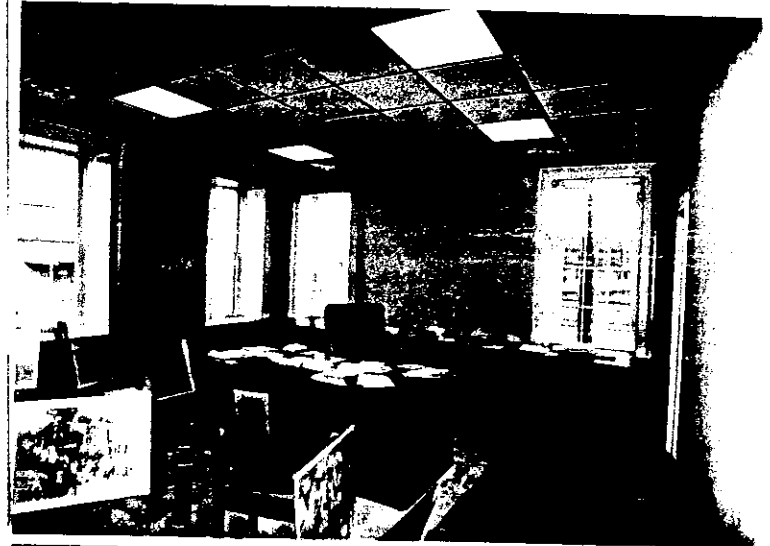
7

Second Floor, Facing Southwest

Interior was rehabilitated as per the approved HPCA Part 2; trim was copied from an existing section in the attic or garrett level

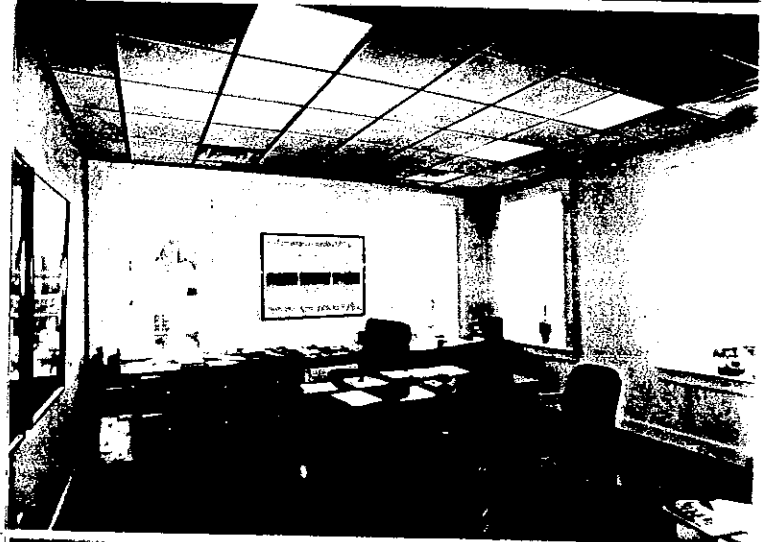
8

Second Floor, Facing Southeast

Interior was rehabilitated as per the approved HPCA Part 2

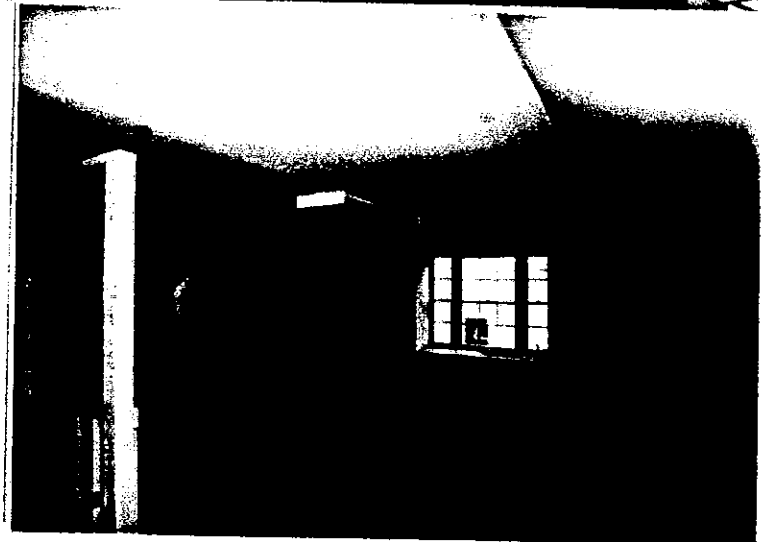
9

Attic, Facing Northeast

Attic was rehabilitated as per the approved HPCA Part 2
