## HISTORIC PRESERVATION CERTIFICATION APPLICATION — PART 1

Address of property: Street 241 East Bay St.

**HISTORIC PRESERVATION CERTIFICATION  
APPLICATION — PART 2**

**Part 2 DESCRIPTION OF REHABILITATION**

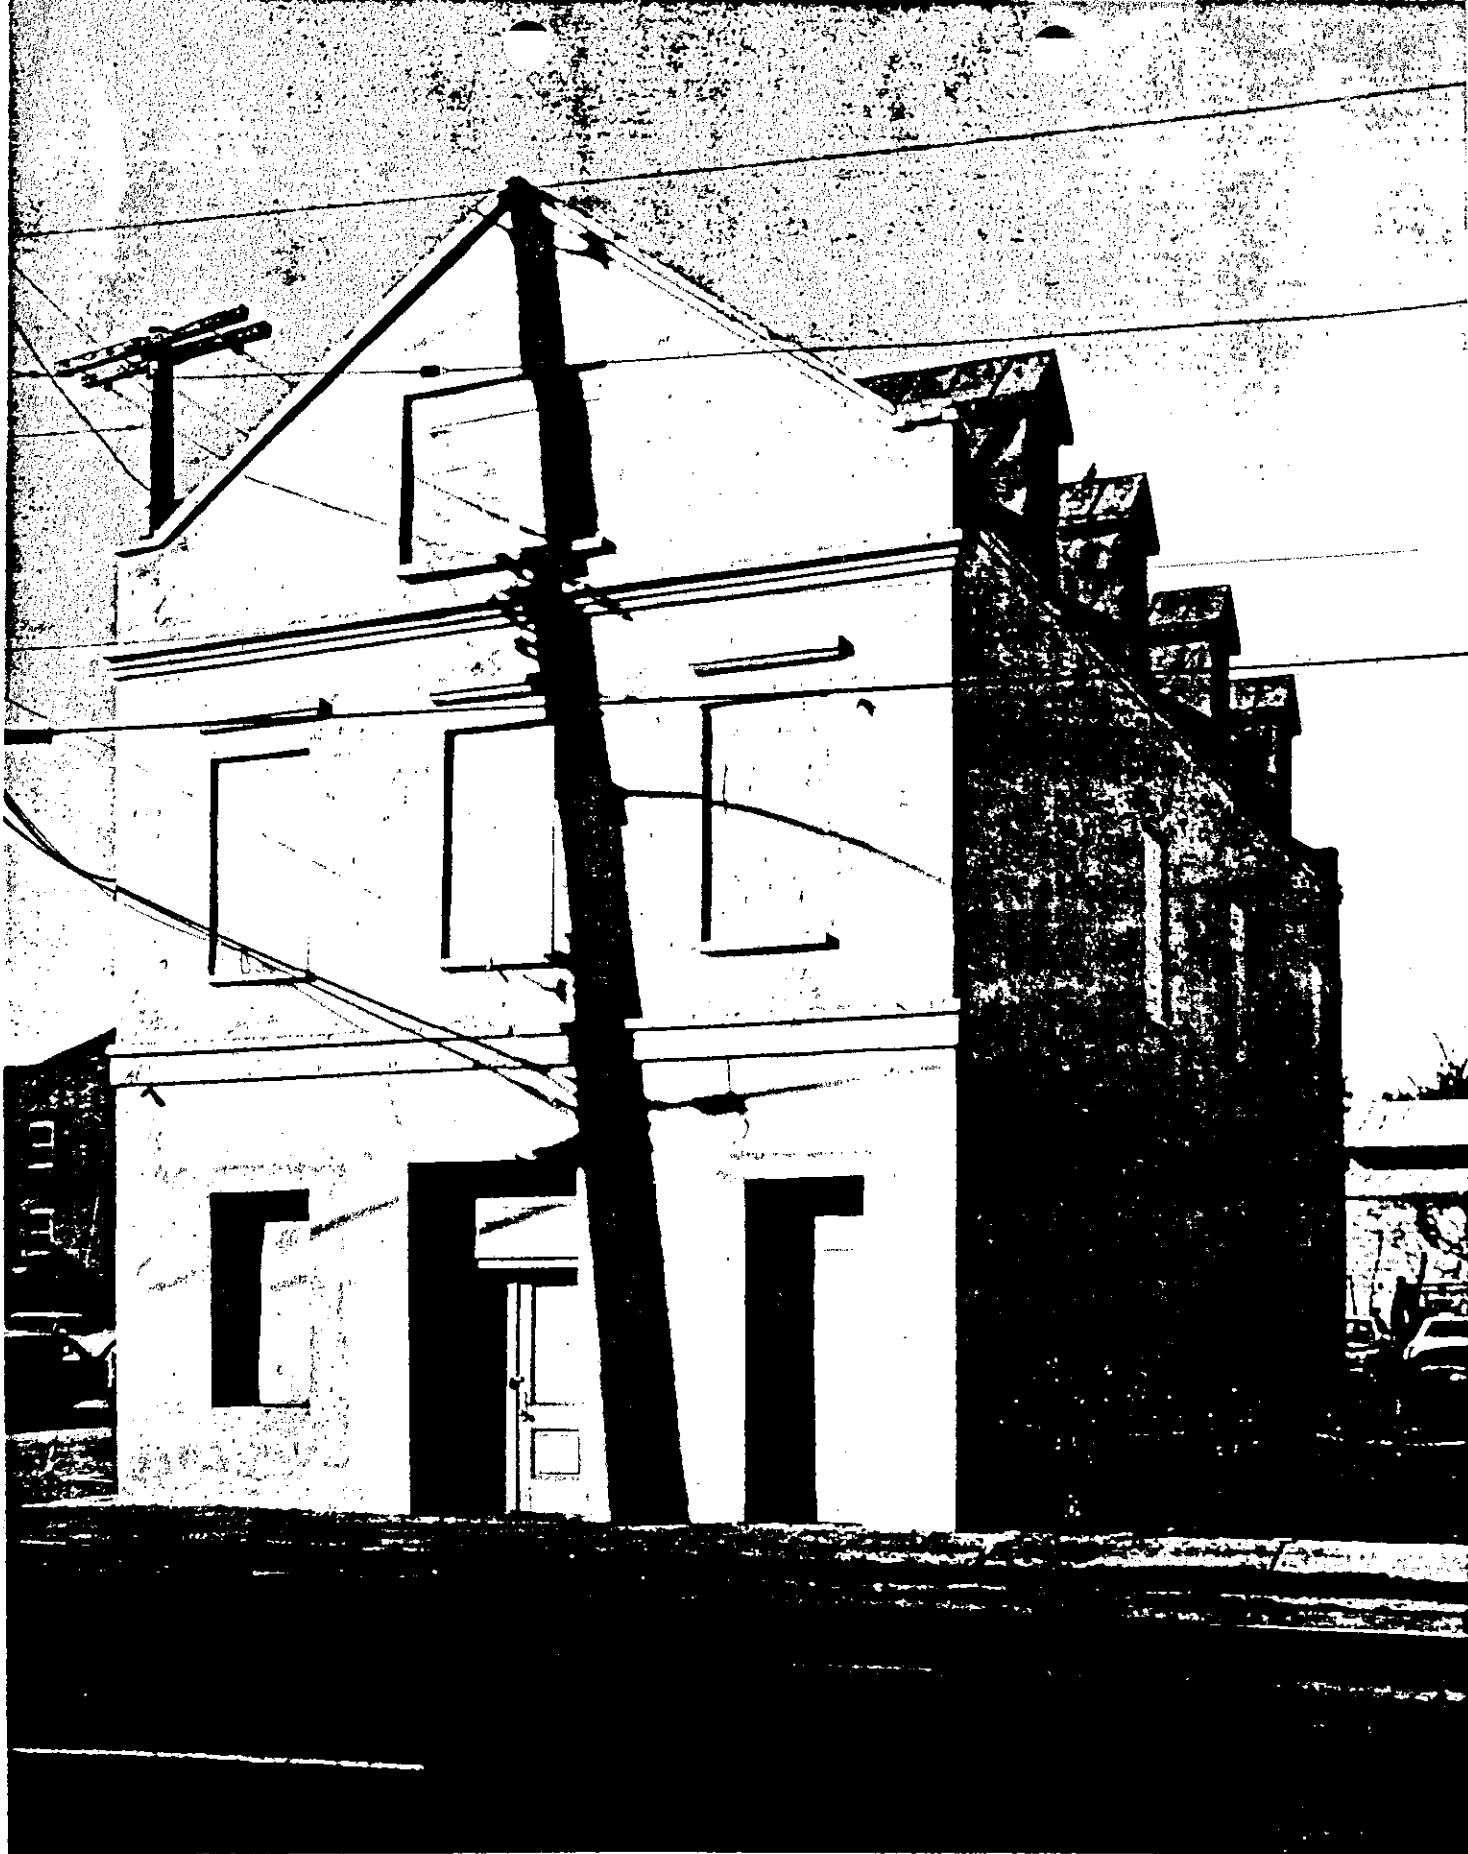
Photograph No. 1.  
241 East Bay Street, Charleston, S.C. 29401  
Owner: Street Brothers, Inc., 235 East Bay St., Charleston, S.C. 29401  
East Bay Street facade showing fenestration, stuccoed brick detail,  
also north elevation with stuccoed brick cornice, four dormer windows.

NUMBER <b>6</b>	Architectural feature <u>Masonry</u> Approximate date of feature <u>c. 1861-1872</u>	Describe work and impact on existing features Brick to be repointed where necessary. Entire building to be restuccoed with mixture compatible with the existing, in appearance and texture.
Photo no <u>1-4</u> Drawing no <u>4</u>

NUMBER <b>7</b>	Architectural feature <u>Roof</u> Approximate date of feature <u>c. 1861-1872</u>	Describe work and impact on existing features Existing roof shape, dormers and tin roof to be retained. Tin roof to be repaired, cleaned and repainted in existing red color. New aluminum half round gutters and 4-inch diameter downspouts to be installed.
Photo no <u>1-4</u> Drawing no <u>4</u>

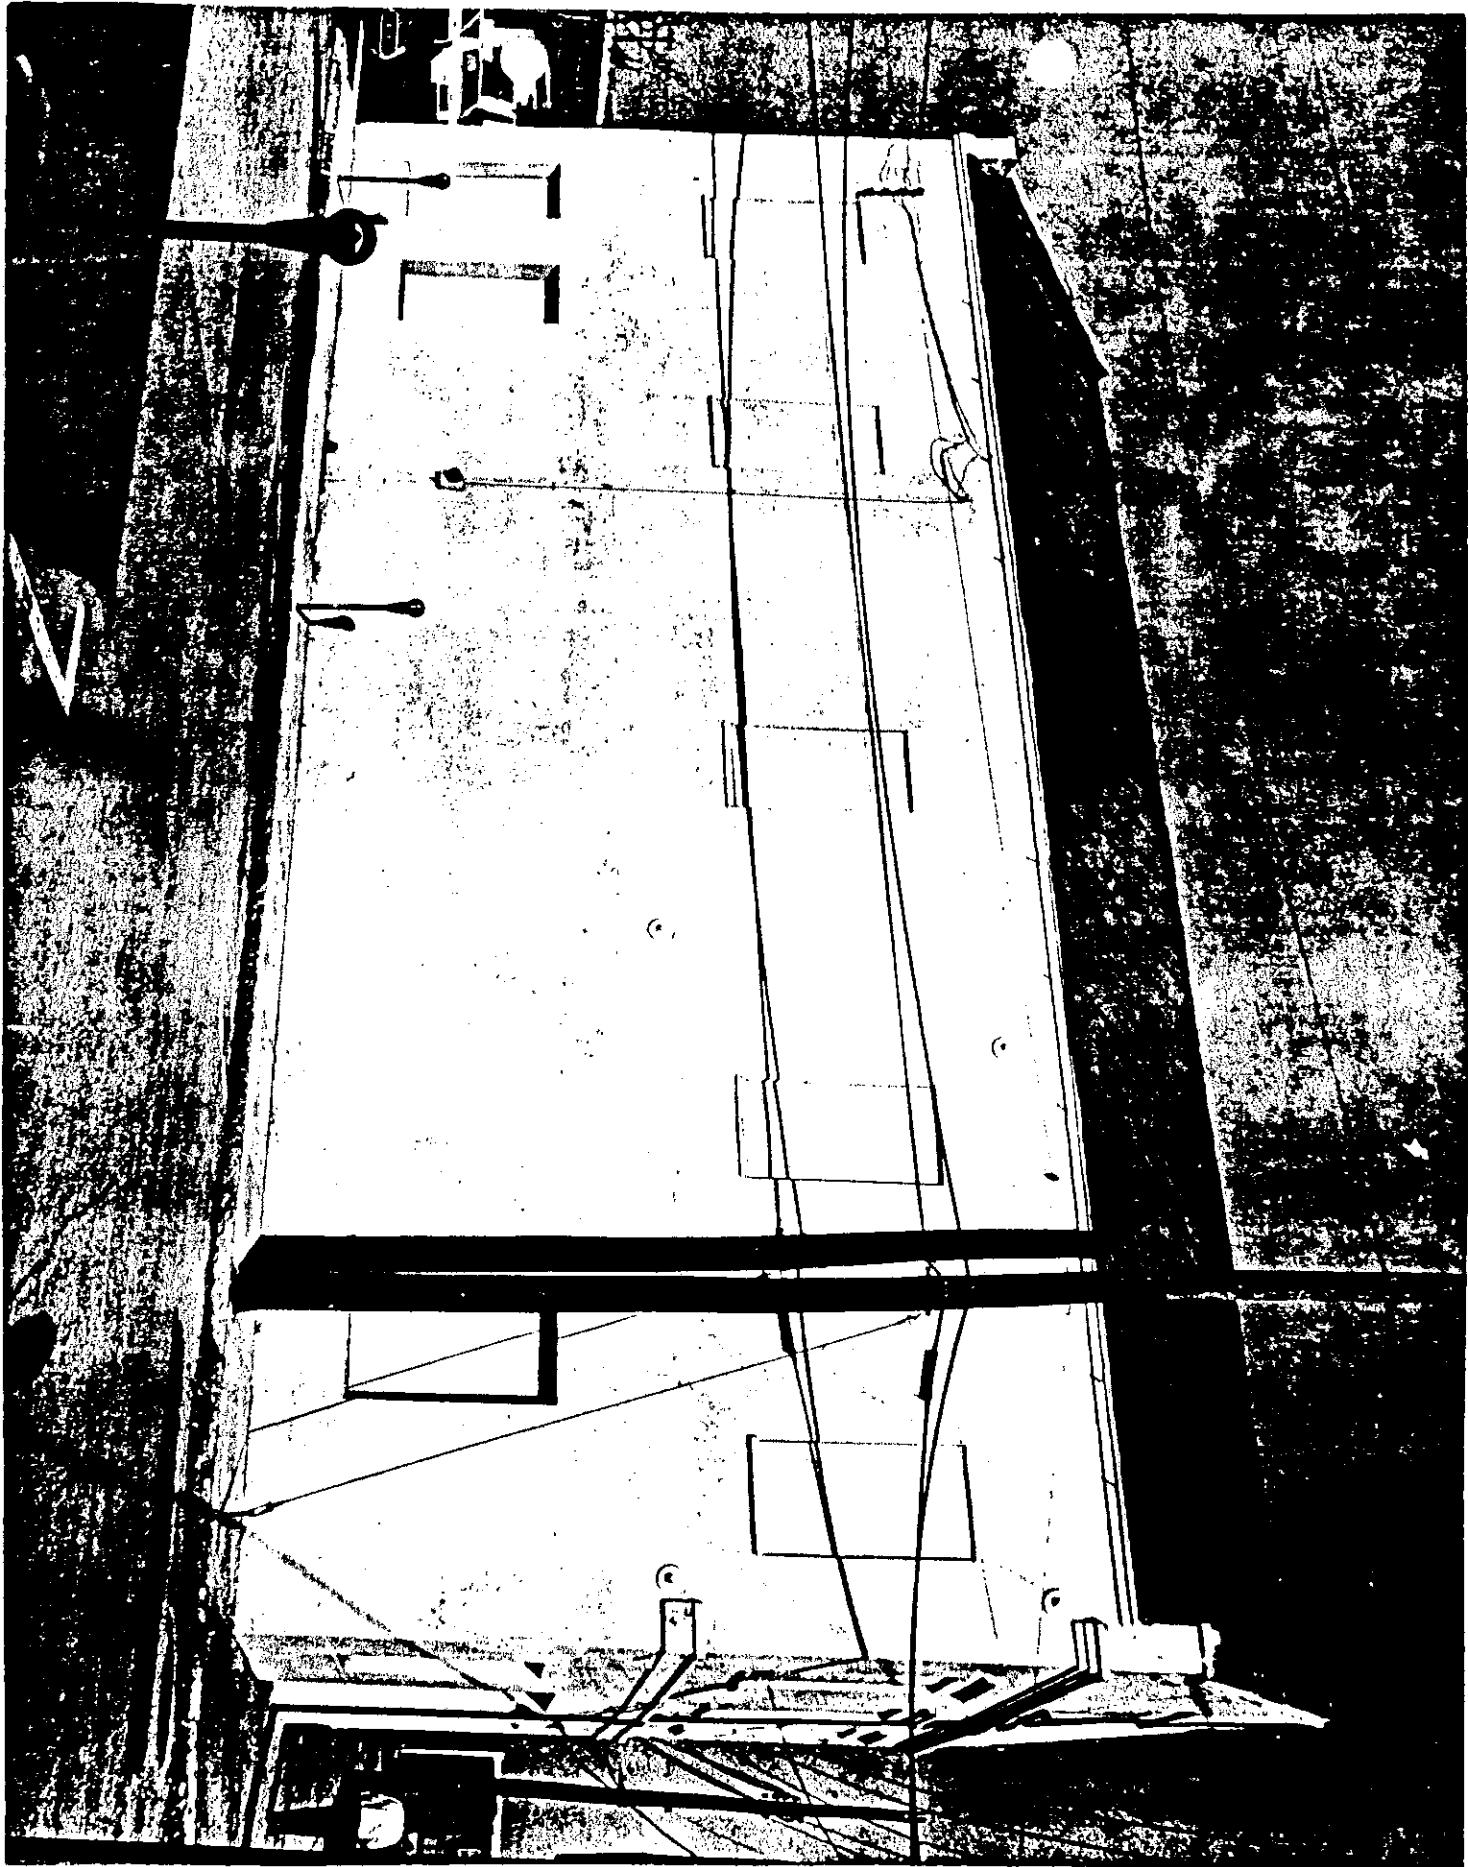
Photograph No. 2.

Describe existing feature: Existing service on Guignard Street side of building, with obtrusive pipe and tangle of wires.

Guignard Street elevation showing irregular fenestration, closed windows,  
stuccoed brick cornice and tin roof.

Describe work and impact on existing features: Existing service mast and meter to be removed. New service mast to be erected in less obtrusive place, on southwest corner of roof.

NUMBER <b>8</b>	Architectural feature <u>Windows &amp; doors</u> Approximate date of feature <u>c. 1861-72 &amp; later.</u>	Describe work and impact on existing features Fenestration to be made more regular on Guignar street (south) side by closing of some asymmetrically placed windows and adding symmetrically placed on Single door, front, to be returned to window. Single door, rear (not original) to be replaced by window new rear door added to left, with four-paneled door in mid-19th century style.
Photo no <u>1-4</u> Drawing no <u>4</u>

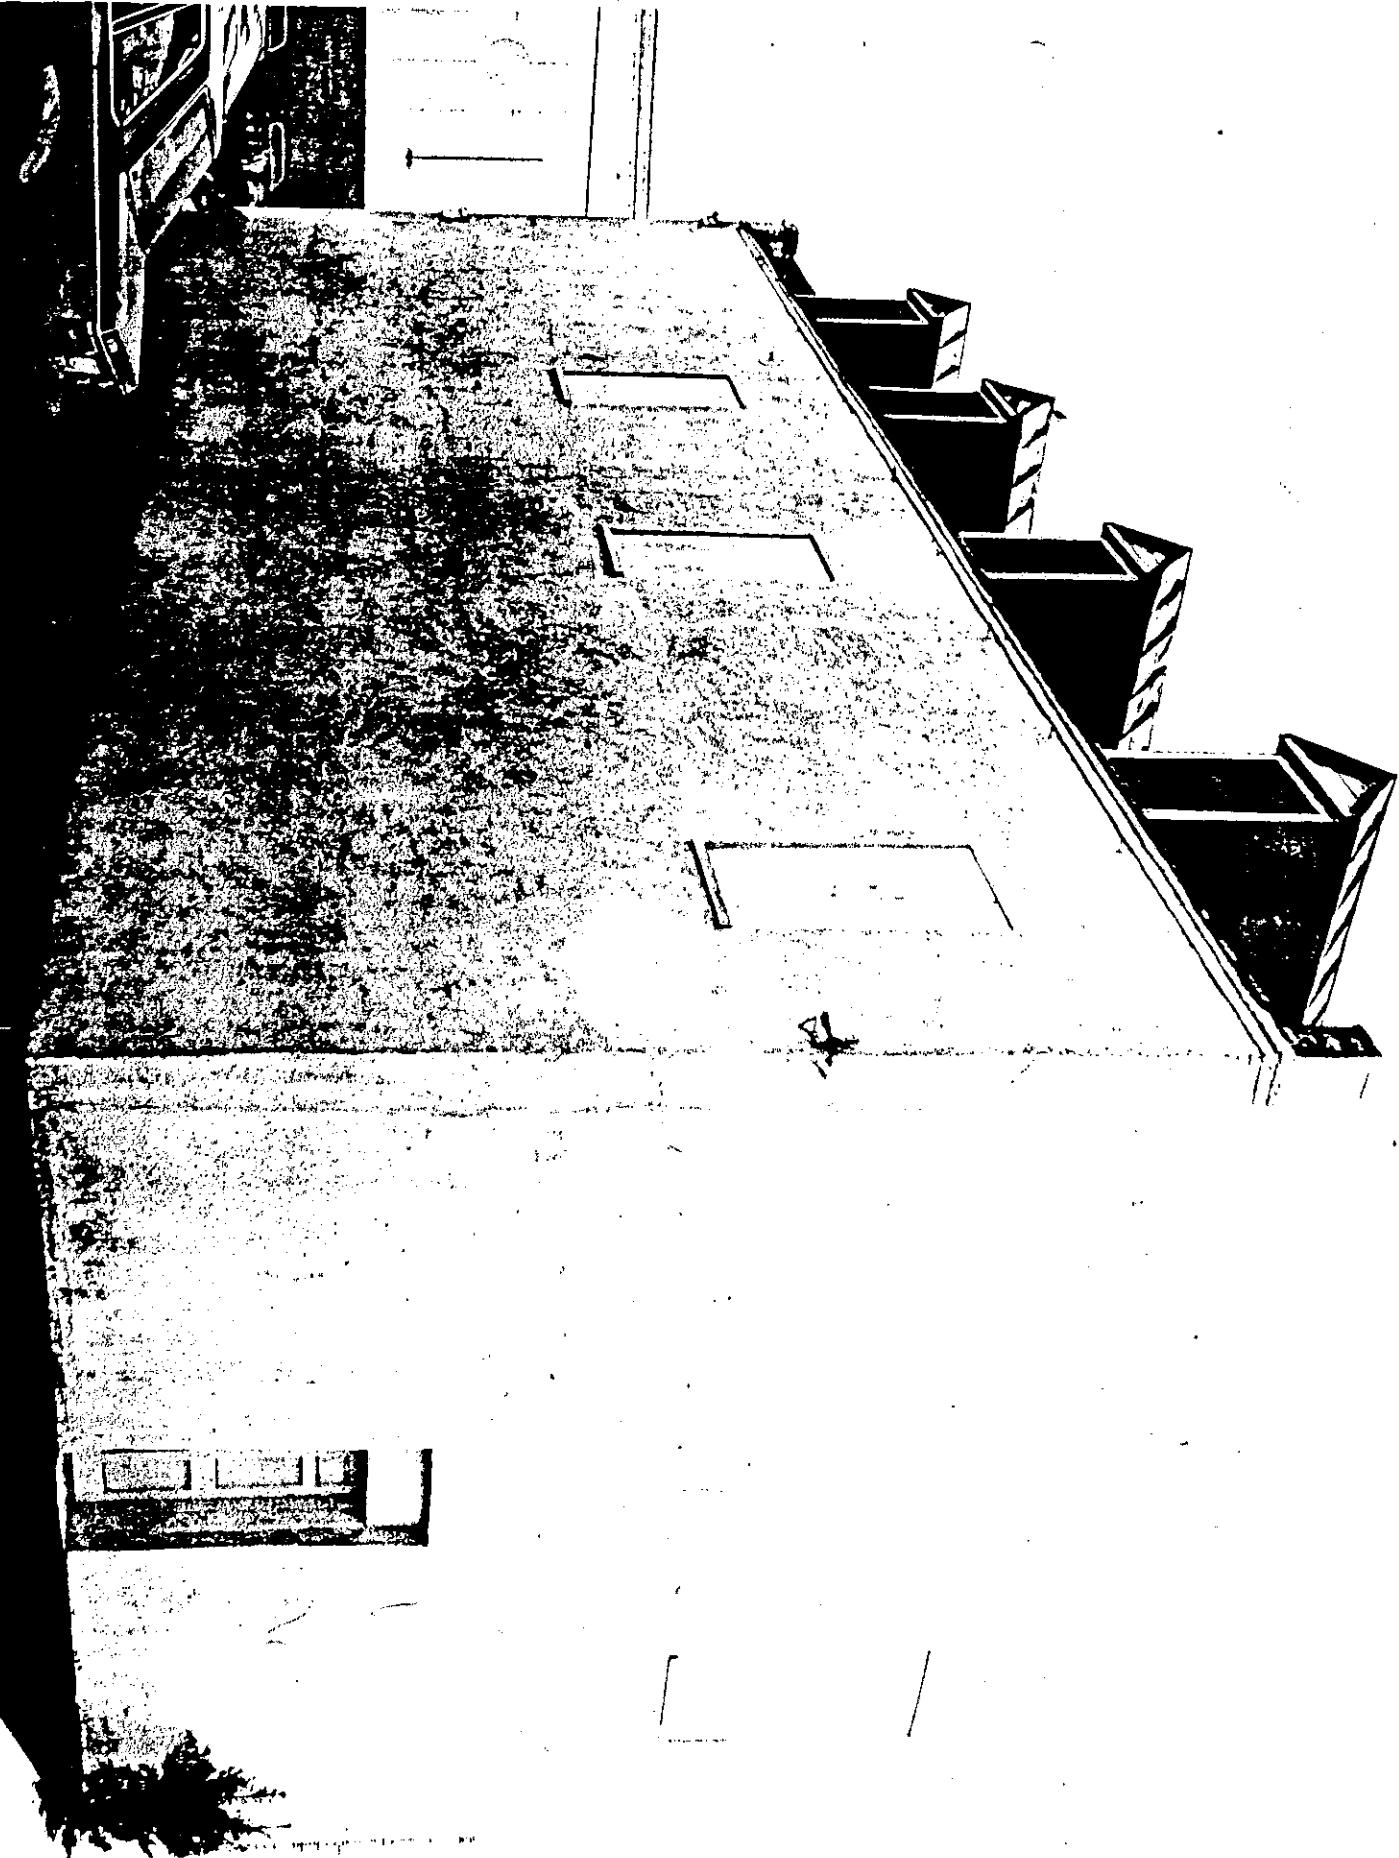
Photograph No. 3.  
241 East Bay Street, Charleston, S.C. 29401  
Owner: Street Brothers, Inc., 235 East Bay St., Charleston, S.C. 29401  
Northwest corner of building showing north and west (rear) elevations,  
with fenestration, dormer windows, closed windows, parking lot.

Describe work and impact on existing features: Existing plantings to be augmented by new plantings & trees. Post & chain fence to be removed and asphalt patched. New fence to be erected, with 16-inch masonry piers with corbelled caps, stuccoed to match building, and sections of 3/4-inch steel pickets. Lights on inside face of piers to illuminate parking lot.

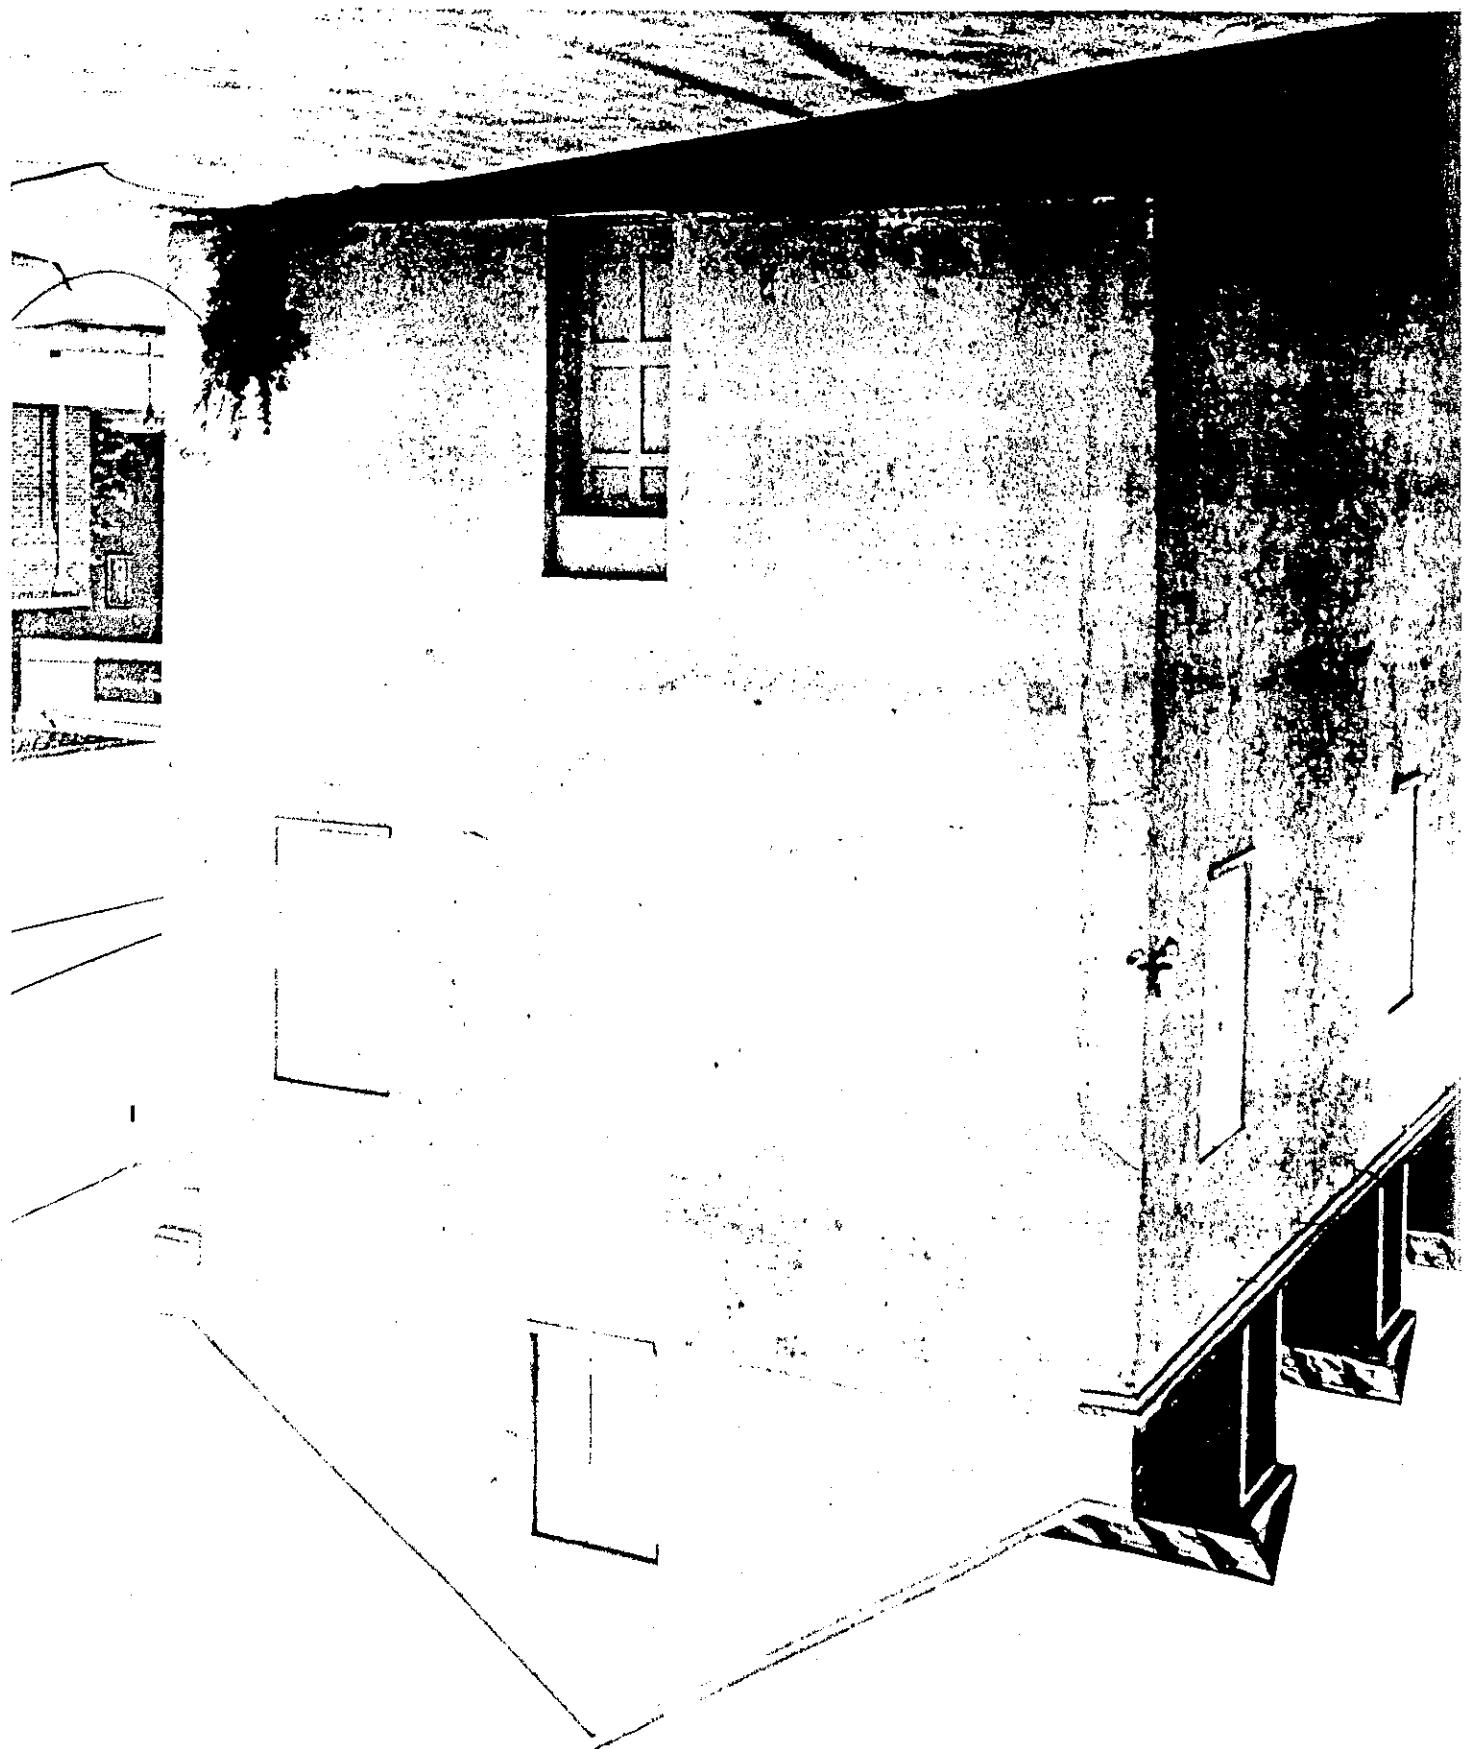
Photograph No. 4.  
241 East Bay Street, Charleston, S.C. 29401  
Owner: Street Brothers, Inc., 235 East Bay St., Charleston, S.C. 29401

Rear of building showing gable end, stuccoed brick cornice returns,  
fenestration, oversized door replaced by single door, parking lot.

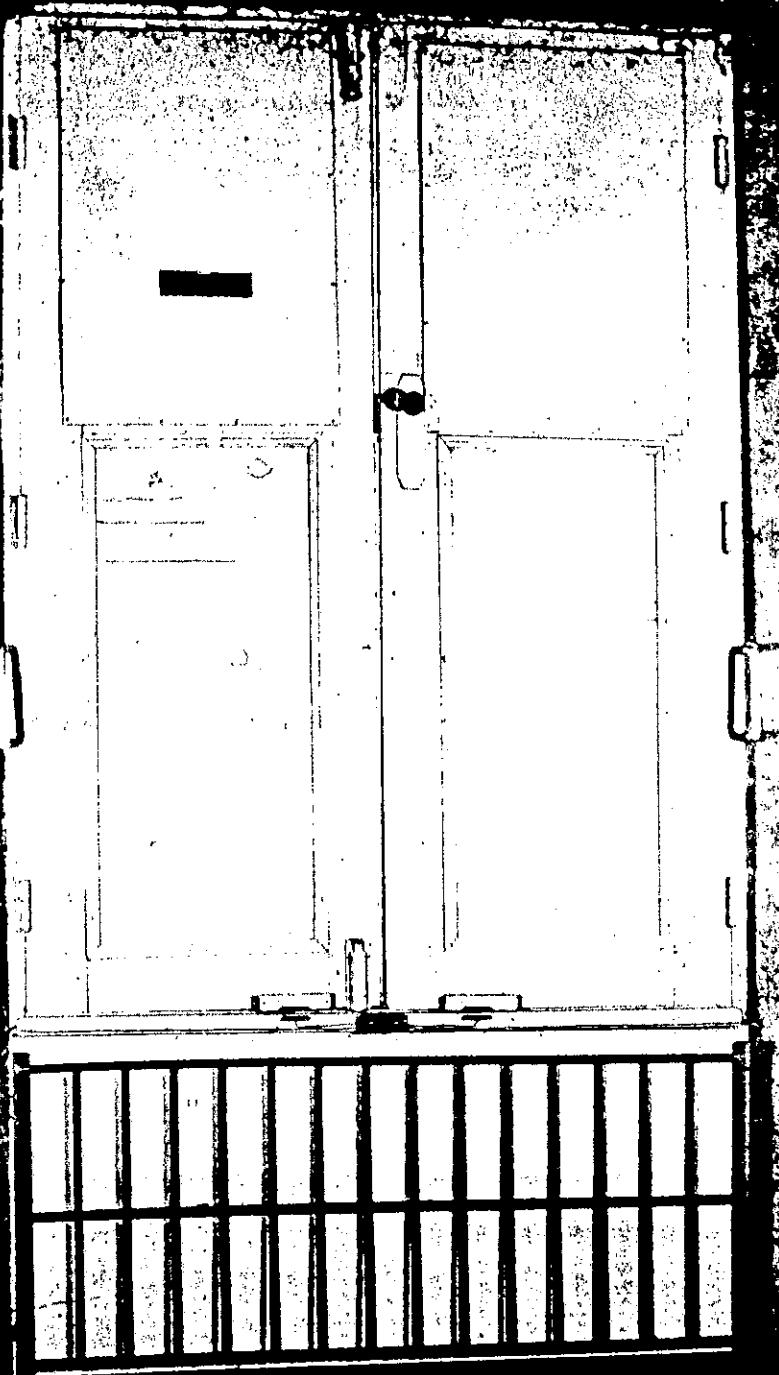
Photograph No. 5.  
241 East Bay Street, Charleston, S.C. 29401.  
Owner: Street Brothers, Inc., 235 East Bay St., Charleston, S.C. 29401.

Interior side of front entrance, showing present double doors (not original), closed transom, exposed electrical system.

NUMBER <b>9</b>	Architectural feature <u>Front doorway</u> Approximate date of feature _____	Describe work and impact on existing features New wooden doors, paneled, more in scale with building, with multi-light, fixed glass transom above, to be added.
Photo no <u>1,5</u> Drawing no <u>4</u>

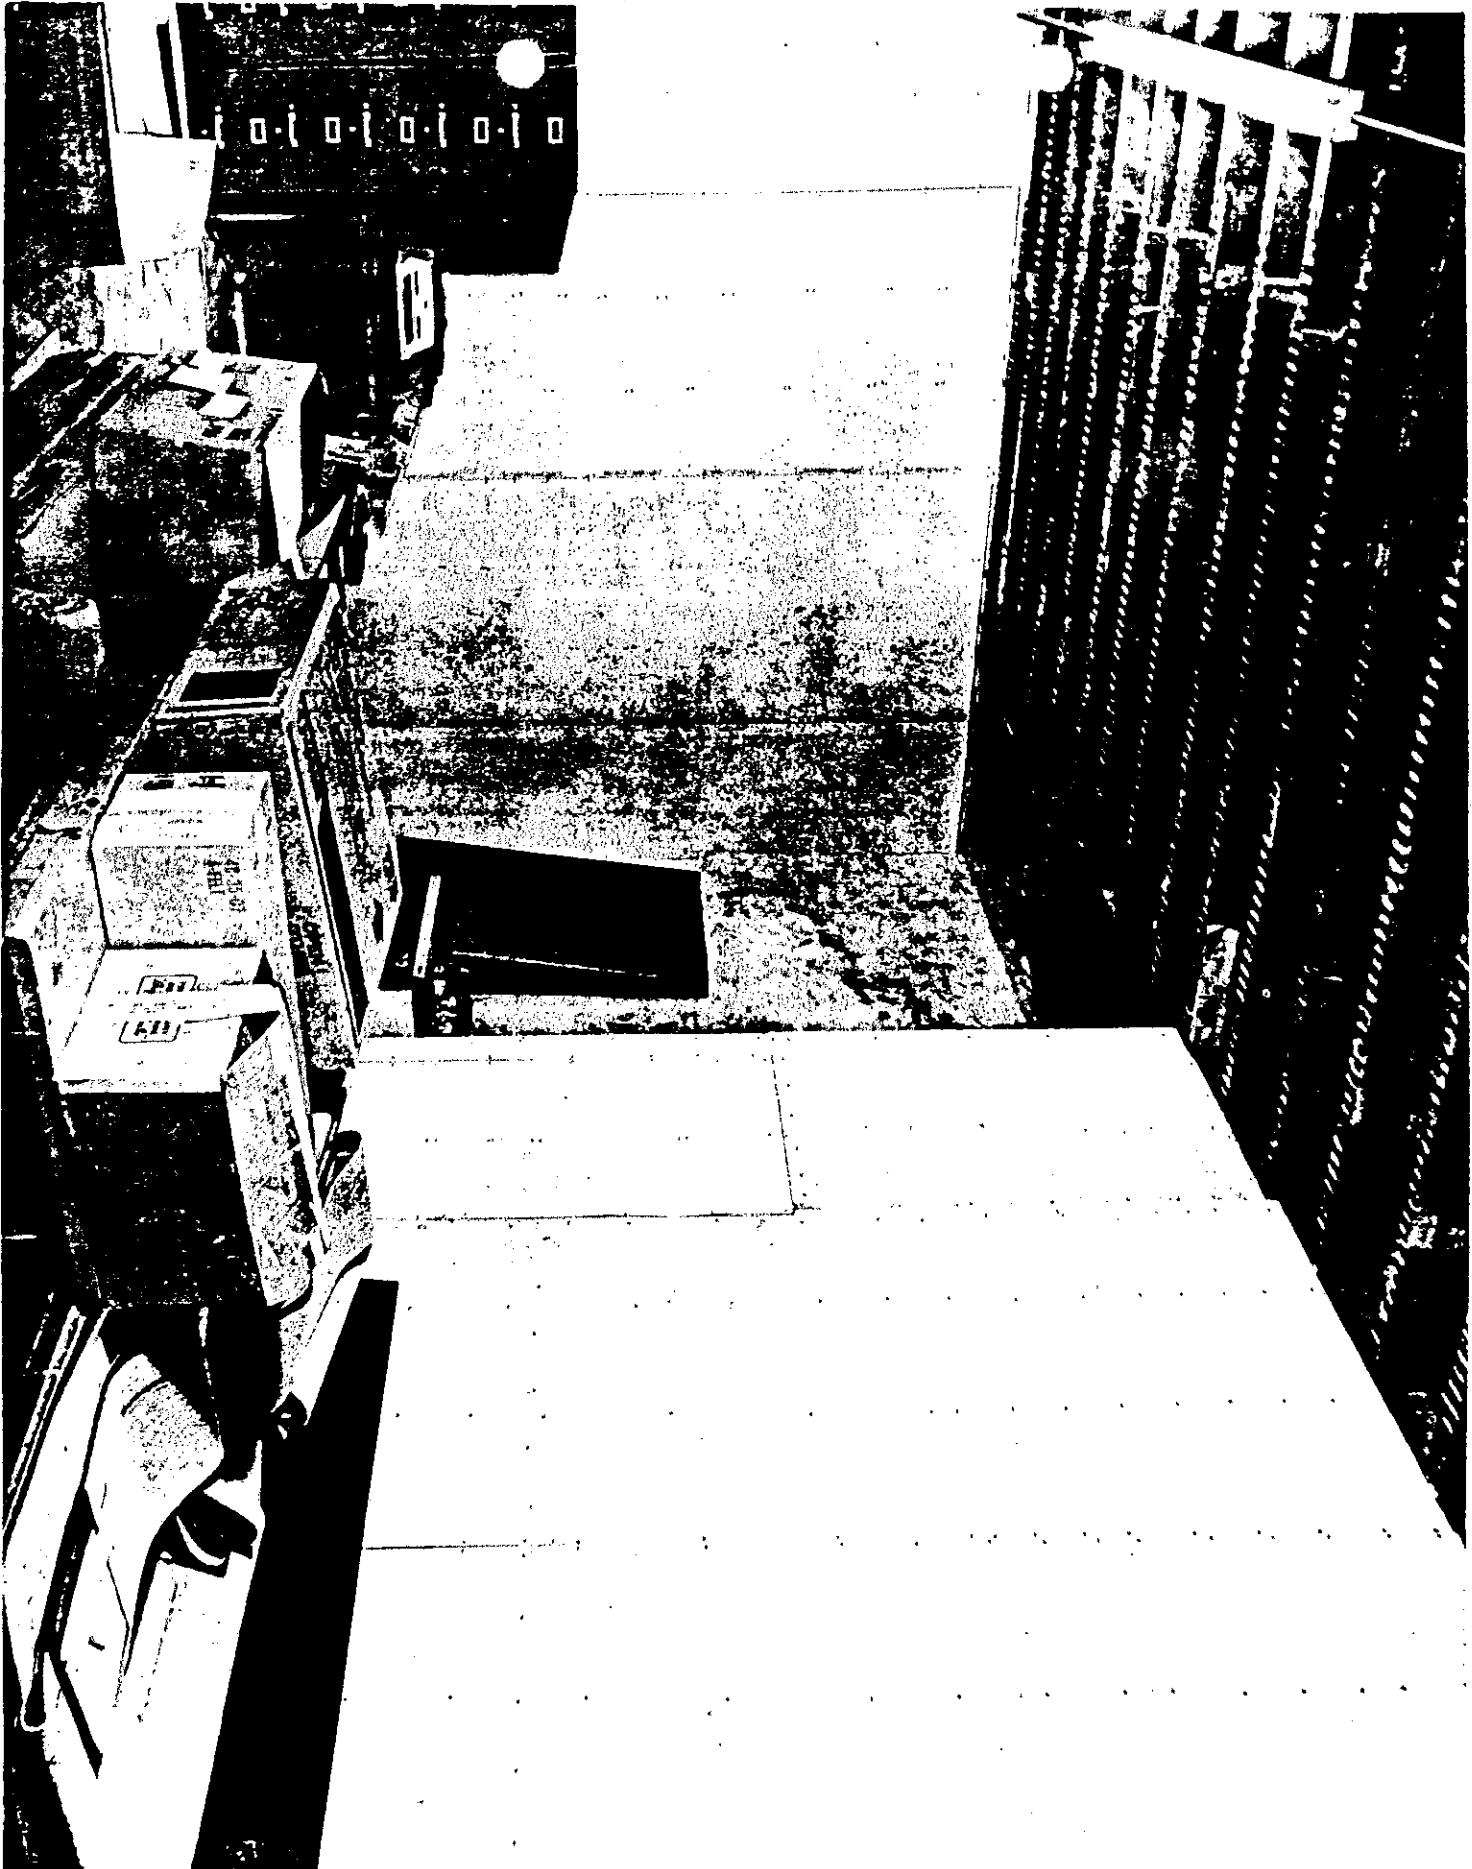
Photograph No. 6.

Interior of front room, first floor, showing exposed joists with lath  
marks, unconcealed electrical system, roughly finished partitions.  
Partition on right encloses stairway. Partition to rear divides first  
floor into two rooms.

Describe work and impact on existing features Existing stair, ladder stair and partitions to be removed. New major stair, serving all floors, to be built in rear. Second stair, required by fire code, to be spiral, 6' diameter, serving all floors. New partitions to be erected. Drop ceilings to be built on lower levels, raised ceiling on third.

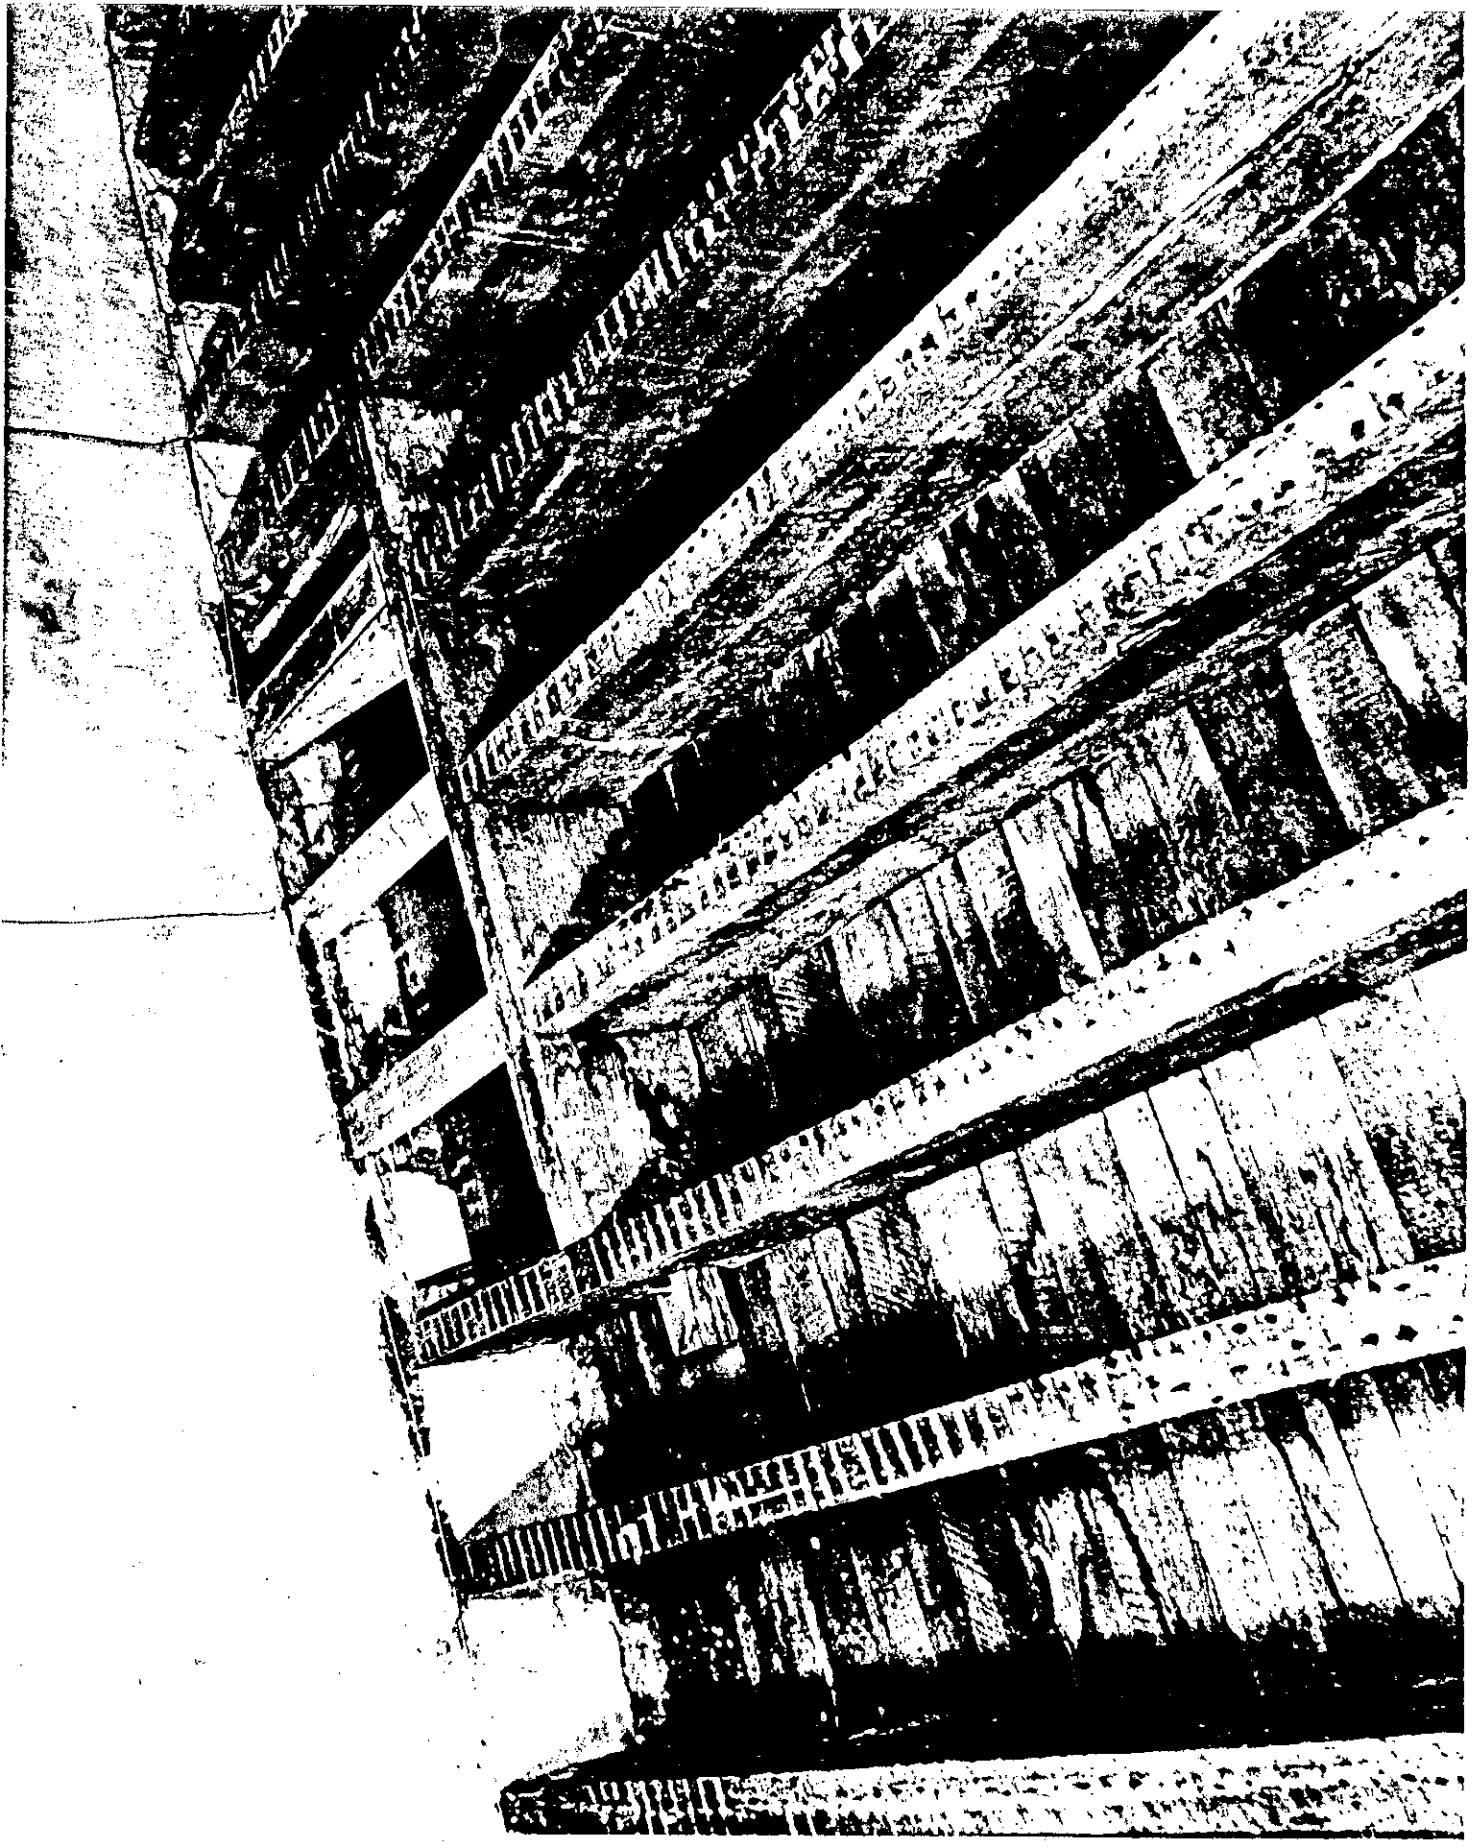
Photograph No. 7. 241 East Bay St., Charleston, S.C. 29401  
Owner: Street Brothers, Inc., 235 East Bay St., Charleston, S.C. 29401

Ceiling of front room, first floor, showing exposed joists with circular  
saw marks and lath marks; framing for former chimney with mortise-and-  
tenon and pegged construction; flooring of old pine with circular saw  
marks.

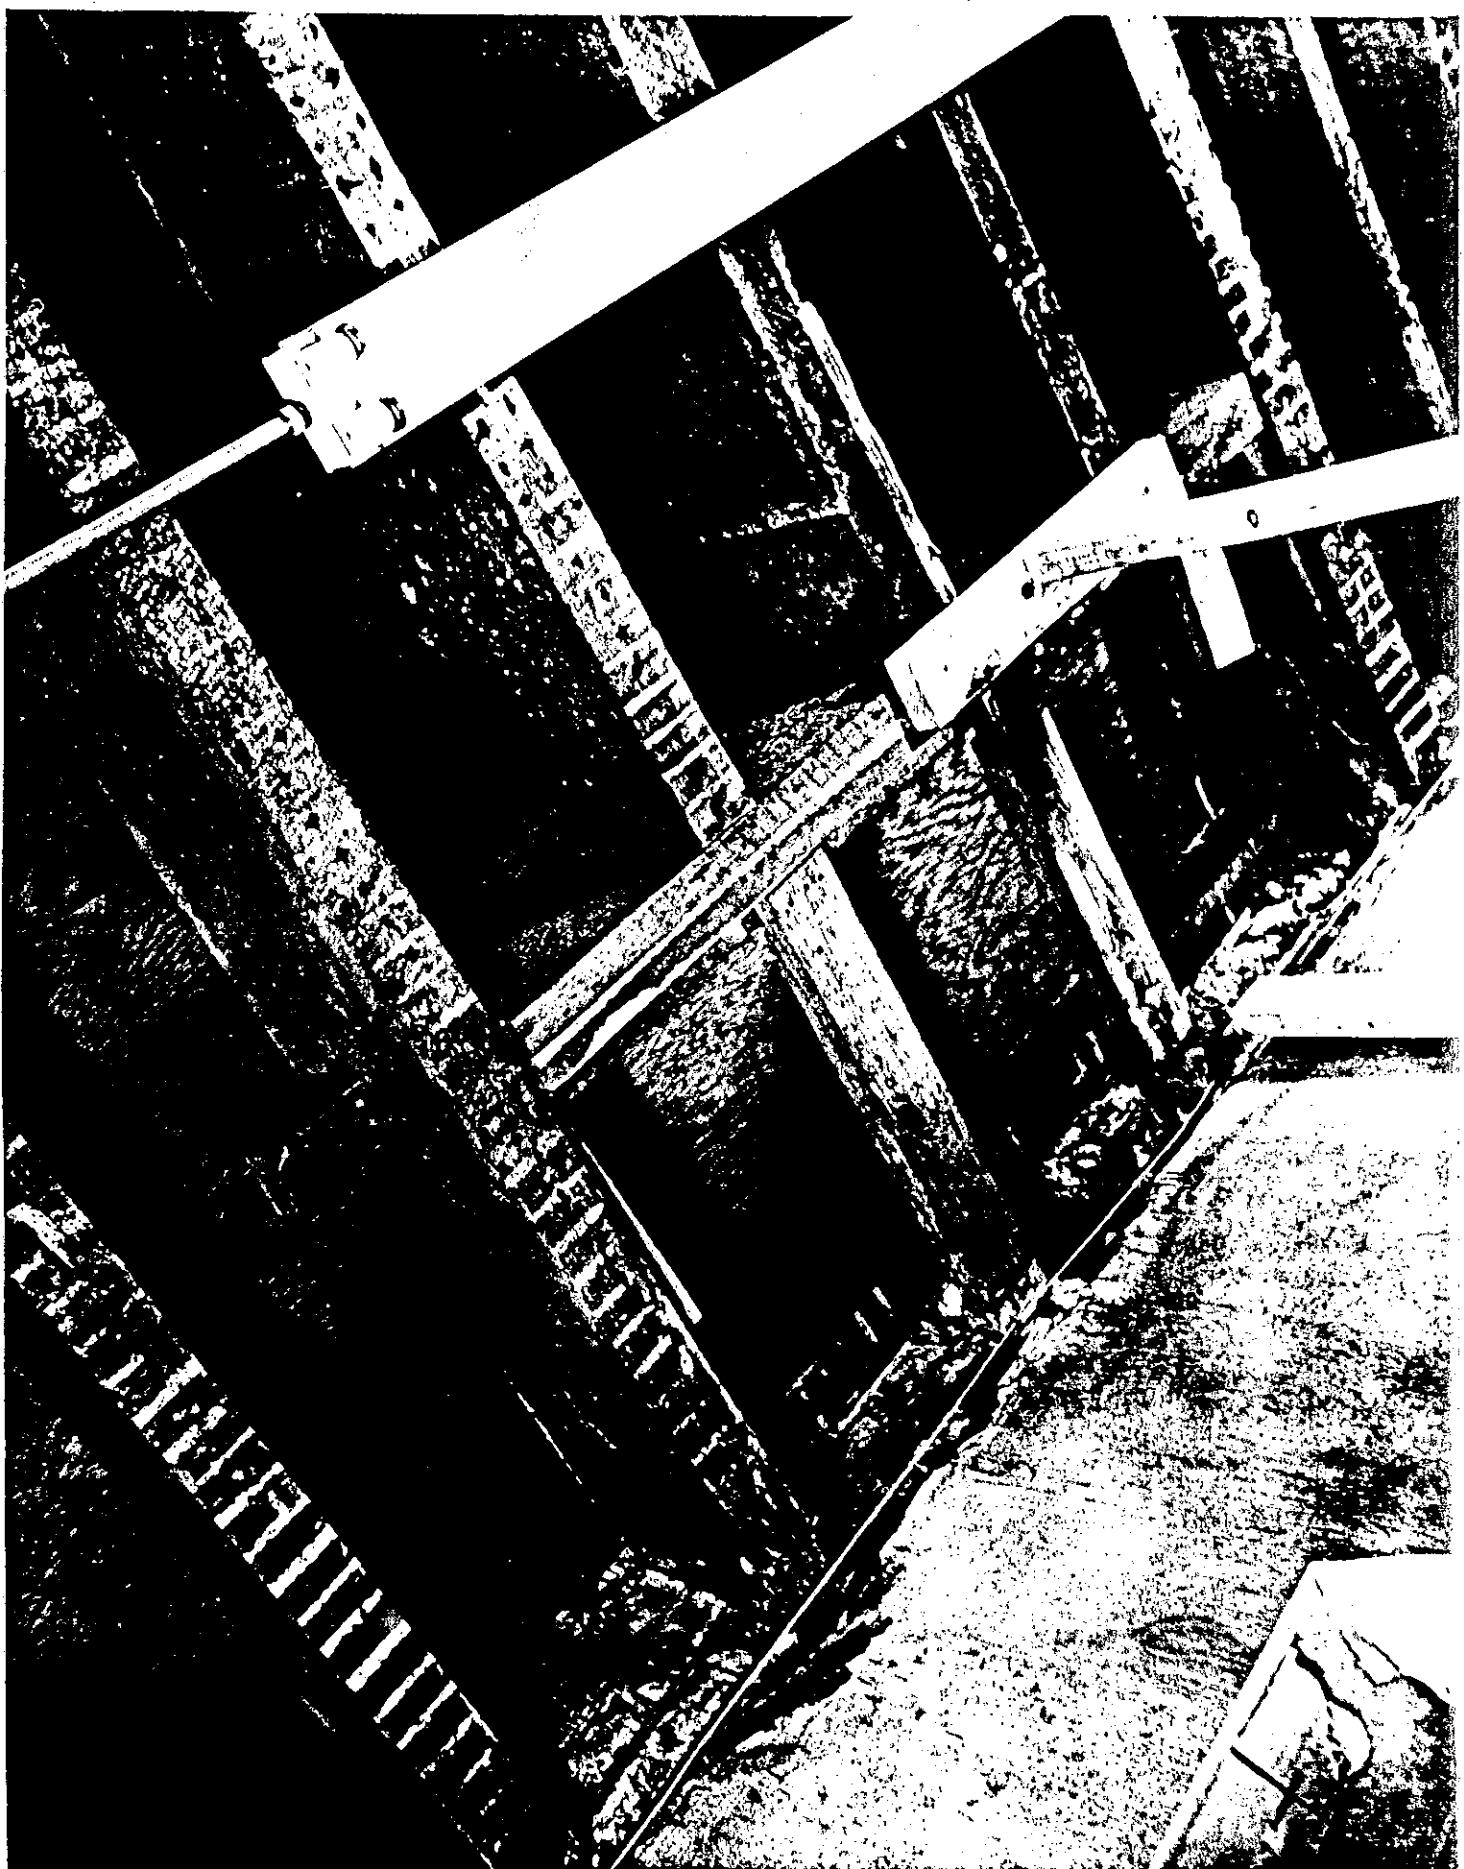
Photo No. 8.  
241 East Bay Street, Charleston, S.C. 29401  
Owner: Street Brothers, Inc., 235 East Bay St., Charleston, S.C. 29401  
Ceiling of rear room, first floor, showing exposed joists with circular  
marks and lath marks; framing of former chimney with mortise-and-tenon,  
pegged construction; un concealed electrical system.
