## HISTORIC PRESERVATION CERTIFICATION APPLICATION — PART 1

Address of property: Street 241 East Bay St.

**HISTORIC PRESERVATION CERTIFICATION  
APPLICATION — PART 2**

**Part 2 DESCRIPTION OF REHABILITATION**

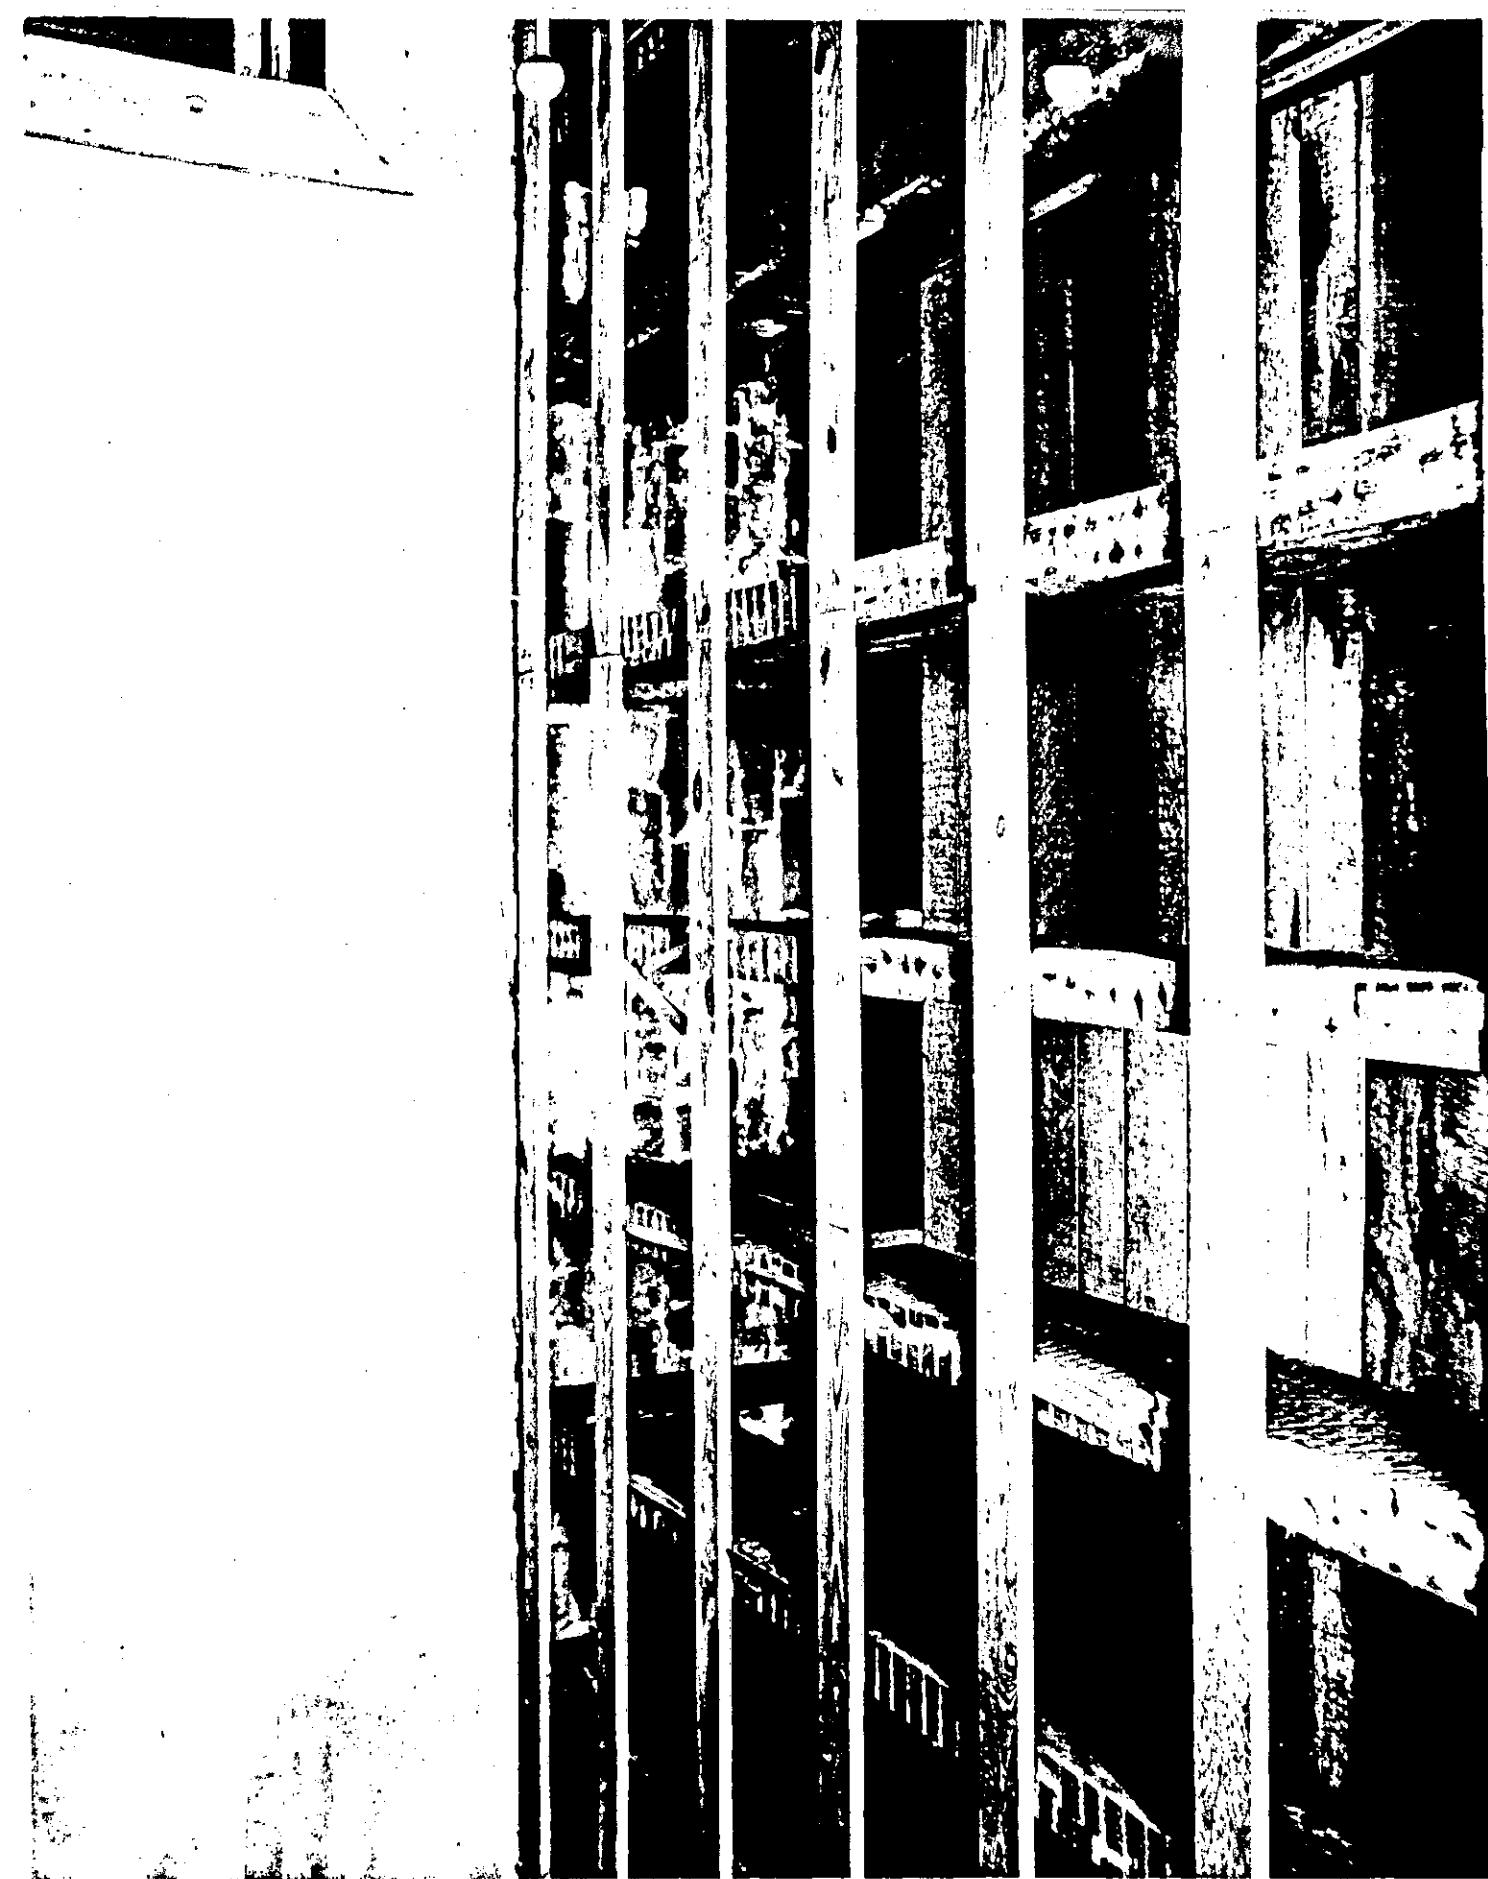
Photo No. 9.  
241 East Bay Street, Charleston, S.C. 29401  
Owner: Street Brothers, Inc., 235 East Bay St., Charleston, S.C. 29401

Ceiling of second floor, showing exposed joists with circular saw marks and lath marks, recently applied furring; old pine floor boards of half story, showing circular saw marks; interior brickwork, with some scorched bricks, indicating probably salvaged from ruins of 1861 fire.

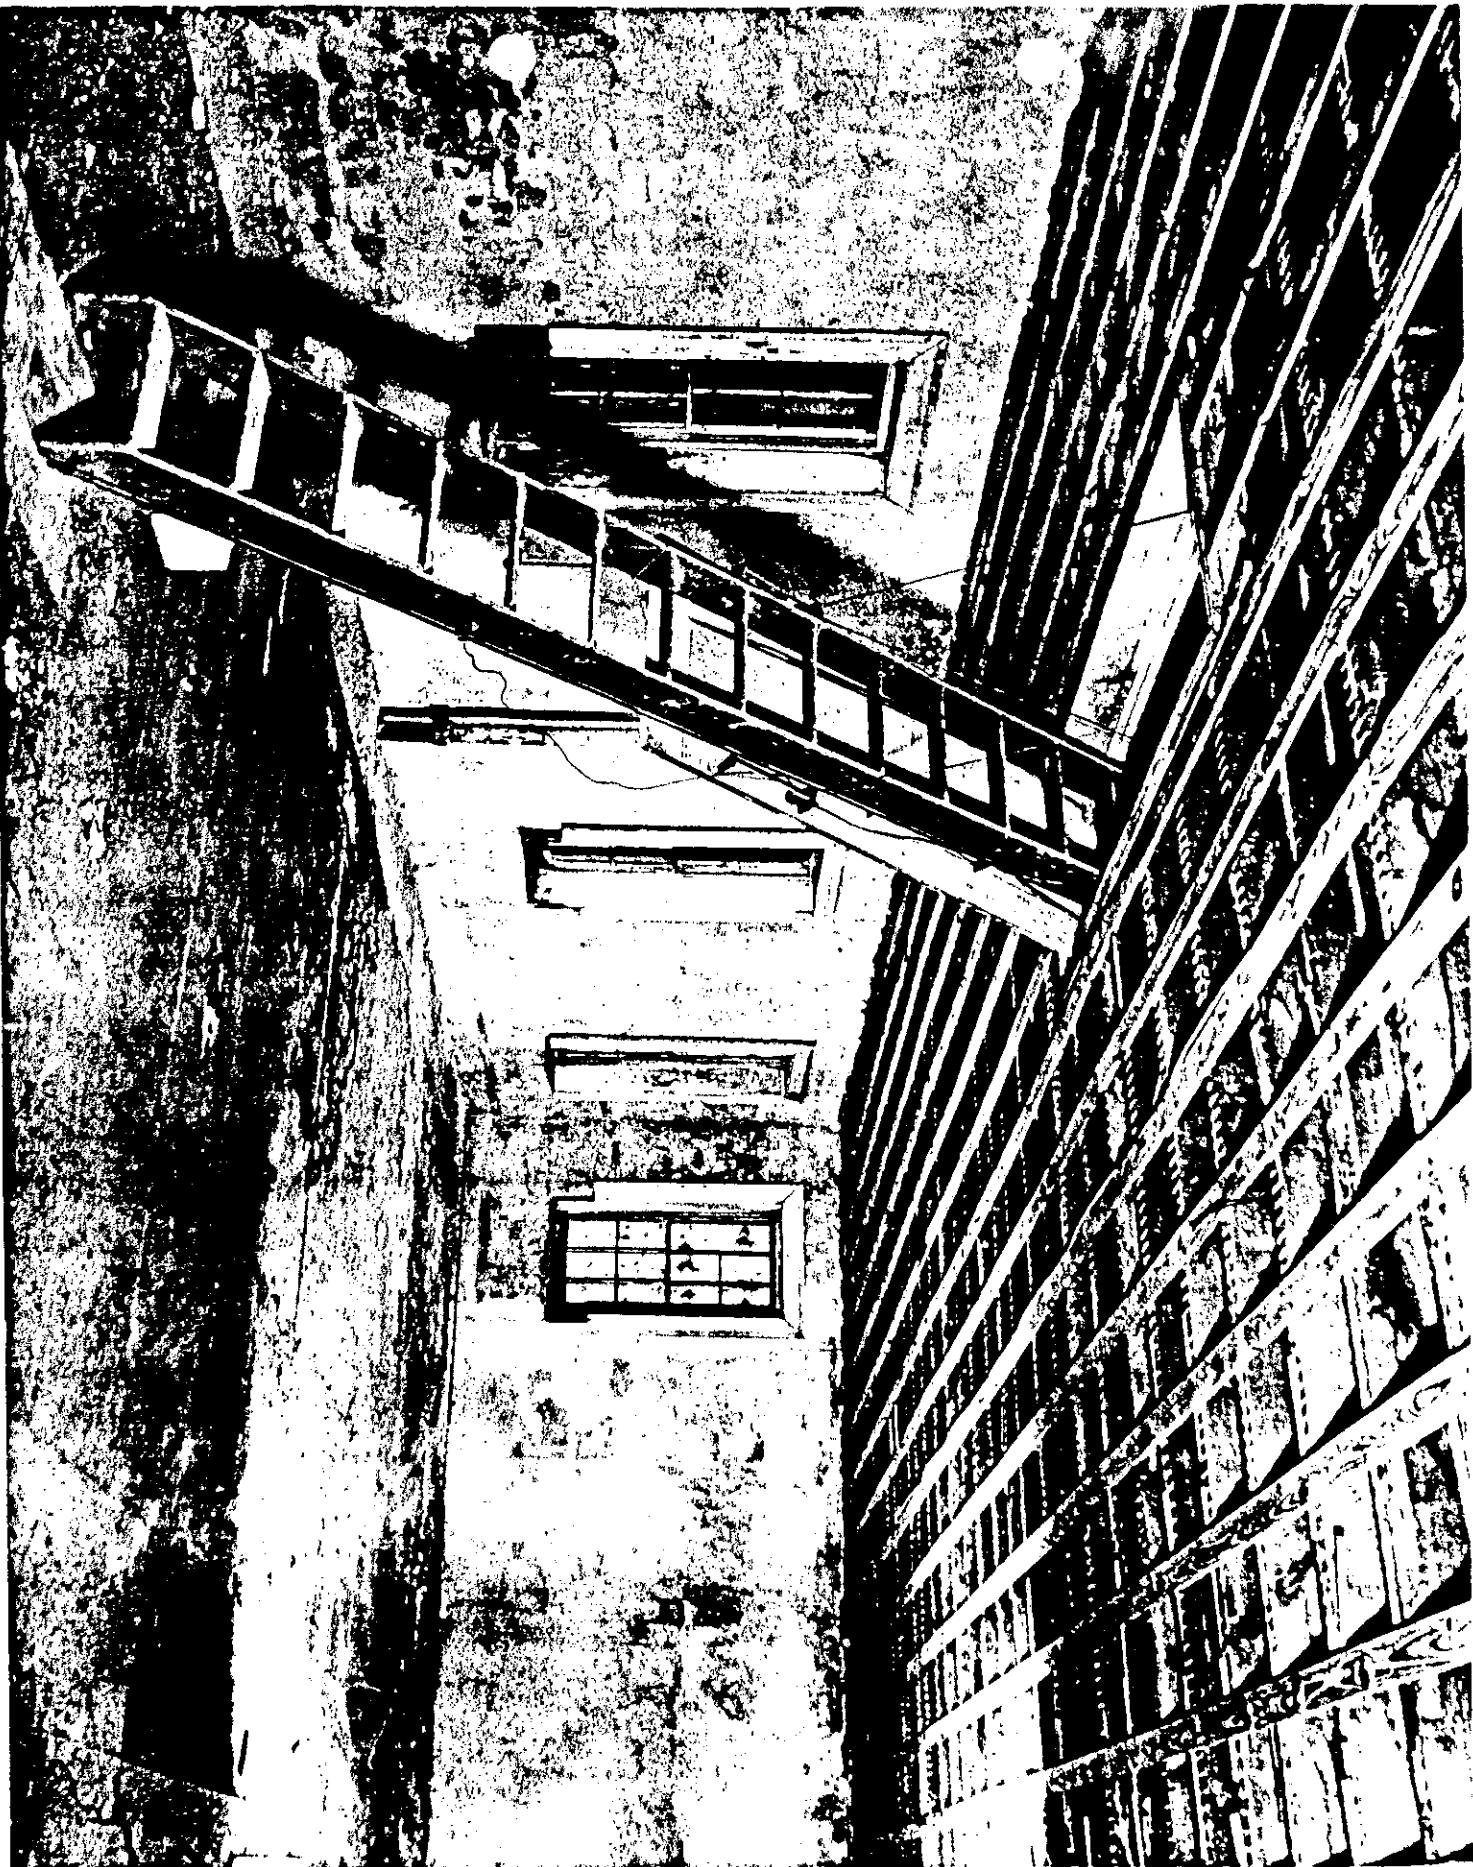
Photo No. 10.

Describe existing feature Original wooden window frames and sills remain. A few original double hung sashes, with six lights to a sash, remain. Majority of window sashes replaced at recent time with new. In Photo no 10-13 Drawing no. 4 good condition but many missing lights.

Interior of second floor, ~~showing~~ showing exposed joists and furring, ladder  
stair, original woodwork and six light sashes (replacements of original),  
plywood flooring.

Describe work and impact on existing features Existing frames and sashes to be retained, with missing lights replaced.

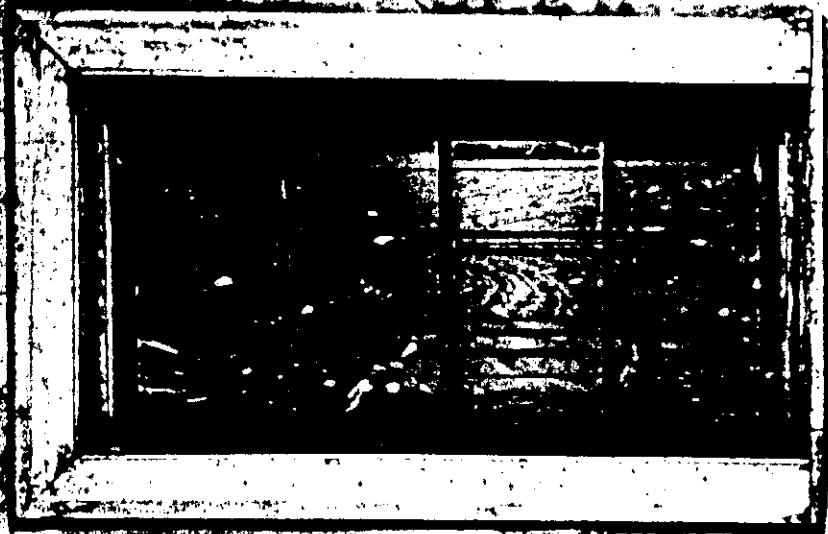
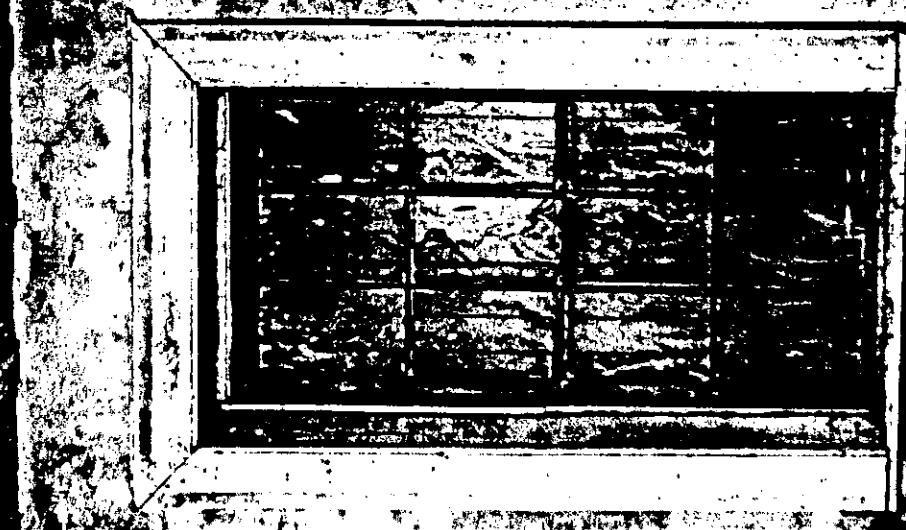
Photo No. 11. Charleston, S.C. 29401.  
241 East Bay Street, Charleston, S.C. 29401.  
Owner: Street Brothers, Inc., 235 East Bay St., Charleston, S.C. 29401.

Interior, second floor, showing woodwork, windows. Sashes on left are  
original, sashes on right are recent replacements.

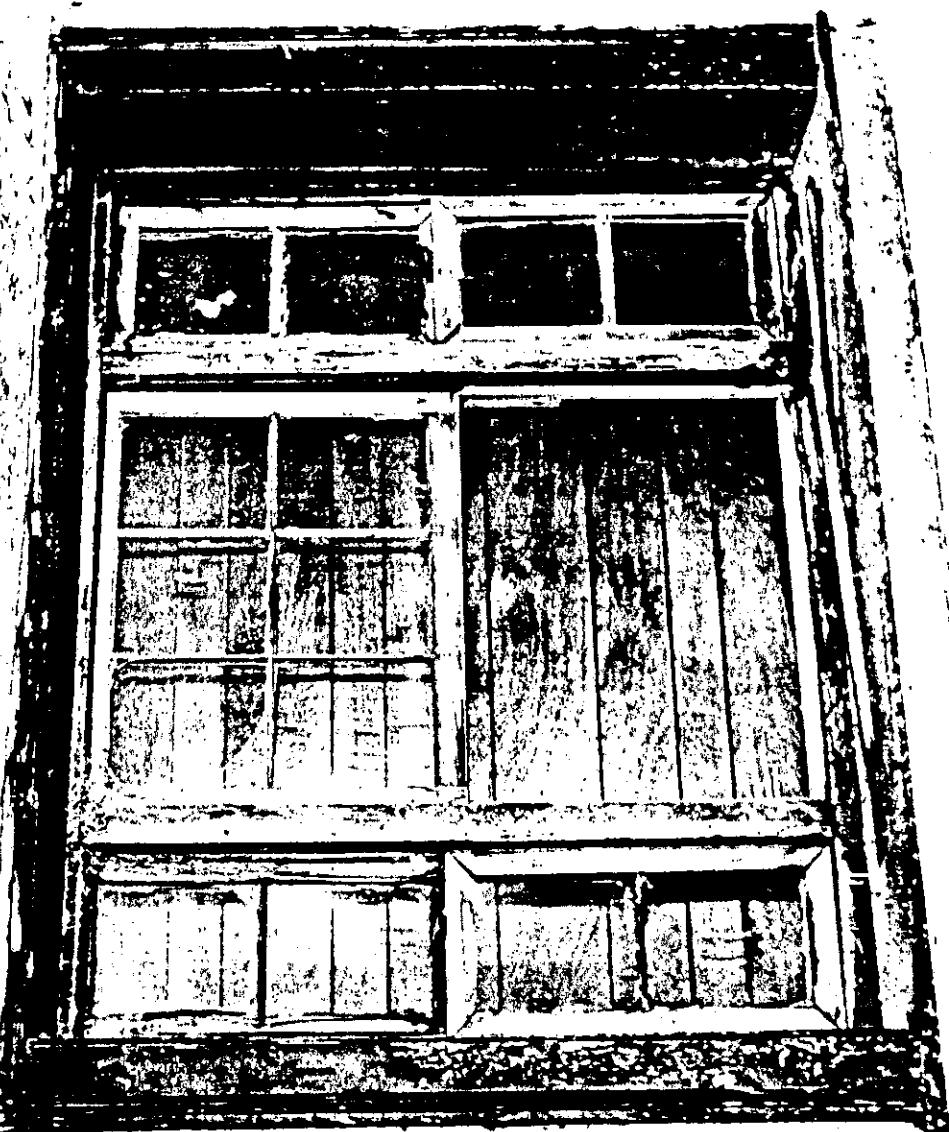
Photo No. 13.  
241 East Bay Street, Charleston, S.C. 29401.  
Owner: Street Brothers, Inc., 235 East Bay St., Charleston, S.C. 29401.  
Interior: Detail showing tripartite window of front gable, in half  
story. Window frame, woodwork original, sashes recently replaced.

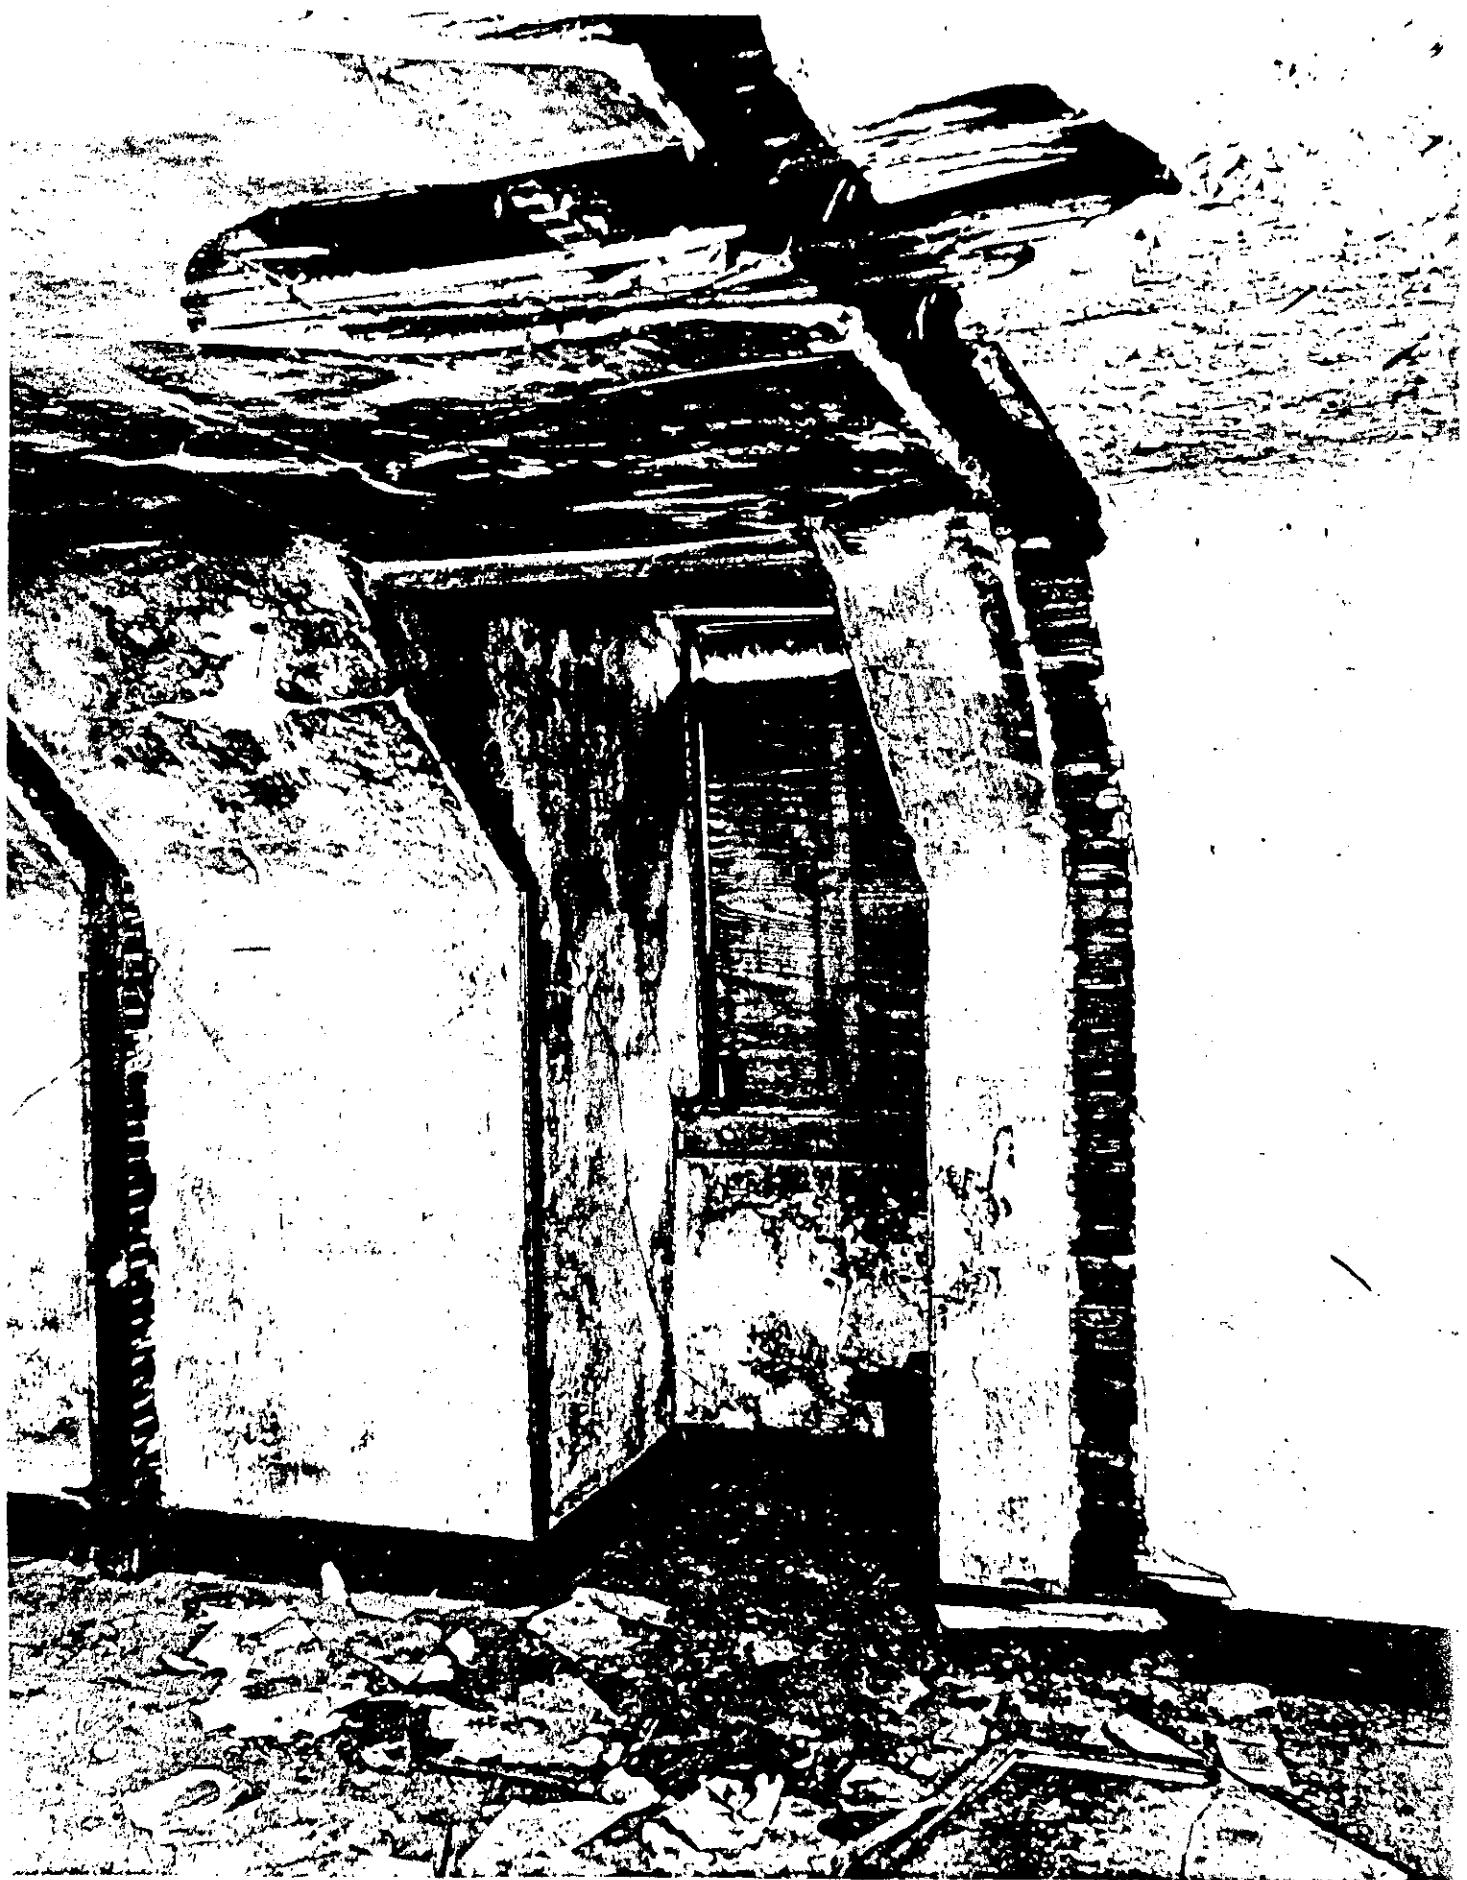
Photo No. 14.  
241 East Bay Street, Charleston, S.C. 29401.  
Owner: Street Brothers, Inc., 235 East Bay St., Charleston, S.C. 29401.  
Interior, half story, showing dormer recess, window framing and woodwork,  
old plaster on machine cut lath, marks of former partitions.

& lath had to be removed to study roof problems. Study determined that existing roof could be retained and repaired. Plaster to be replaced with sheetrock. Removal of plaster facilitates raising of ceiling in half story.
