PLANTING FIELDS FOUNDATION

THREE TRACERY PANELS

DINING ROOM, W13,14,15

9 FRAGMENT PANELS (DINING ROOM, WEST BAY, W1, 2, 3, 4, 5, 8, 13, 14, 15)

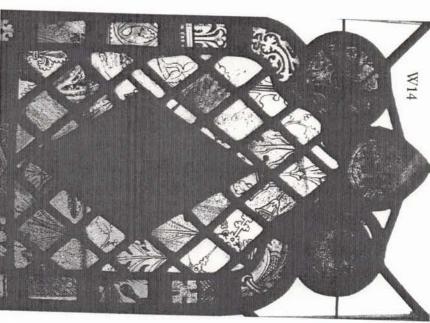
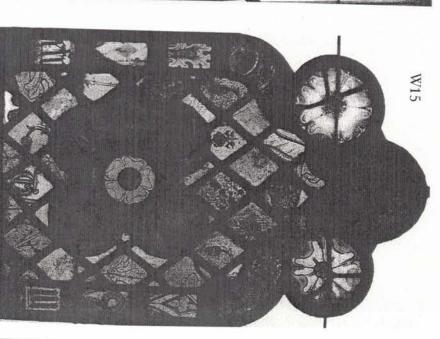
W13

possibly the time period when these panels were designed and assembled from a collection of fragments. On all panels: main lines and diamonds leaded with 3/8" flat H came, 1/4 " flat H came inside the borders. The central design (flower, diamond of character) is leaded with 5 and 4mm round H came. Repairs are made with 4mm and 2mm H lead came or, during the last restoration, with copper wire flanges.

- Glass: (Front surface assessment) the panels consist mostly of fragments of clear glass painted with grisaille and silver stain, all from old origins (14th-16th centuries) with the possible exception of one central rose piece (W1, made for this series to match W4?) Colored fragments (shades of blue, red, green with or without paint) were used to create a contrast between the pictorial items. These fragments' age scale is wider and closer to us, and a fair amount of modern pieces have been included where necessary. Sometimes these modern pieces are splattered with paint to imitate corrosion. Of the three represented figures, W3's attire seems to be the most consistent and served as an inspiration to dress the two other characters. Glass fragments were chosen and cut for them to match this dressing style. The head pieces are independently manufactured; W2 and W3's main fragment seem to have a common origin (England?) although both are not intact (replacements for W2, stopgaps for W3.) W5 looks German and although its broken fragments were mended with epoxy glue during the last restoration (in the 1970s), they are all original. The variety of places of origin and glass composition accounts for the many different surface aspects and conditions. The glass fragments are from flat to uneven and from thin to very thick. Scratched, corroded in various patterns (areas of dispersed to densely gathered pits, large craters), or very smooth describe those various front surface conditions. Removal of the back protective plate is necessary for complete assessment of the glass deterioration

- Paint: The variety of painted designs and styles determine that the fragments are
 coming from different windows, whereas the paint techniques used determine a
 period of time starting from the fourteenth century (silver stain). These paints
 have a slightly satin texture and are mostly in stable condition where untouched
 by corrosion. The turquoise-green piece, however, suffered major paint loss, and
 many of the top pieces on the tracery panels that are extremely altered by
 corrosion have lost much of their silver stained layer.

Recommendations:

- Category C
- Cautiously cleaning the front and back surfaces of the glass.

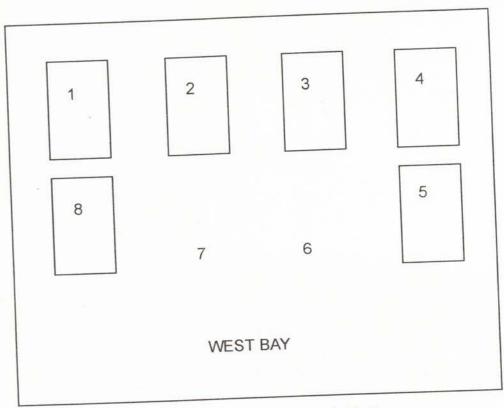
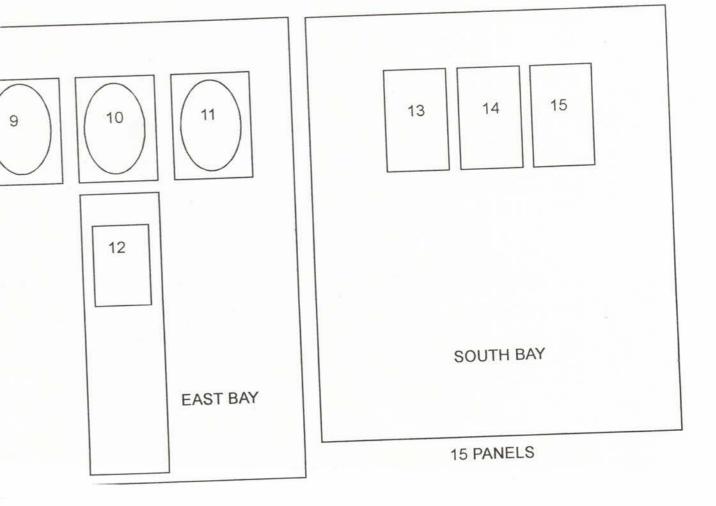
DINING ROOM room W

- All stained glass panels are installed within a protective glazing frame. That frame
 is fixed into a rectangular quarry window doubling as a vent, with the exception
 of W14. Panels W1, W2, W3 and W4 feature a small arched panel directly above
 the rectangle. The steel portion of the vent windows are to be examined for
 maintenance needs (rust), especially window W14, the bottom of which is not
 closing properly and was temporarily fixed with wire.

- W5, W8, W13, W14 and W15 are reinforced horizontally with two flat rebars soldered to the lead at joints, placed at the top and bottom of the protective glazing frame.

- Protective glazing and installation of the painted panel: PG#3. Two flat rebars are placed behind panels W13, 14 and 15; three rebars are placed behind panels W1, 2, 3, 4, 5 and 8. They run horizontally across each panel. A sheet of Plexiglas is glazed in the back of the panel at a distance of approximately two inches, exposed outdoors. Fourteen holes pierced around the protruding frame allow indoors air to circulate between the panel and the Plexiglas. The Plexiglas has become opaque.

- Lead: 5/8" flat H in good condition; all panels (except W13 and W15?) were reglazed while installation of new protective glazing.
- Glass: mostly clear blown glass, a few float glass pieces. No cracked piece.

Lead: the leading is consistent throughout the whole series of panels, an
indication that it is possibly the original one. The type and condition of the lead
(with ridges, good condition) suggest a time period around the nineteenth century,

Recommendations:

- Cleaning and treating the steel structure against rust.
- Removing the protective glazing sheet in order to assess the glass condition on the back. Replacing the Plexiglas. Cleaning the frame.

In situ regular maintenance.
