CATURDAY AUGUST 23, 1947, dawned into a Spleasant summer's day, but the events of the late morning would turn it into the blackest day in the history of A V Roe & Company Ltd. The reason was the tragic crash at Woodford, near Manchester, of the Avro Tudor II prototype airliner, G-AGSU, with the loss of an outstanding crew and the company's technical director Roy

FlyPast February 1999

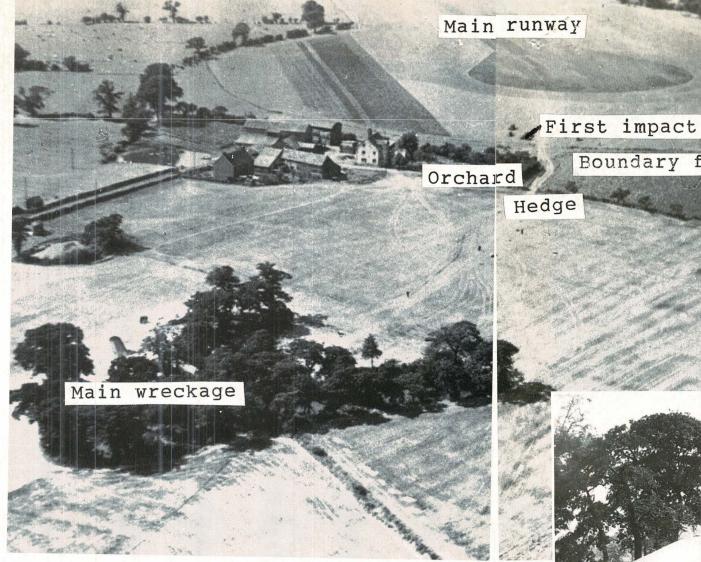
An aerial view of the crash site, with the Tudor's tail just visible in the trees. The rescue vehicle tracks from the airfield almost follow the same path as the crashing aircraft.

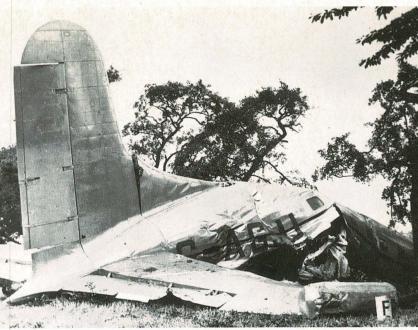
The shattered tail section of G-AGSU.
