# THE COMMUNICATIONS RECEIVER

### NO. 7 — RESTORING THE NATIONAL PW DIAL DRIVE

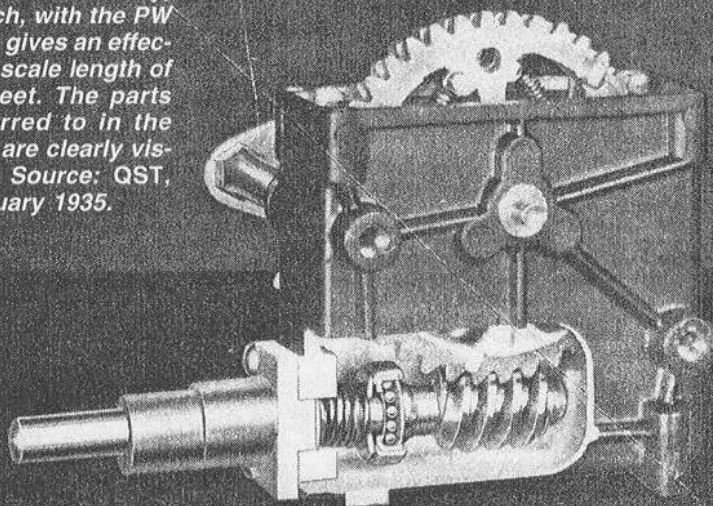
The PW Condenser drive assembly, which, with the PW dial, gives an effective scale length of 12 feet. The parts referred to in the text are clearly visible. Source: QST, January 1935.

Another significant source of trouble is the zinc casting offset hub that the numbered dial rides on. It must be miked for roundness and size, and more often than not it will be found to be oversized and out-of-round, sometimes enough to kill the whole dial drive. The nominal size of the dial hole is 0.560 inches, and the hub should be slightly smaller, by about 2-3 mil. Work the hub down with a file and every cloth to correct size, checking frequently to be sure it is round. Take enough time here to do a good job, and it will pay off. A 0.312 inch drill bit passed through the shaft hole in the hub will clean it out. Using a swab, regrease the hole.

Zinc dye castings have a tendency, depending on storage conditions, to increase in dimension (grow) with time. Literature references indicate about 0.001 inches in five years; thus the hub in 40 years could "grow" as much as 0.004 inches, enough to cause trouble. Furthermore, the growth will be uneven due to the offset center hole, resulting in an oval.

The fiber washers, when exposed to oil and pressure over time, tend to flex with the force of the spring. This will bind the inner race of the bearing, causing heavy drag. Replacement with steel washers seems to work well, even though the original design probably used the fiber to act as a noise suppressor and insulator.

Start by cleaning out all the old grease, using a solvent such as gasoline or a light oil as WD-40. A 10-mil shim worked back and forth between the gears will help. Swabs, Q-tips, etc., will all aid the cleaning. The grease may be quite

To make the drive action smoother and to correct a major problem, I found it necessary to replace the aged and distorted fiber washers with thin steel ones. Mine measured 0.680 inch OD, 0.330 inch ID and 0.020 inch thick. Note that the washer must just fit through the housing hole, but be big enough to ride on the outer race of the bearing. The assembly consists of the bearing, a washer, the spring, and a second washer.
