## Brief History of Restoring the Hendrick Martin House:

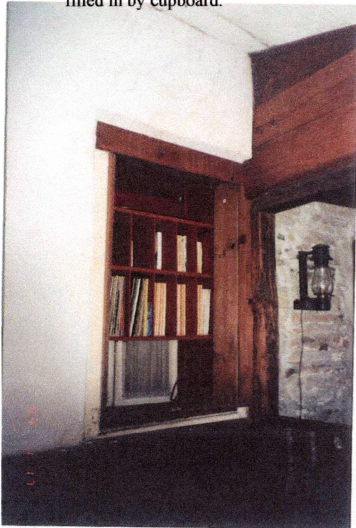
Before 2000: Dado and stucco cover stone. Window filled in by cupboard.

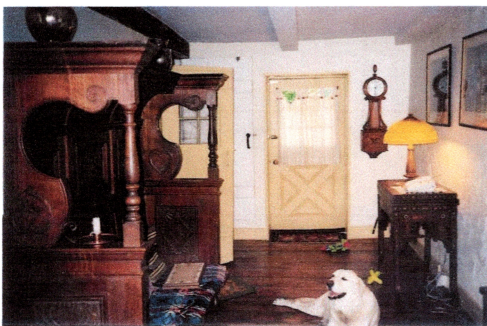
## ***Hall***

Stone wall on right bounds the earliest house. Original plaster  
Lathe and plaster ceiling collapsed and was then removed to expose original ceiling.

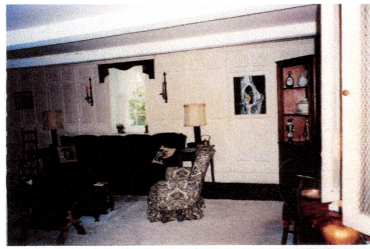
Living room before 2000 restoration. Note wall panels of Sear's doors and black painted floor. Note that panels narrow the window. Beams are covered with layers of paint.

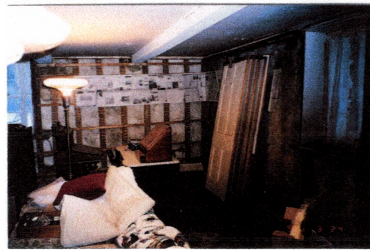
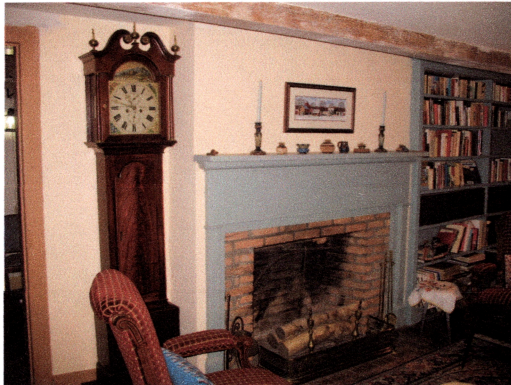
During 2000 restoration. False panels removed. Heavy framing revealed. Original plastered stone seen between studs.

Modern panels and very heavy framing were removed as well as Victorian lathe and plaster walls. The two external original walls were left intact and an interior shell was built of light framing, wire mesh, solid insulation and layered plaster.

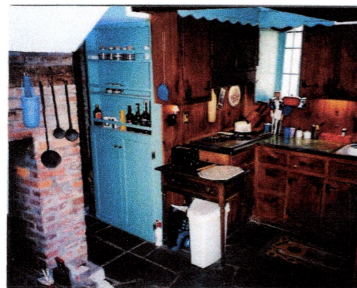
Kitchen before 2000 restoration.

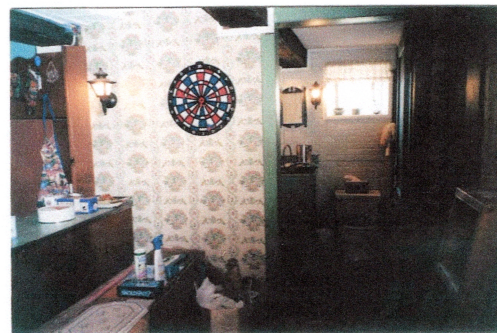
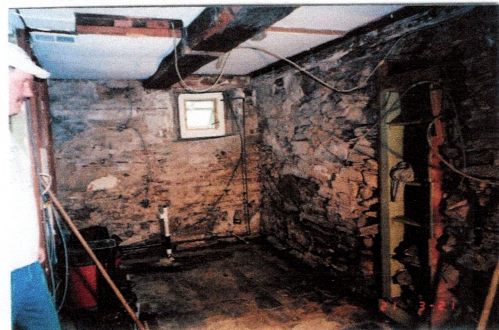
Kitchen during 2000 restoration. Plaster removed to allow stone wall to be re-pointed and stabilized. Original framing of window exposed and left intact.
