**Historic Landscape Observation and Investigation Report  
For the Historic Charleston Foundation**

**The Charles Magwood House, ca. 1824-1825  
61-63 Smith Street, Harleston Village  
Charleston, South Carolina**

**March 17, 2008**

## Historic Landscape Observation and Investigation Report 61-63 Smith Street, Harleston Village Charleston, South Carolina

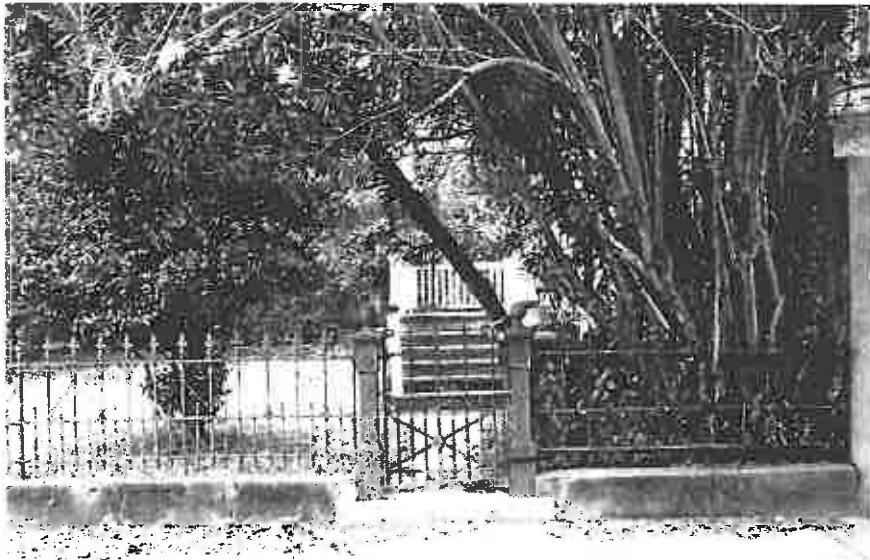
Entry on Smith Street, cast-iron posts and wrought iron gate and fence with masonry coping wall

The iron fencing along Smith Street should be properly repaired, primed, and painted for preservation of this feature. Other wire and wood fencing on-site is not noteworthy and is not suggested for retainiage.

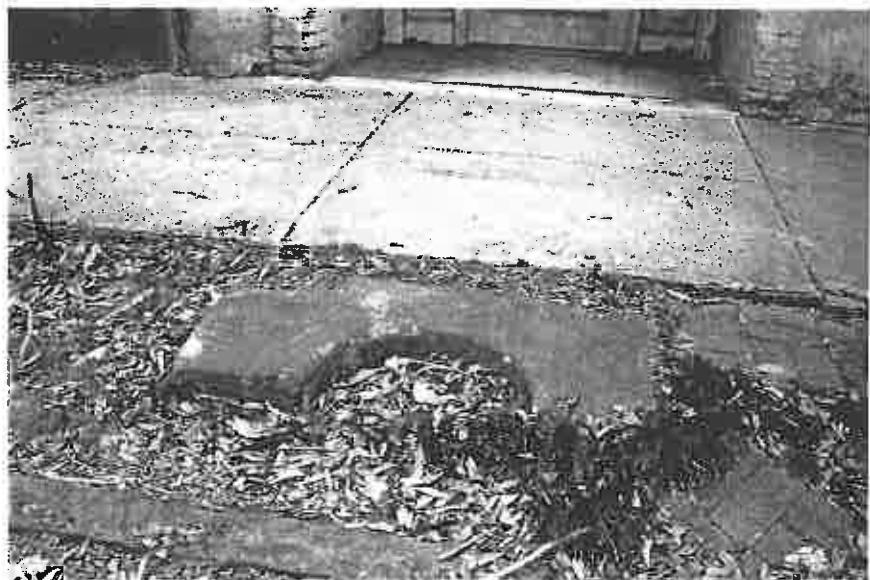
Brownstone step at Smith Street curb, doorway beyond

All stone and brick on site should be collected, inventoried, palleted and stored for use on the property at a later date. Additional pieces from those currently visible will most likely be found during the presumed restoration of the structure. The particularly nice carved brownstone carriage step at the street should also be stored for safe keeping and should be reset in place after restoration of the structure.

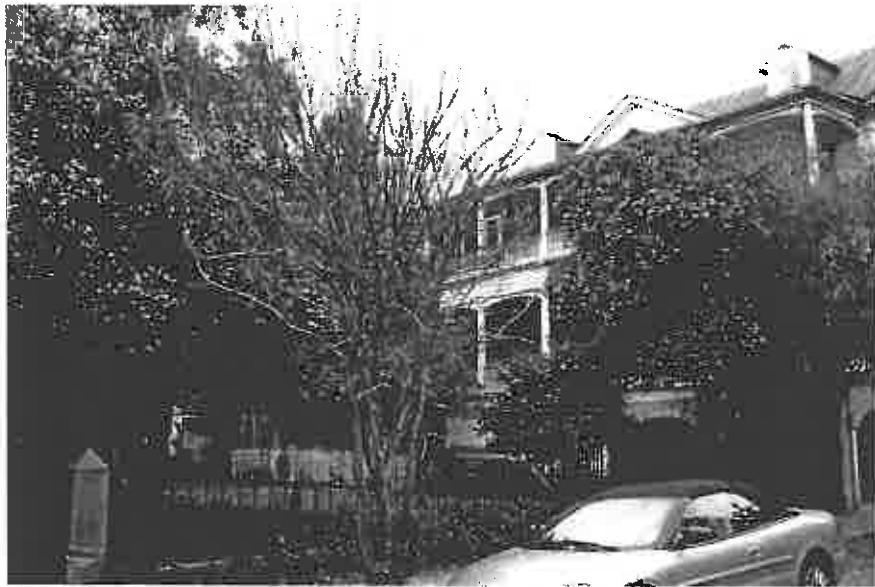
Garden and house from Smith Street, looking north-west

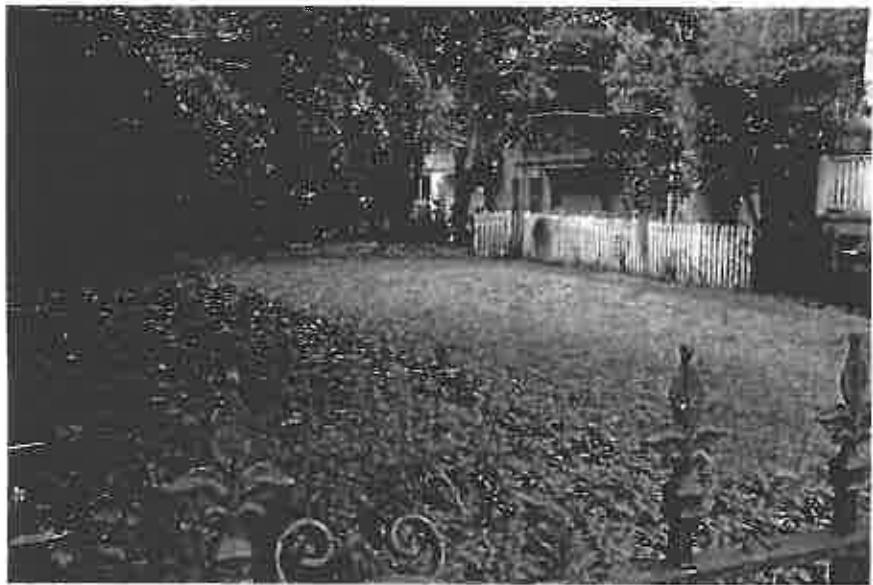
Garden space and deteriorated iron fence (cast finials) looking north-west from Smith Street sidewalk

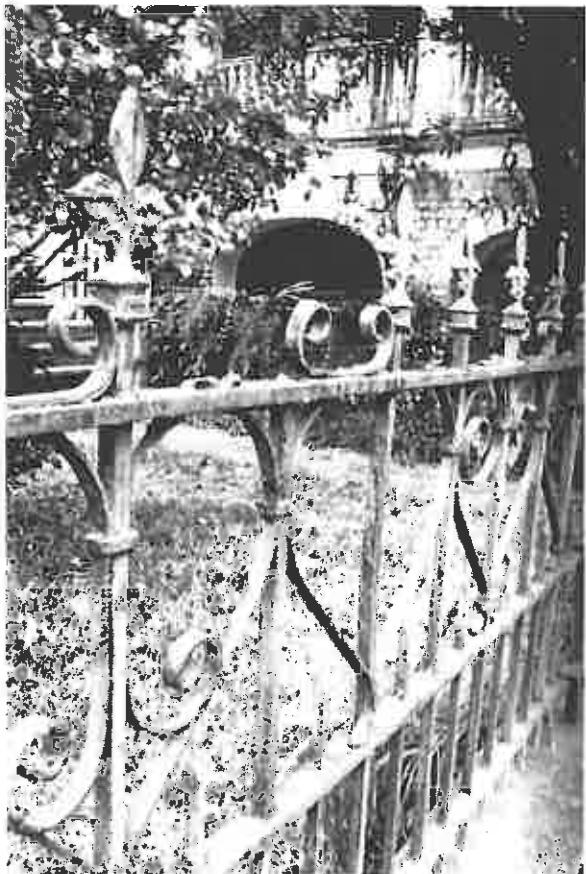
Deteriorated fencing looking north-west from Smith Street sidewalk

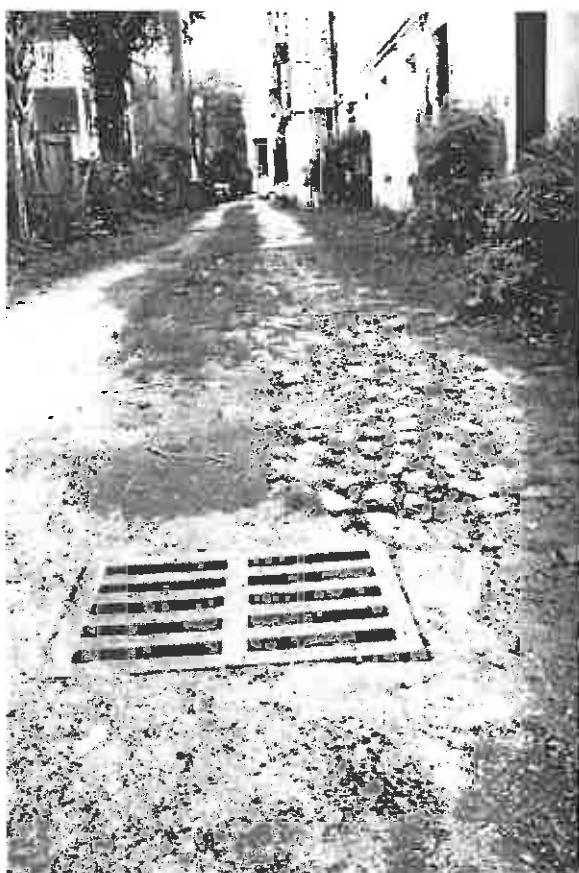
The property does have city storm drains on-site, most likely draining to the Smith Street storm sewers. Drains exist on the north, west, and south sides of the structure.

City storm drain on northwest corner of kitchen house, looking east down driveway

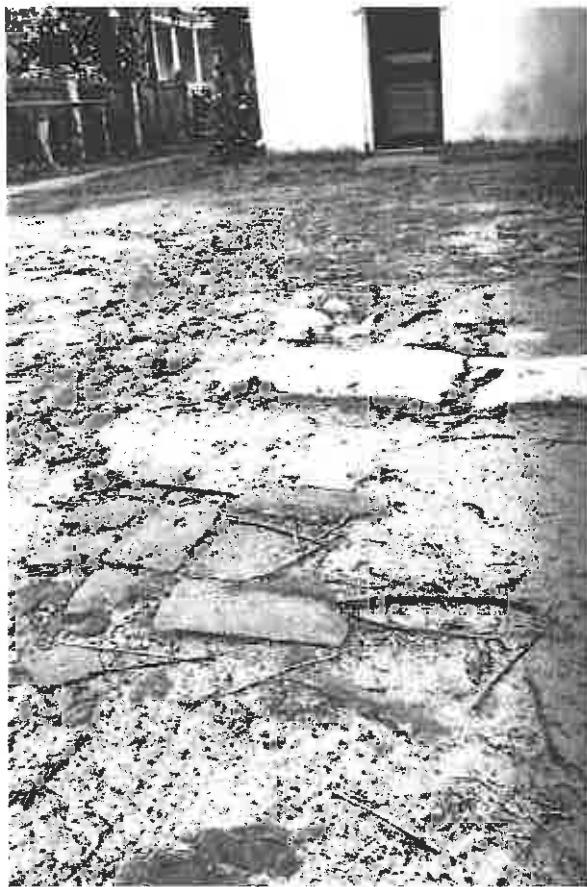
Any obvious evidence of a working garden or work yard from single-family era have not been found. There is a small amount of bluestone, granite, English brick, and river stone or ballast stone around the property. The front (east) of the property is contained front the street and sidewalk by a neglected cast-iron fence and gate.

Brick and stone on site, behind kitchen house

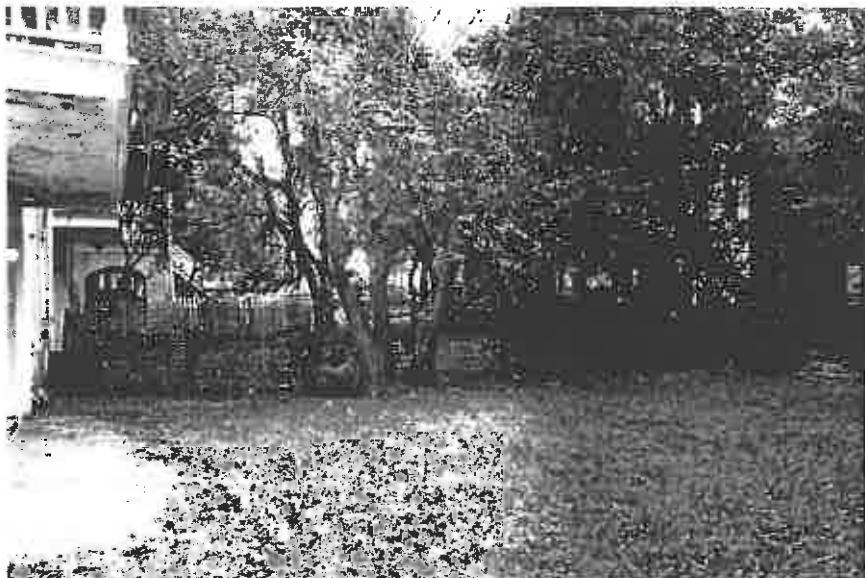
Existing fence lines and vegetation, looking east (toward Smith Street) from back of property
