The Charleston Earthquake Tour

A Walk, Through History

August 31, 1886 and Today

This brochure was created by the Advanced GIS students at the
College of Charleston.

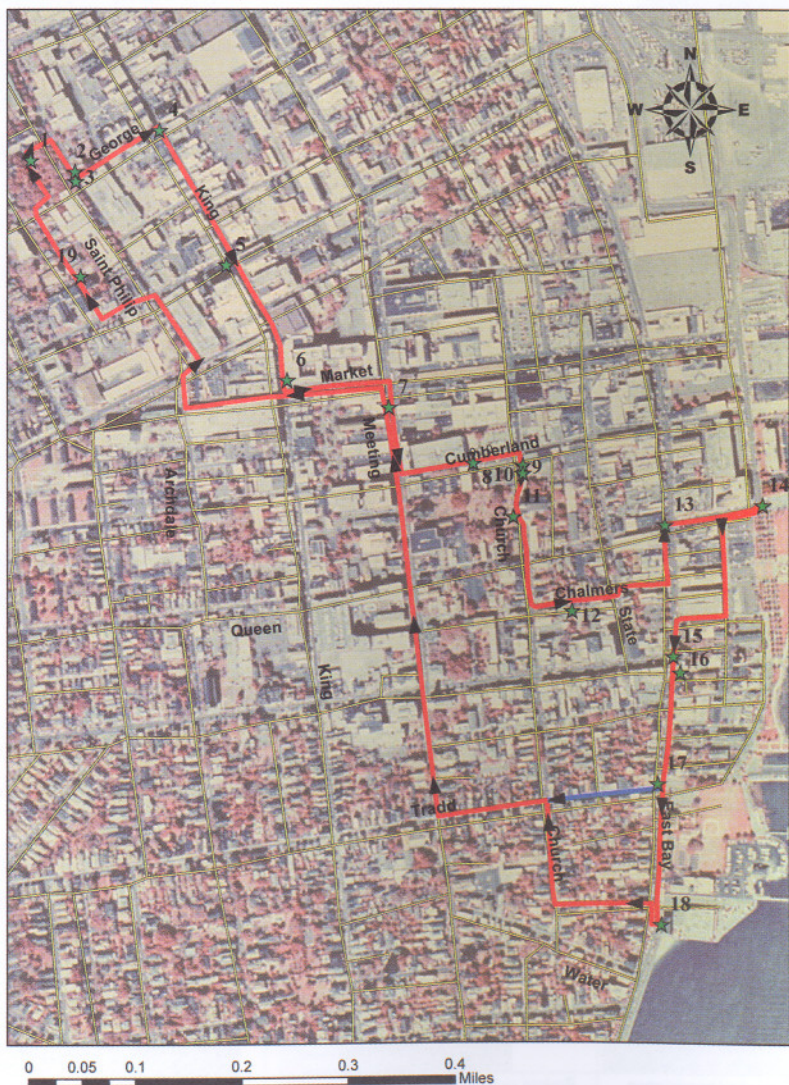
This walk will take you through some of the worst hit areas in Downtown Charleston.

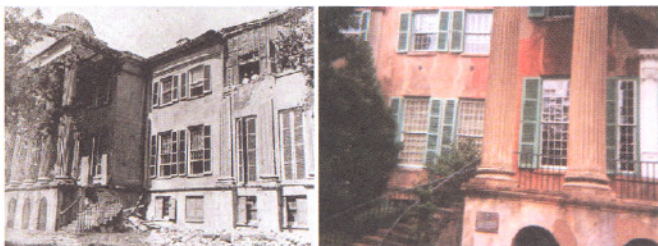
Stop 1. Start off in front of **Randolph Hall** on the College of Charleston campus. Construction was completed in 1829. There are many things to notice on this building: a) the large vertical cracks between windows that are structurally weaker than the rest of the building; b) the color and change of the roofline; c) the steps had collapsed and have been rebuilt; d) the windows are also not in line with one another due to settling after the earthquake; e) earthquake bolts that were used to tie the walls together; f) the new front façade.

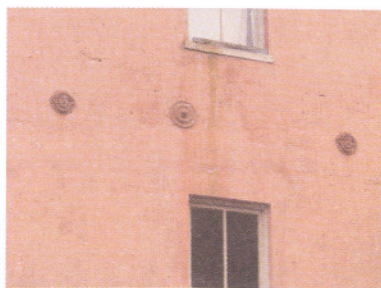
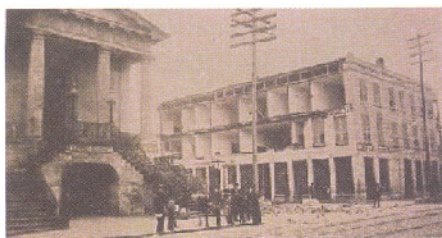
Stops 4-5. Continue down George Street and stop at the intersection with King Street. Look at the building on the southeast corner of the intersection. King Street exhibits a lot of evidence of the 1886 earthquake on most of the buildings. Earthquake bolts (in circles above and below) were installed after the 1886 earthquake to hold damaged buildings together. After their installation, they were literally screwed in little by little to bring walls back together. Turn right on King Street and continue to Wentworth Street. You will pass **327 King Street** at George Street and **273 King Street** at the corner of King and Wentworth Streets. Like most brick buildings, they exhibit the earthquake bolts (in circled areas). The bolts on 327 King Street have stylish decorative “heads” covering the bolts.

Stop 6. One block further on King Street on the left, you will see the **Charleston Place Hotel complex**. This hotel was built nearly 100 years after the earthquake and was built to code to resist earthquake damages. In fact, a seismograph (which records earthquake seismic waves) is located behind the Bell station! The seismograph is there to detect vibrations and to measure settling of the building. The Earthquake bolts seen are *decorative* bolt plates (circled) installed in order to blend the structure into its surroundings.

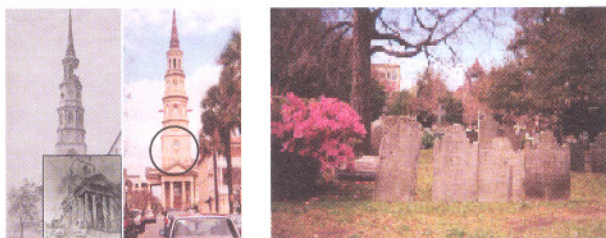
Stop 10. St. Philips Church is located at 146 Church Street. The original church was constructed 1722-23, while the present day church was constructed 1835-38. Note the large brace supporting the steeple (in circled area).

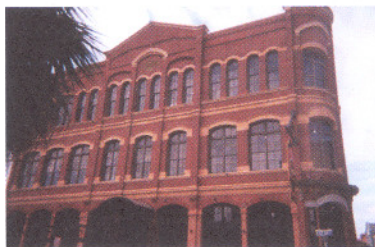
Stop 13. Continue walking across State Street and cut through the parking lot to East Bay Street. Turn left on East Bay Street and walk up to Queen Street. At this point, cross to the other side of East Bay Street. Look back at the **Wagener Building** (1880) on the corner of Queen and East Bay. Notice all the cracks in the building.

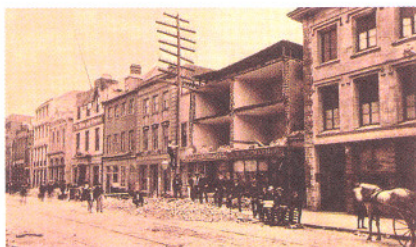
Stop 15. Walk down East Bay Street towards the Battery. From in front of the old Custom House (Old Exchange Building) on the corner of East Bay Street and Broad Street, take a look down **Broad Street**. This street had near total destruction. Note today's current street has been restored to the old look.

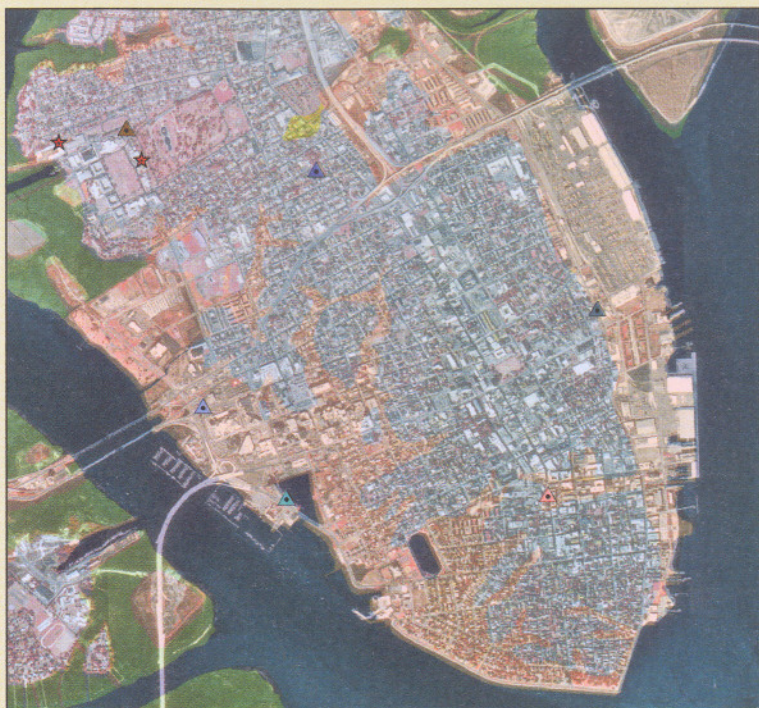
A View of Charleston Today

Aerial photograph of downtown Charleston overlain on the present day geologic map. Note that much of the present day city is built on formations labeled as “Artificial Fill” and “Marsh or Swamp Deposits”. These materials are extremely unstable under conditions of severe shaking present during a large earthquake.

If an earthquake similar to the 1886 event happened today, many problems would result in Charleston due to the large percentage of land with artificial fill and large number of historic homes. These areas, shown in this map, could experience liquefaction during an earthquake. A great deal of damage would occur in these areas. Notice where the Hospitals are located!

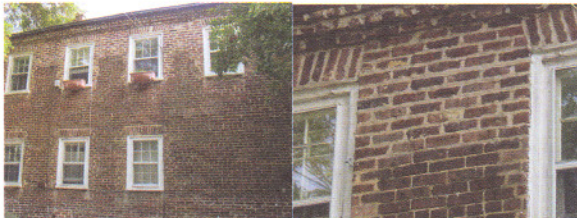
25 Bull Street shows evidence of repairs. Clearly visible is the difference between the pre-earthquake building and the repaired structure.
