Hidden Treasures: Discovering Artifacts in Rats' Nests

**Kymberly Mattern
Student Conservation Report
Conservation Science
HP810/HPSV 810
Frances Ford and Richard Marks
April 2016**

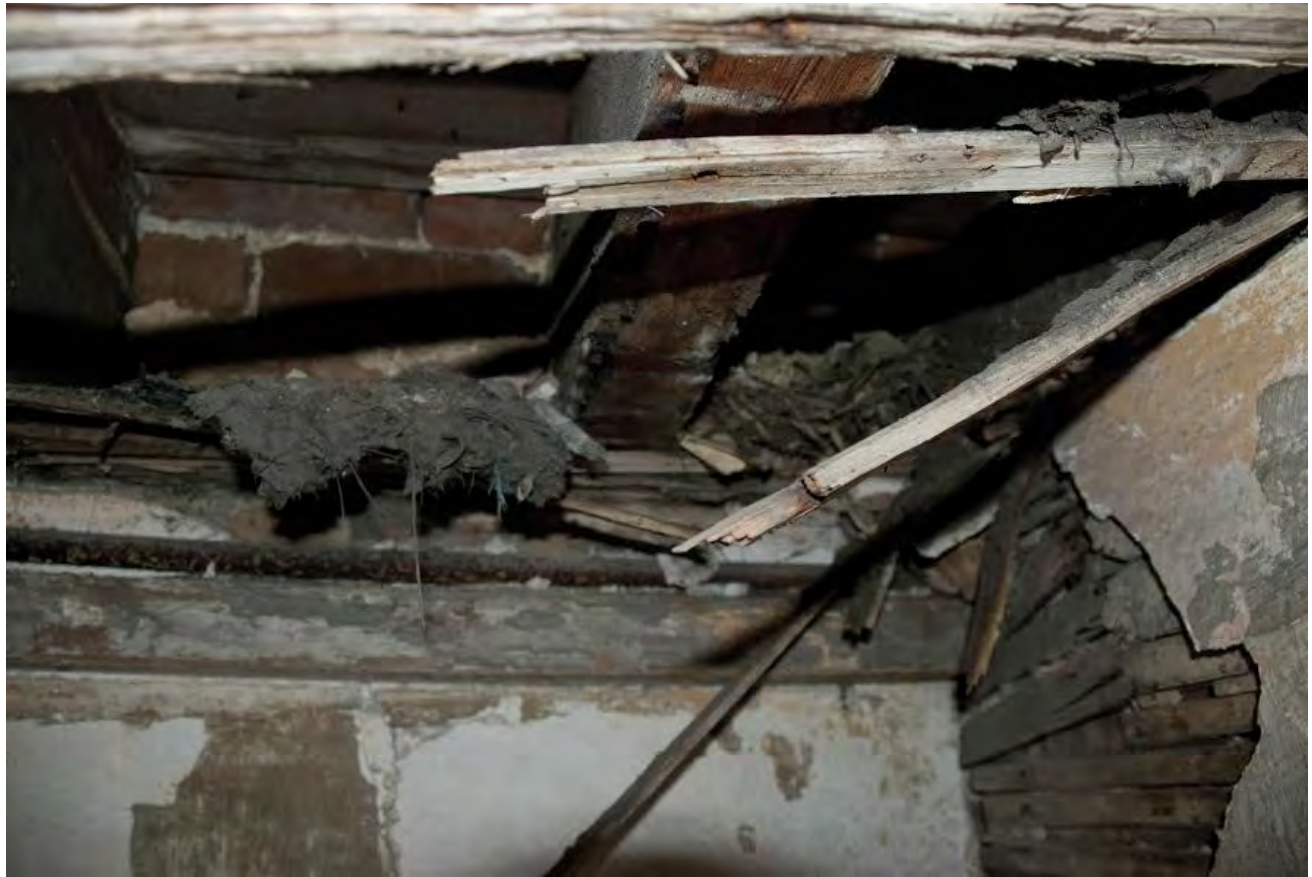
The photograph above illustrates the location of the rat's nest in the Aiken-Rhett House kitchen. Courtesy of Historic Charleston Foundation.

The rat's nest was found in the ceiling above the door to the east of the stairs in the kitchen, laundry, and slave quarters outbuilding (which is referred to as the kitchen building) at the Aiken-Rhett House in Charleston, South Carolina in 2011. Since rat's stay in a close proximity of about 100 feet to their nests, only the history of the buildings and rooms that are in close range to where the nest was discovered will be discussed.

The rat's nest was found above the lath on the ceiling in the kitchen. Some of the lath was removed from the ceiling in order to access the rat's nest. When the rat's nest was removed, it was put in a plastic container. Students and staff at Historic Charleston Foundation sifted through the nest to see what artifacts were in the nest, and pulled out artifacts that they thought were important. Some of these artifacts were put back in the plastic container. Two pieces of wooden lath were placed in a sealed plastic bag, and three pieces of textile were put in an archival folder. The rat's nest had been left untouched in the plastic container since 2011.

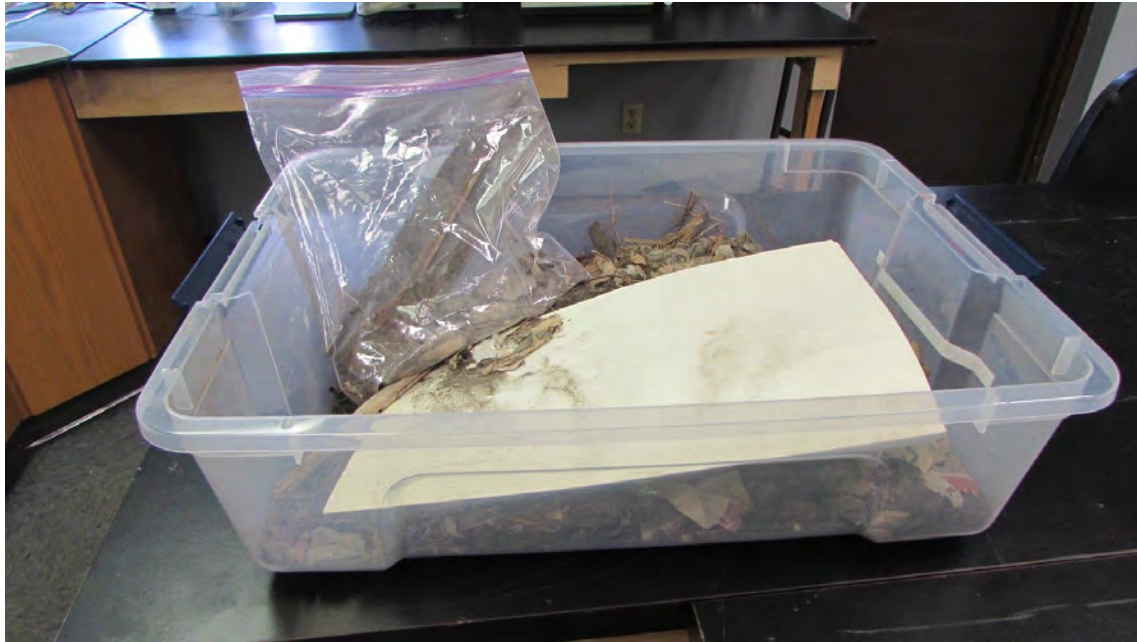
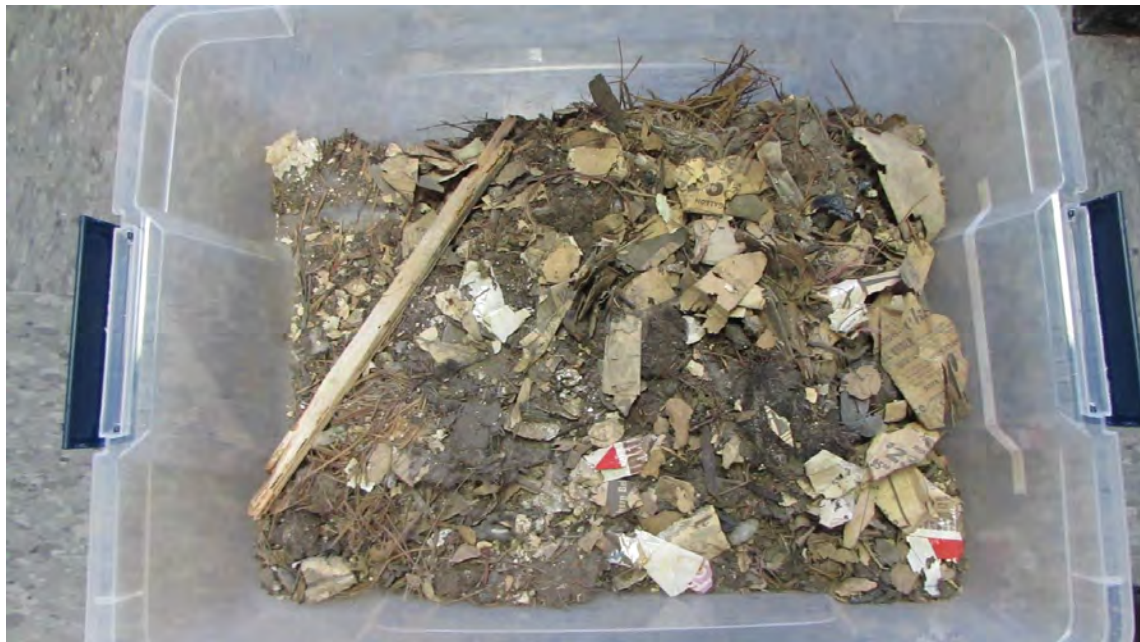
The photographs above depict the rat's nest at the beginning of the case study. Some of the objects in the rat's nest are visible in the bottom photograph.

The rat's nest contains wooden lath, pieces of textiles, slate, wood, a few pieces of brick, several pieces of plaster, plastic, paper, and miscellaneous objects such as beads and buttons.

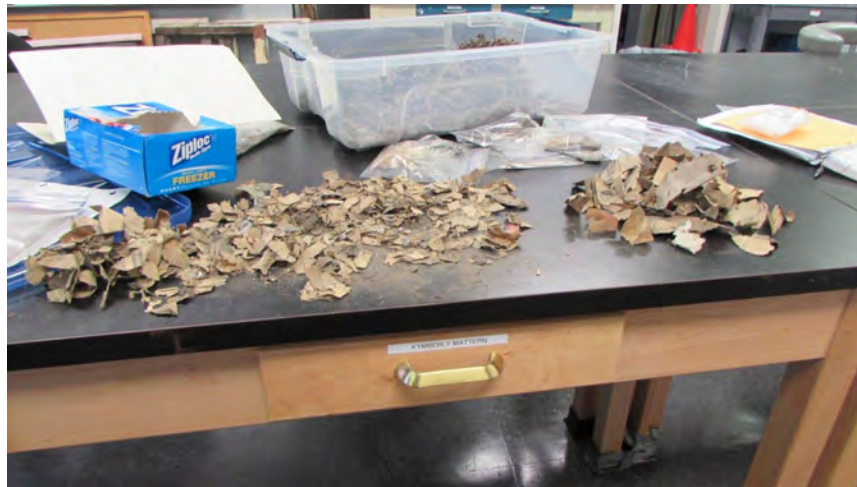
The photograph illustrates paper artifacts in the process of being sorted by hand.

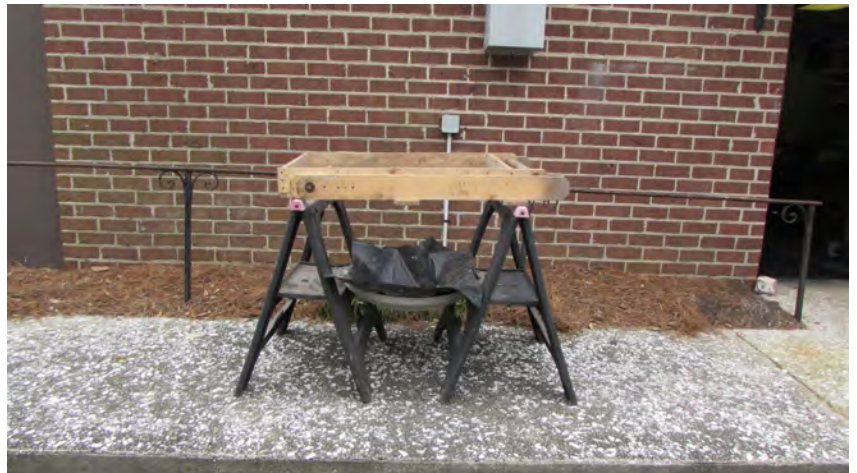
The photograph illustrates the archaeological sifting screen used in the case study.

The larger materials in the rat's nest were picked out by hand before the rat's nest was sifted using a ¼ inch archaeological sifting screen. The materials were sorted into the following groups: wooden lath, wood, slate, plaster, small pieces of plaster, textiles, landscape elements, plastic, paper, and miscellaneous. Material, size, shape, and use of the material were factors in determining the groups. The larger debris from the rat's nest that was on top of the archaeological sifting screen (after sifting) and the smaller dirt and debris that was on the bottom of the archaeological sifting screen (after sifting) were put in separate sealable plastic bags that were labeled. The dirt and debris were gently brushed off of every artifact before the artifacts were archived. Artifacts that yielded information about the building materials,

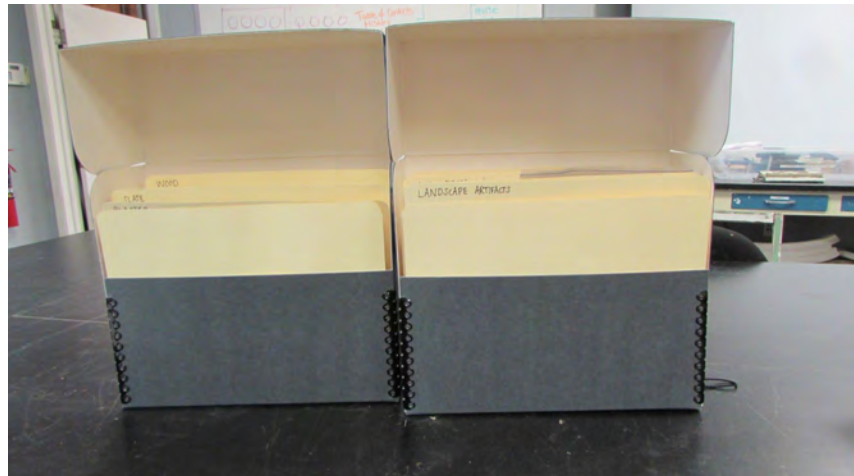
The photograph illustrates the archival boxes used in the case study.

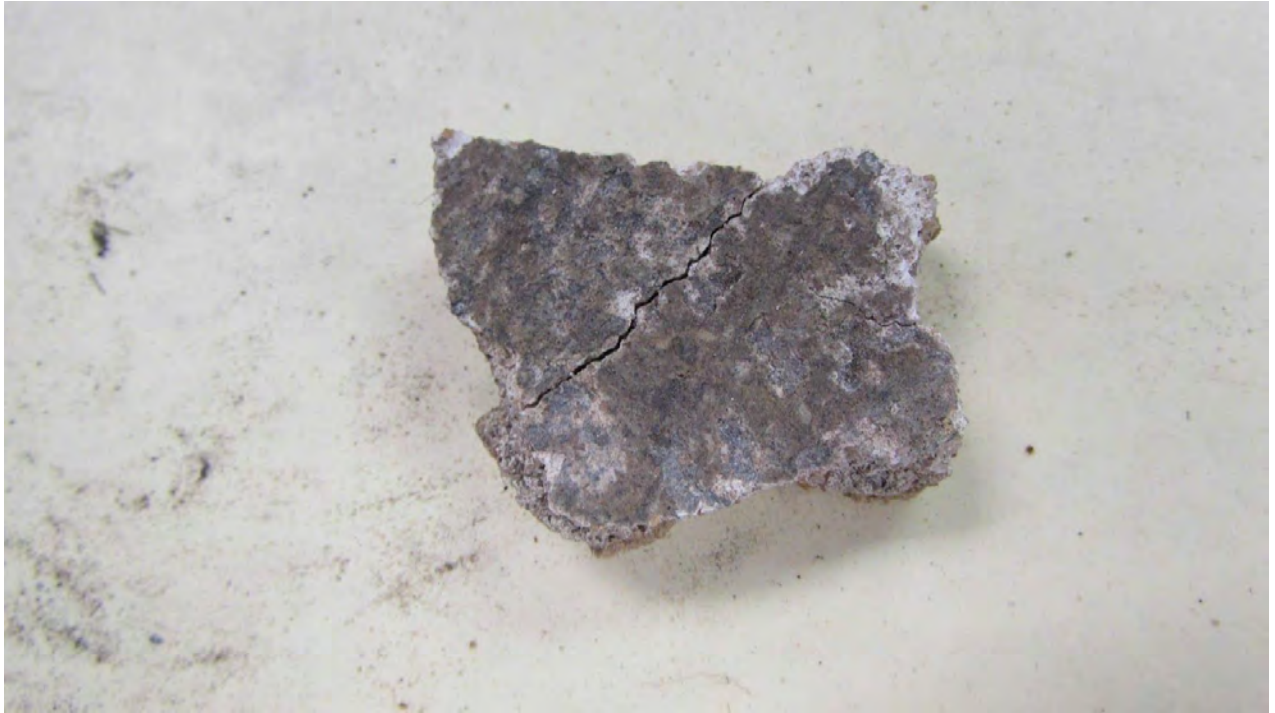
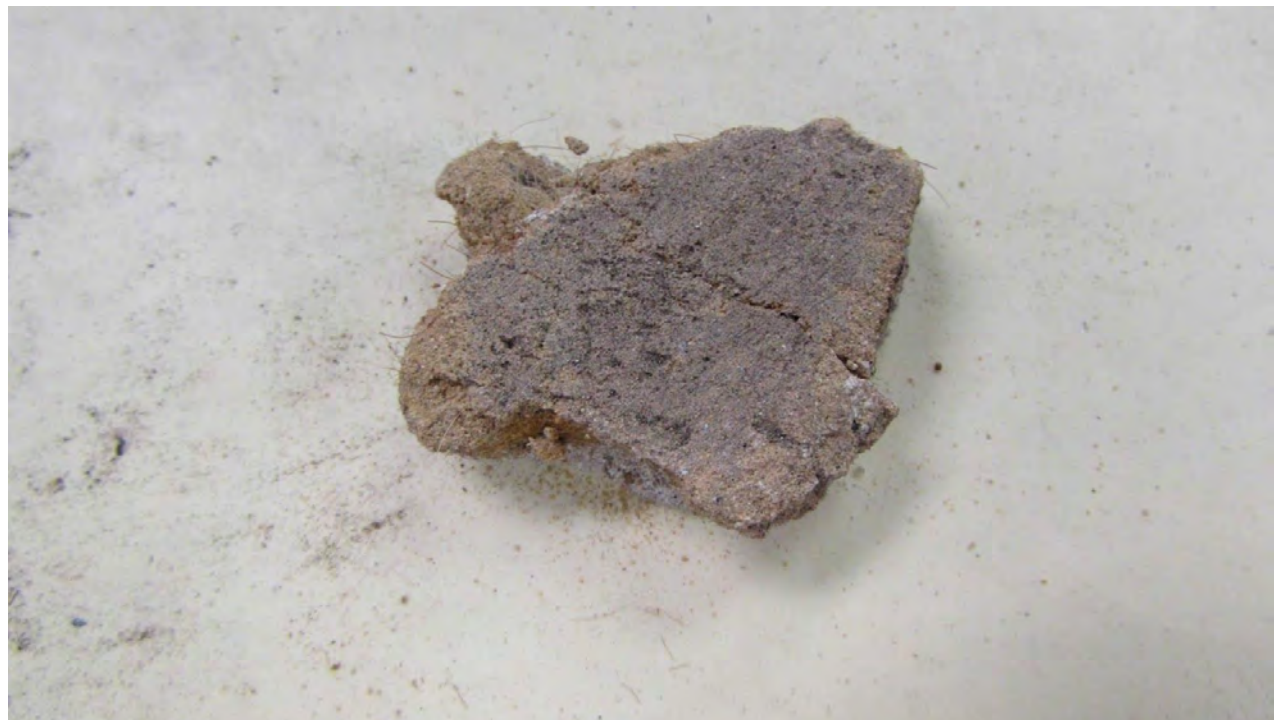
Plaster:

Notes: The plaster is cracked, and should be handled with care.

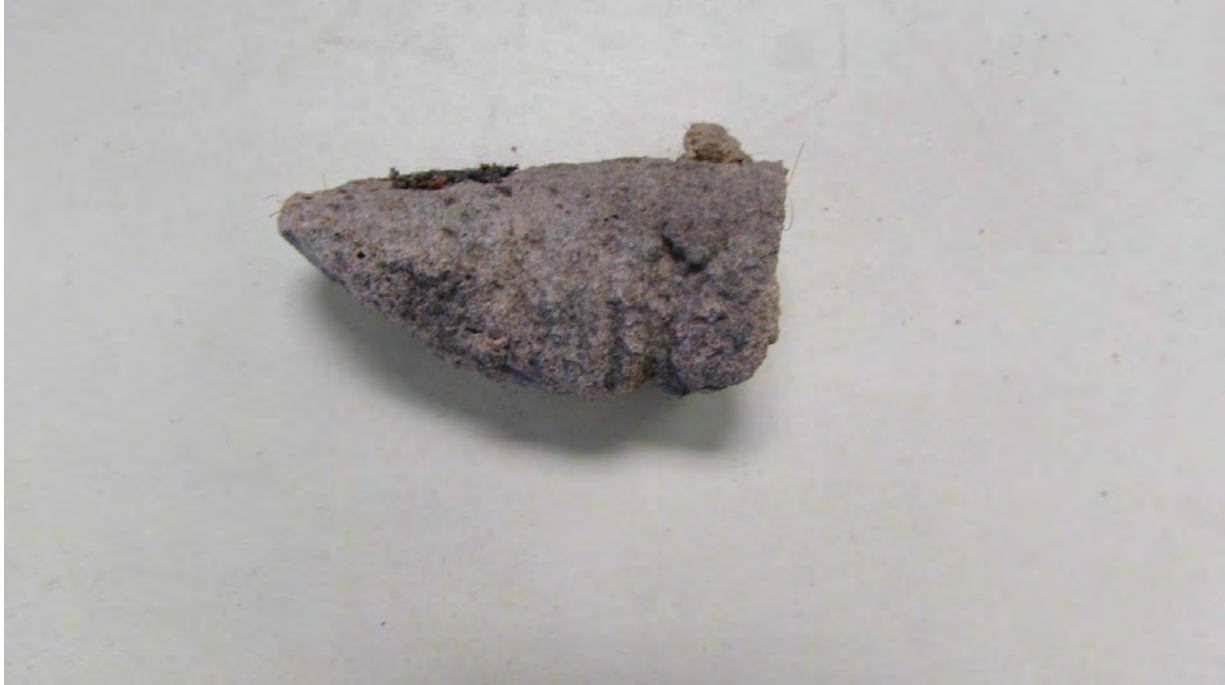
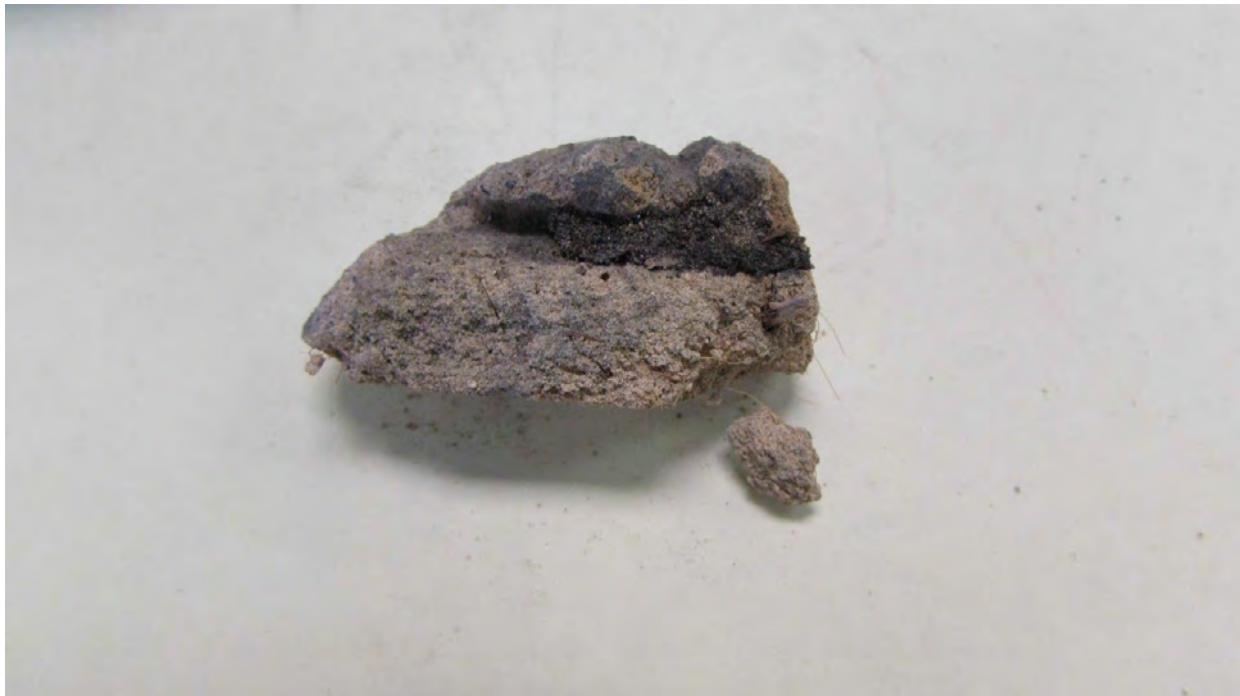
Plaster:

Notes: The plaster contains horsehair as a binder, which is visible without a microscope.

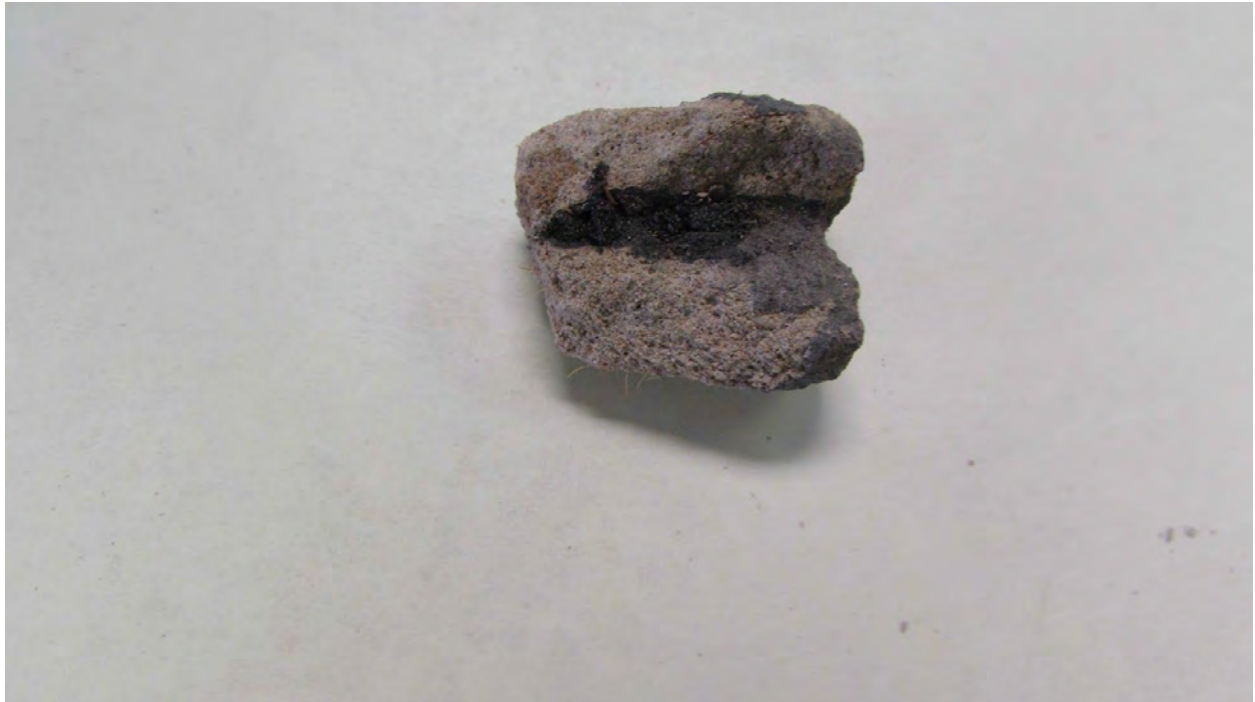
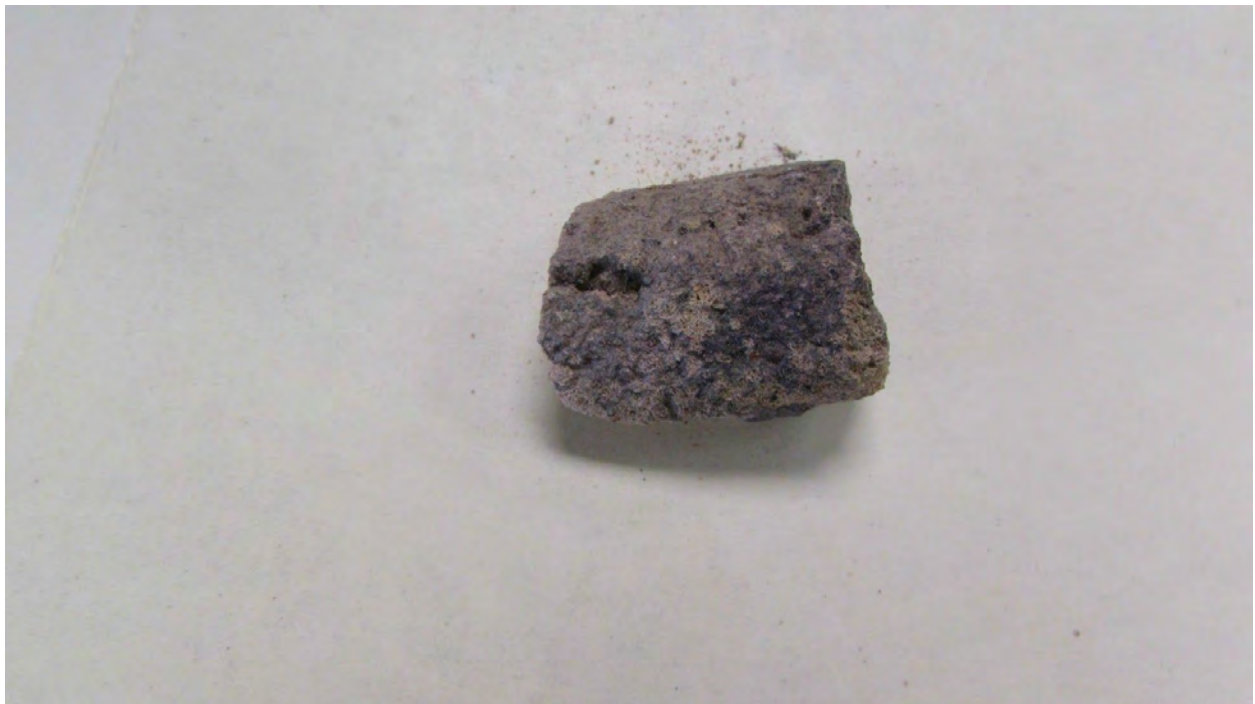
Plaster:

Notes: The plaster contains horsehair as a binder, which is visible without a microscope.

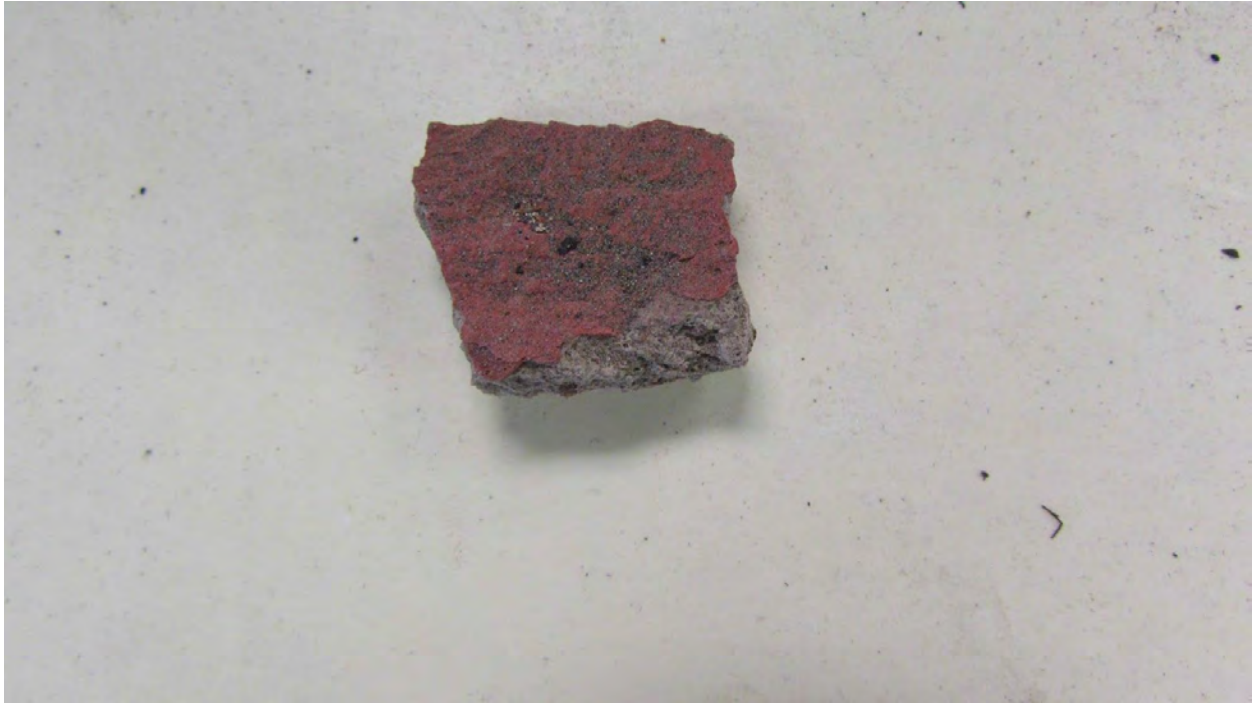
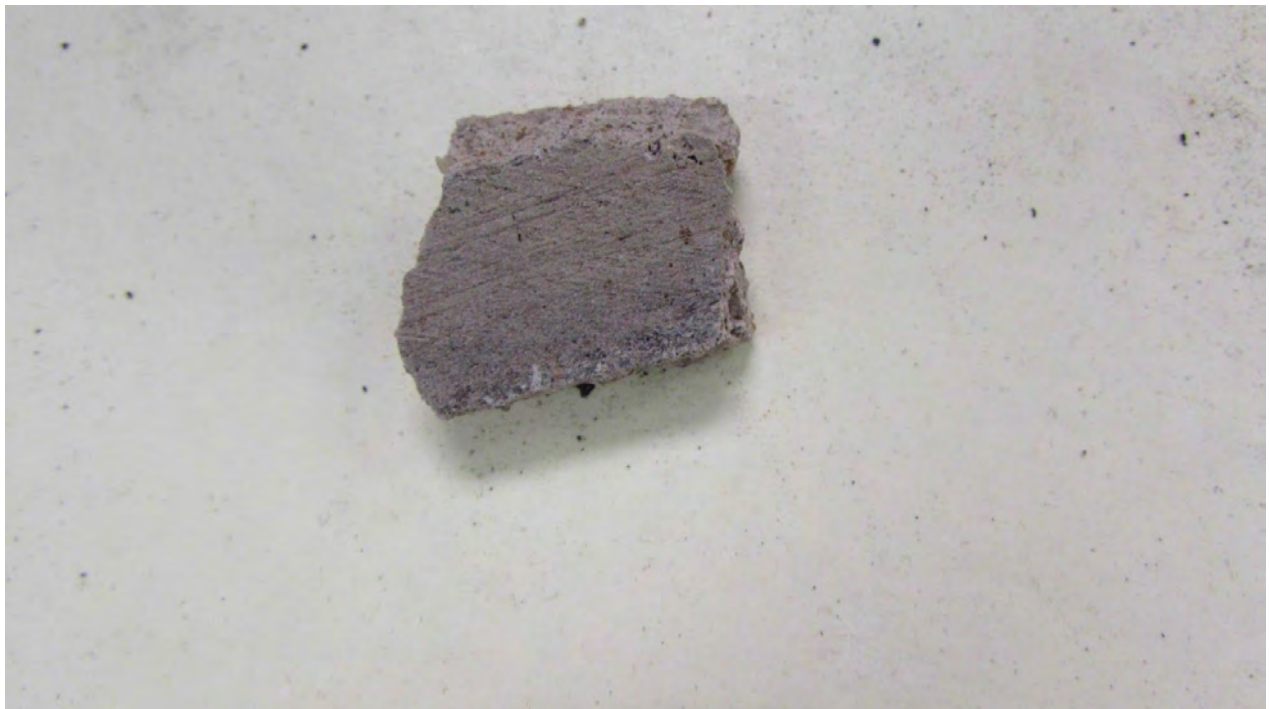
Plaster:

Notes: The plaster has been painted red.

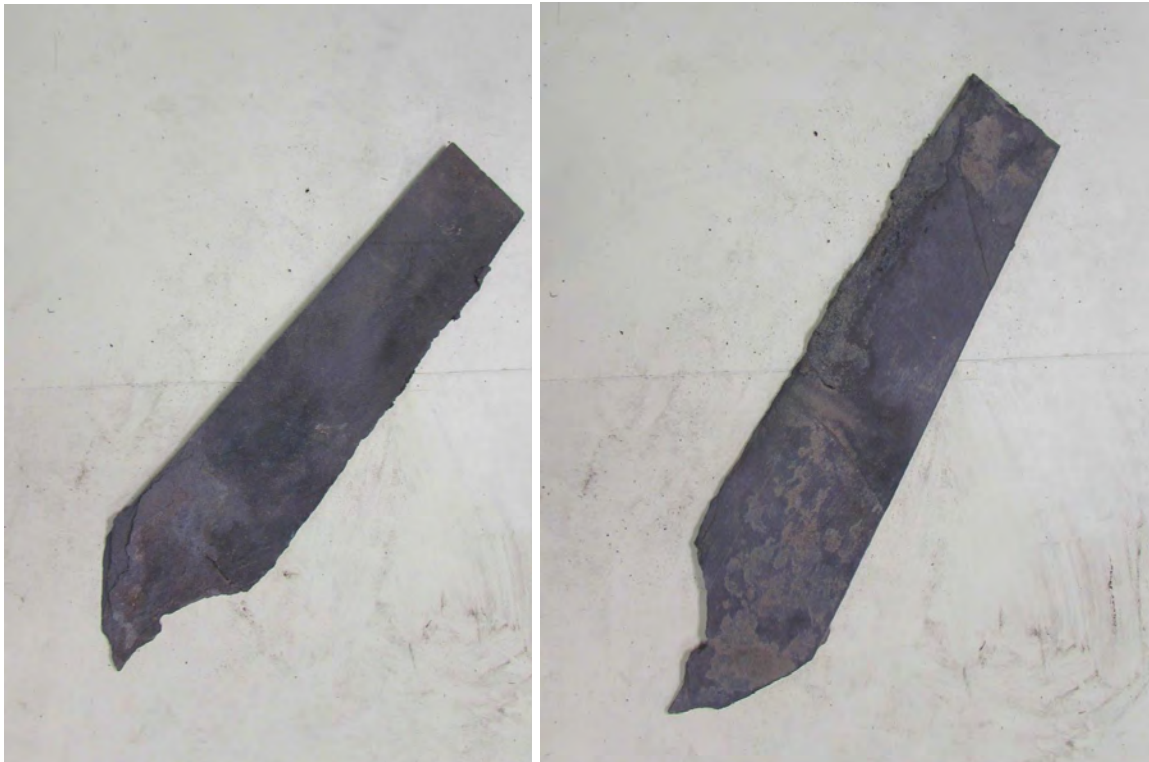
Slate:

Notes: Further testing could include a porosity test.

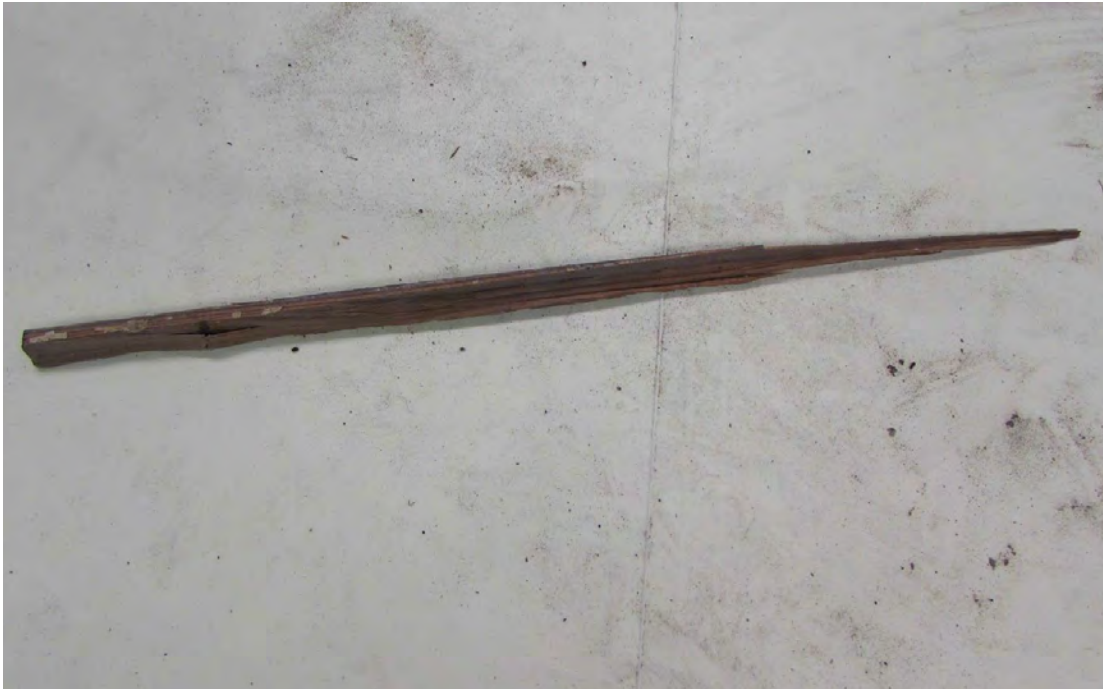
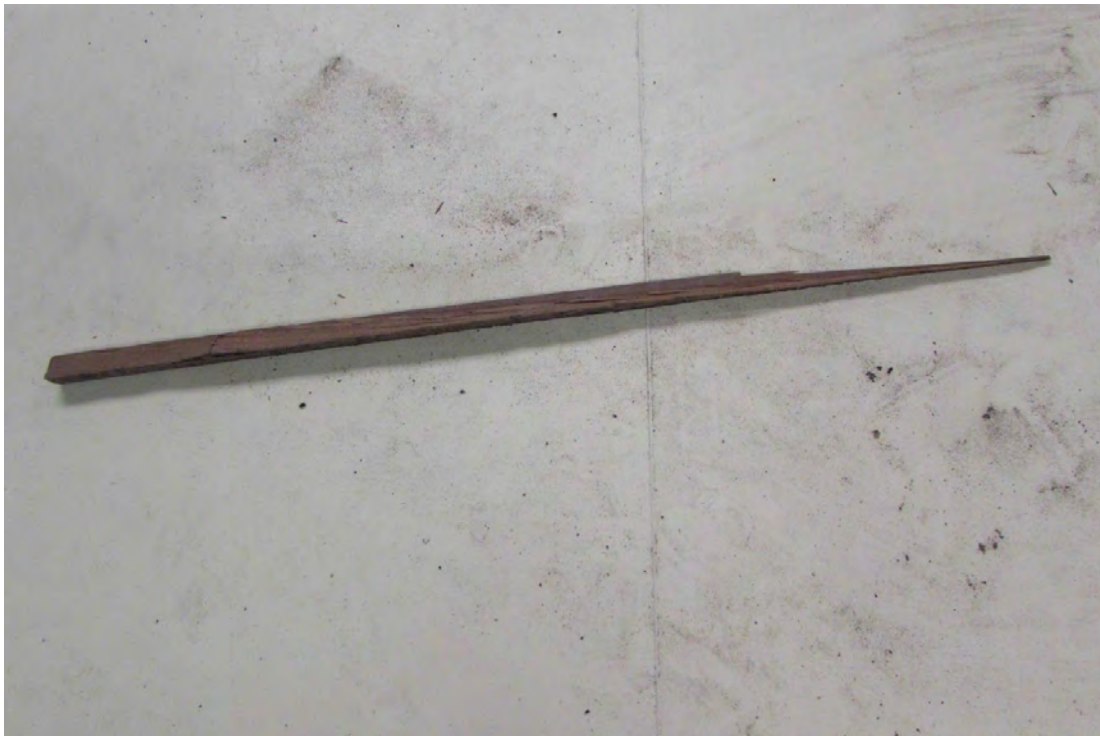
Wooden Lath:

Notes: Further testing could include wood identification, porosity testing, and wood maceration to ensure that the wooden lath matches the wood type that is in the architectural and historical records at the Aiken Rhett House.

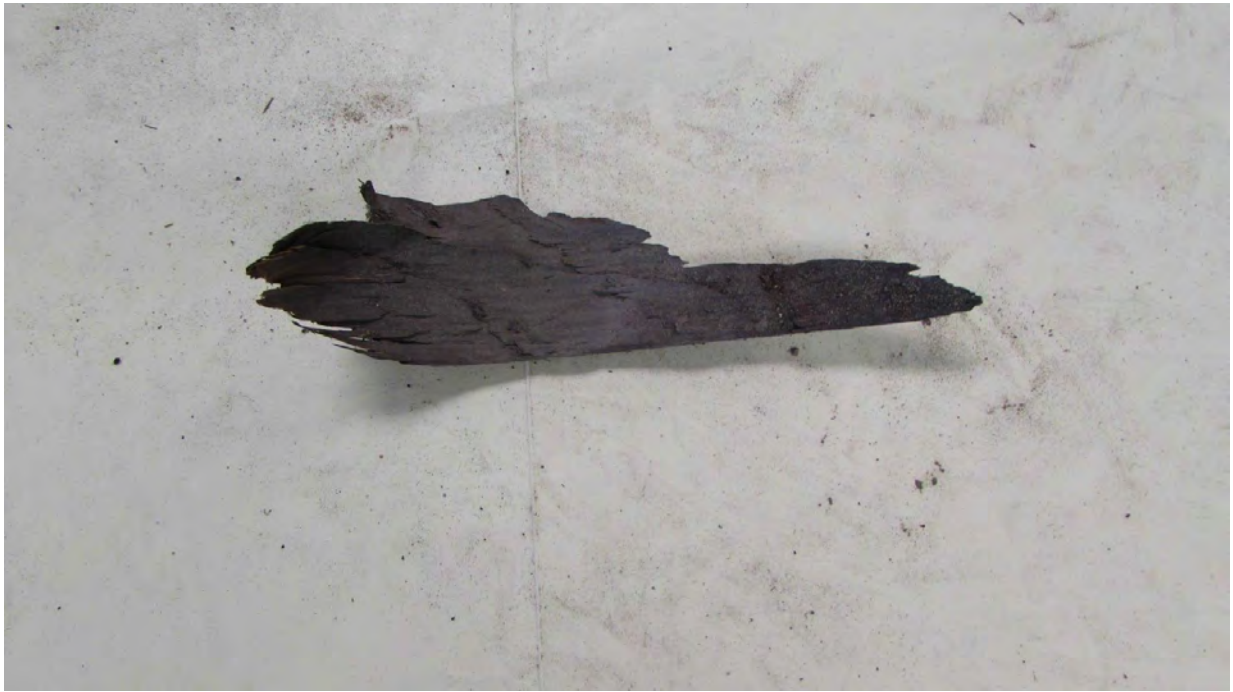
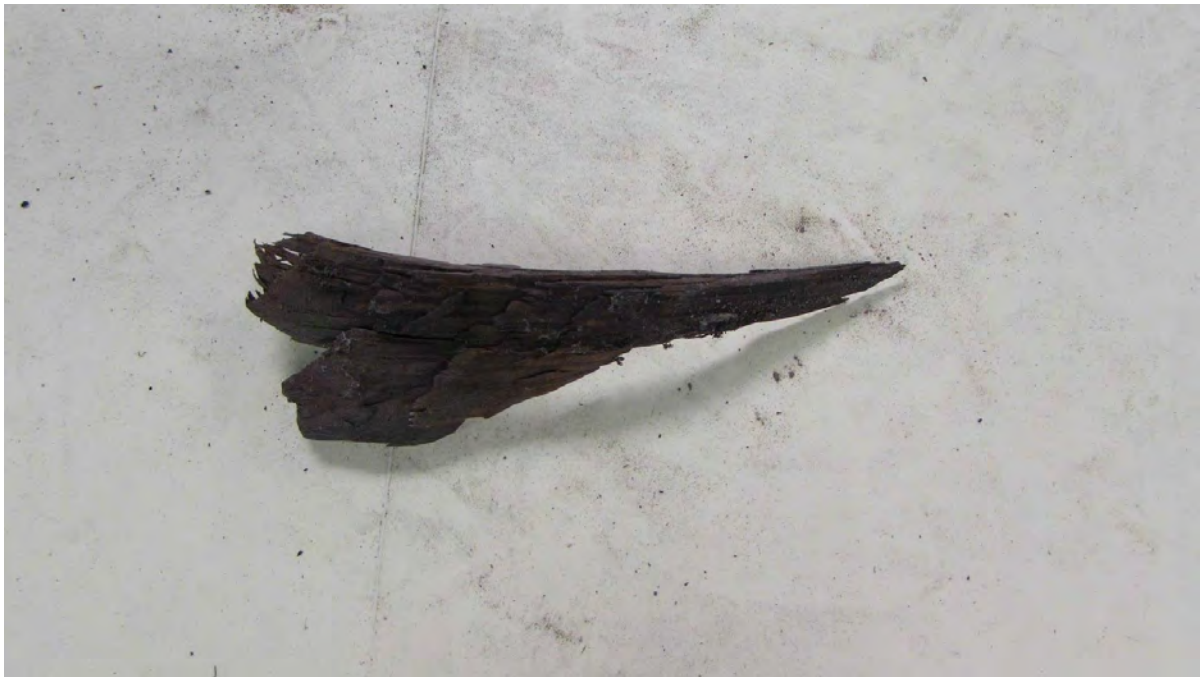
Wood:

Notes: Further testing could include wood identification, porosity testing, and wood maceration to ensure that the wood matches the wood type that is in the architectural and historical records at the Aiken Rhett House.

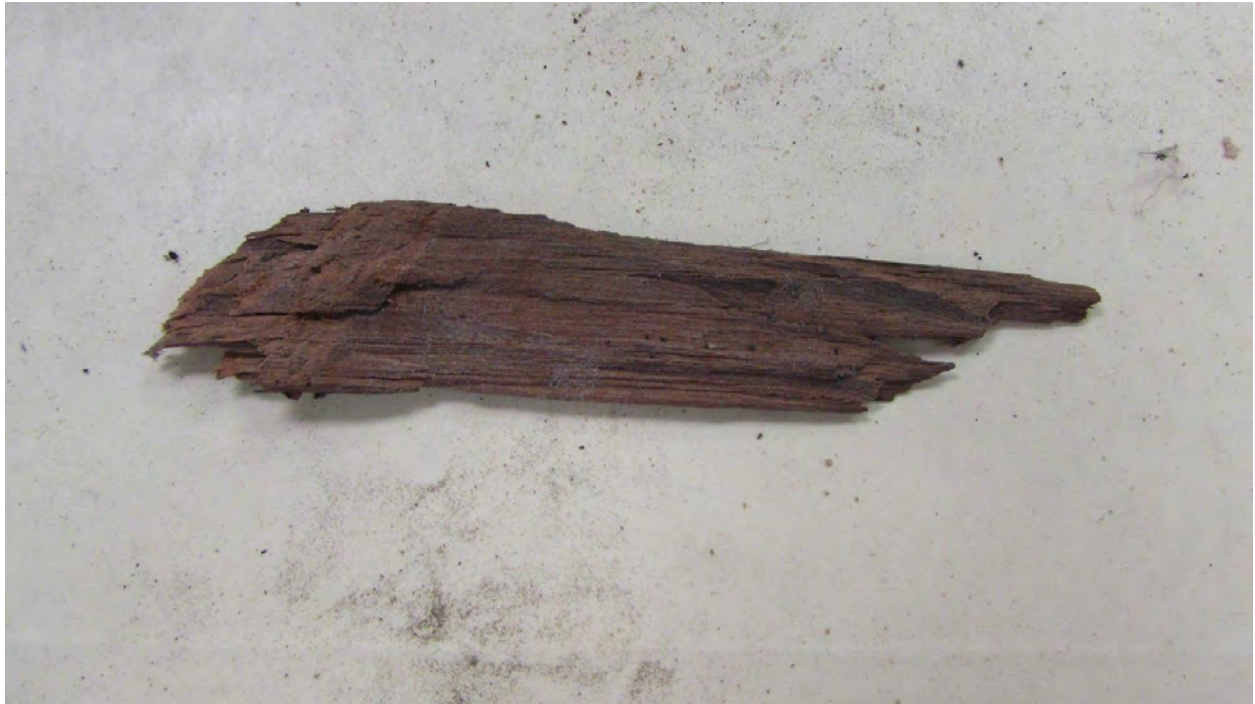
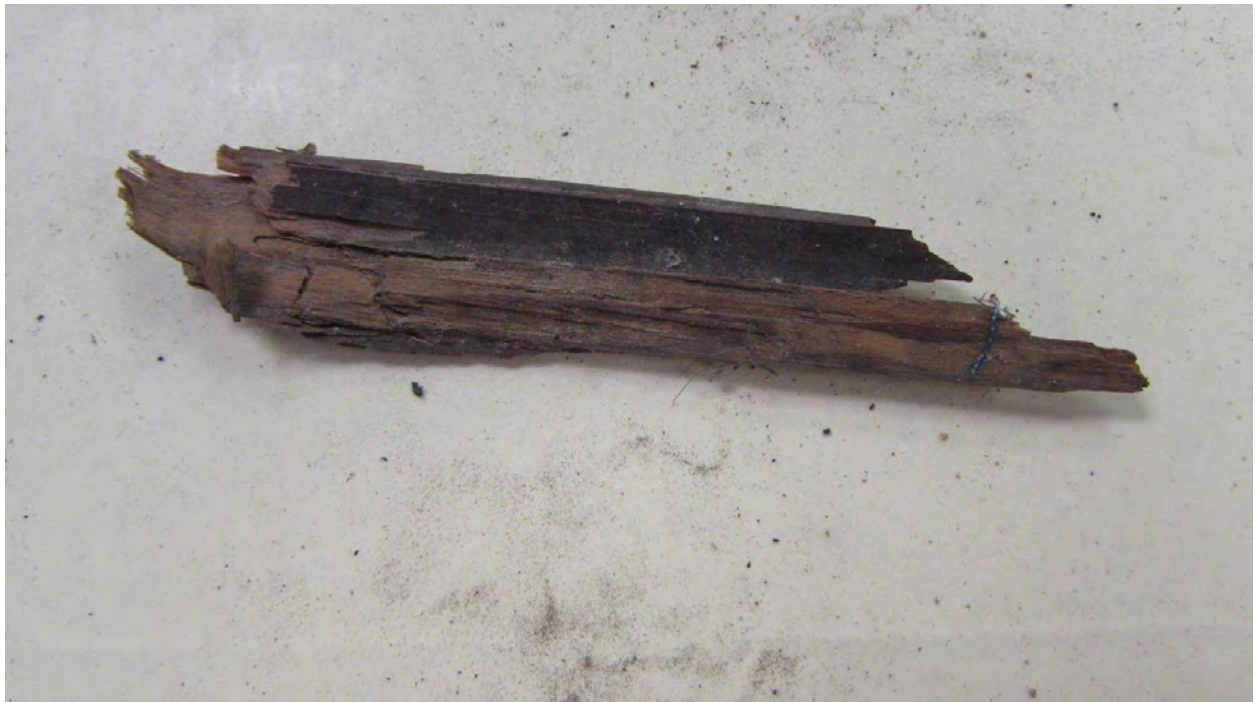
Wood:

Notes: Further testing could include wood identification, porosity testing, and wood maceration to ensure that the wood matches the wood type that is in the architectural and historical records at the Aiken Rhett House.

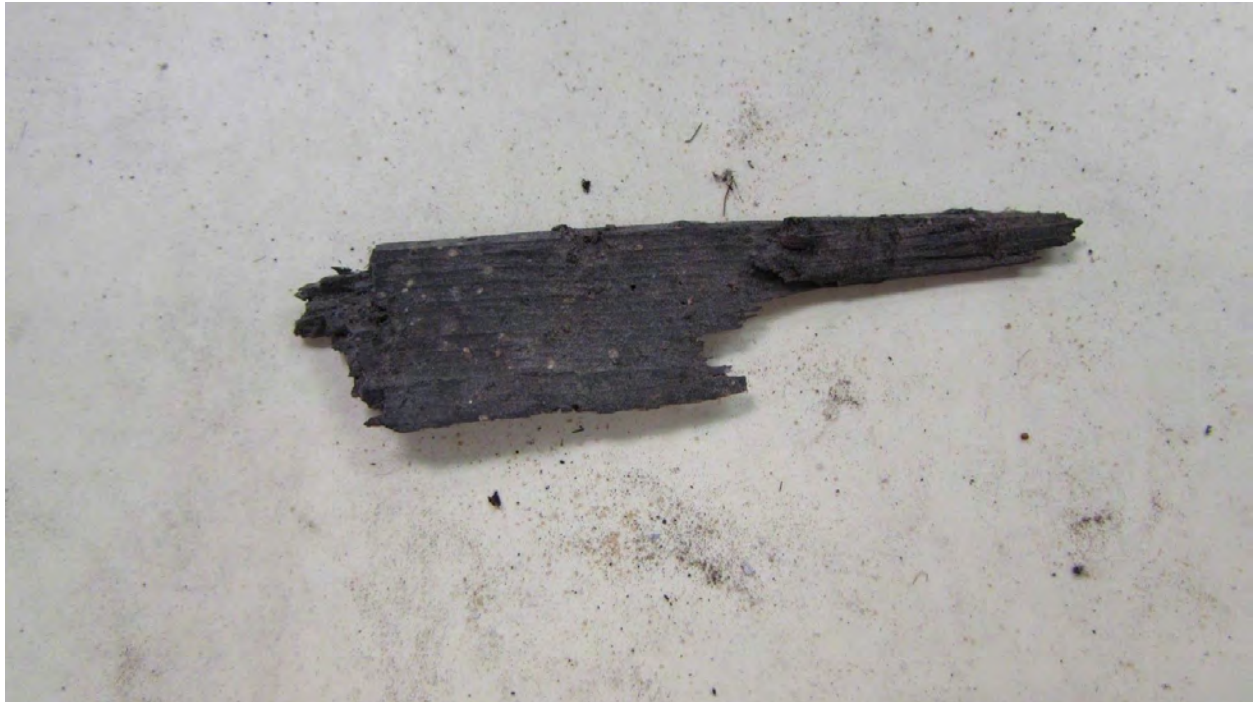
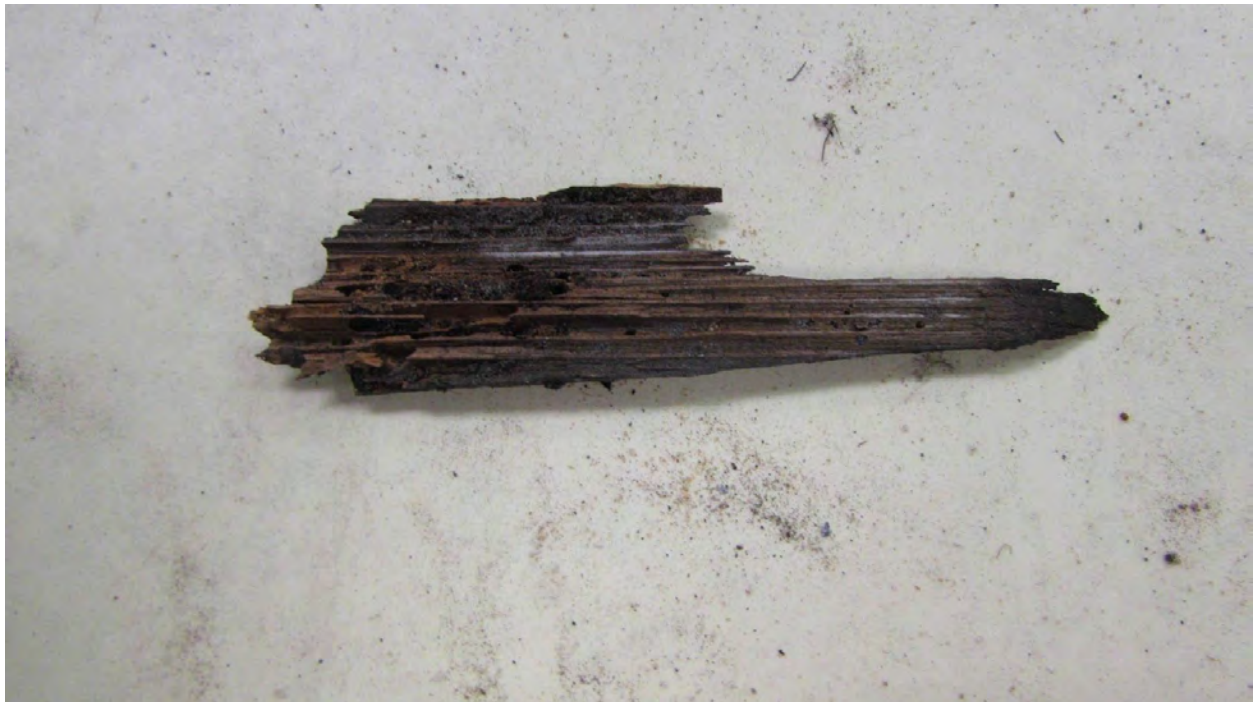
Wood:

Notes: The wood appears to have been burnt. Further testing could include wood identification, porosity testing, and wood maceration to ensure that the wood matches the wood type that is in the architectural and historical records at the Aiken Rhett House.

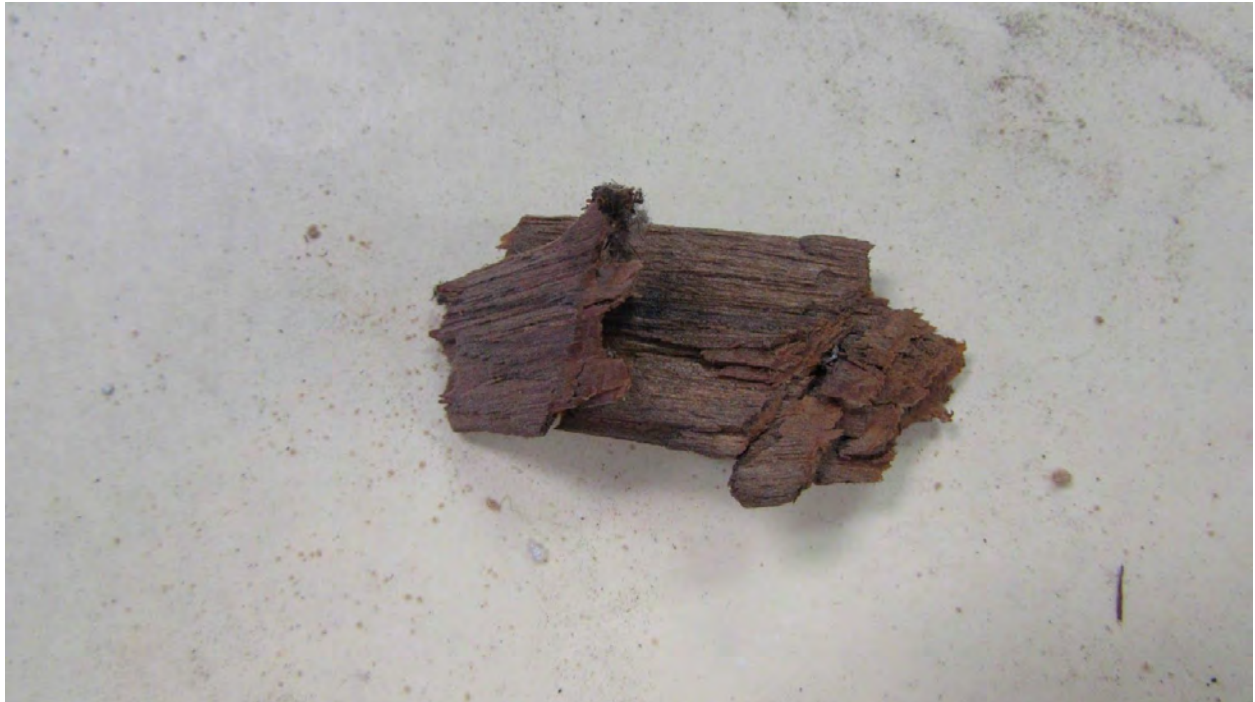
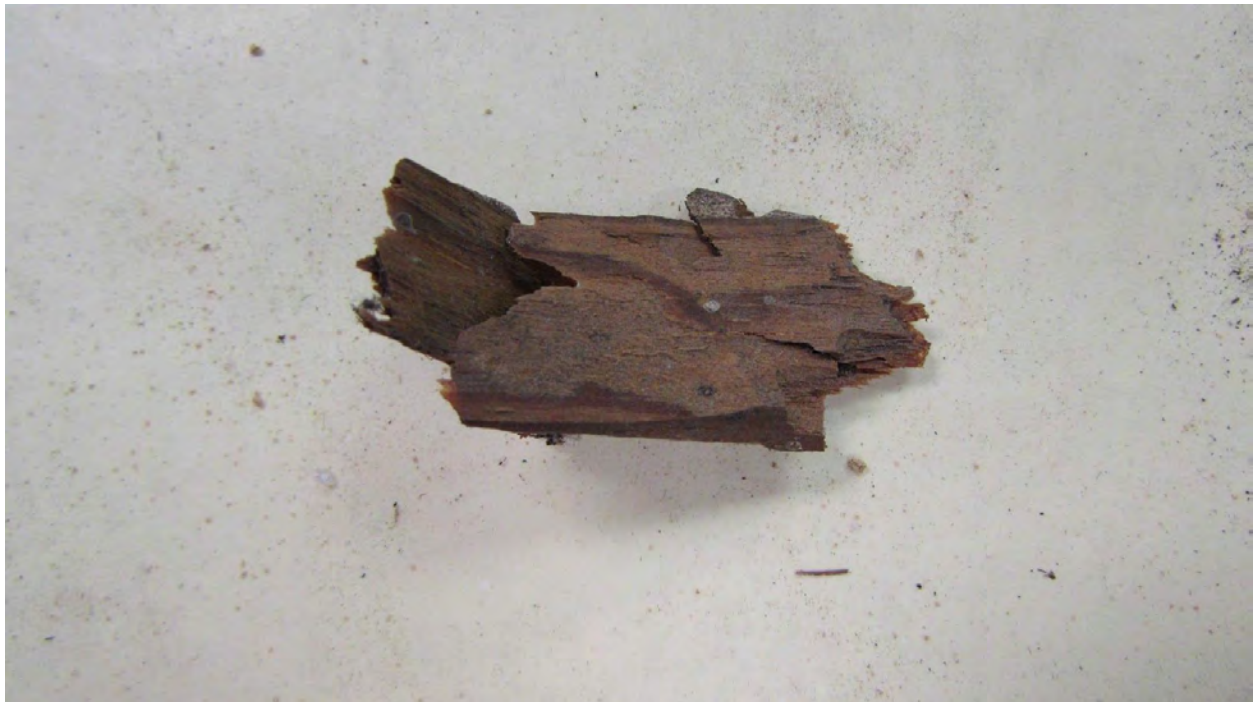
Wood:

Notes: Further testing could include wood identification, porosity testing, and wood maceration to ensure that the wood matches the wood type that is in the architectural and historical records at the Aiken Rhett House.
