Hidden Treasures: Discovering Artifacts in Rats' Nests

**Kymberly Mattern
Student Conservation Report
Conservation Science
HP810/HPSV 810
Frances Ford and Richard Marks
April 2016**

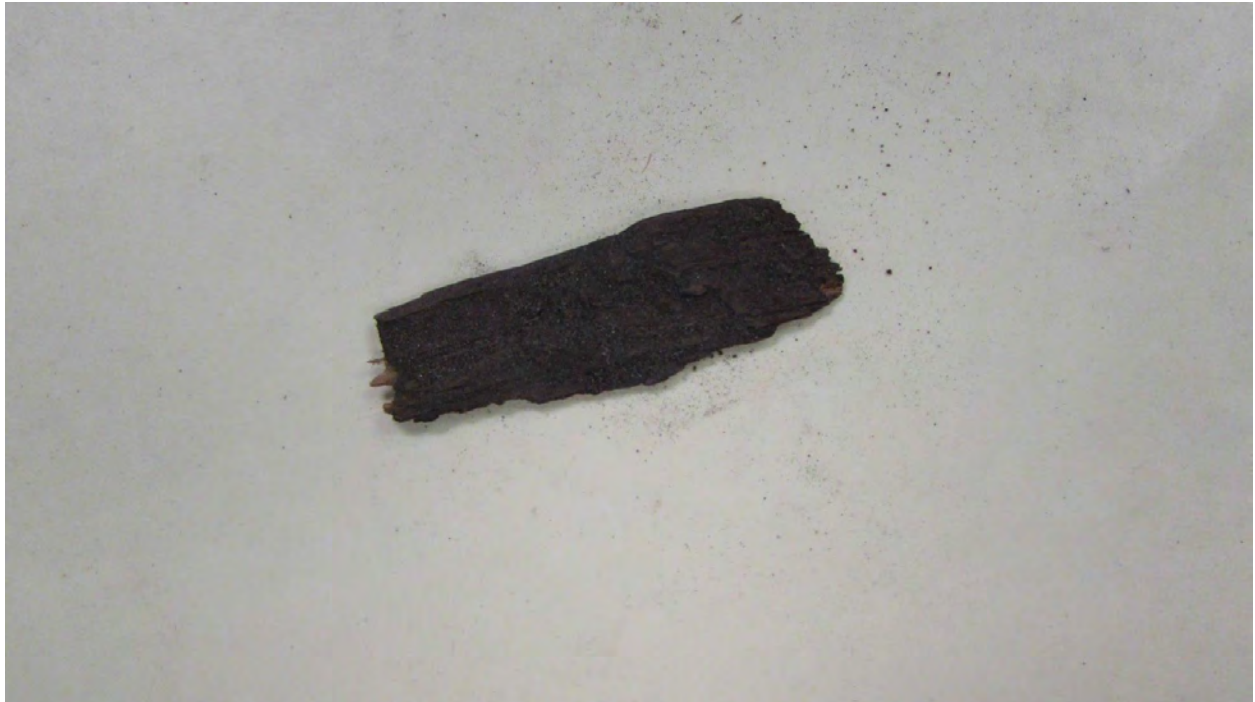
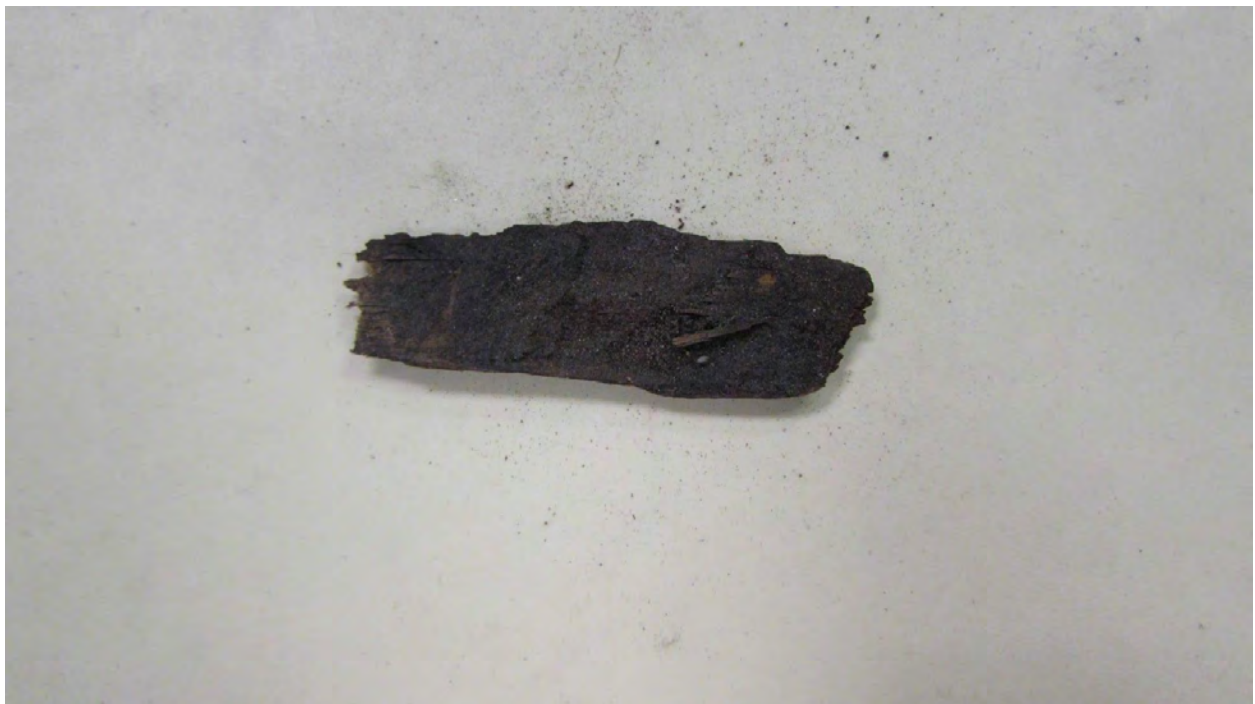
Wood:

Notes: This piece of wood appears burnt. This piece of wood could use further cleaning. Further testing could include wood identification, porosity testing, and wood maceration to ensure that the wood matches the wood type that is in the architectural and historical records at the Aiken Rhett House.

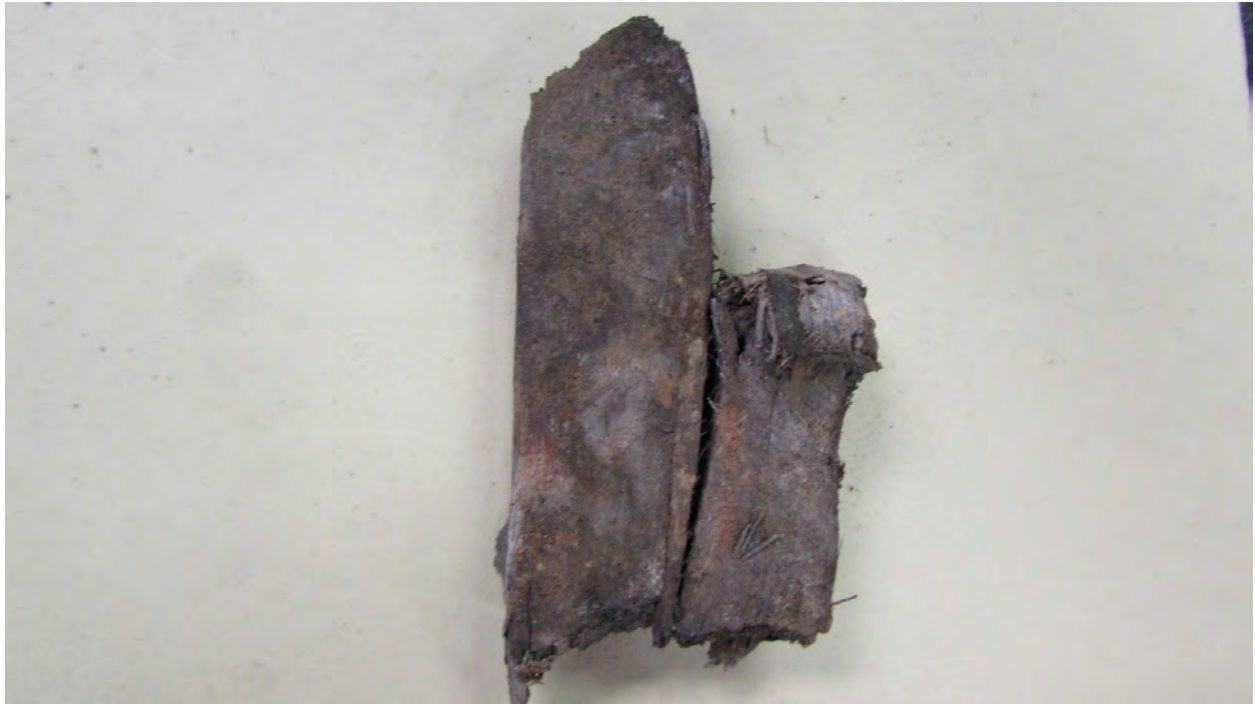
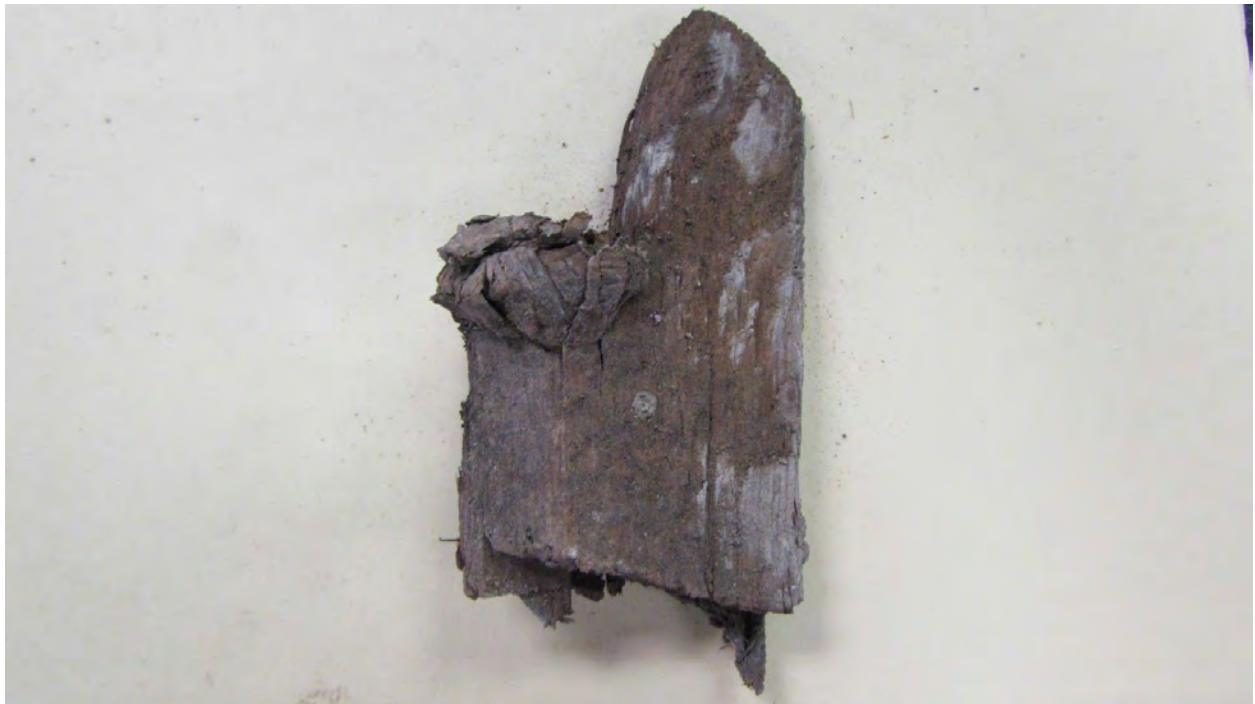
Wood:

Notes: Further testing could include wood identification, porosity testing, and wood maceration to ensure that the wood matches the wood type that is in the architectural and historical records at the Aiken Rhett House.

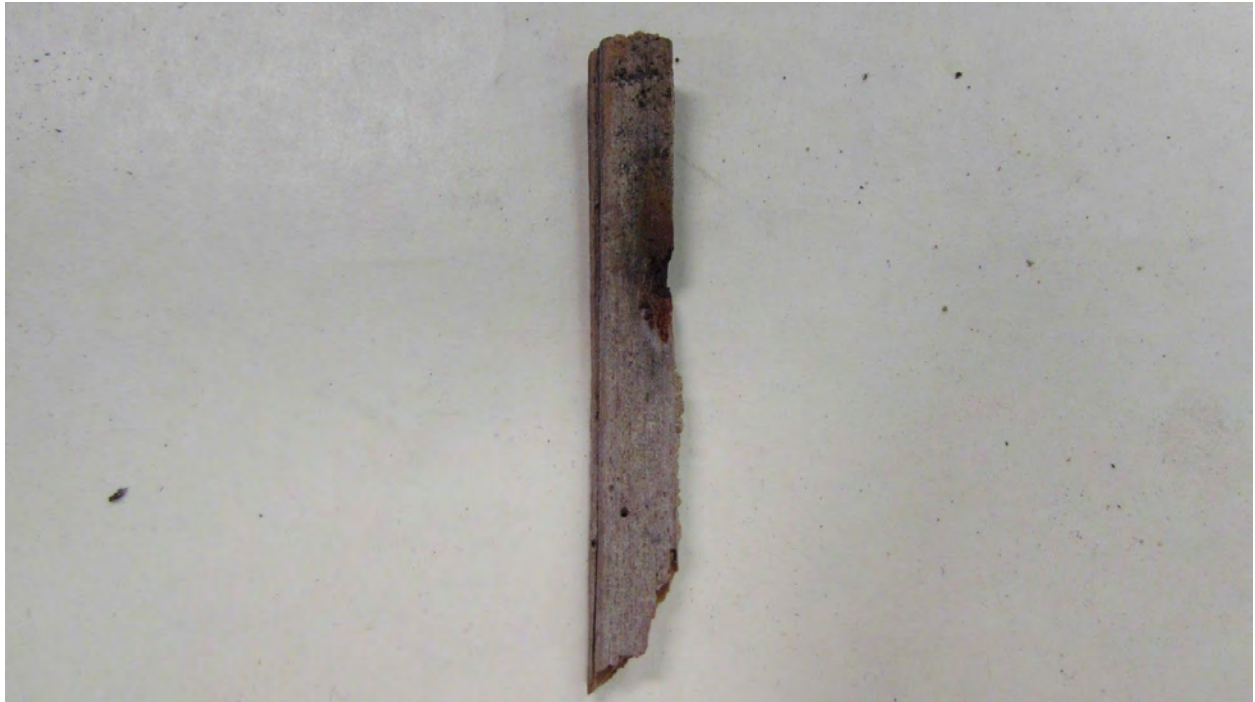
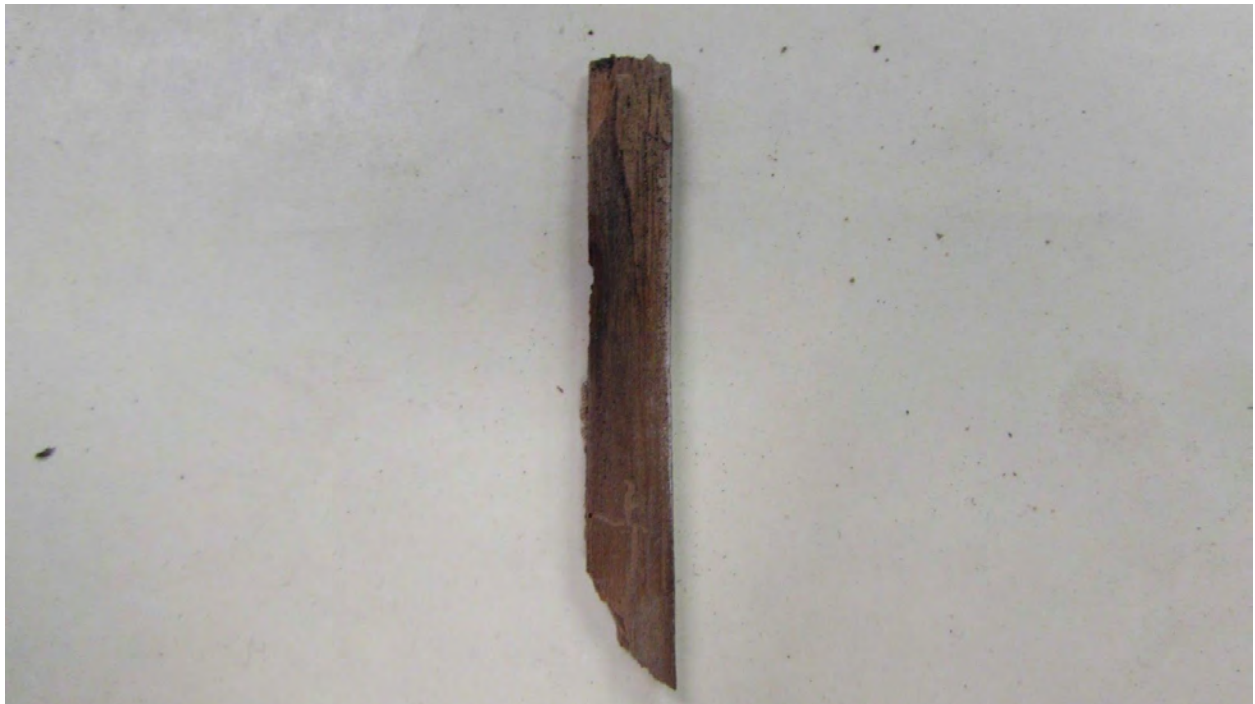
Wood:

Notes: Further testing could include wood identification, porosity testing, and wood maceration to ensure that the wood matches the wood type that is in the architectural and historical records at the Aiken Rhett House.

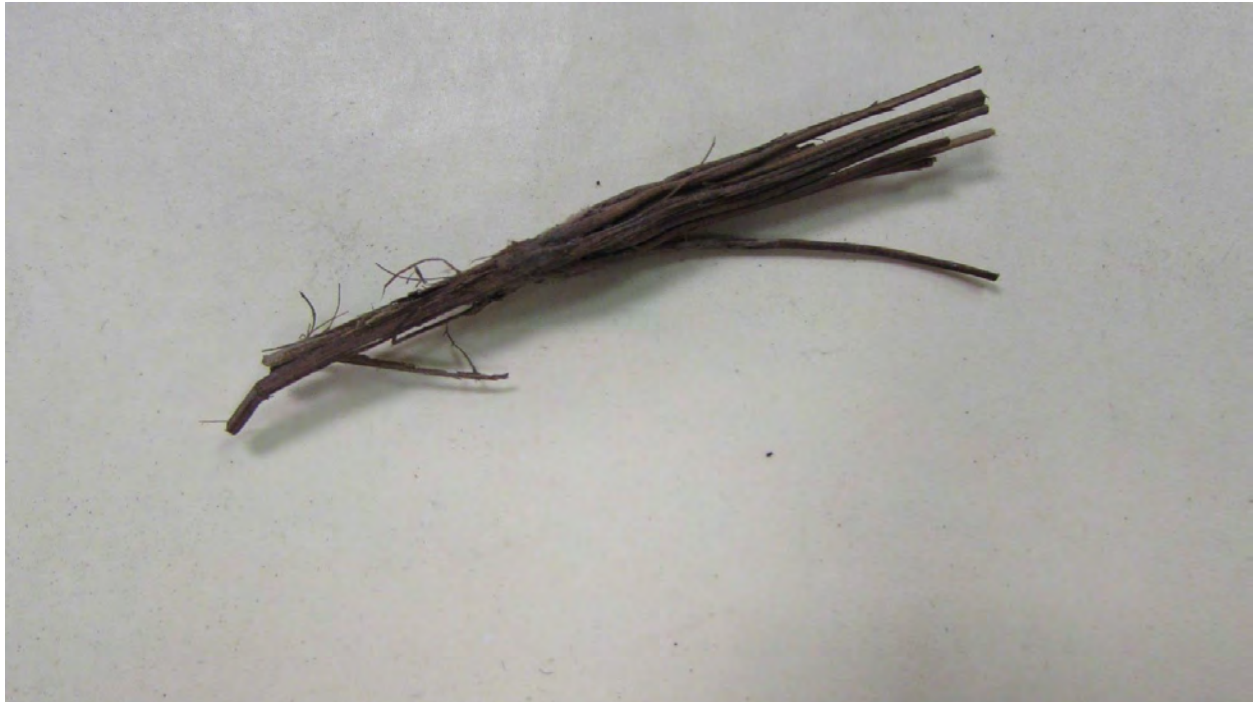
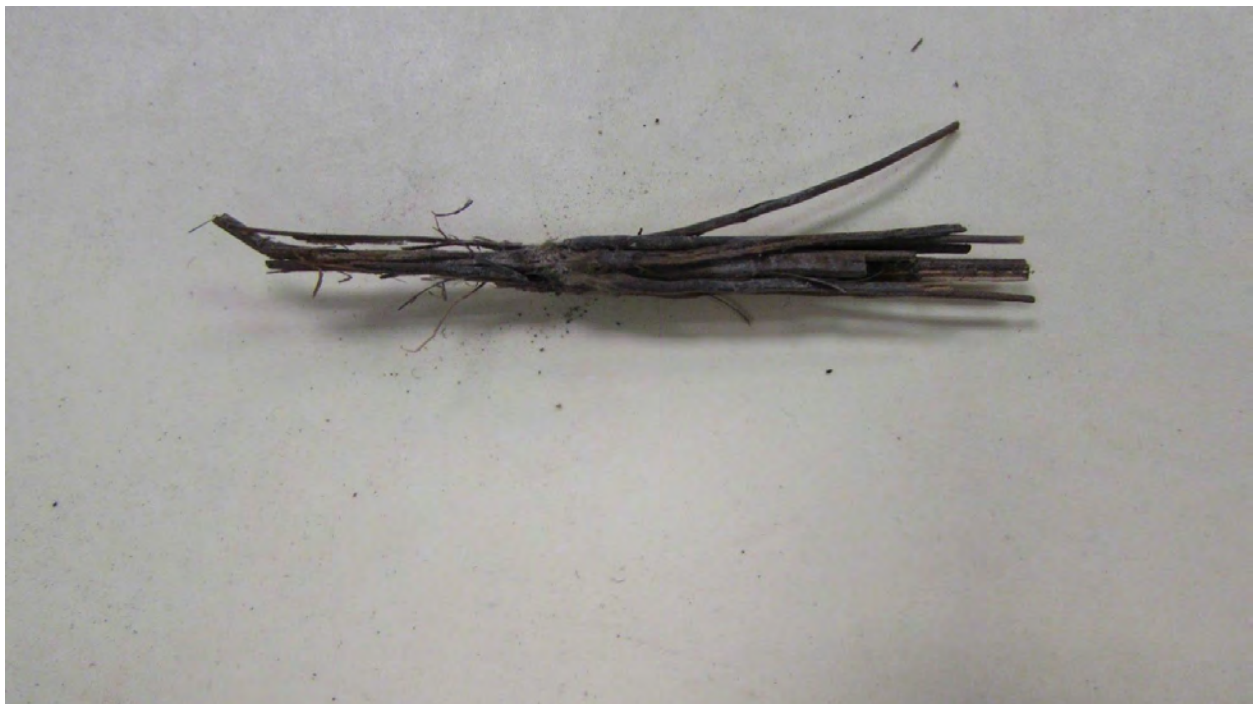
Wood:

Notes: Further testing could include wood identification, porosity testing, and wood maceration to ensure that the wood matches the wood type that is in the architectural and historical records at the Aiken Rhett House.

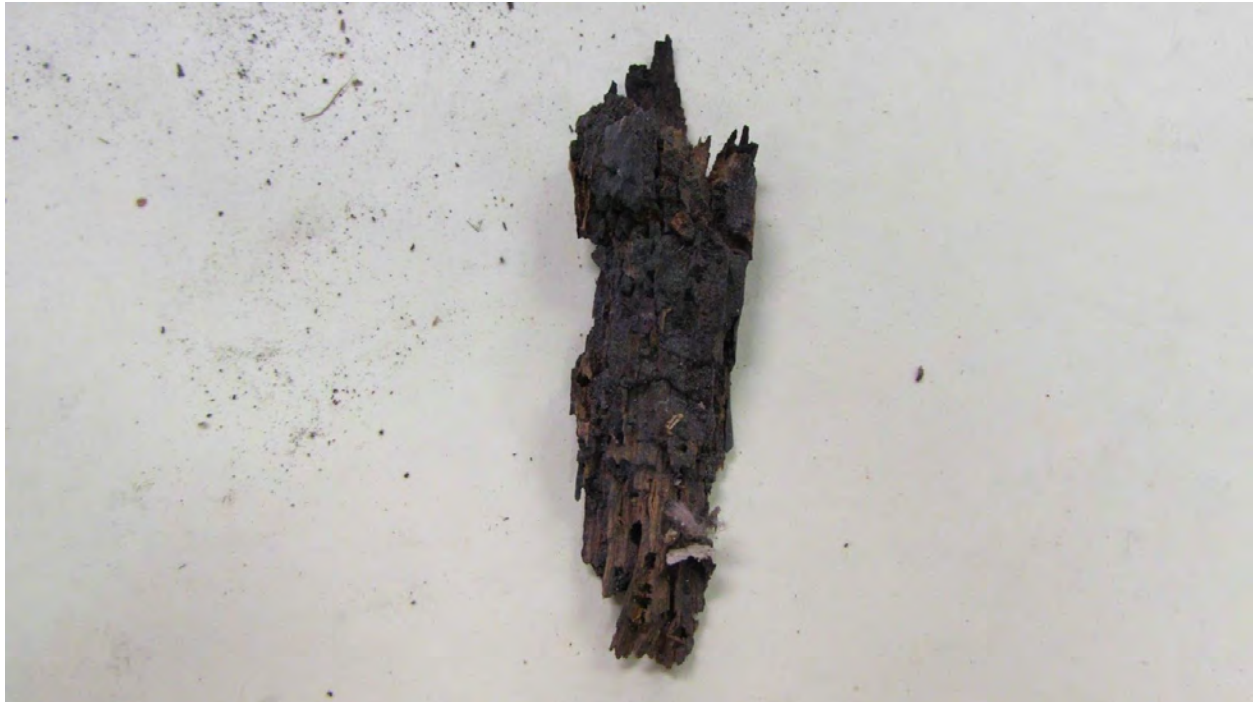
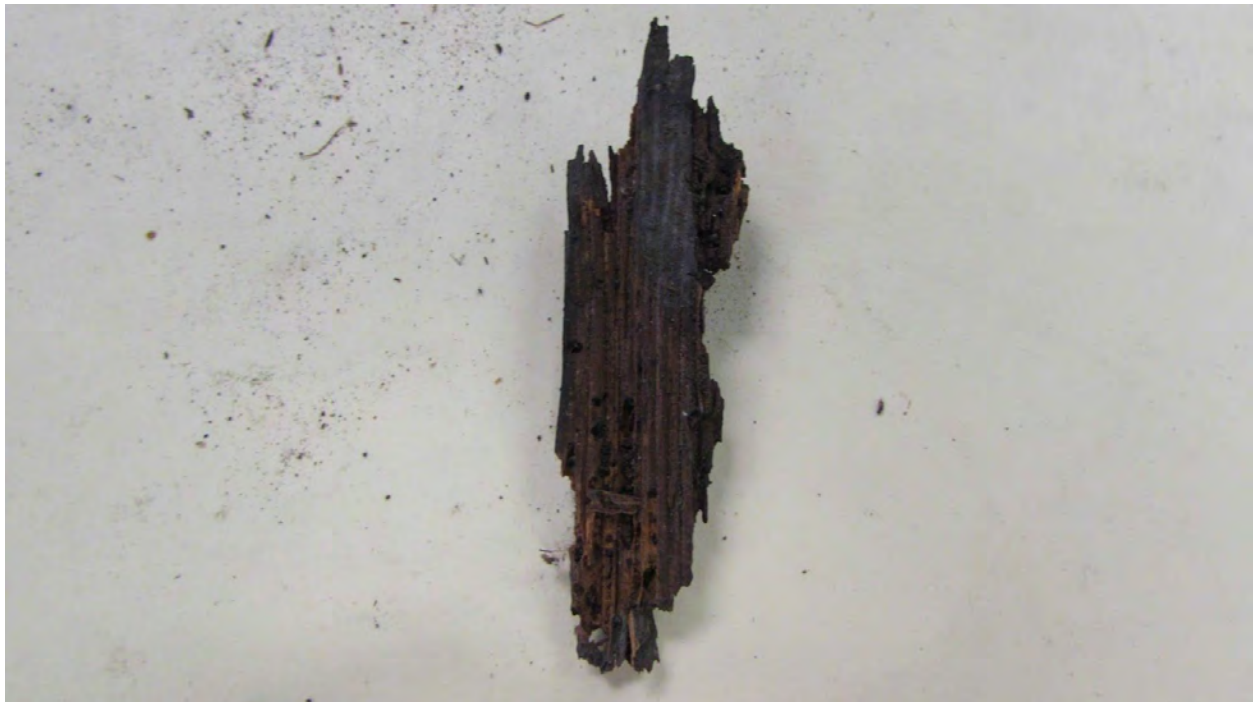
Wood:

Notes: This wood appears burnt. Further testing could include wood identification, porosity testing, and wood maceration to ensure that the wood matches the wood type that is in the architectural and historical records at the Aiken Rhett House.

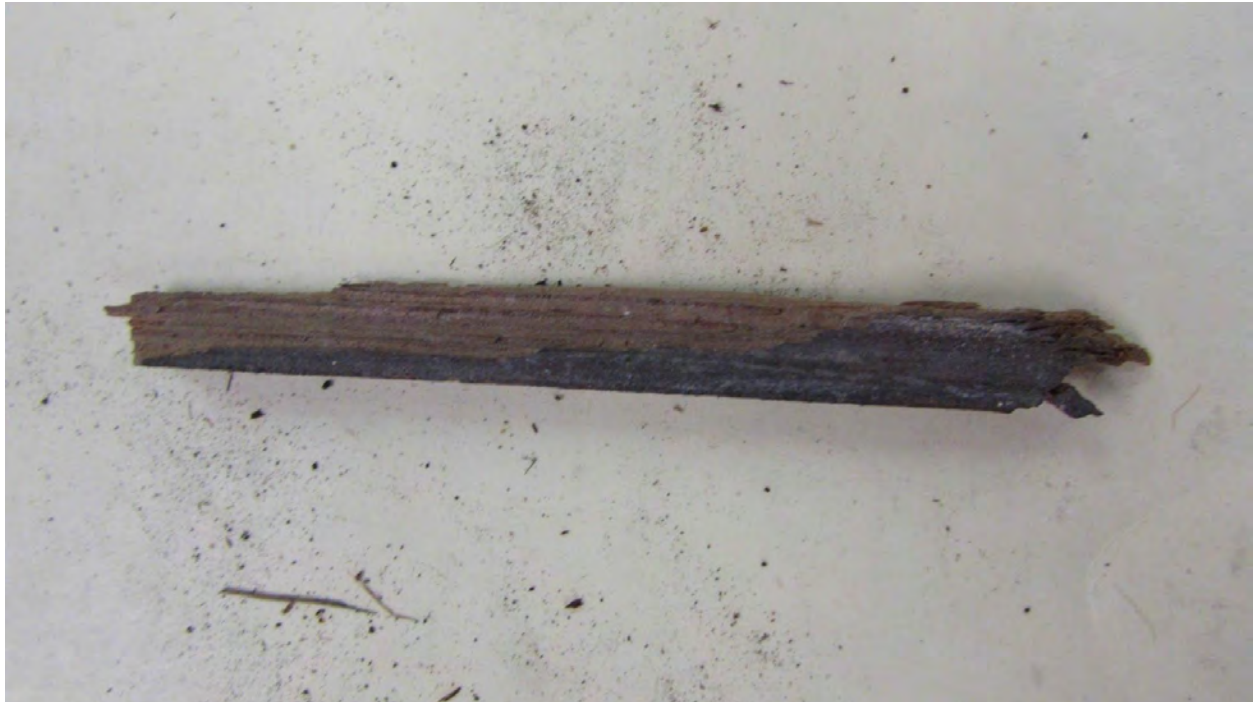
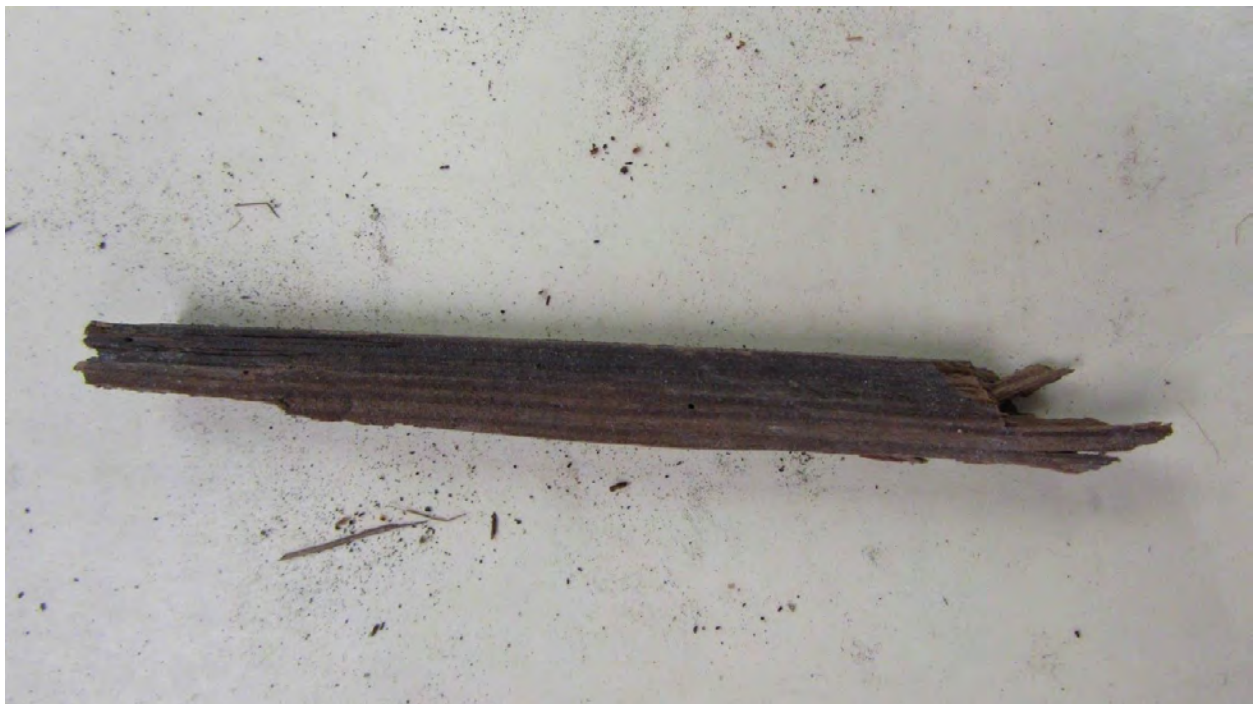
Wood:

Notes: This wood appears burnt. Further testing could include wood identification, porosity testing, and wood maceration to ensure that the wood matches the wood type that is in the architectural and historical records at the Aiken Rhett House.

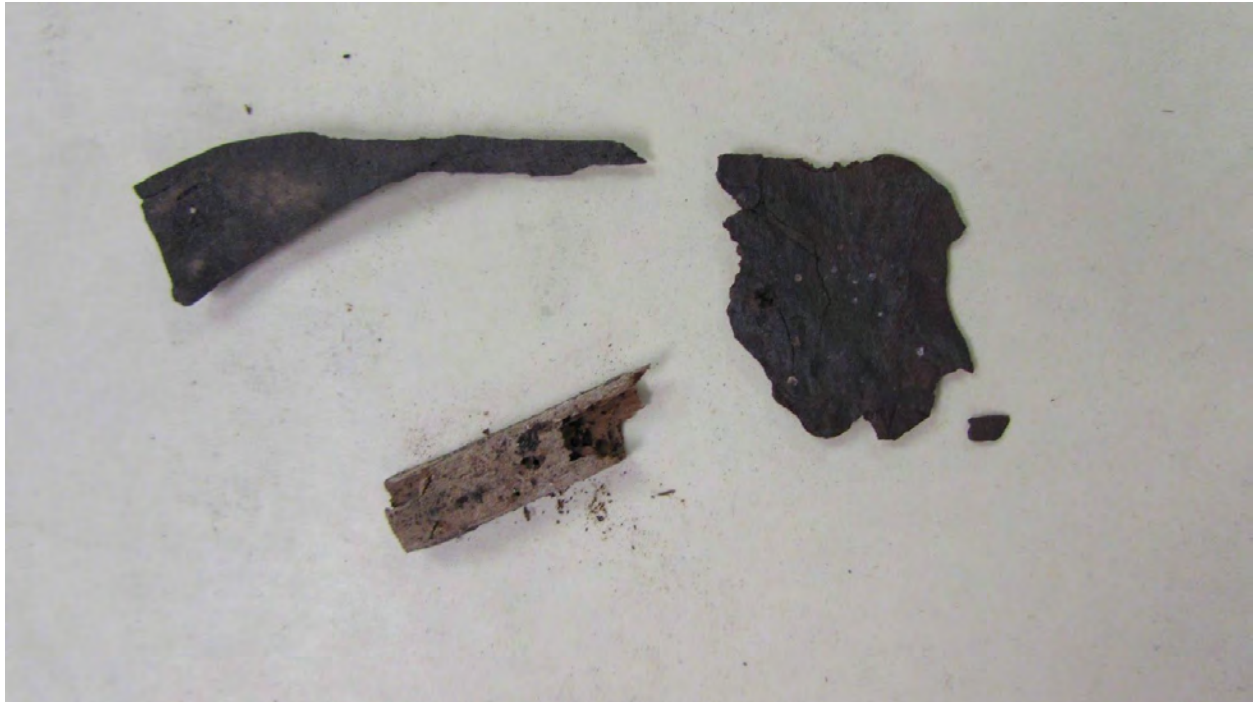
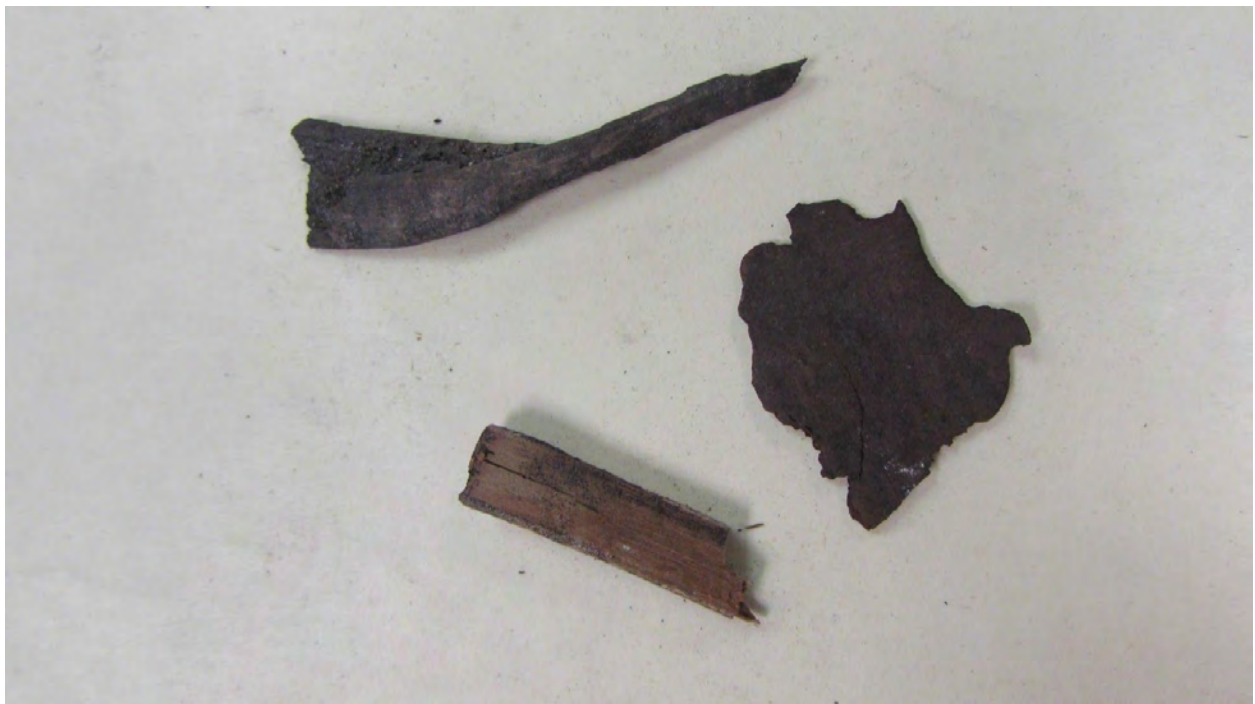
Wood:

Notes: This wood appears burnt. Further testing could include wood identification, porosity testing, and wood maceration to ensure that the wood matches the wood type that is in the architectural and historical records at the Aiken Rhett House.

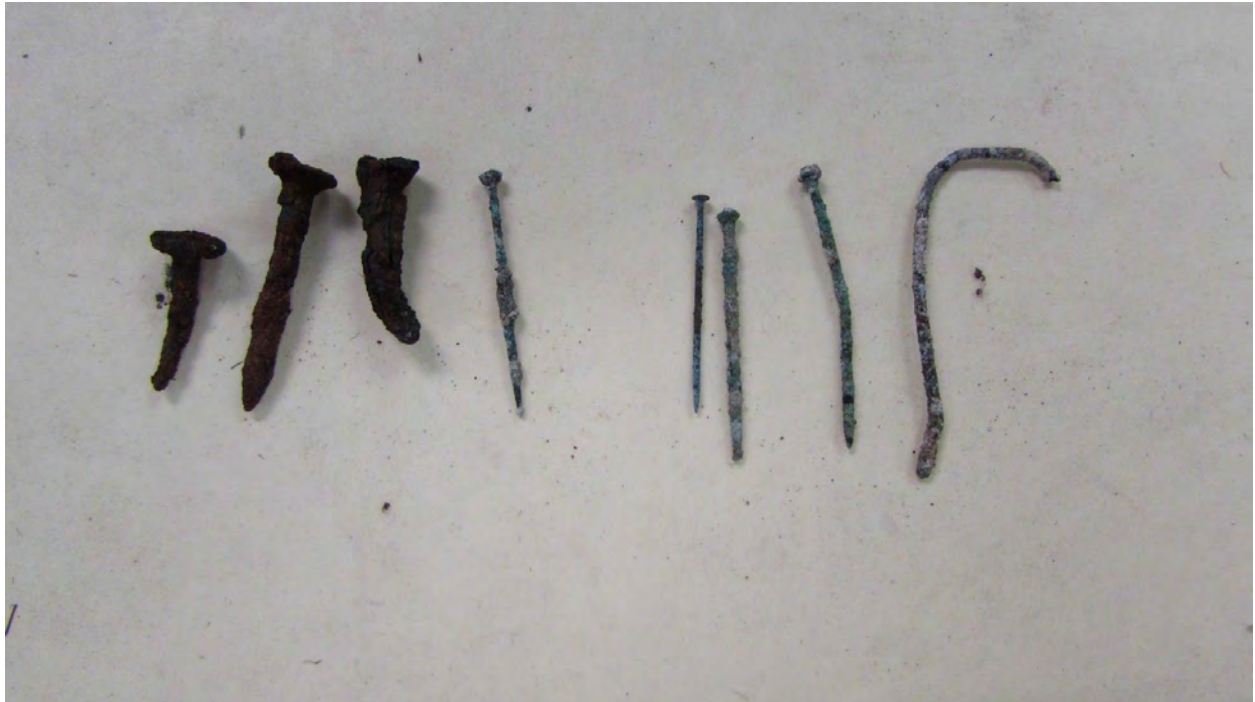
Hardware:

Notes: The hardware found in the rat's nest includes nails and a hook. The nails are from different time periods.

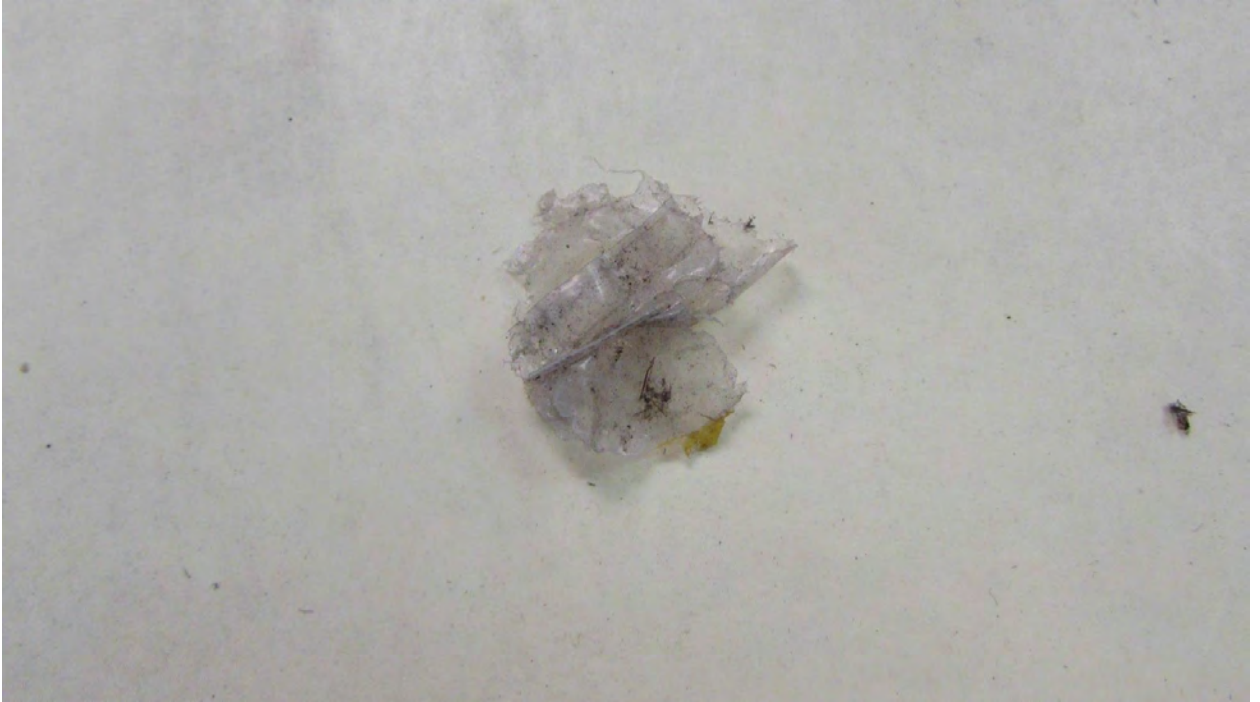
Plastic:

Notes: This object is a piece of a plastic bag. It might be part of a wrapper, as suggested by the yellow portion.

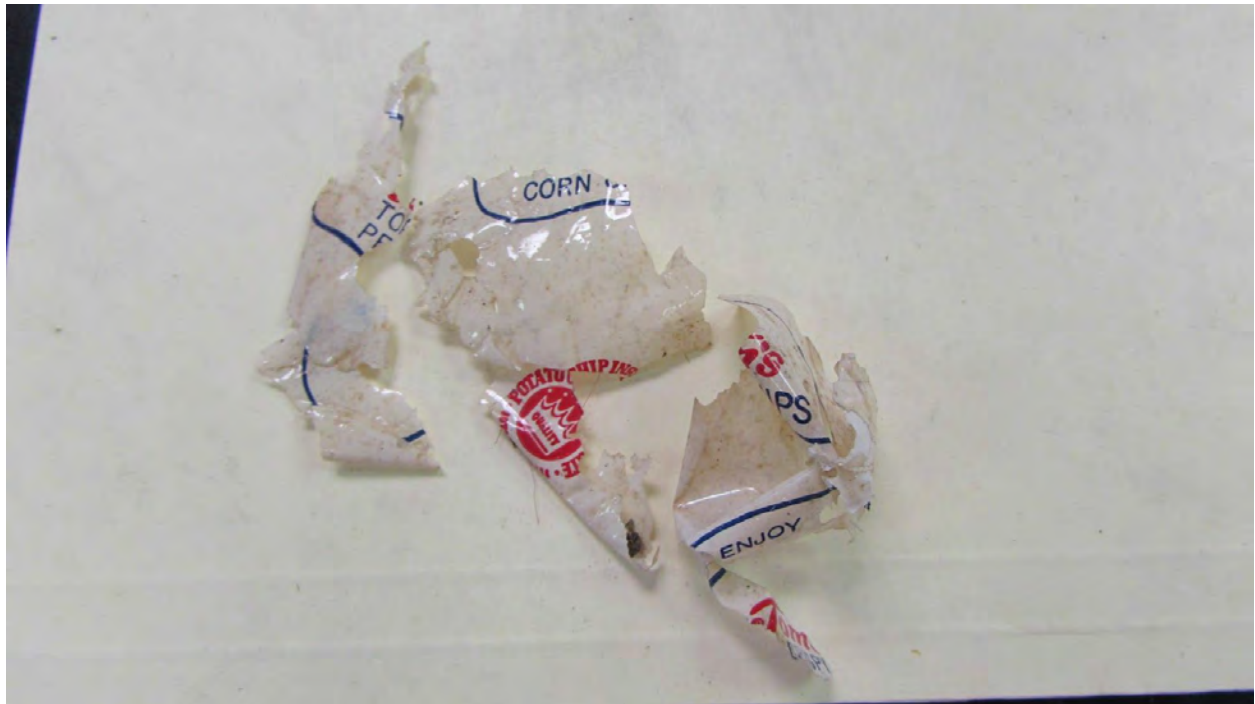
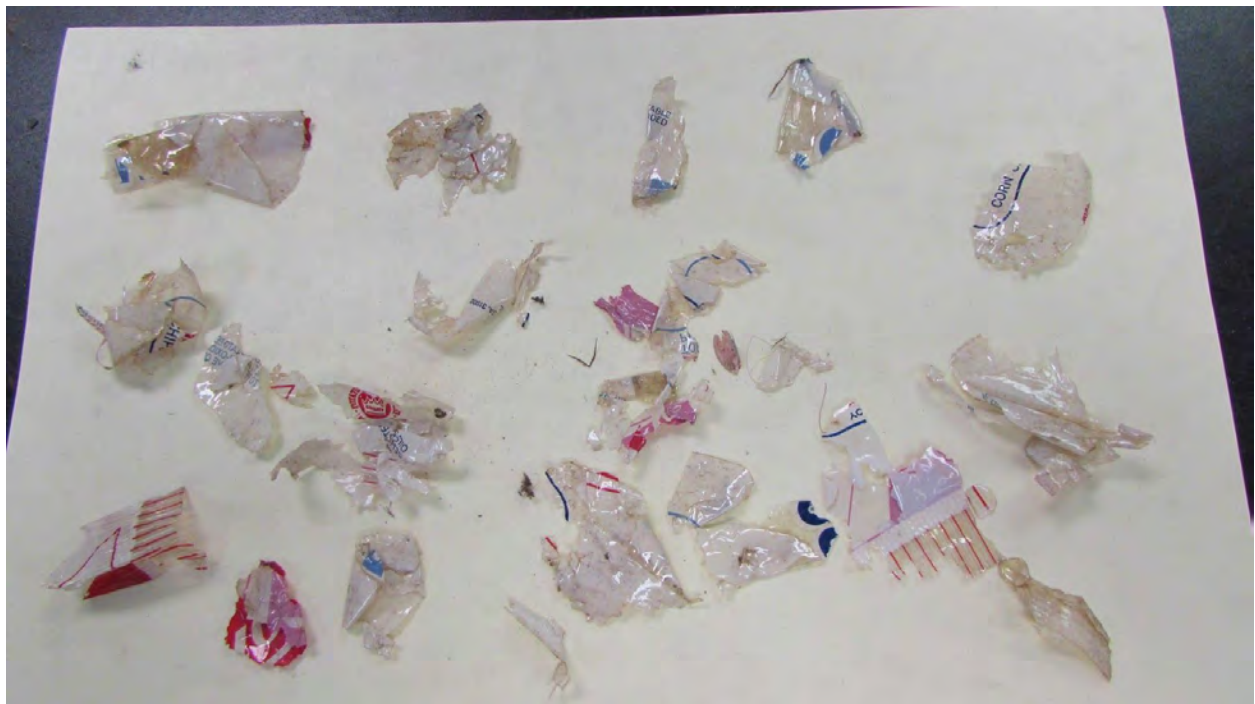
Plastic:

Notes: These pieces are all part of a food wrapper. The pieces contain text that indicates that the food is “Tom’s Crispy Corn Chips” and is a product of “Tom’s Foods.”

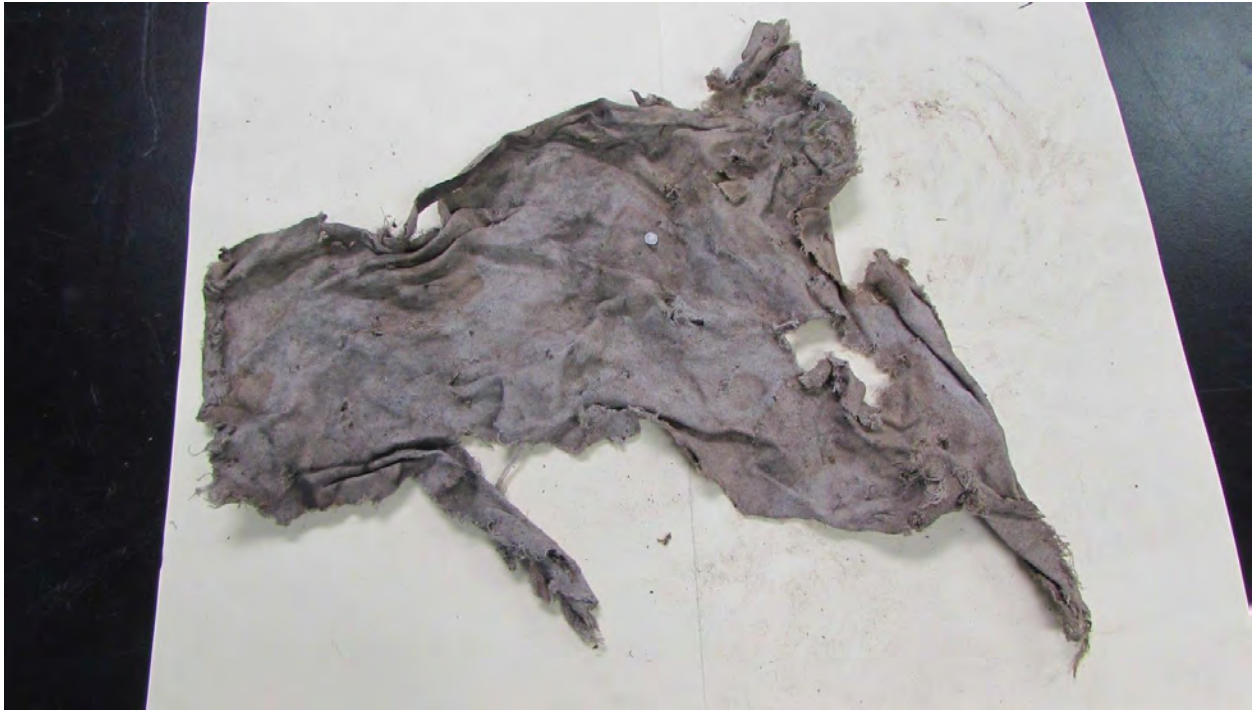
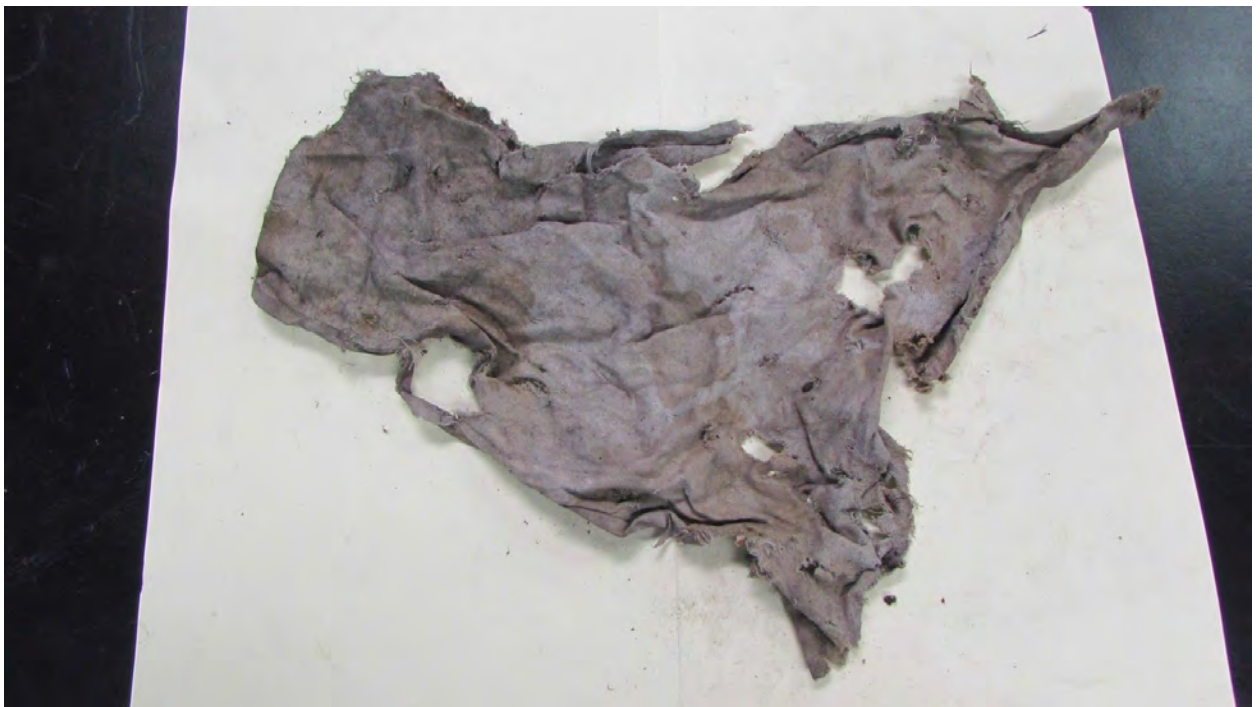
Textile:

Notes: This textile has a simple grey design. The textile also contains holes, which could possibly be caused by rats.
