HISTORIC PRESERVATION CERTIFICATION APPLICATION
PART 1 – EVALUATION OF SIGNIFICANCE

1. Name of property: Westendorff BuildingAddress of property: 25 Warren/114 St. Phillip StreetsCity Charleston County Charleston State SC Zip Code 29403Name of historic district: Charleston Old and Historic District National Register district certified state or local district potential historic district

Westendorff Building

WESTENDORFF BUILDING
25 Warren/114 St. Phillip Streets
Charleston, South Carolina

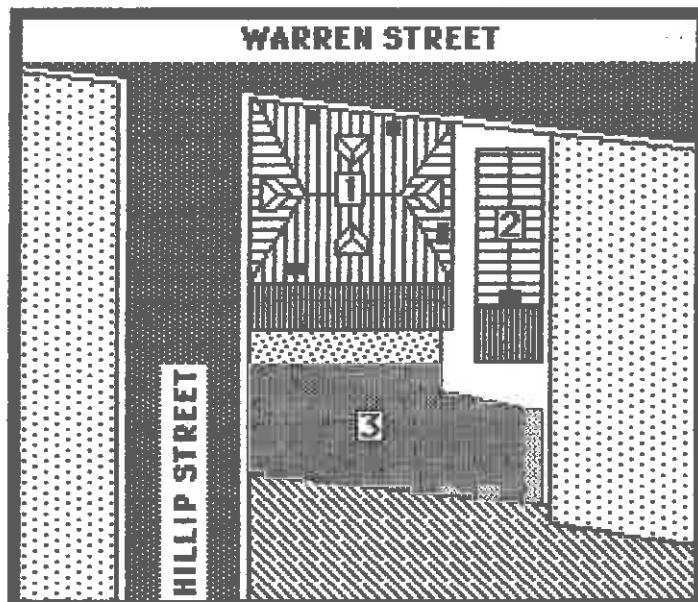
Siteplan

- 1 - Westendorff Building**
- 2 - 25-1/2 Warren Street**
- 3 - Garage**

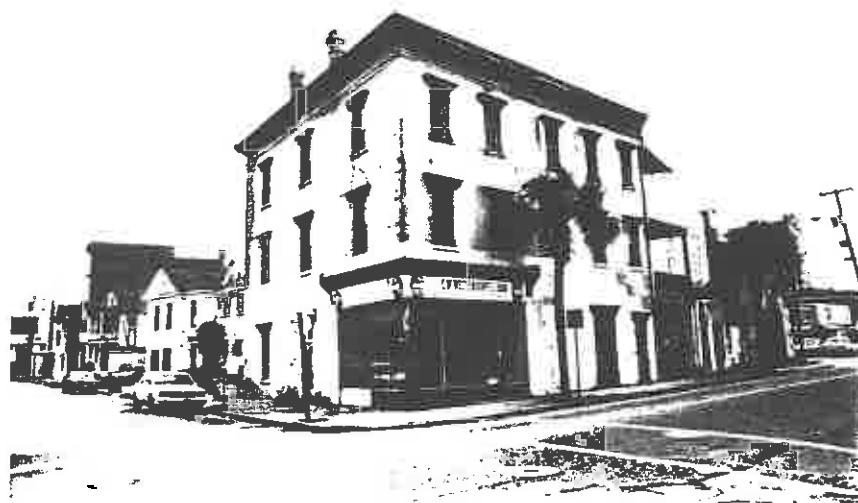
#1

North and West
Elevations,
Streetscape, Facing
Southeast

Note: Chimneys with corbelled caps, pressed metal cornice, 1/1 windows with pressed metal hoods, altered storefront

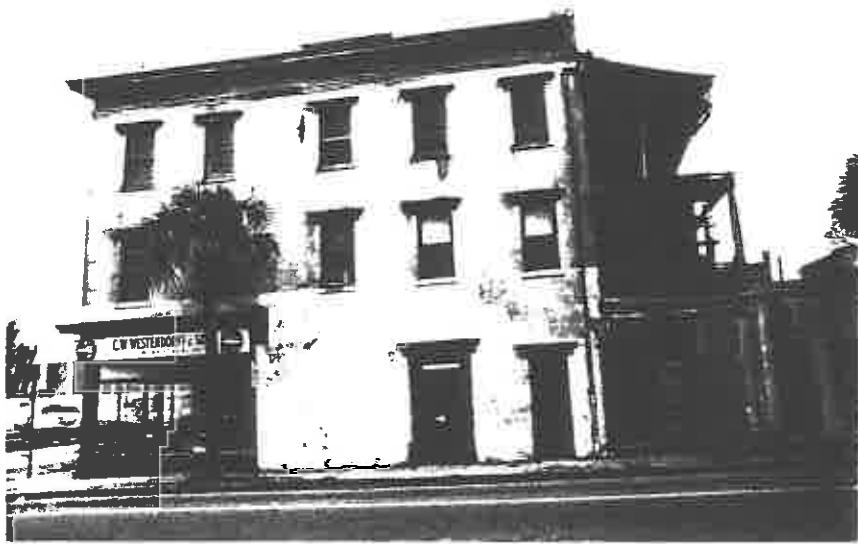
#2

West Elevation,
Facing East

Note: Pressed metal cornice, 1/1 windows with pressed metal hoods, two-tier piazza, altered storefront

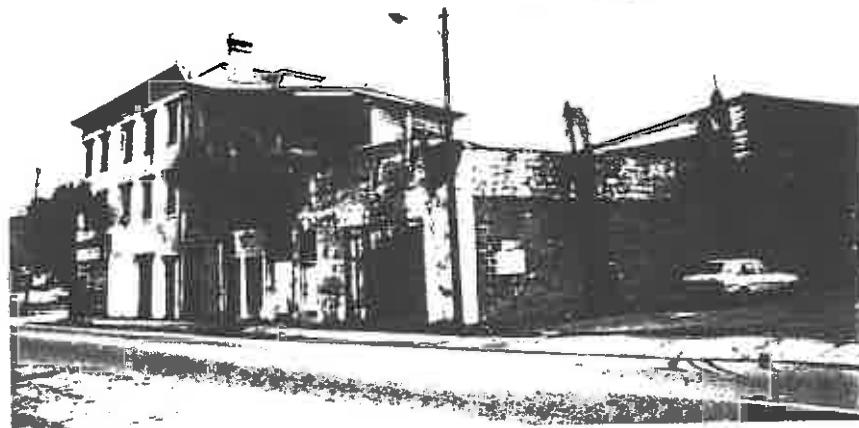
*3

**West and South
Elevations, Facing
Northeast**

Note: Hipped roof with dormers, chimney with corbelled cap, pressed metal cornice, 1/1 windows with pressed metal hoods, two-tier piazza; note intrusive 20th century garage on property in foreground

A deteriorated three-tier piazza extends across the entire south elevation. The first floor level includes paired entrance foyers, with staircases leading to the second and third floors respectively, at the west end and storage space for the first floor commercial area to the east. The east end of the upper levels of the piazza has traditionally been infilled by frame piazza enclosures. Remnants of the original piazza columns and balustrade remain in severely deteriorated condition. Openings in the south elevation include centrally placed entrances with transoms and sidelights on each level, flanked to the west by 1/1 sash windows.

The exterior of the Westendorff Building retains the integrity of its early-20th century design. Changes have been limited to the reversible infill of certain first floor openings and the deterioration and partial collapse of the south piazza.

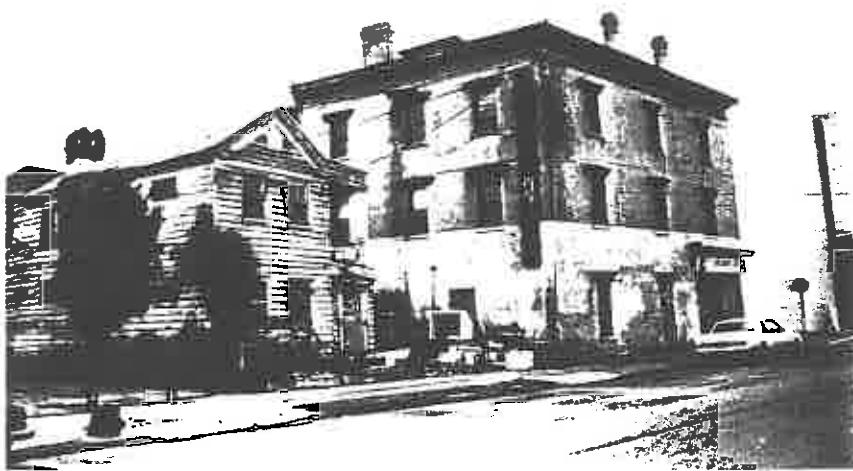
*4

**East and North
Elevations, Facing
Southwest**

Note: Chimneys with corbelled caps, pressed metal cornice, 1/1 windows with pressed metal hoods, altered storefront; note single house on property at left

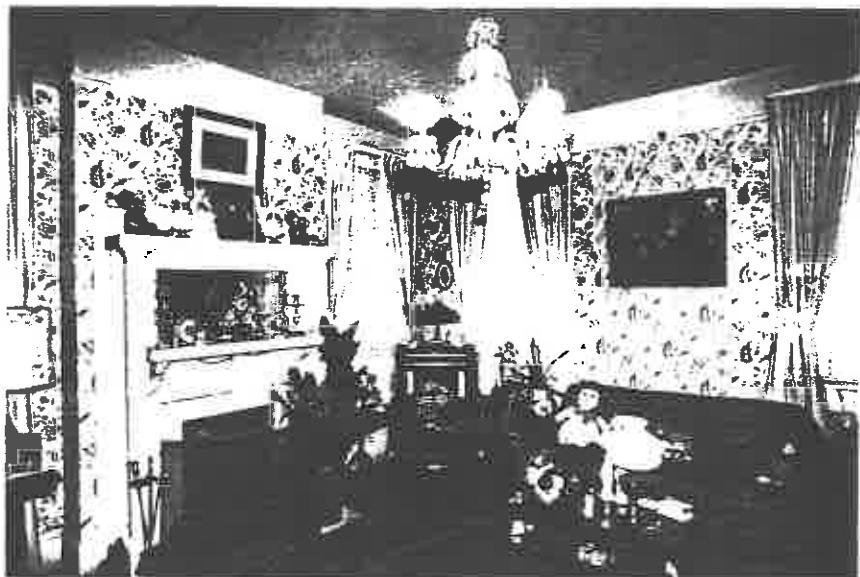
*5

Typical Interior
View, Second Floor
Parlor, Facing
Southwest

Note: Original mantelpiece

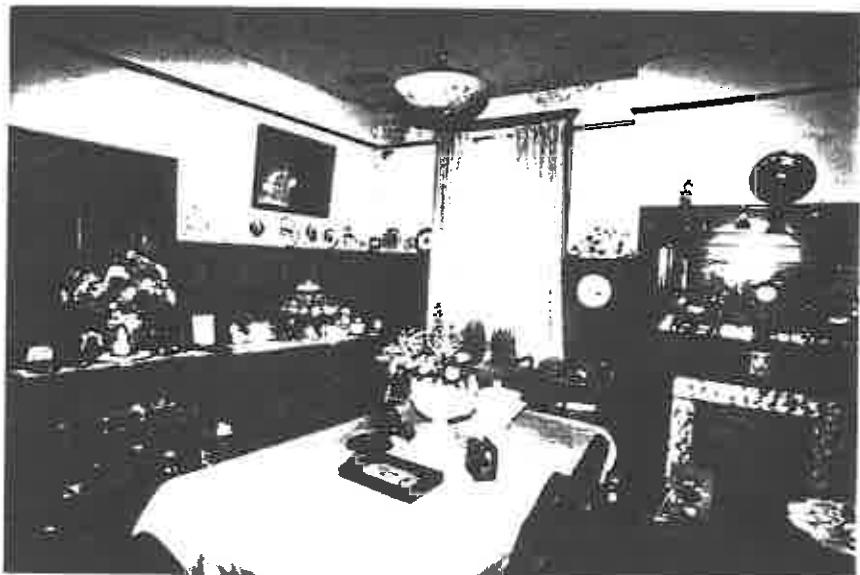
*6

Typical Interior
View, Second Floor
Dining Room, Facing
Northeast

Note: Original mantelpiece
