“TURNING SHAMBLES INTO SHOWCASES:”
HERBERT A. DECOSTA, JR.’S ROLE IN THE
ANSONBOROUGH REHABILITATION PROJECT
IN CHARLESTON, SOUTH CAROLINA

A Thesis
Presented to
The Graduate Schools of
Clemson University and the College of Charleston

Comprehensive Rehabilitation: 82 Anson Street

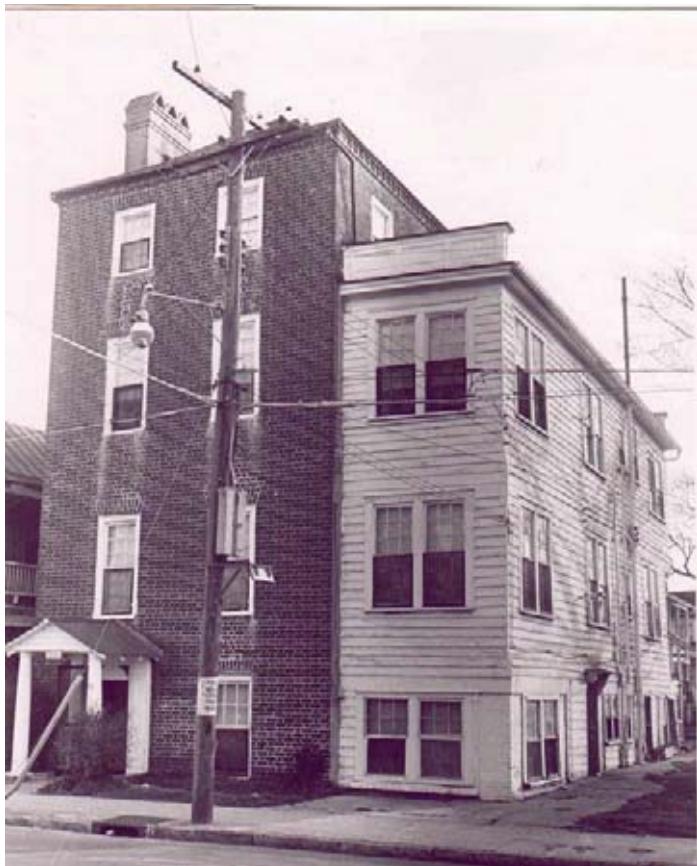
Figure 4.42: 82 Anson Street before its move and rehabilitation. Courtesy of HCF Photograph Collection.

Prior to its renovation in 1970, the house served as a single family dwelling for wealthy members of Charleston's society, a boarding house, a two-family dwelling, and eventually as the Oakman Apartments (*figure 4.42*). Purchased by Clarence Oakman in 1938, the property was divided into eight or nine apartment units in the main house while additional dwelling spaces were carved into a separate one-story structure on the

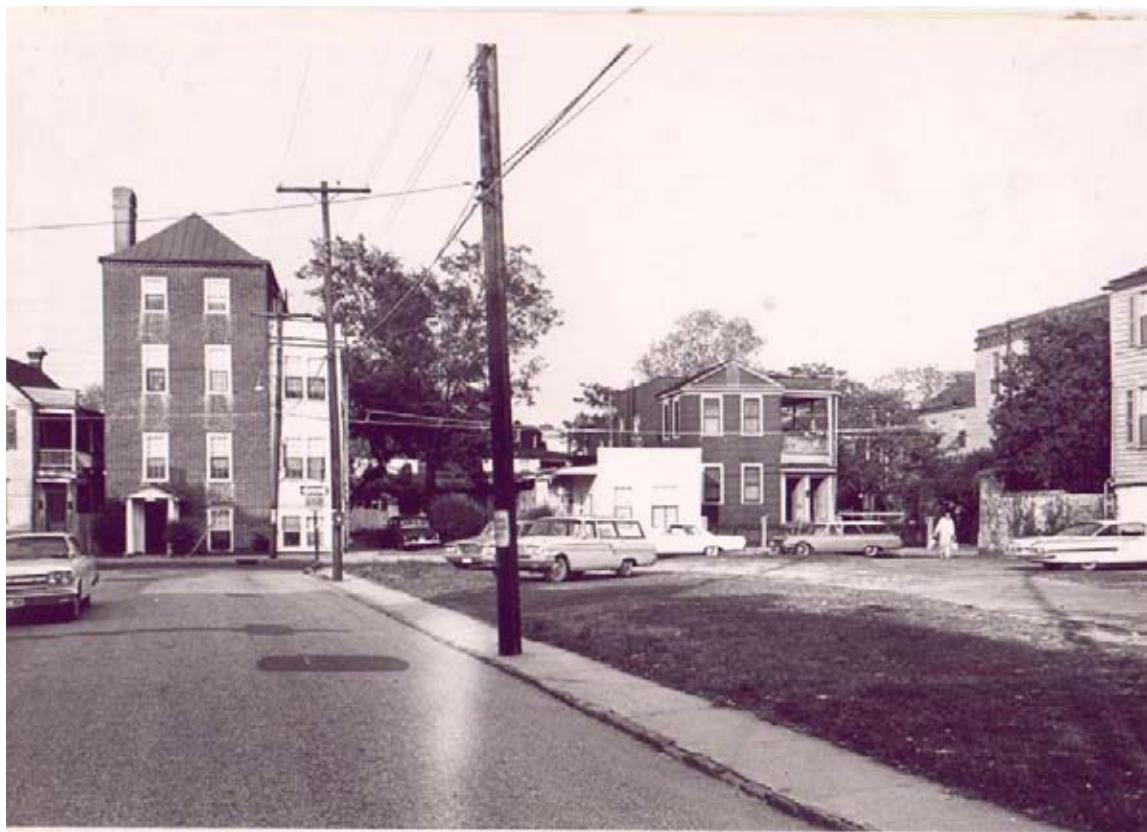
Figure 4.43: 82 Anson Street before its move from its original location at 86 Anson Street at the end of George Street. Demolition because of plans to extend George Street encouraged the relocation of this structure. The original 82 Anson Street is the two-story structure to the right. Courtesy of HCF Photograph Collection.

area cleared for the municipal auditorium, this large brick building stood in the direct path of the extension of George Street eastward to East Bay Street. In spite of the excessive cost connected with moving a brick building, the Historic Charleston Foundation chose to finance the transfer of the structure approximately 100 feet directly down the street to the south (*figures 4.43 and 4.44*).⁴⁶

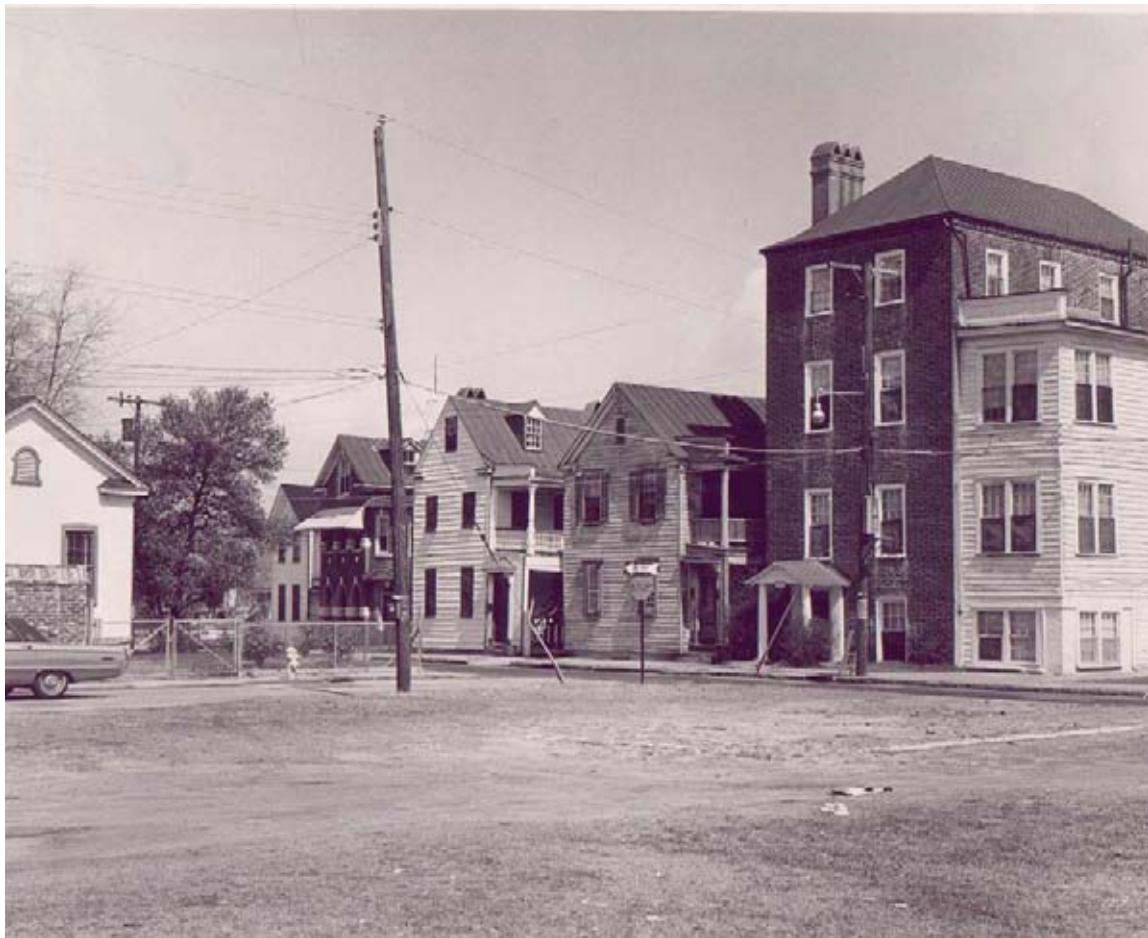
Figure 4.44: 82 Anson Street (foreground) in its original location at 86 Anson Street. Note the enclosed piazza and street entry, as well as the frame structures to the left. These residences were all demolished to make room for the new municipal auditorium. Courtesy of HCF Photograph Collection.

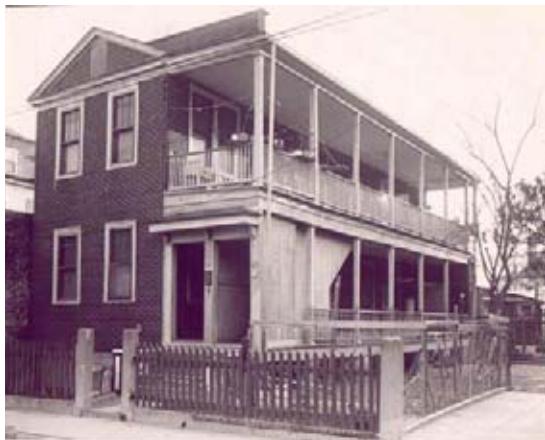
Figure 4.45: Original structure at 82 Anson Street that was demolished to provide a site for 86 Anson Street. Courtesy of HCF Photograph Collection.

In order to acquire a new site for this structure, two of its less impressive neighbors were demolished to clear a double lot that would provide ample space for the house and a spacious garden. The original house at 82 Anson Street was a wooden structure and was described as being “handsomely faced with peeling red asbestos shingles” (*figure 4.45*).⁴⁷ The structure that occupied the northeastern corner of Anson

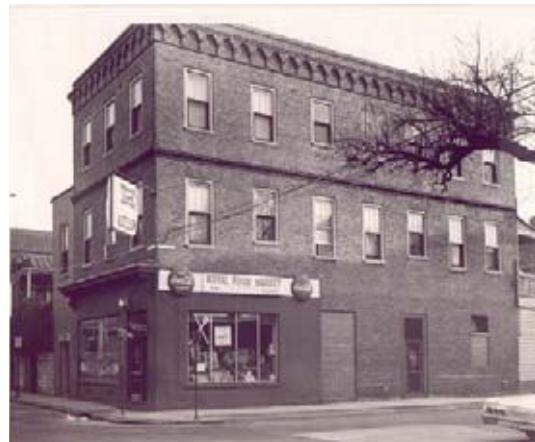
Figure 4.46: Finkelstein Grocery Store located at 78 Anson Street that was demolished to provide space for a garden for the new 82 Anson Street. Courtesy of HCF Photograph Collection.

and Laurens Streets was a three-story brick building that was constructed around 1900 and housed the Finkelstein grocery store (*figure 4.46*). The upper floors of the structure were divided into apartments like many of its neighbors. Because HCF considered these two buildings to be architecturally inferior to the dwelling at 86 Anson Street, they chose to sacrifice both to provide a site for what HCF intended to serve as a gatepost on the northern boundary of Ansonborough.

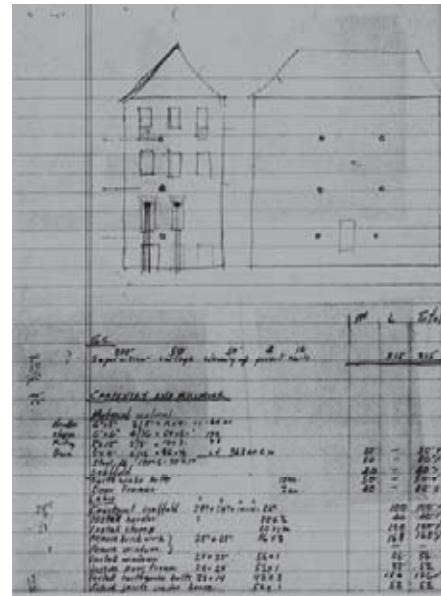
Figure 4.47: Sketch and estimate of structural stabilization for 82 Anson Street planned by the H. A. DeCosta Company. Courtesy of ARC, H. A. DeCosta, Jr. Papers, Box 38.

Rolled down the street on logs, the house was positioned on its new site on top of steel beams with no foundation underneath. DeCosta described the dangerous job of reinserting a foundation under this house in his 2003 oral history interview with HCF: “We had to put a new foundation, new footings, and build the walls back up. We had to join the existing walls, the walls that were left, and that was really sort of a dangerous job because, see, some of that brickwork had fallen.”⁴⁹ DeCosta met with architect Sidney Stubbs of the Lucas and Stubbs architectural firm to discuss suggestions for measures required to make the building structurally sound. Seven recommendations were made:

1. Install earthquake bolts on north and east sides at first, second and third floor levels.
2. Repair cracks in brickwork that are structurally unsound and replace loose brickwork.
3. Install needles and shores under the tops of the second floor east windows and remove all masonry from between windows and ground floor doors in order to eliminate dangerous bulge in east wall.
4. Rebuild brick walls that were removed using steel lintels to reinforce jack arches in new brickwork.
5. Rebuild or tie in bulge where window was closed with bricks on north side.
6. Extend missing floor joists in first floor Stair Hall area in order to provide necessary tie-in for north masonry wall.
7. Install missing brickwork on ground floor of south side where same is needed to support brick wall above.⁵⁰

These recommendations illustrated the deteriorated condition and the extent of rehabilitation required for the building, as well as the range of services that the H. A. DeCosta Company was able to perform. Of special note, an estimate and subsequent invoices indicate that renowned ironworker Philip Simmons handcrafted the earthquake bolts for the house. Overcoming the precarious issue of stabilization, the company continued with a complete restoration of the structure that would both modernize the dwelling and respect its historic materials (*figure 4.47*).

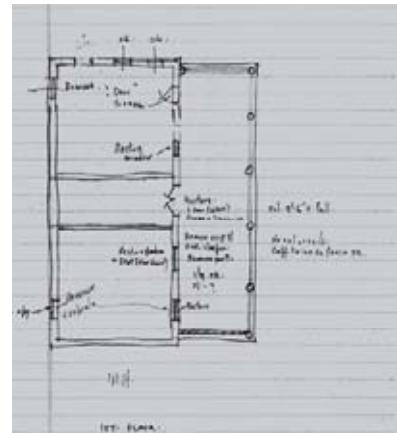
Figure 4.48: Sketch of second floor plan showing details by H. A. DeCosta Company. Courtesy of ARC, H. A. DeCosta, Jr. Papers, Box 38.

were enclosed with brick (*figures 4.48 and 4.49*).

Although the reasoning behind this method was not determined through research, floor plan sketches and notes on the project indicate that at least one window was bricked to accommodate a closet and another may have provided space for a china cabinet. While the closing of the windows altered the original fenestration of the structure (and would not be an appropriate decision today), the reuse of the removed window frames in the restoration of other windows illustrated DeCosta's consistency in reusing historic fabric. The frames of the filled windows were removed and reused on the south façade of the house. In many cases, the windows on the south side had been converted into doorways to provide access from the main house to the enclosed porches that made up the living spaces of the apartments. In his early estimate for the rehabilitation of the property, DeCosta included specifications in three rooms for this reuse. In both the front and rear room of the first floor and in the

rear room of the second floor, the estimate stated, “Remove window frame and sash from north side and install in existing door opening on south wall.”⁵⁶ The window was then to be bricked under with restored paneled jambs on the exterior while a window seat was constructed on the interior. In some cases, existing doorways remained to provide access to the piazza. DeCosta took advantage of the historic fabric available to him and developed a fenestration pattern that more closely reflected the original appearance of the structure.

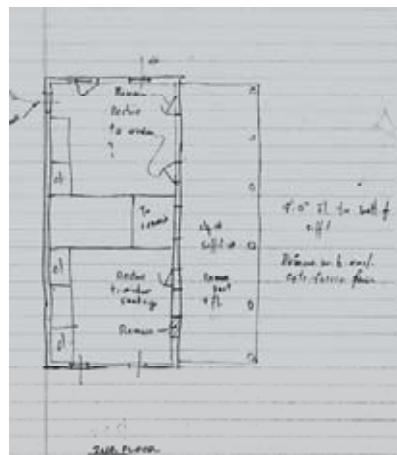
Figure 4.49: Sketch of second floor plan showing details by H. A. DeCosta Company. Courtesy of ARC, H. A. DeCosta, Jr. Papers, Box 38.

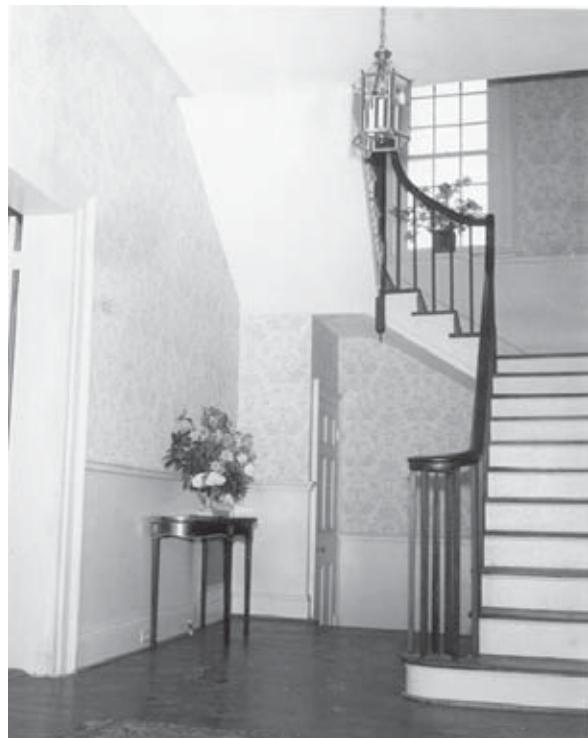
Figure 4.50: Restored stair hall at 82 Anson Street. The door to the coat closet designed by DeCosta is visible on the left. Courtesy of HCF Photograph Collection.

essential alterations. In a letter to benefactor Charles Woodward, Frances Edmunds described DeCosta's plans for these improvements as "quite ingenious."⁵⁷ Two stairs led down to a coat closet on the left and to an access door on the right that provided access "to the basement stairs that will remain open inconspicuously, but that can be closed and locked" (*figure 4.50*).⁵⁸

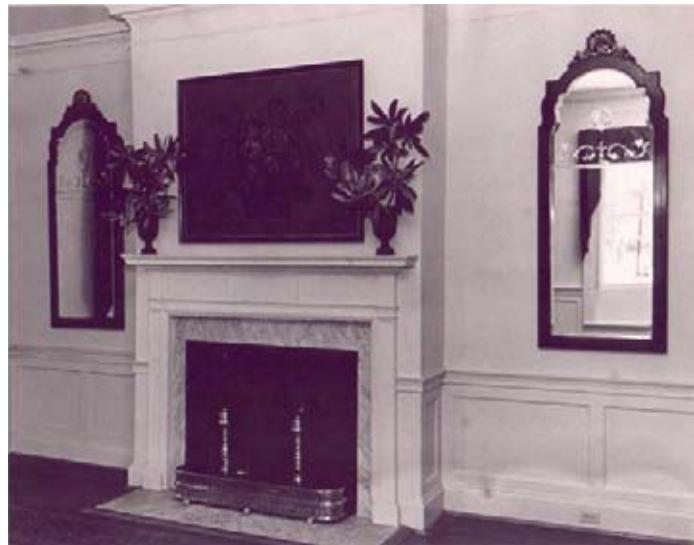
Figure 4.51: Restored interior, 82 Anson Street. Courtesy of HCF Photograph Collection.

In addition, DeCosta removed partitions to open the floor plan, and repairs were made to the plaster walls and ceiling details. Fortunately, a majority of the period details on the interior of the house were intact at the time of the renovation. The original mantels adorned the formal rooms, and first period wainscoting and a carved dentil cornice remained as reminders of the house's former elegance (*figure 4.51*). Using a method widely accepted at the time, DeCosta burned the woodwork to remove built up layers of paint before fresh coats of paint were applied. Where portions of these details had been removed, DeCosta seamlessly integrated new elements to match the existing features.

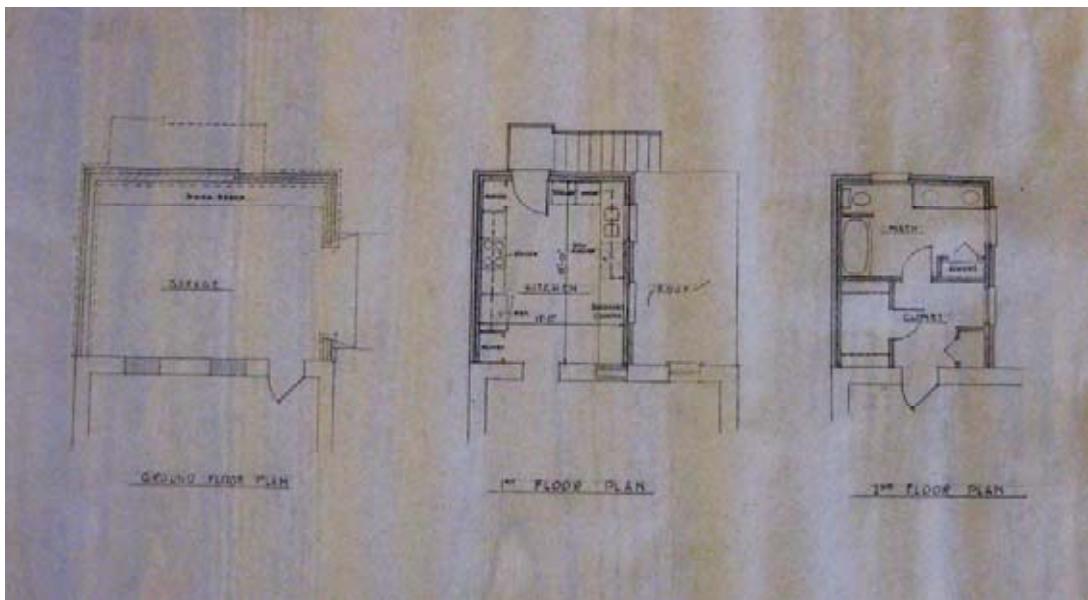
Figure 4.52: Proposed plans of the addition to 82 Anson Street. Plans by H. A. DeCosta Company, drawn by J. Cobbs and checked by H. A. D. (Herbert DeCosta). Dated May 21, 1969. Courtesy of ARC, H. A. DeCosta, Jr. Papers, Box 200.

In addition to the restoration of the historic portion of the house, DeCosta designed a two-story addition on the east (back) side of the building. This modern addition provided a garage at ground level, a “spanking new and delightfully antiqued” kitchen on the first floor, and a dressing room and bath on the second floor (*figure 4.52*).⁵⁹ Paying close attention to the details of this addition, DeCosta successfully supplied the house with modern amenities in a secondary structure which is considered the most appropriate solution for historic structures.

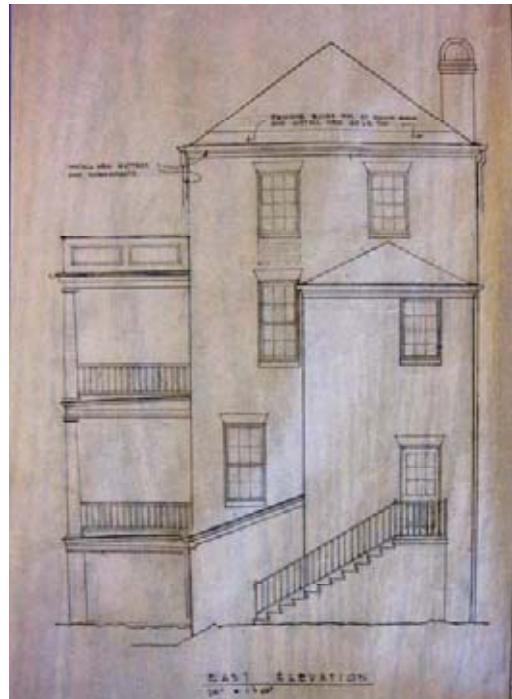
Figure 4.53: Elevation of east façade of 82 Anson Street with addition. Plans by H. A. DeCosta Company, drawn by J. Cobbs and checked by H. A. D. (Herbert DeCosta). Dated May 21, 1969. Courtesy of ARC, H. A. DeCosta, Jr. Papers, Box 200.

Smaller in scale than the main dwelling, the addition was designed in such a way to mimic the proportion of the former kitchen house that has been moved with the structure (*figure 4.53*). Using new Waccamaw brown brick that closely matched the locally made brick of the main house, this addition blended into the main structure effortlessly. In addition to matching the color of the brick, DeCosta also constructed the addition using the same English bond pattern as that of the historic portion of the property. Finally, DeCosta designed the garage door openings on the basement level of the addition to arch slightly across the top. This detail imitated the traditional openings of carriage houses and was praised by HCF supporter Charles Woodward. The scale of the addition, the materials used, and the details of the design combined to produce an addition that was both aesthetically pleasing and historically congruent with the neighborhood (*figure 4.54*).

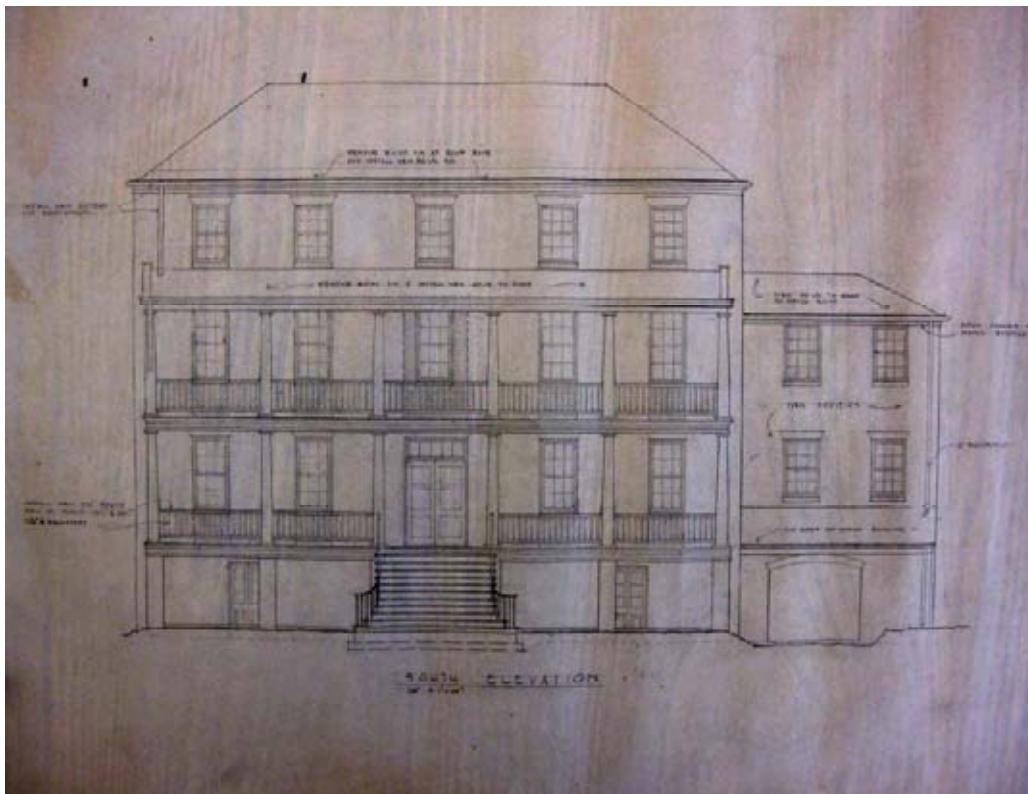
Figure 4.54: Elevation of south façade of 82 Anson Street with addition. Plans by H. A. DeCosta Company, drawn by J. Cobbs and checked by H. A. D. (Herbert DeCosta). Dated May 21, 1969. Courtesy of ARC, H. A. DeCosta, Jr. Papers, Box 200.

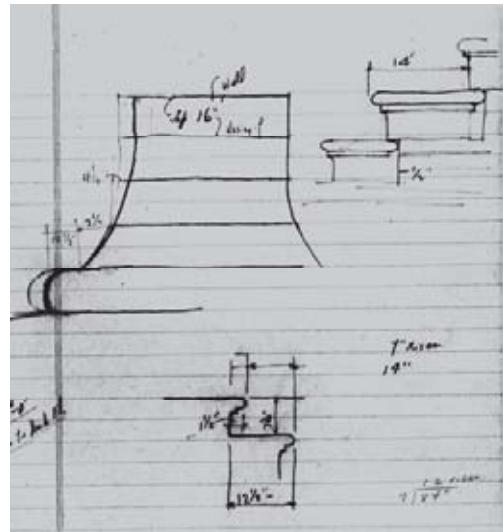
Figure 4.55: Sketch of proposed stairs showing details by H. A. DeCosta Company. Courtesy of ARC, H. A. DeCosta, Jr. Papers, Box 38.

The last major project in the rehabilitation of the house involved the construction of new steps from the garden to the first floor piazza and the main entrance of the house (figure 4.55). Using the same Waccamaw brick utilized in the construction of the garage addition, DeCosta designed a grand set of stairs to provide an appropriate entry from the garden to the house. The original plan for the steps called for “brick steps with a W. I. [wrought iron] Railing and stucco treads and risers colored to simulate sandstone.”⁶⁰ However, HCF chose to eliminate the stucco treatment in an effort to economize and to keep this project from going further over the intended budget. In spite of this change, the

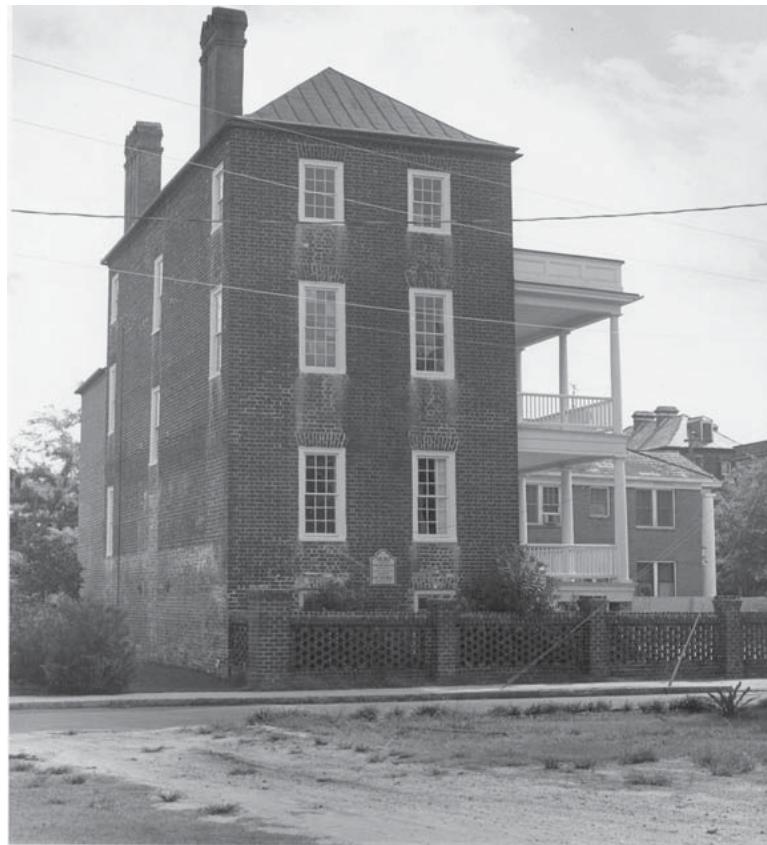
Figure 4.56: 82 Anson Street, west façade, after rehabilitation.
Courtesy of HCF Photograph Collection.

The rehabilitation of 82 Anson Street culminated the restoration work that Herbert DeCosta performed in Ansonborough (*figures 4.56 and 4.57*). Encompassing basic stabilization, exterior restoration, interior renovations, and compatible new design, 82 Anson Street serves as the best example of comprehensive rehabilitation in the entire Ansonborough Rehabilitation Project.

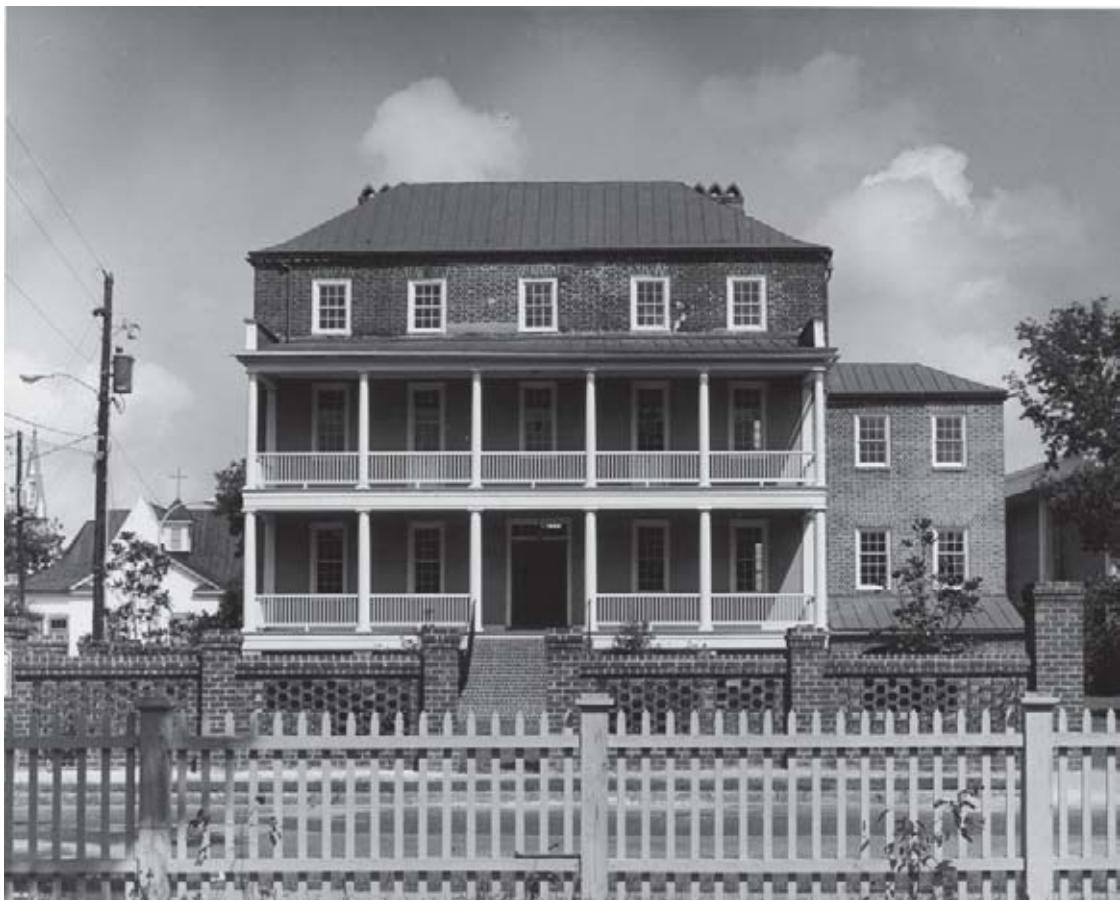
Figure 4.56: 82 Anson Street, south façade, after rehabilitation. Courtesy of HCF Photograph Collection.
