Freedman's Cottage Survey

1 Kracke Street

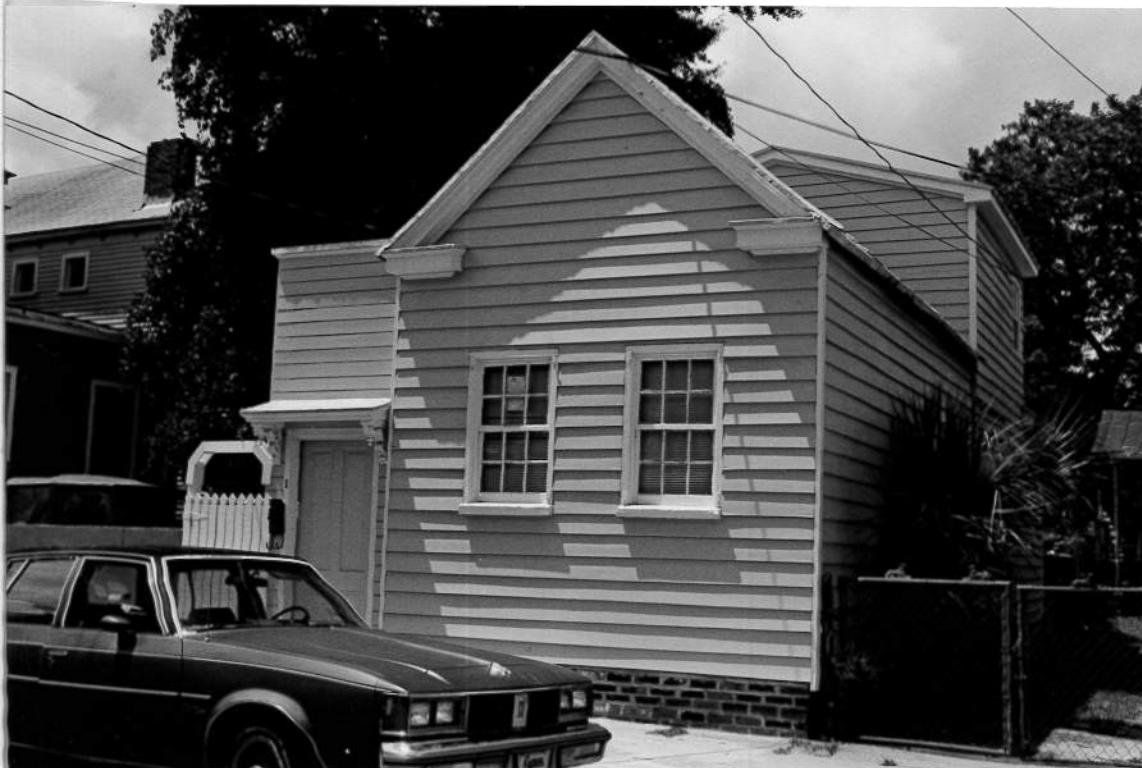
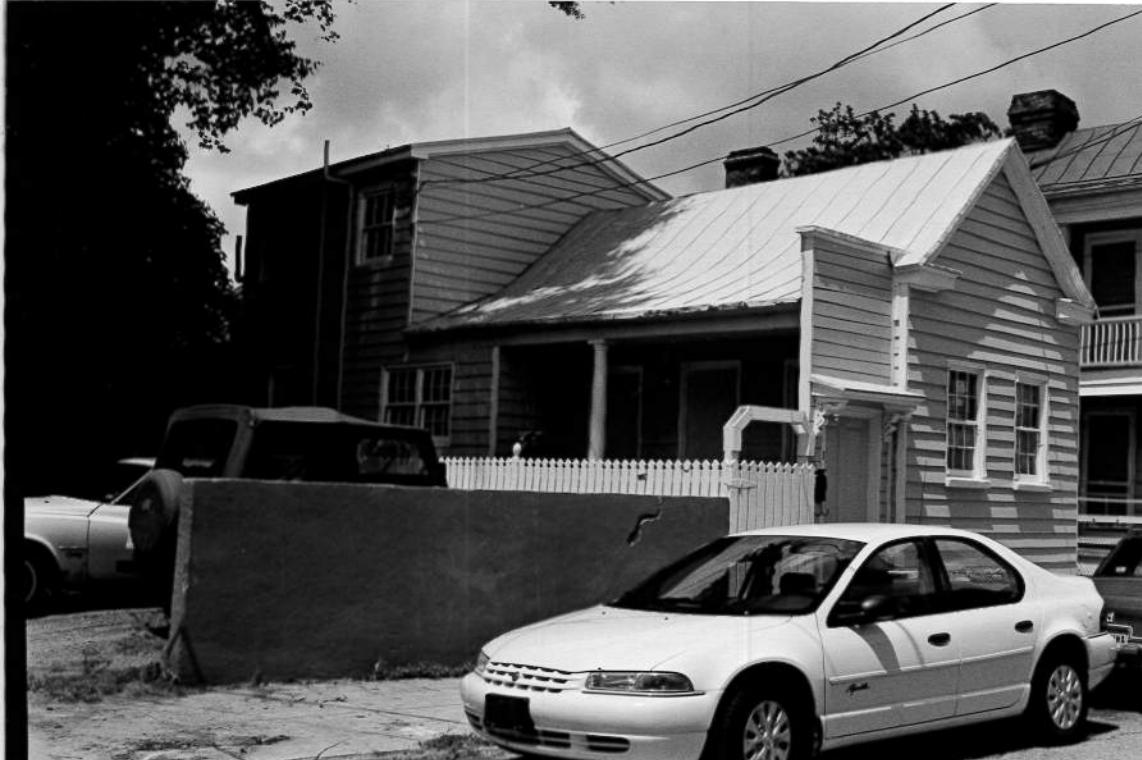
2 story addition at back. 6/6 windows at front. Partial returns, deep cornice molding, metal roof, piazza screen parapeted, door is new, two ornate brackets under hood. Tuscan columns visible on porch. Still open: WDD then probably window, but back part has been filled in. Good condition. End of roll.
