**HISTORIC PRESERVATION CERTIFICATION APPLICATION
PART 1 – EVALUATION OF SIGNIFICANCE**

Name of historic district: Charleston Old and Historic District

**Historic Preservation Certification
Application Part One**

35 Legare Street

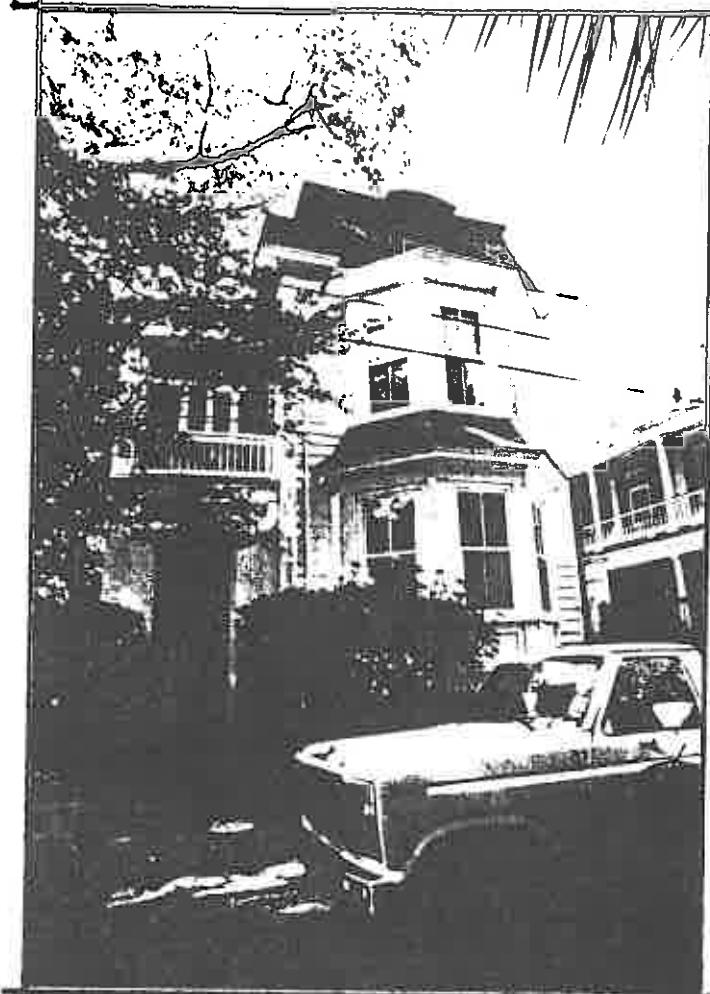
*1

East Façade, Facing Northwest

Note: Metal mansard roof, projecting bay, historic 2/2 wood sash windows, weatherboard siding, 2-tier piazza at left

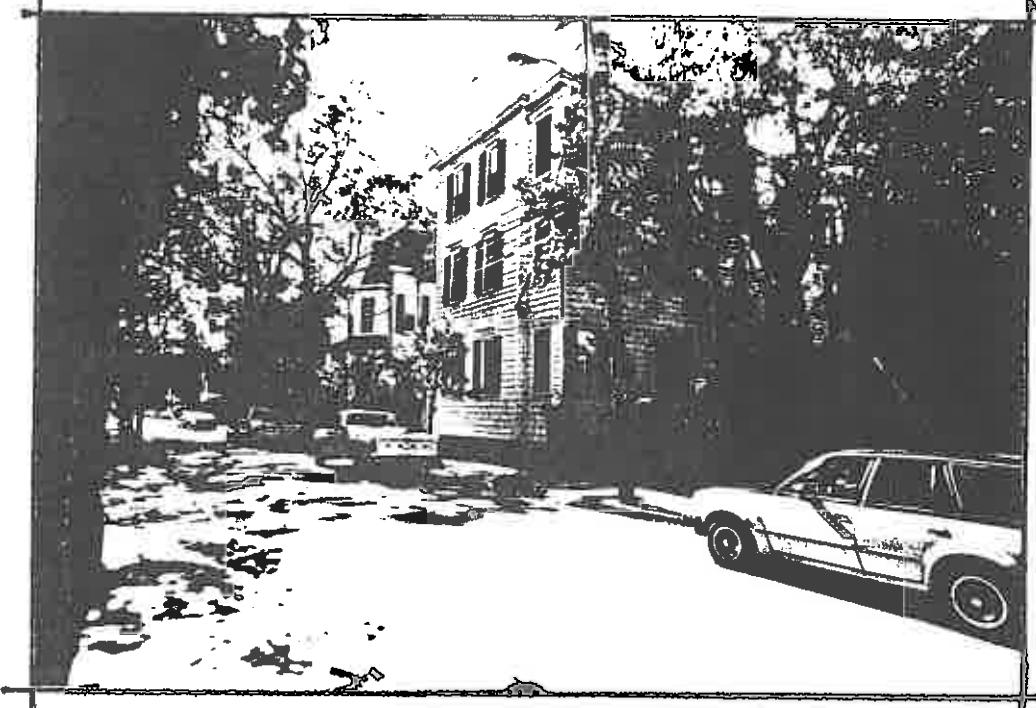
*2

Streetscape, Facing Southwest

Note: Similarity of scale and materials between 35 Legare Street and surrounding structures

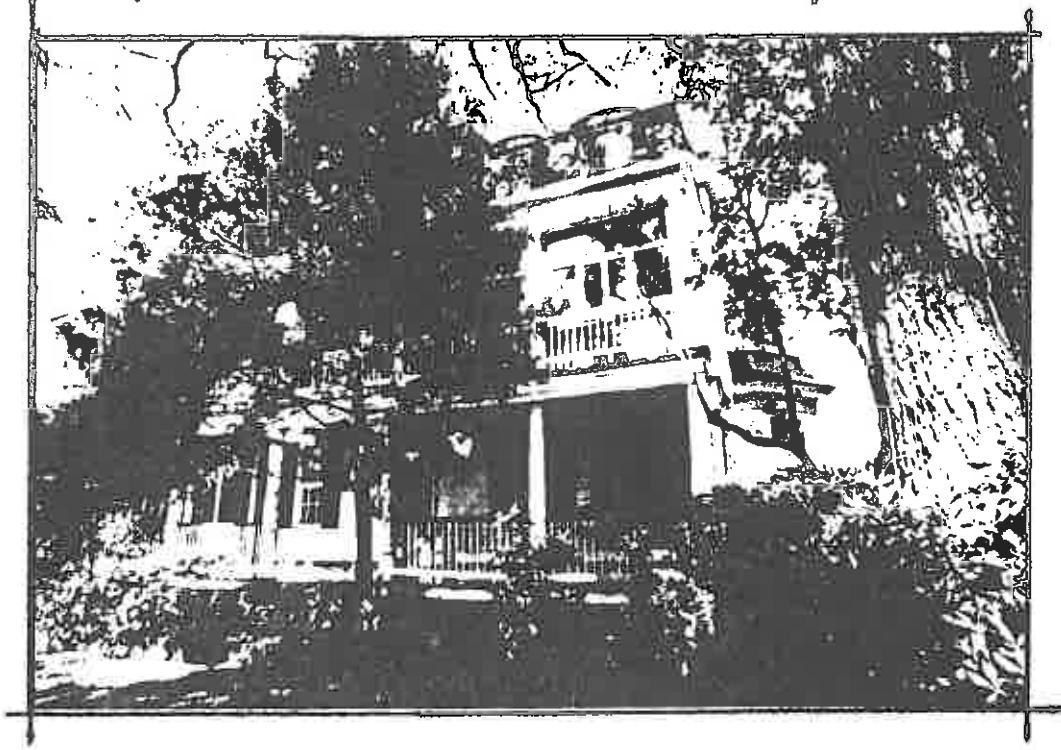
*4

South Elevation

Note: Dormers, two-tier
piazza, original 6/6 sash
windows

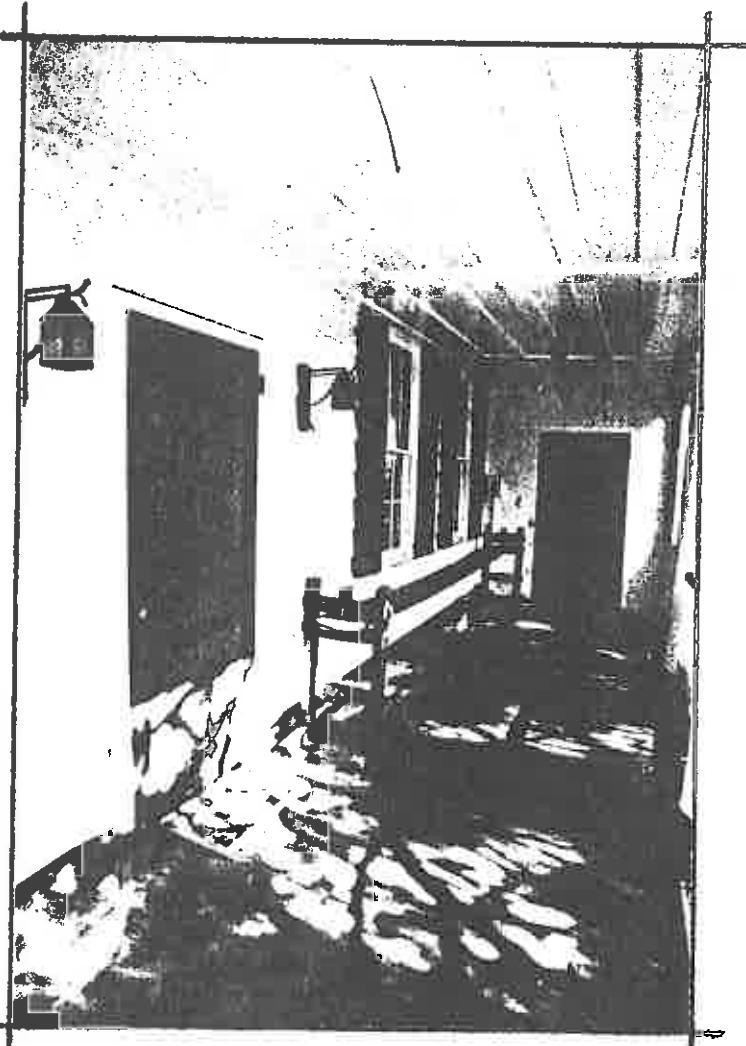
#6

**View at First Level of
Piazza, Facing East**

Note: Original 6/6 sash windows with blinds, principal entrance at left
