Faber House

635 East Bay Street, Charleston, SC

EXTERIOR FINISHES ANALYSIS

Frances Henderson Ford/FORD RESTORED/August 2018

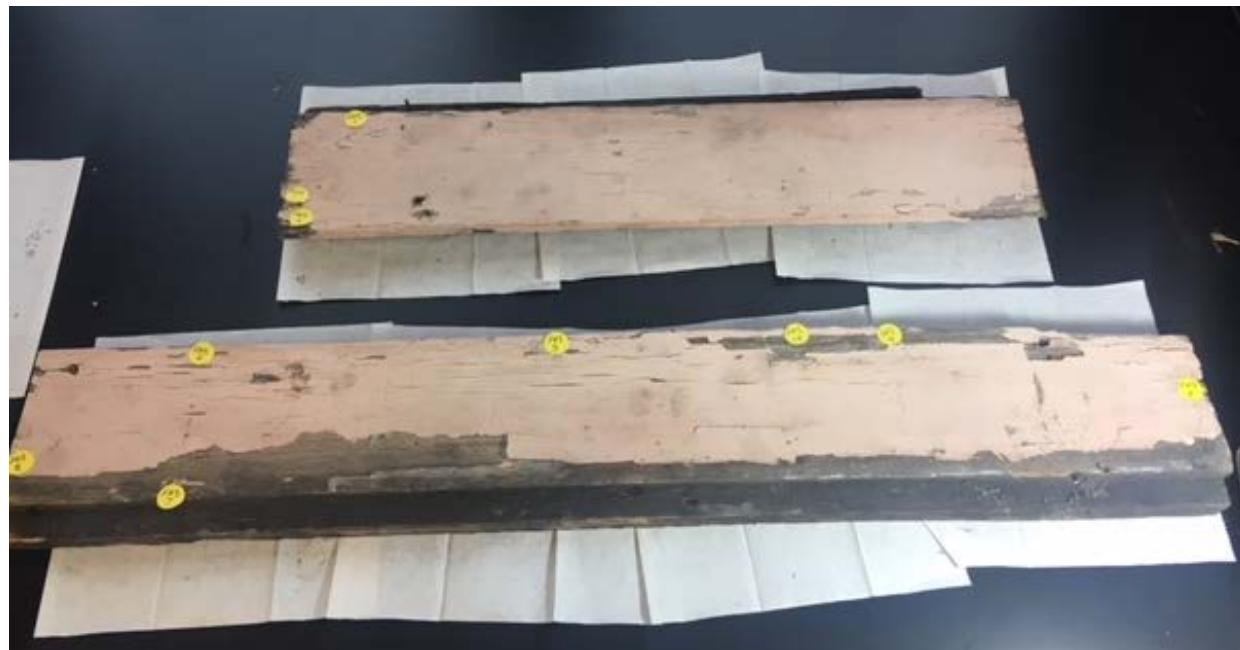
Figure 2: Siding boards with sample location dots.

Element	Sample #	Analysis notes
Siding		
No photo	FHS-1	Modern paint/primer/repair/debris from paint prep
No photo	FHS-2	Fractured sample/modern paint/repair/primer/substrate slivers show gray
No photo	FHS-3	Modern layers/substrate separated

4x/10x	FHS-4	Good example of paint prep/modern layers/ early gray soaked into wood substrate
4x	FHS-5	++ Primer layers/paint/gray on substrate
4x	FHS-6	4 campaigns of primer and pink paint/gray on substrate
No photo	FHS-7	4 campaigns of primer and pink paint/substrate fractured/gray on substrate
4x/10x	FHS-8	Pink campaigns/earlier cream/gray first
4x/10x	FHS-9	2 pieces/light color primer on wood substrate/4 campaigns of primer and pink paint.
4x/10x	FHS-10	2 pieces/light color primer on wood substrate/4 campaigns of primer and pink paint.

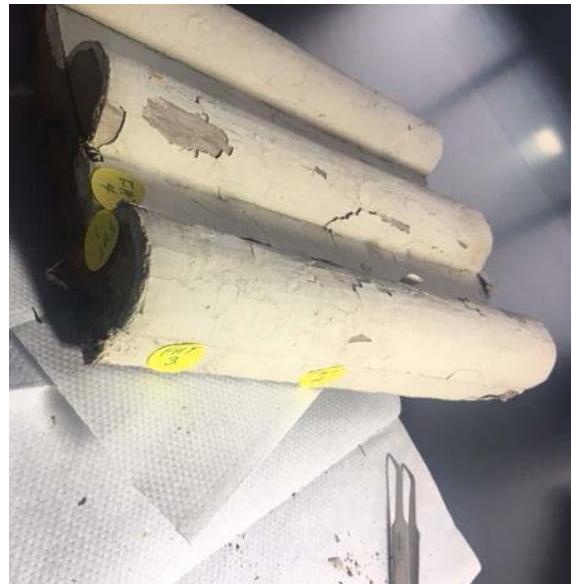
Figure 3: Trim piece with sample location dots.

Element	Sample #	Analysis notes
Trim		
4x	FHT-1	4 campaigns of paint and primer/same as current color
4x	FHT-2	4 campaigns of paint and primer/same as current color
No photo	FHT-3	Same as 2 but jumbled
No Photo	FHT-4	3 pieces

4x	FHT-5	Off white and substrate
4x/10x	FHT-6	2 pieces/off white on substrate/paint
No photo	FHT7	Fractured/3 pieces
4x	FHT-8	Full cross section
No photo	FHT-9	2 pieces/paint campaigns/jumbled
4x	FHT-10	Paint campaigns and substrate

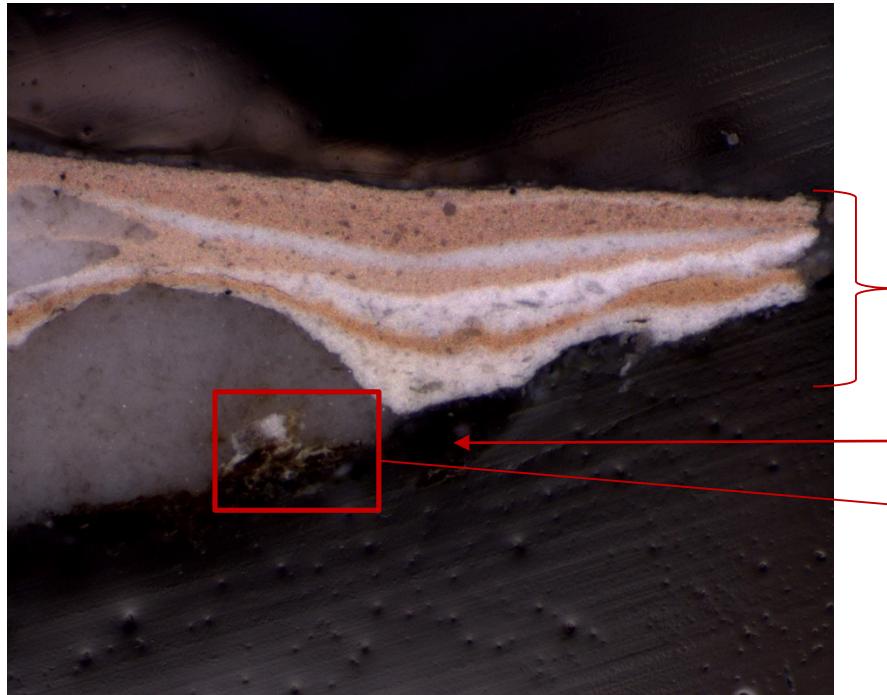
Figure 4: FHS 9 @ 4x

Samples were taken from the two pieces of siding provided. Cross sectional analysis found 4 modern campaigns of pink paint and primer on all intact samples. A closer look at the wood substrate found remnants of a light gray.

This sample shows 4 campaigns of white primer and pink paint

Wood substrate

Area of interest

The siding pieces also revealed a fairly consistent use of pink paint over white primer for the last four paint campaigns. Although samples did show some effects of time and sanding for paint prep substrate retained what looks like a cream primer with gray paint. For this study gray would be the most historic finish for the wood siding at Faber House. I matched it to BM 2109-60, Portland Gray. A lighter or darker hue would be acceptable as different cross sections found the gray light-dark.

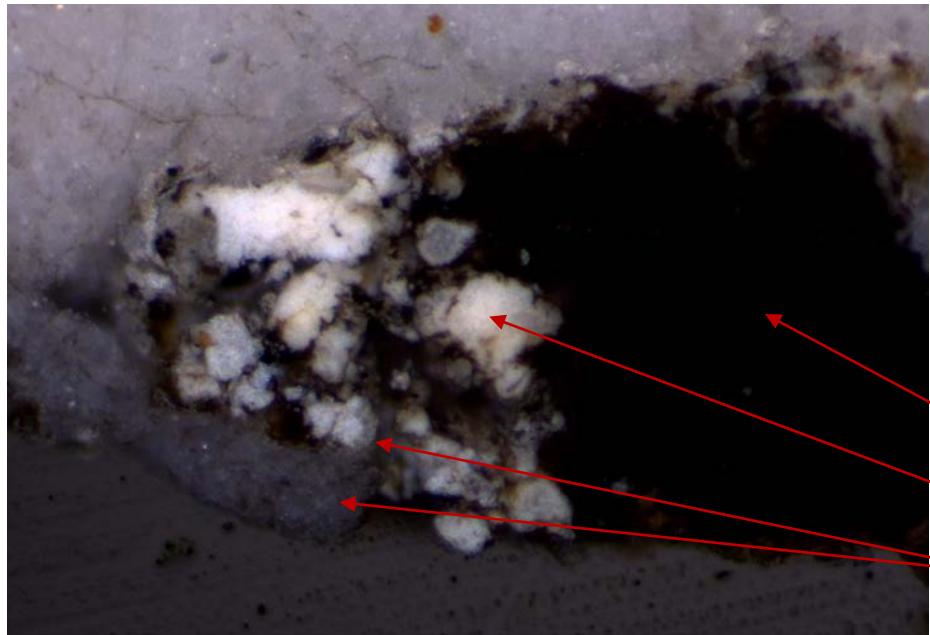
Figure 5: area of interest @ 10x.

This area of interest shows wood substrate, an off white to cream primer and early gray paint. Although a little jumbled due to age of the paint layer (exposed to the elements for an extended time and degraded) and probable paint prep for the next finishes campaign, gray is clearly the first color of the siding.

Wood substrate

Primer

Paint

Munsell 10R 8/2

Benjamin Moore BM 2109-60 Portland Grey

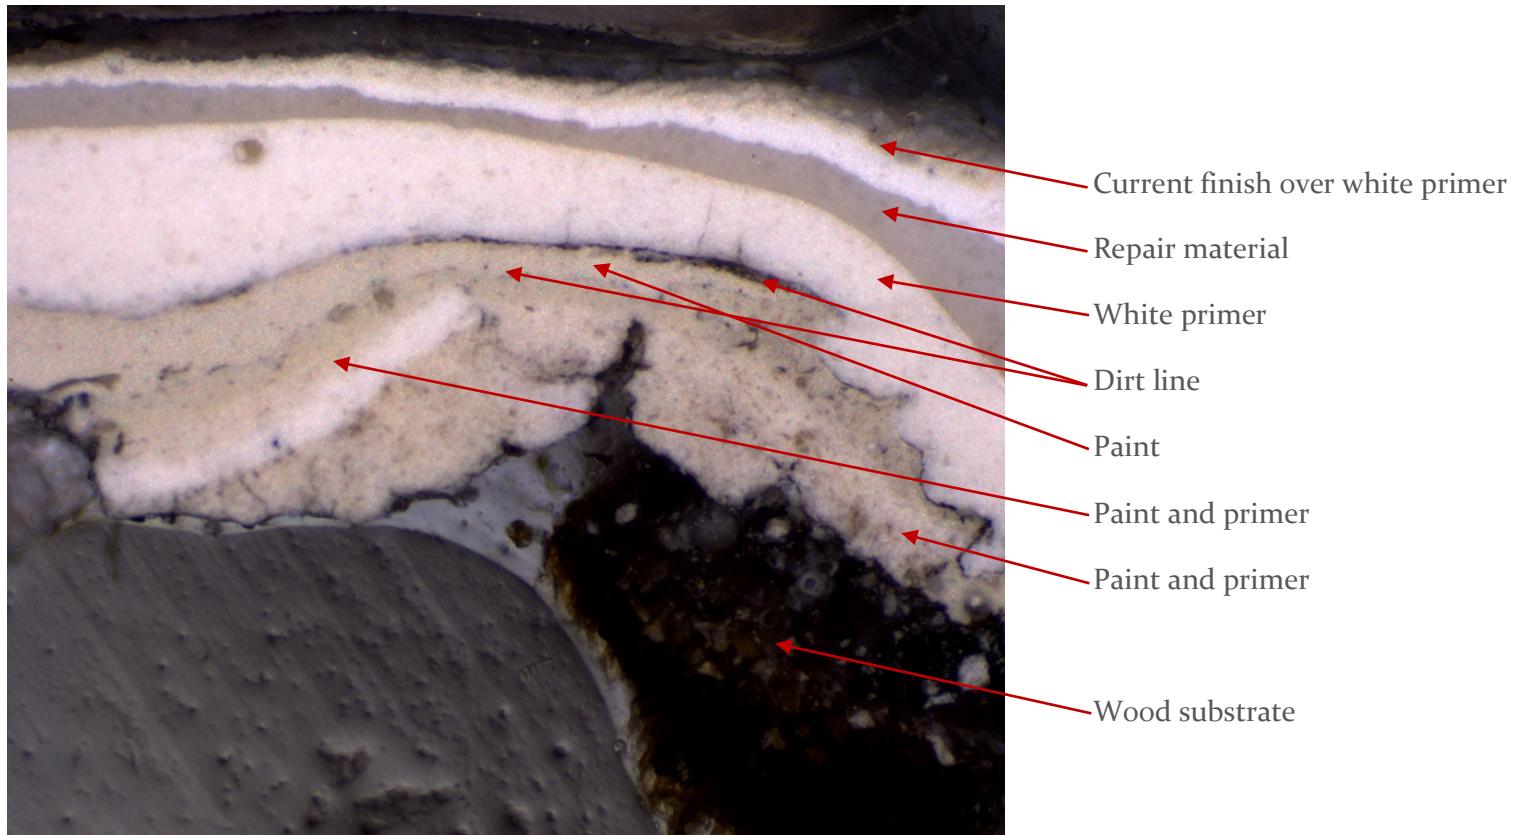
Figure 6: FHT 2a

Samples were taken from the one pieces of trim provided. Cross sectional analysis shows that the color has been consistent since this piece was installed (it is not historic).

Cross sections show four lighter primer and creamier top coat campaigns.

The trim piece that was provided reveled that since its installation the color has remained virtually the same. You can be fairly certain that the intent was always to replicate the off white. Any choice in this color family would be appropriate, I matched it to BM 2148-60, Timid White.
