80 Alexander St - Outbuilding Historic Structure Evaluation

Introduction

Houselore has been asked to evaluate the historical value of the outbuilding to the rear of 80 Alexander St. The main house was built in 1803 by Alexander Mazyck. The main house and outbuilding are located in the vicinity of the original site of Charleston's Liberty Tree.

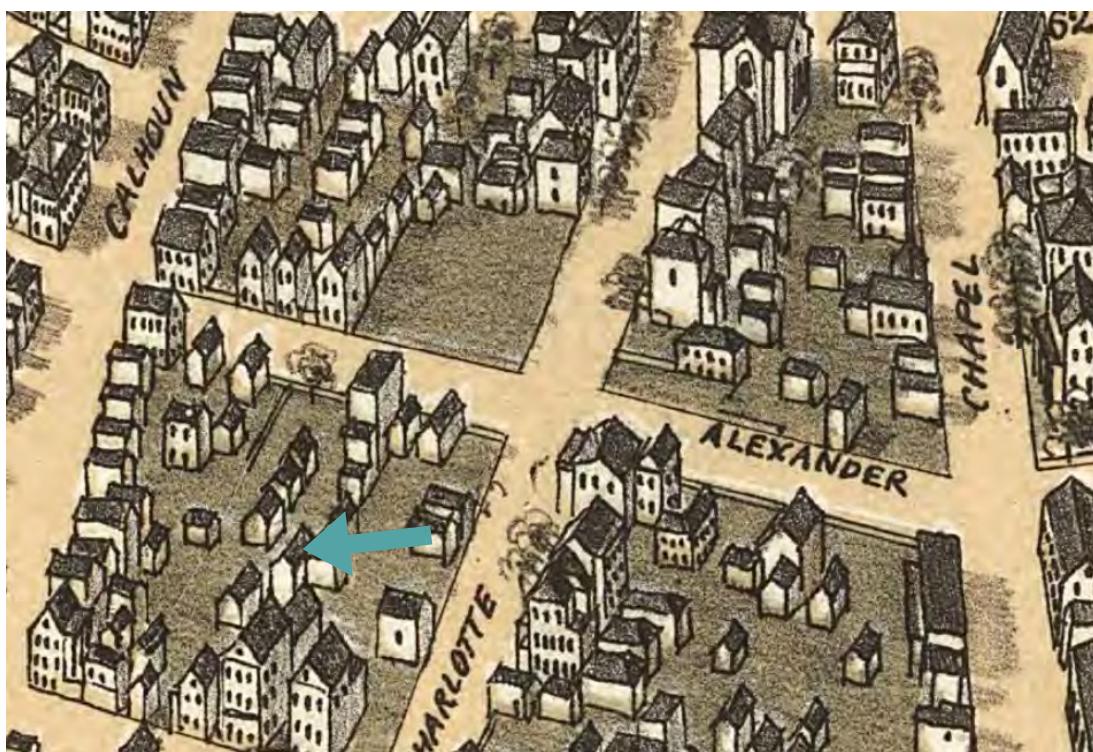
The earliest topographical representation of the property can be found in the 1872 'Birds Eye View' map by C.N. Drie. The arrow indicates the outbuilding under evaluation.

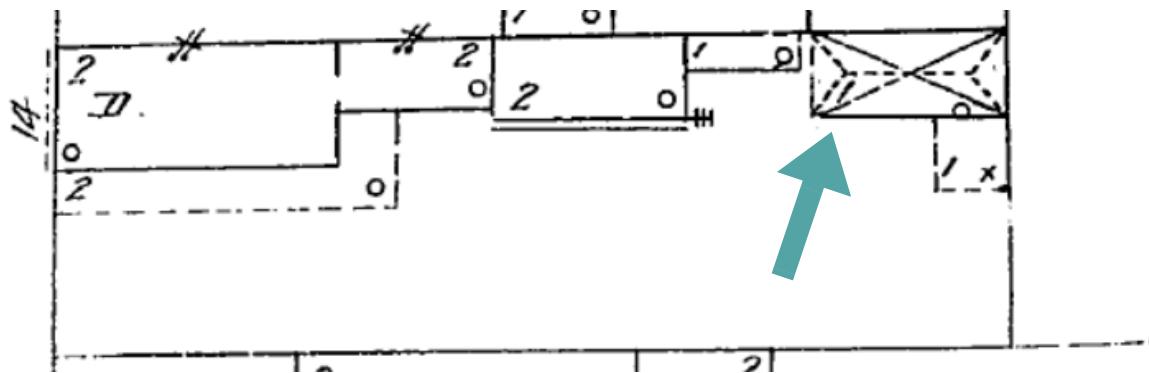
(Above) Excerpt from 1902 Sanborn Fire Map

The earliest representation of the property in the Sanborn Fire Maps is found in 1902. At this time, the property is known as 14 Alexander St. Here, the outbuilding is depicted as a one story carriage house with a pitched shingle roof.

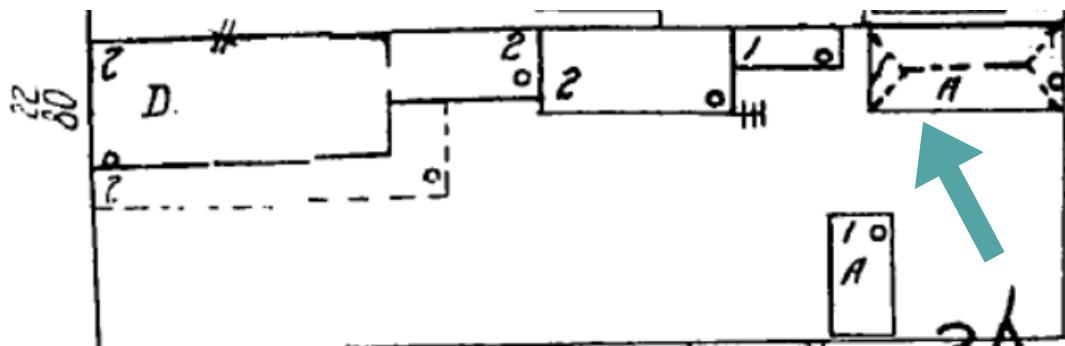
(Above) Excerpt from 1951 Sanborn Fire Map

The next representation of the property in the Sanborn Fire Maps is found in 1951. This map shows that the property number briefly changed to 20 before becoming known as 80 Alexander St. Here, we see that the outbuilding is being used as a garage. It is still one story, with a pitched shingle roof.

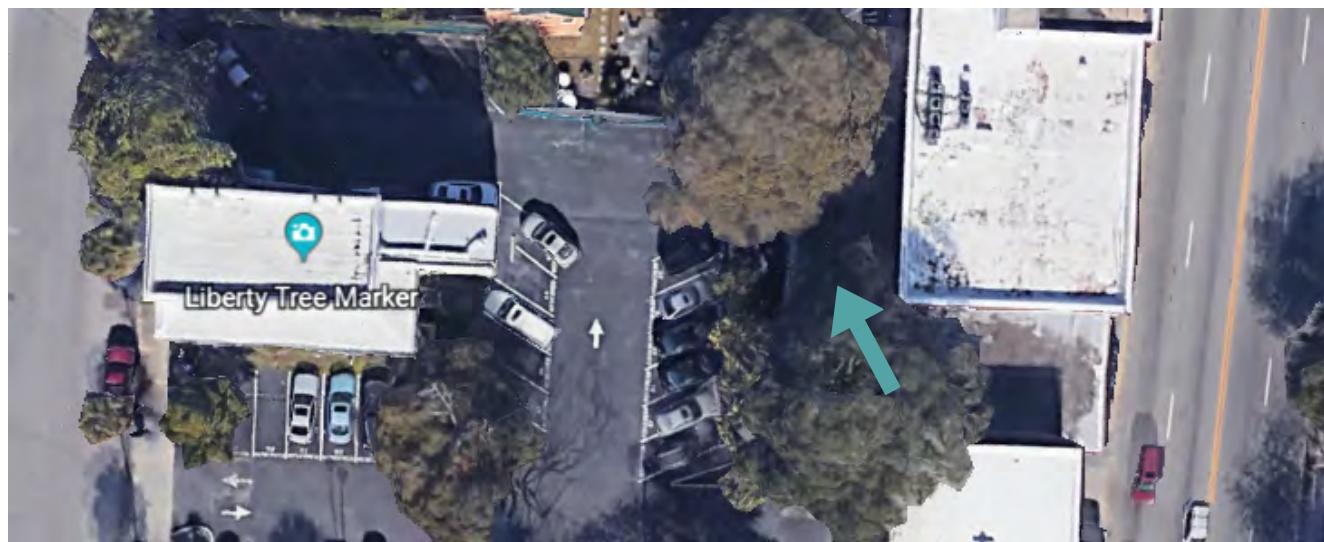
Today, several buildings depicted in the Sanborn Fire Maps between the main house and the outbuilding are no longer standing. The current location of the outbuilding is marked.

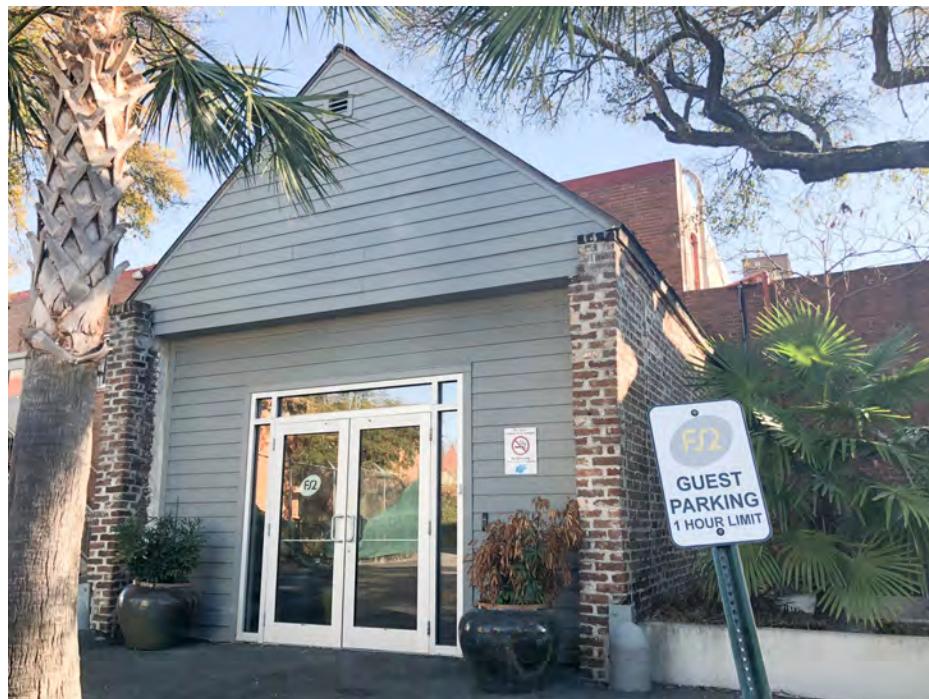
The outbuilding has undergone extensive repairs and renovations over time. Today, the front and rear facade are no longer standing. The front facade is a modern rebuild, and the rear facade has been removed and leads into a modern building, although remnants of this rear facade remain inside.

(Above) Front facade of the outbuilding, (Below) Remains of the rear facade on the interior, 2018

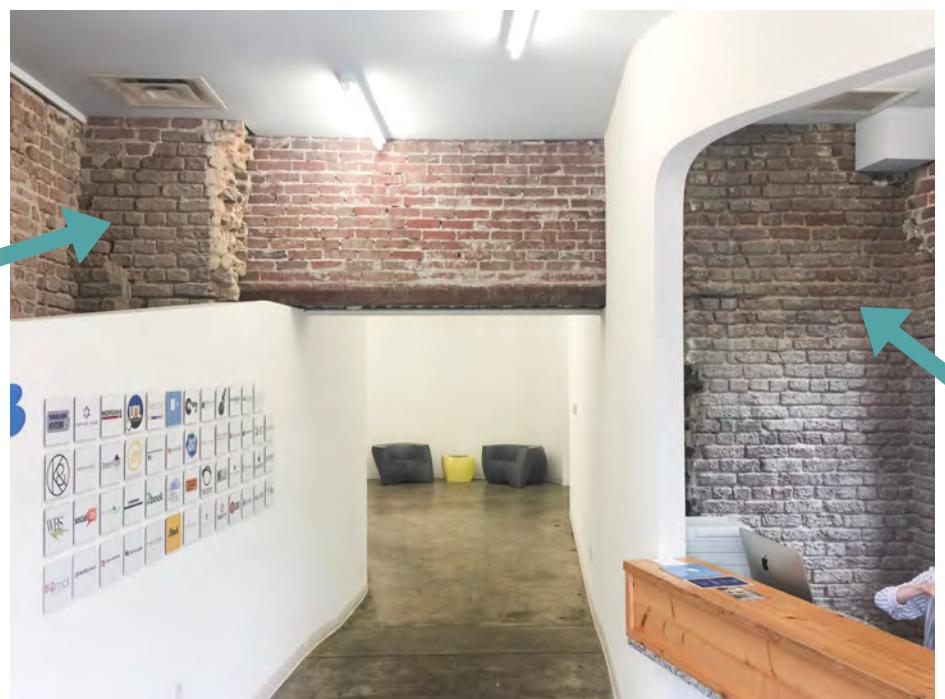
Portion of original
rear wall, 15" deep

Portion of
original rear wall

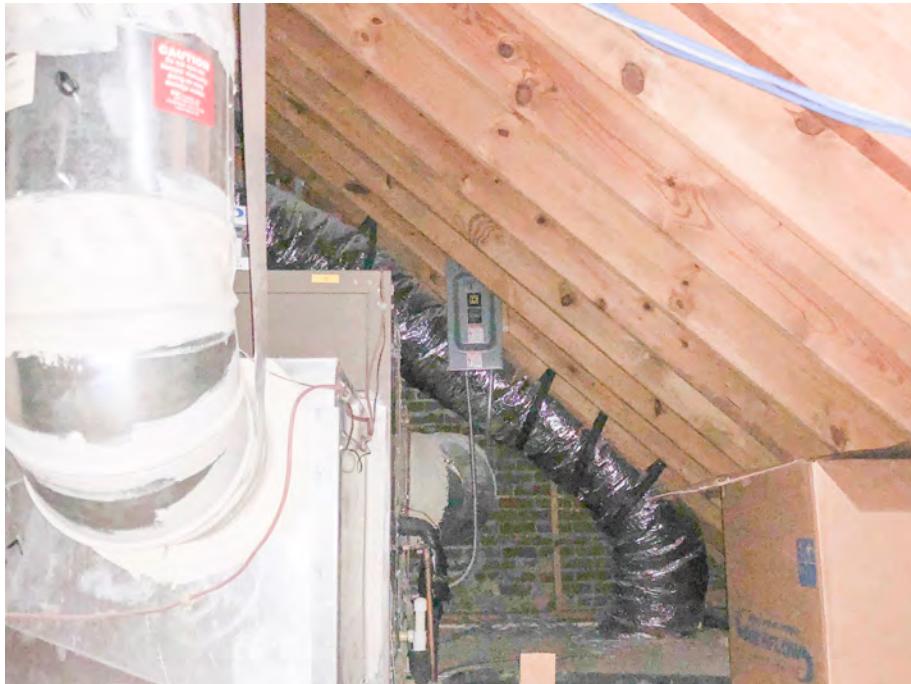
Upon inspection, it appears that the roof and its supporting structure is also modern. Modern stretcher bond brickwork is seen at the rear of the building.

(Above) Interior of the attic/roof structure, 2018

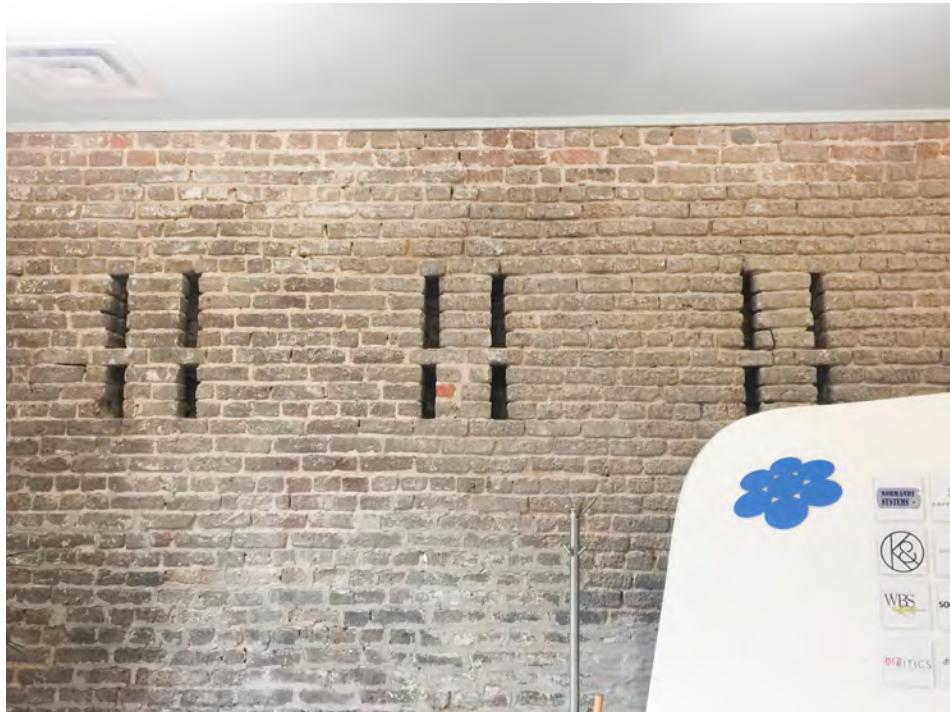
The northern wall does contain the original vertical decorative vents within the brickwork on the interior, but they have been covered over on the exterior.

(Above) Interior vertical decorative vents on northern wall, 2018

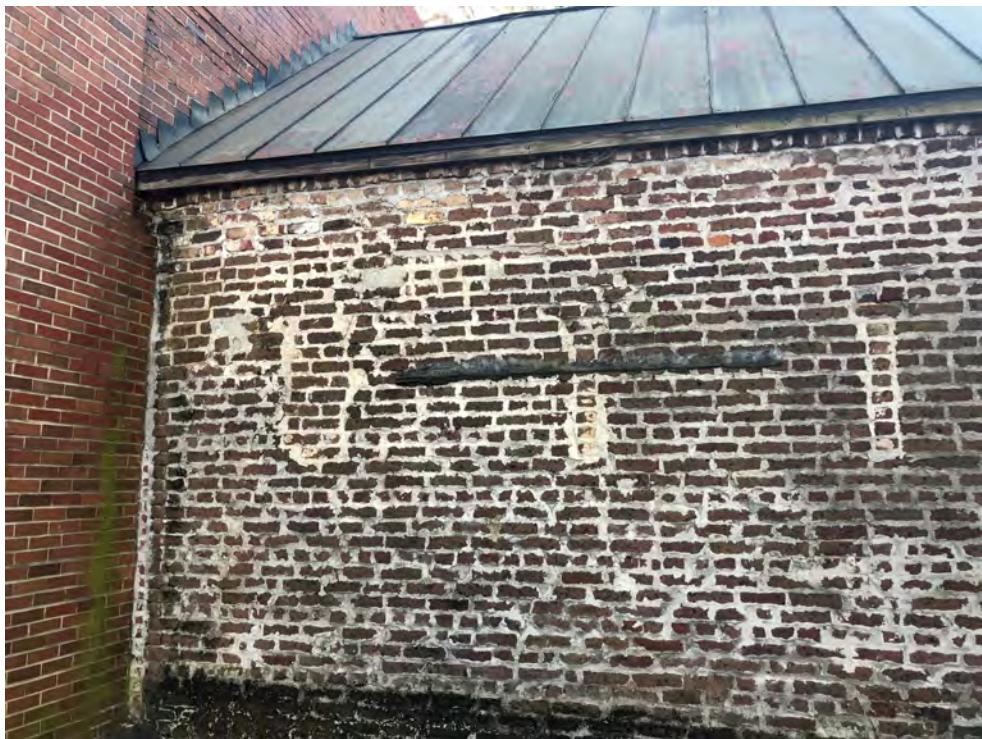
(Above) Exterior of northern wall, 23' long and 11' tall, 2018

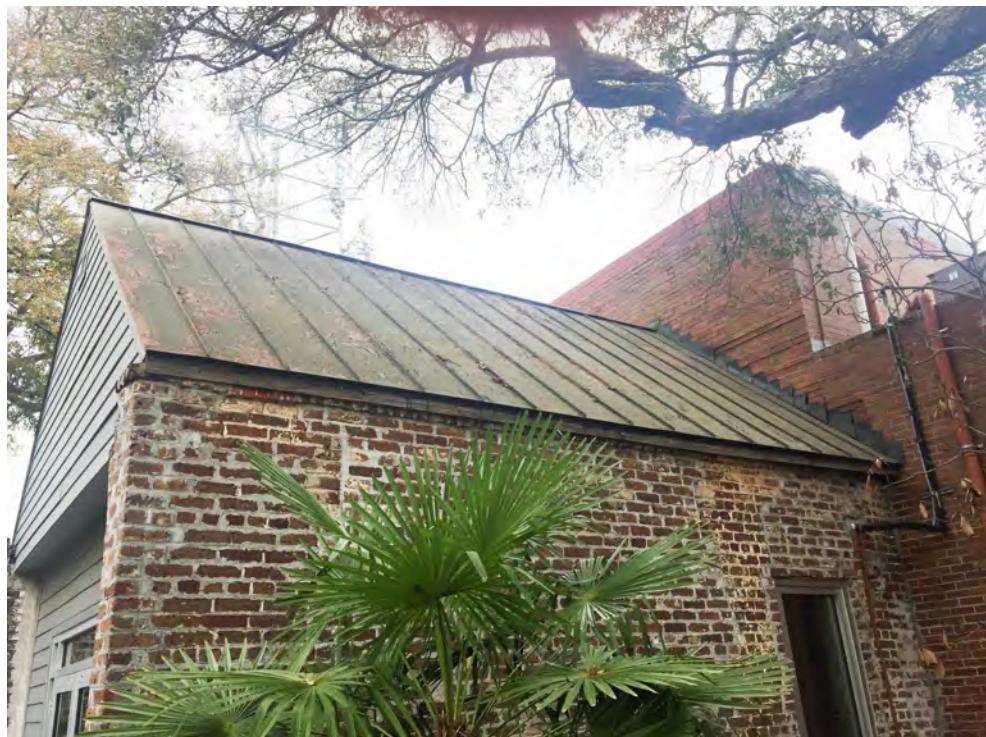
The southern wall appears to have undergone extensive repair, and a large portion of the middle section is modern brickwork. A modern window has also been installed.

(Above) Exterior of southern wall, 23' long and 11' tall, 2018

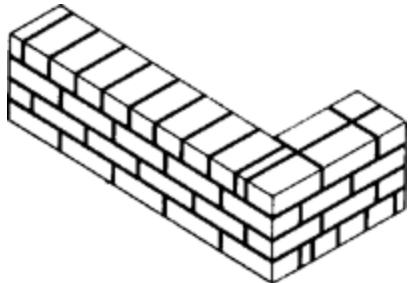
The original brickwork of the outbuilding, much of which remains in the northern and southern walls, is an English Garden Wall bond. This is unusual, as English Garden Wall bond is rarely found on buildings outside the northern states, although it is particularly prevalent on the east coast. This bond pattern was used from the late 18th century onward. It is characterized by one row of headers to three rows of stretchers. The bricks in both walls are handmade and some of the original lime/sand/shell mortar remains.

(Above) English Garden Wall bond cross section

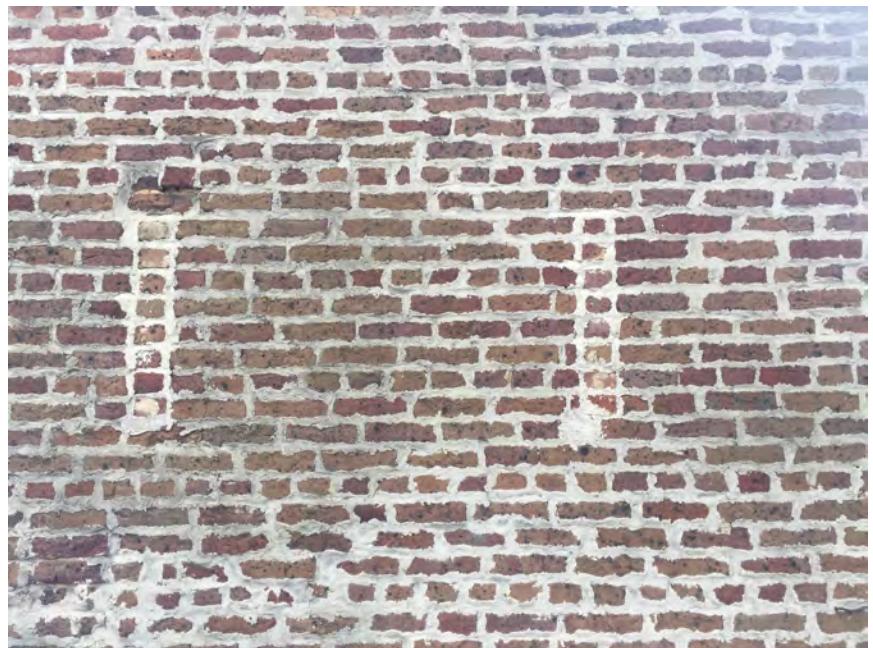
(Above) Northern wall showing English Garden Wall bond and filled in decorative vents
