NATHANIEL RUSSELL HOUSE CHARLESTON, SC MORTAR ANALYSIS REPORT

PREPARED FOR:
WILL HAMILTON
HISTORIC CHARLESTON FOUNDATION
CHARLESTON, SC 29401

PREPARED BY:
MEADORS, INC.
PO BOX 21758
CHARLESTON, SC 29413

DATE: 09.19.2016

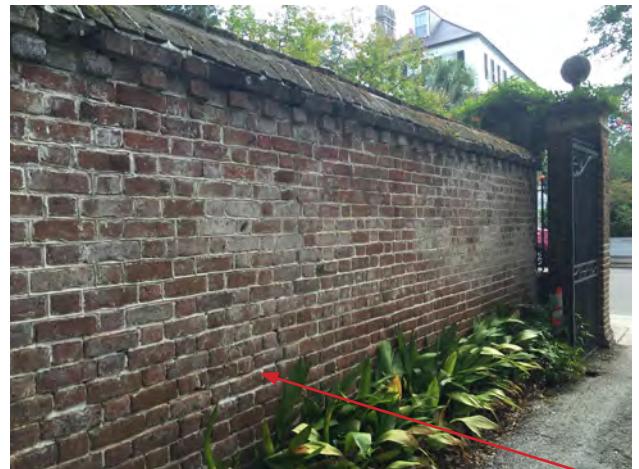
Figure 1: Photo of sampling location on north perimeter wall.

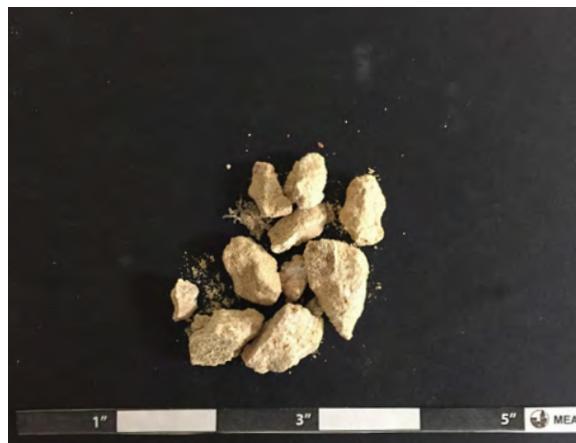
Figure 3: Photo of bulk sample.

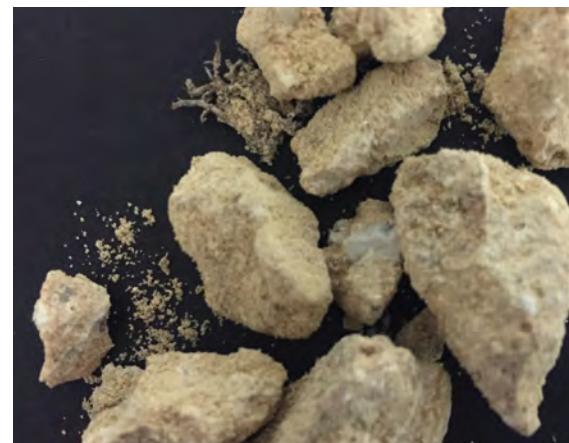
Figure 4: Close-up of bulk sample showing numerous shell fragments.

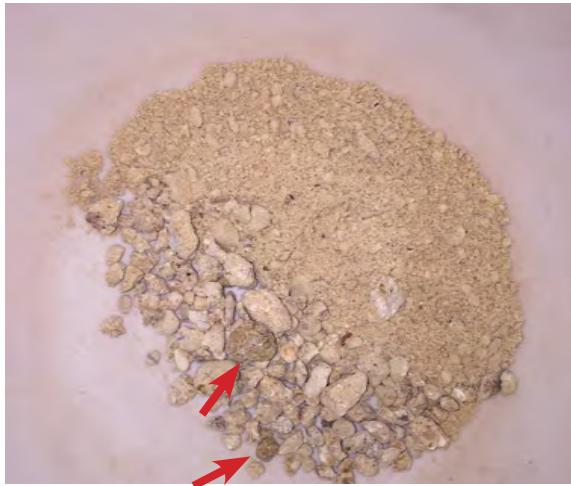
Figure 7: Powdered sample prior to addition of acid. Note round brown clay lumps within mortar (arrow).

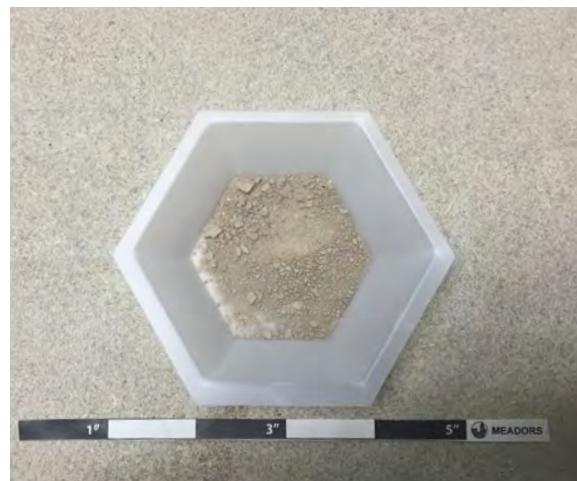
Figure 6: Photo of fines extracted from the sample.

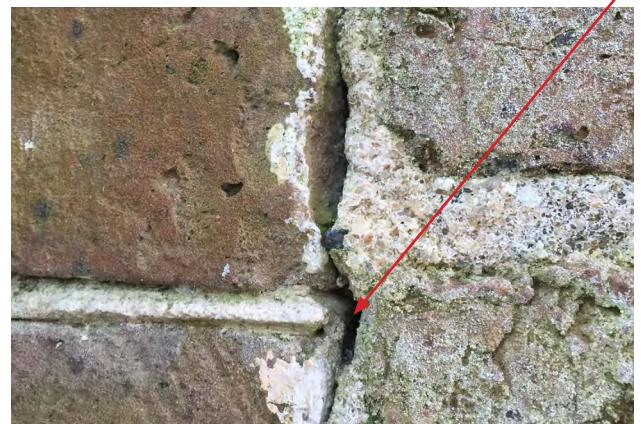
Figure 16: Close-up of sample location.

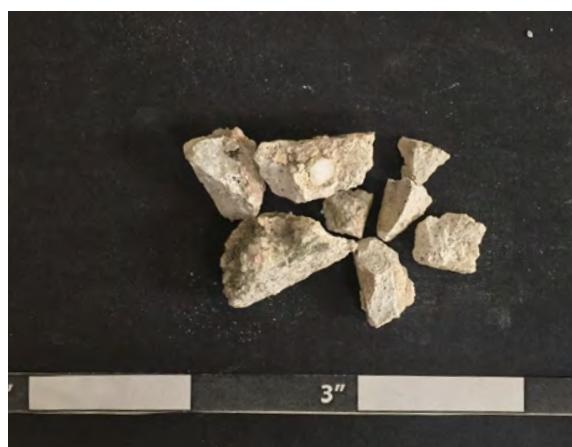
Figure 17: Photo of bulk sample.

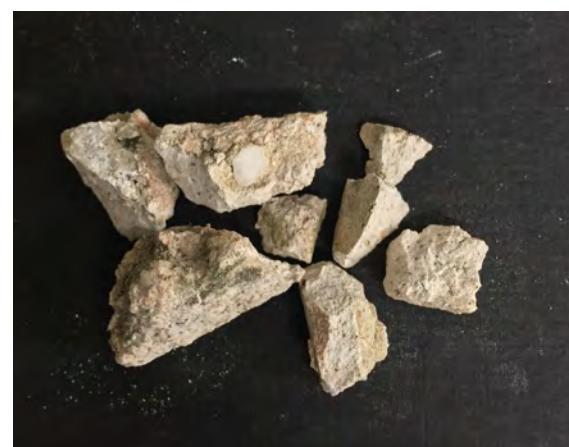
Figure 18: Detail of bulk sample with visible shell aggregate.

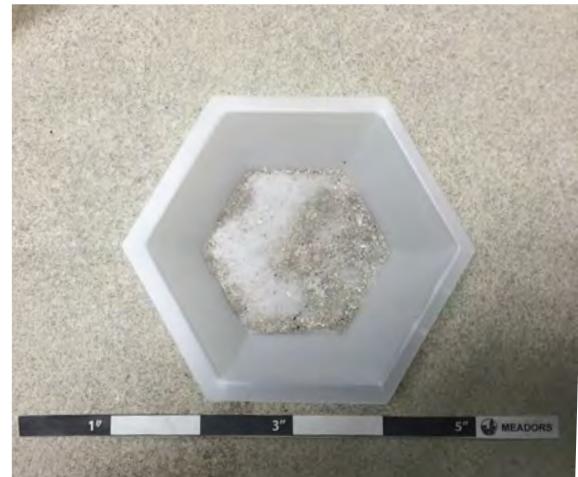
Figure 22: Photo of fines extracted from the sample.
