Nathaniel Russell House

51 Meeting Street, Charleston, SC 29401

Interiors finishes report

November-December 2012

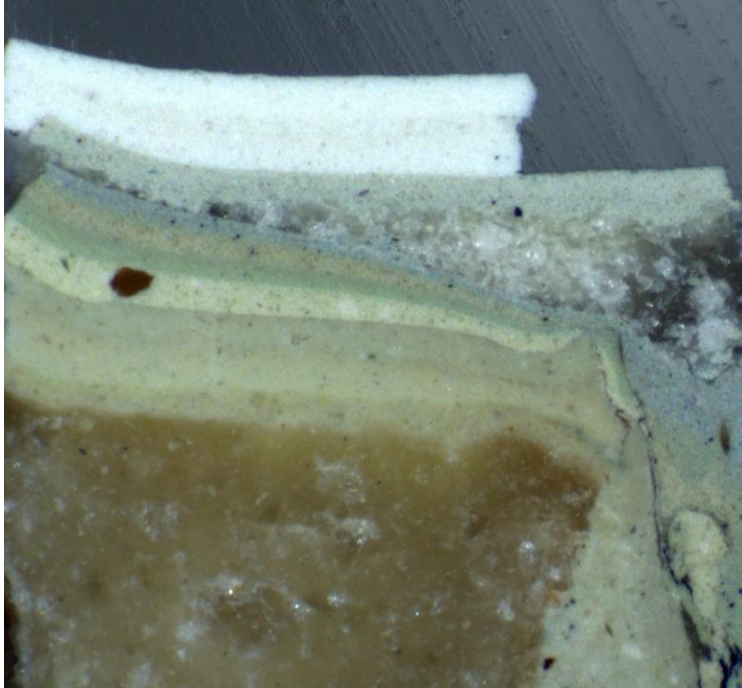
Nathaniel Russell House
Sample Location: 107A east kitchen
Detail: North wall
Sample #:107A-N-3

This sample is the most representative of those taken from the north wall of room 107A (east kitchen). On plaster substrate are three generations of cream distemper paint with visible pigments. A middle period reveals a creamy yellow, pale green and blue wall finish before modern layers of warm white, creamy yellow, white primer and white paint.

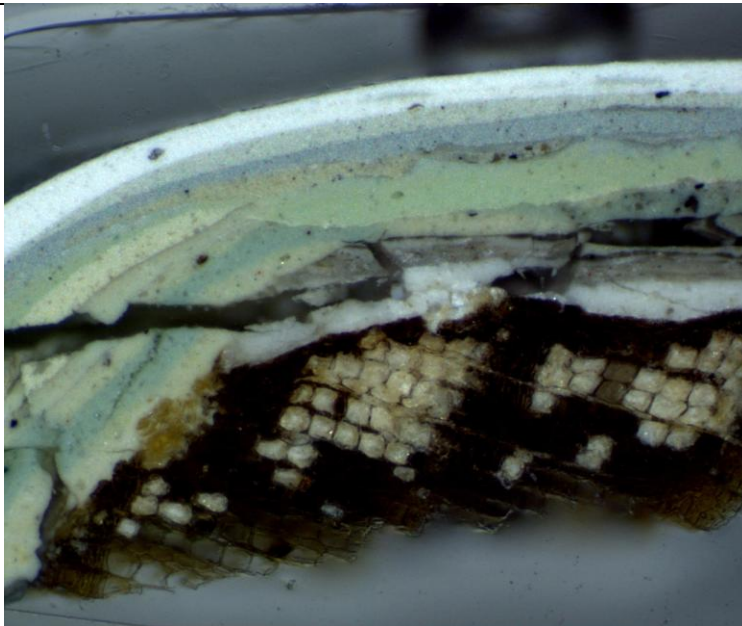
Nathaniel Russell House
Sample Location: 107A east kitchen
Detail: North window surround
Sample #:107A-NW-3

This sample is most representative of those taken from the window surround on the north wall room 107A (east kitchen). On wood substrate is warm white primer and gray finish coat. The next campaign of creamy yellow lines up through modern finishes with that of the wall in this area.

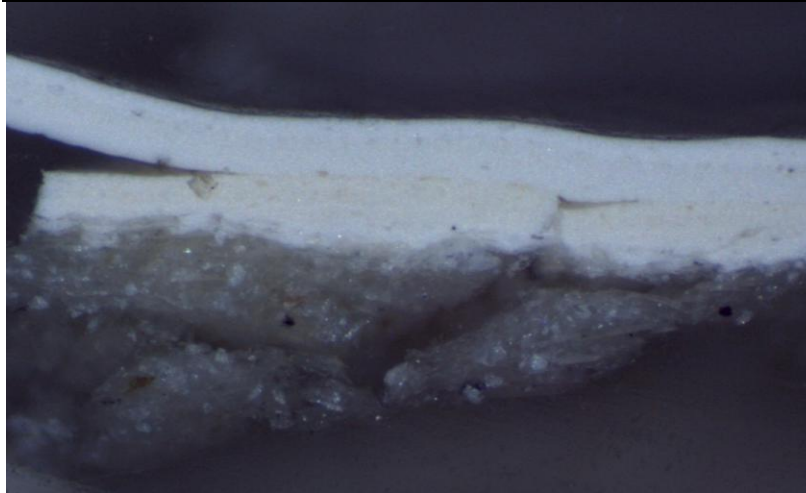
Nathaniel Russell House
Sample Location: 107A east kitchen
Detail: south wall
Sample #: 107A-WS-2

This sample from the south wall of room 107A (east kitchen) confirms data from the 1996 Architectural Analysis that this partition wall was added by Historic Charleston Foundation at the time of its purchase of the Nathaniel Russell House, creating the small office on the south side. It contains only modern paint campaigns

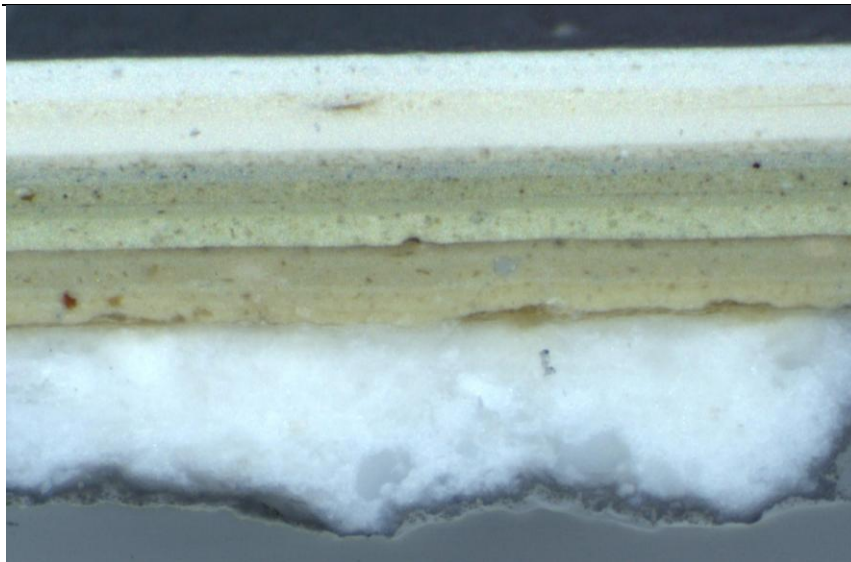
Nathaniel Russell House
Sample Location: 107A east kitchen
Detail: west wall
Sample #:107A-WW-1

This sample from the west wall of room 107A (east kitchen) confirms the stratigraphy found on the north wall.

Early generations of cream distemper paint on plaster substrate with visible pigments (yellow, blue and white). A middle period of creamy yellow, pale green and blue wall finish before modern layers of warm white, creamy yellow, white primer and white paint.

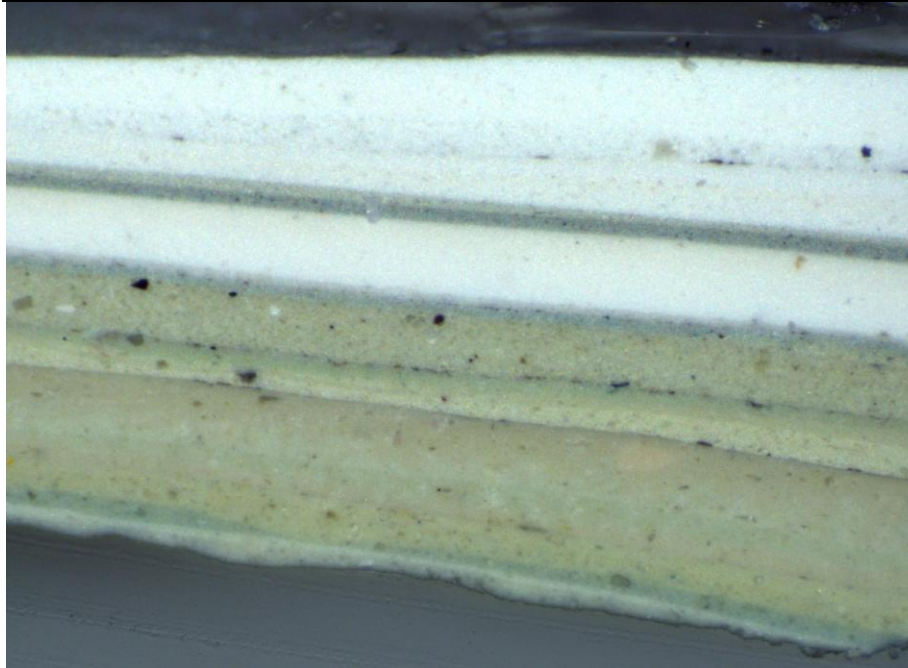
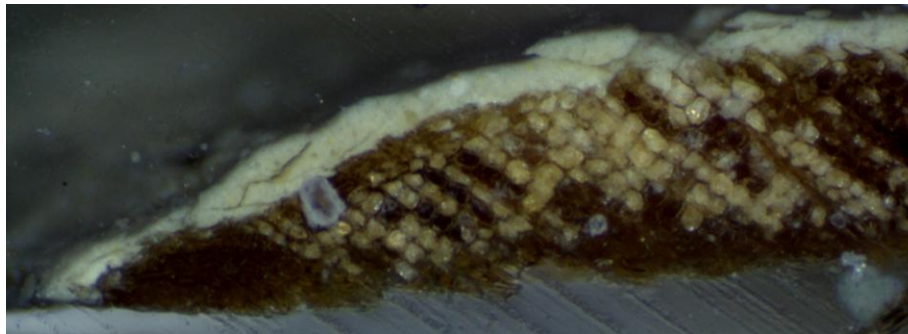
Nathaniel Russell House
Sample Location: 107A east kitchen
Detail: west wall door surround
Sample #:107A WD-1

This sample is most representative of those taken from the door surround on the west wall room 107A (east kitchen). The wood substrate is shown with original cream distemper paint, which, similar to wall samples was continued for three generations. Dirt lines are very evident in this sample to the point of making some layers appear darker. The middle period of finishes are consistent with earlier samples with only in more contemporary times an additional campaign of green and the omission of the modern yellow. The application of paint in this area was for some reason thicker, as evident in the modern white paint layers.

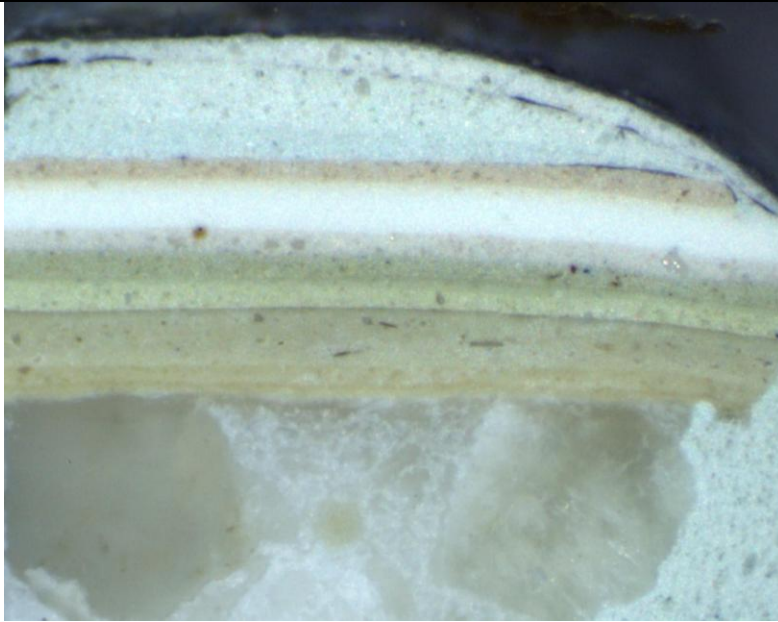
Nathaniel Russell House
Sample Location: 107B office
Detail: wall west
Sample #: 107B-WW-1

This sample from the west wall of room 107B (office) finds paint history prior to the creation of the 1955-56 office. First period creamy yellows, second period creamy green are followed by beige and warm white.

Fourth generation flesh on cream primer was followed with pale blue and pale green.

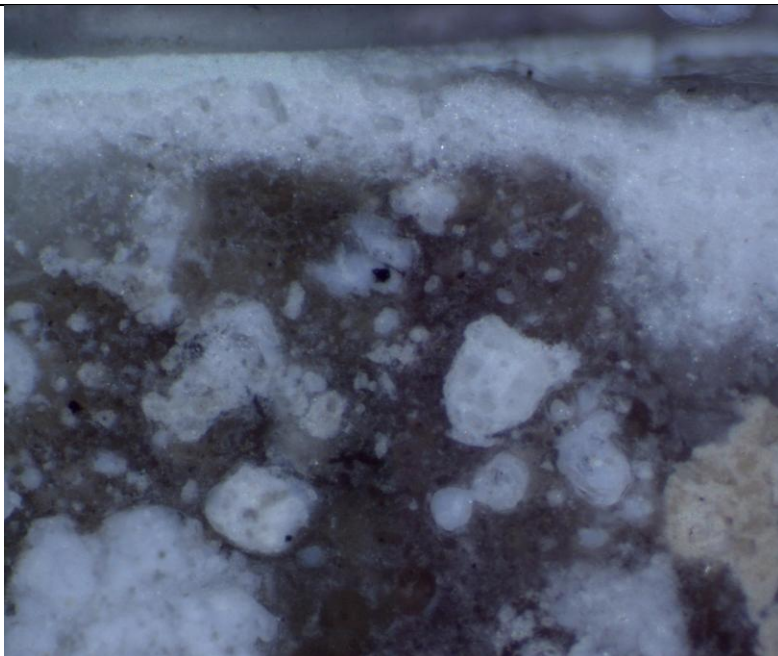
Nathaniel Russell House
Sample Location: 107B office
Detail: wall south
Sample #: 107B-WS-1

This sample from the south wall near the doorway has disturbed layers due to repair or paint prep but modern finishes of flesh, white and pale green are evident. This wall must have been part of the 1955-56 office addition.

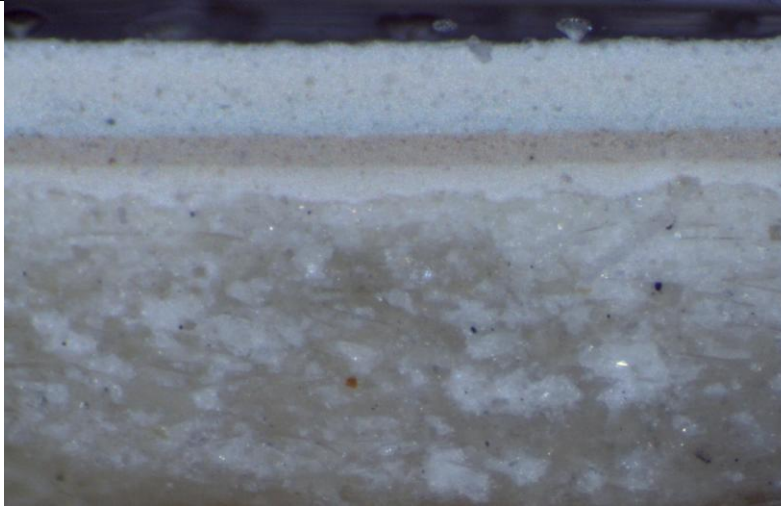
Nathaniel Russell House
Sample Location: 107B office
Detail: north wall
Sample #: 107B-WN-1

This sample from the north wall of room 107B (office) confirms data from the 1996 Architectural Analysis that this partition wall was added by Historic Charleston Foundation at the time of its purchase of the Nathaniel Russell House to create the small office on the south side. It contains only modern paint campaigns which begin with a 1955-56 cream paint, followed by flesh, pale blue and creamy white.

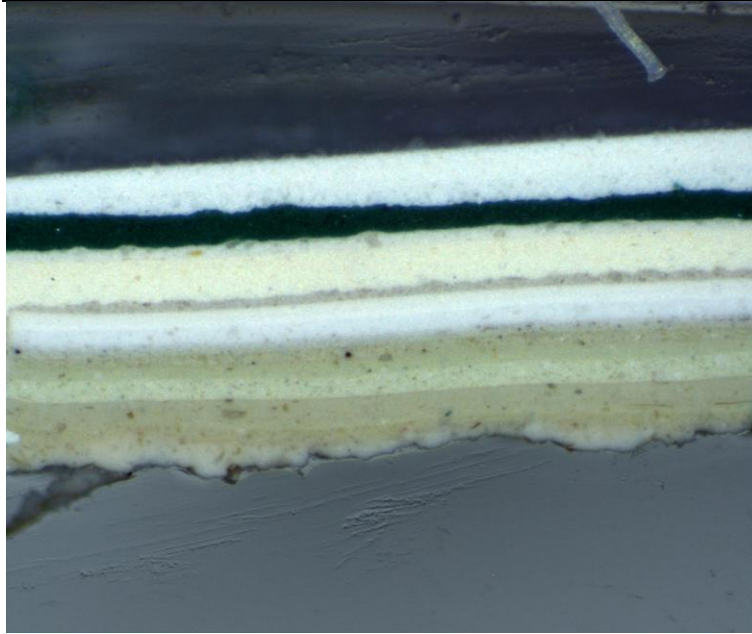
Nathaniel Russell House
Sample Location: 107C west kitchen
Detail: south wall
Sample #: 107C-2

This sample is most representative of those taken from the south wall, room 107C (west kitchen). On wood substrate is a first period cream primer and cream distemper paint, the second period being very similar with just more of a green hue. Tan, white, pale yellow and oatmeal layers follow with modern finishes consisting of pale yellow, dark green on white primer and cream primer and paint.

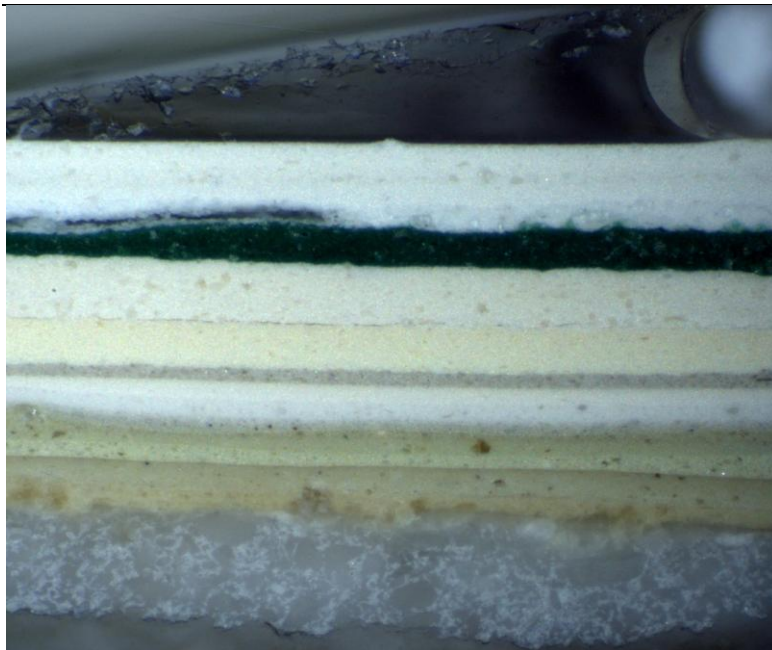
Nathaniel Russell House
Sample Location: 107C west kitchen
Detail: west wall
Sample #: 107C-W-1

This sample is most representative of those taken from the west wall room 107C (west kitchen). The finish layers of this sample are identical to those found on the south wall (sample # 107-C-2, seen above).

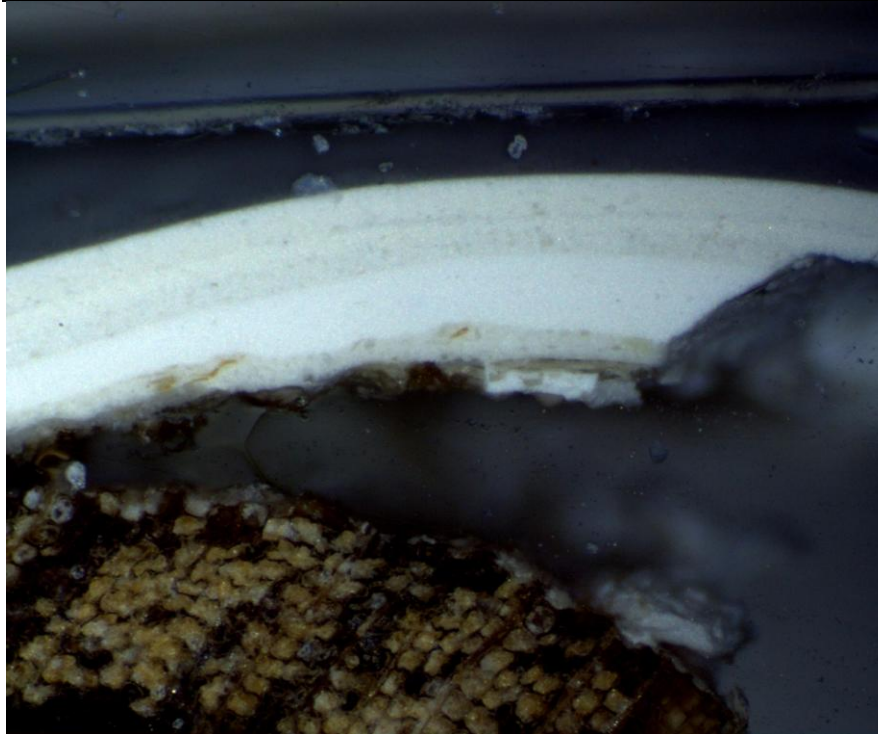
Nathaniel Russell House
Sample Location: 107C west kitchen
Detail: south window surround
Sample #:107C-SW-1, 107C-SW-2

This sample is most representative of those taken from the south window surround room 107C (west kitchen). Modern finishes are all warm whites, the middle section of the chronology no longer present. The original campaign seen on wood substrate is a translucent gray. This gray is most likely the same as found in room 107A. These samples have evidence of paint prep by burning and also repair material.

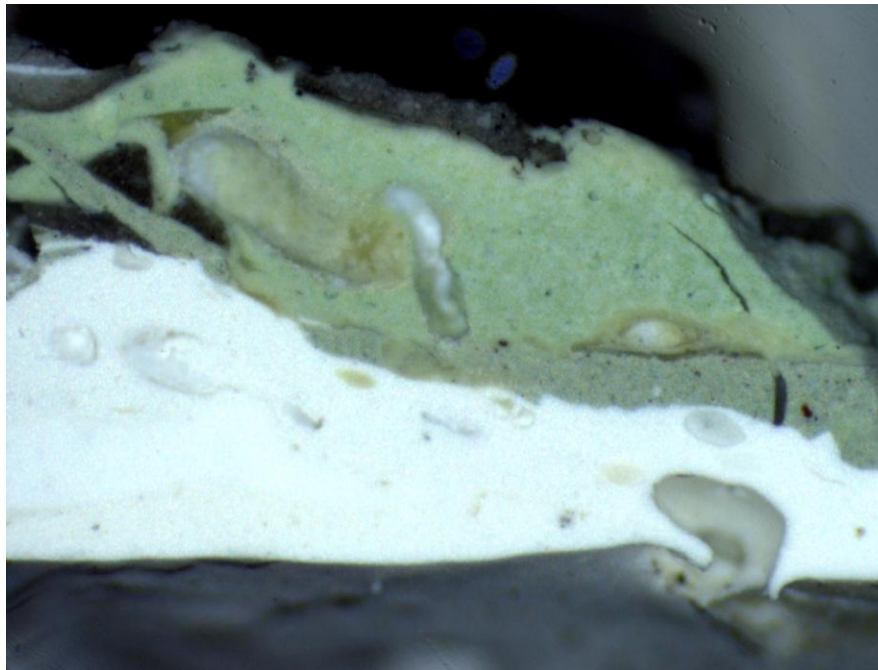
Sample 107C-SW-2 was taken from the same widow surround detail but shows a much different chronology of finishes. Its jumbled state indicates paint prep. Original gray (although appearing much darker here) is followed by green primer and paint. The modern paint layers are warm white latex as seen in sample 107C-SW-1.

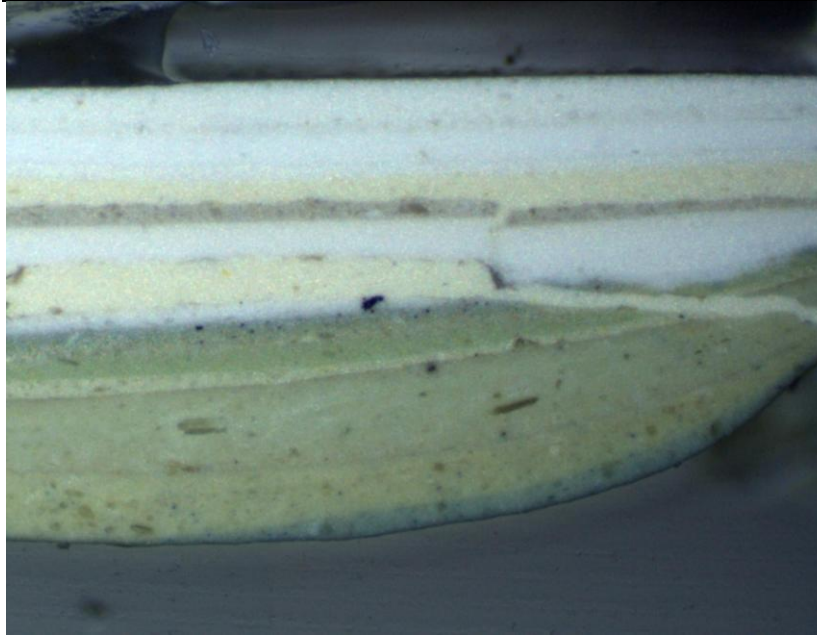
This sample is most representative of those taken from the west door surround room 107C (west kitchen) with 14 layers.

Original finishes of creamy yellow and pale blue are followed by three campaigns of tinted creams; yellow and green. These are followed by a warm white primer and yellow paint, white primer under oatmeal, followed again by yellow. Modern latex layers are warm white.

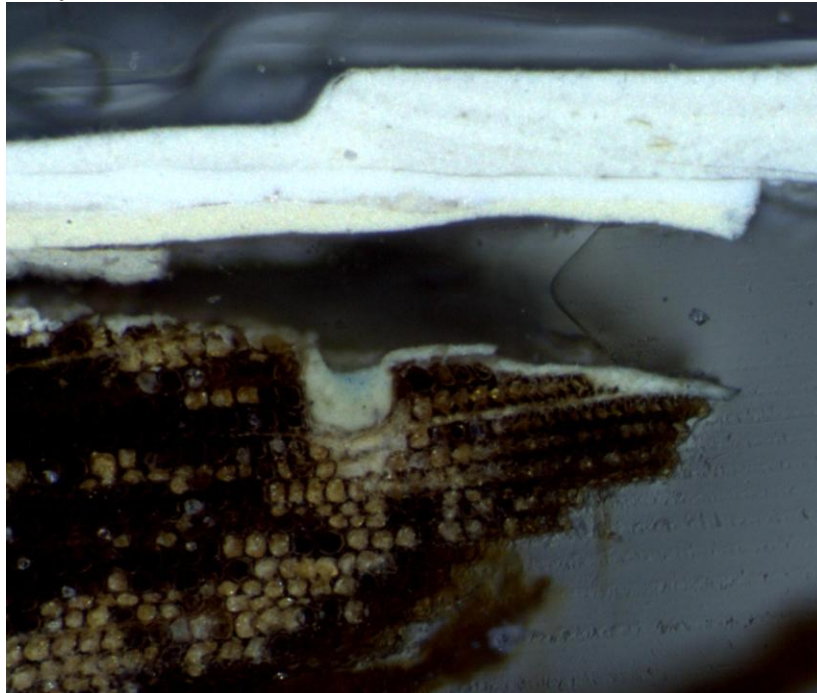
Sample #: 107C-D-2

This additional sample from the west door surround room 107C (west kitchen) is included to confirm original finishes for this detail. Creamy yellow and pale blue captured in a small recess of the wood substrate. All middle campaigns are missing from this sample but resume with modern tan, yellow and warm whites.

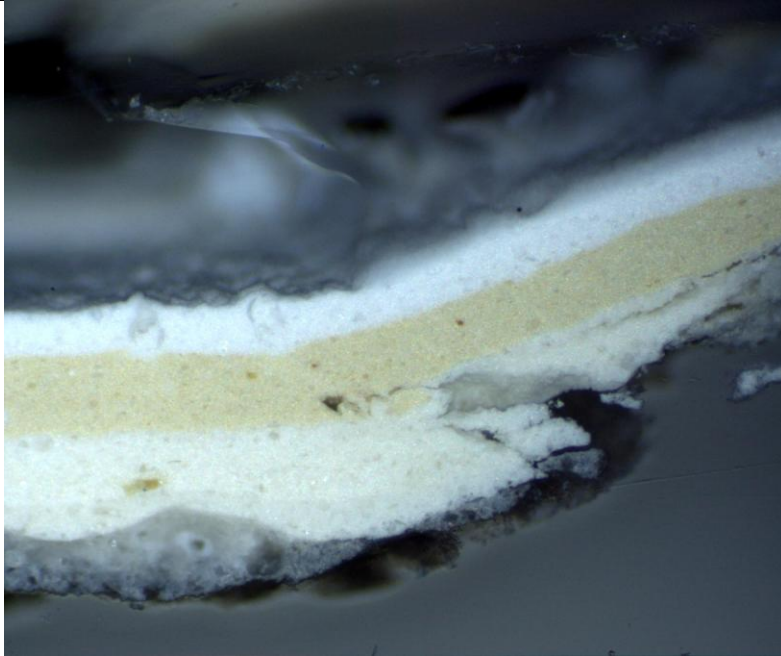
Sample #:108-W-2

This sample is most representative of those taken from the east wall of room 108 (ticket office). A modern wall of unknown date shows a cream primer and yellow paint followed by warm white.

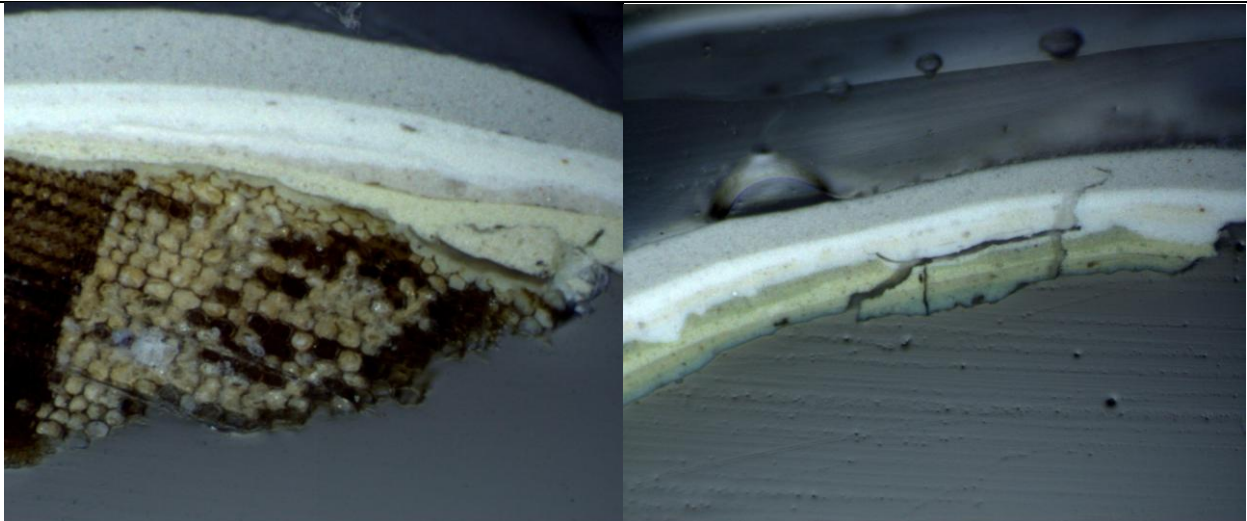
Sample #: 108-D-1, 108-D-2

This sample is most representative of those taken from the east door surround room 108 (ticket office). Two cross sections are shown from the same detail to illustrate modern layers (left sample 108-D-1) but also early layers (108-D-2) which correspond to those from room 107C door surround beginning with creamy yellow and pale blue followed by the first two campaigns of tinted creams seen on the corresponding door surround in room 107C (west kitchen).

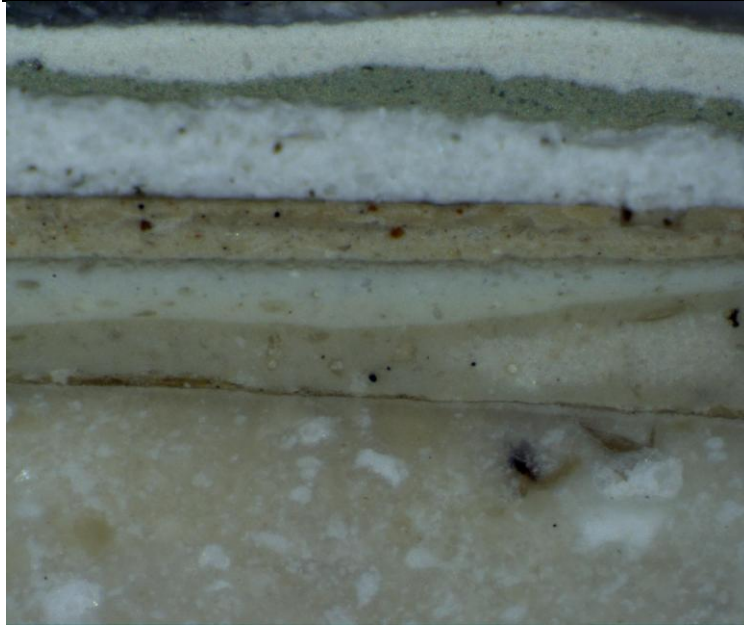
Nathaniel Russell House
Sample Location: 207 office
Detail: north wall
Sample #: 207-N-2

This sample is most representative of those taken from the north wall, room 207 (office). On plaster substrate are two early primer and top coats of cream followed by two yellow creams. A repair material is next followed by green and modern warm whites.

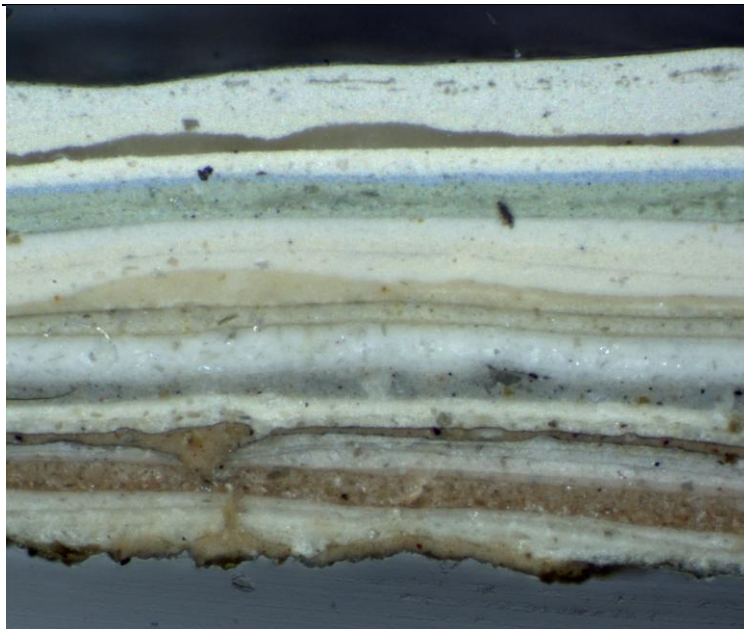
Nathaniel Russell House
Sample Location: 207 office
Detail: north window surround
Sample #:207-NW-2

This sample is most representative of those taken from the north window surround room 207 (office). From the sheer number of layers (18) you would have to assume this to be an original detail in this room. At least six layers of clear or tinted glazes are followed with a tan paint (seen in the photomicrograph as phase one but it seeped through a failure in the paint layers below it) with visible pigments. Creams and warm whites dominated the middle periods with pale green and blue finish before the modern warm whites which are interrupted by a separation between paint campaigns.

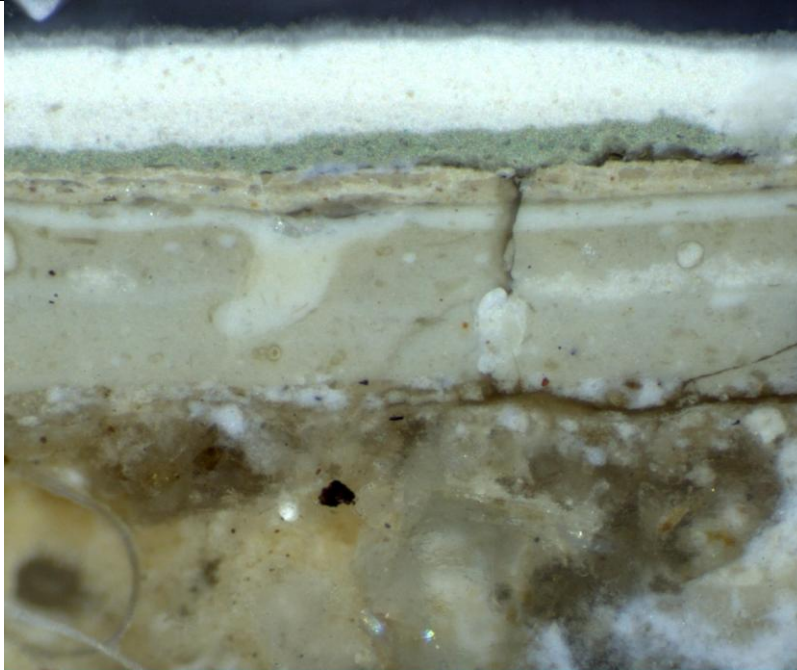
Nathaniel Russell House
Sample Location: 207 office
Detail: west wall
Sample #:207-W-2

This sample is most representative of those taken from the west wall, room 207 (office). Three coat plaster layers are visible before original primer and top coats of cream to cream yellow. Modern layers of green and warm whites follow. This sample is essentially the same as that seen in sample 207-N-2 without the repair material.

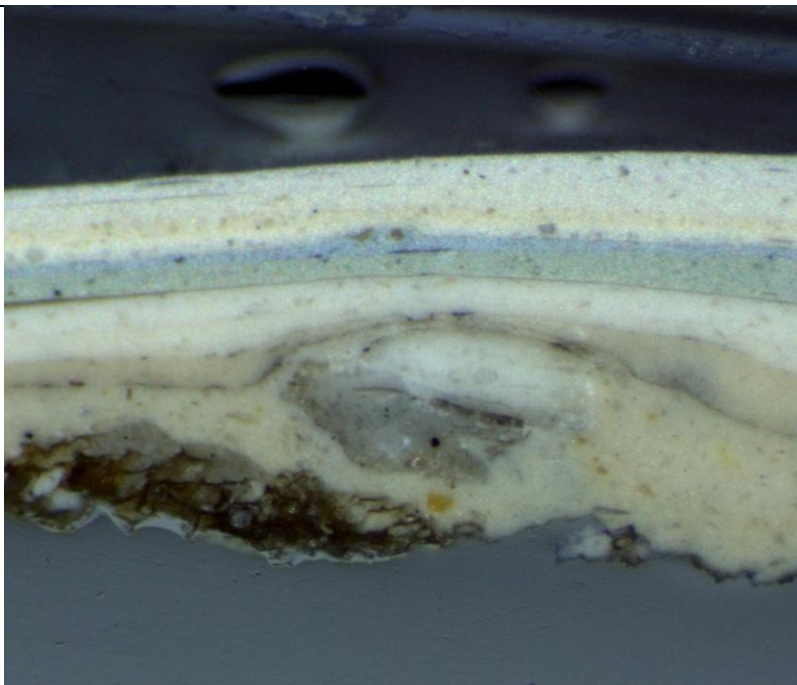
Nathaniel Russell House
Sample Location: 207 office
Detail: west door surround
Sample #:207-WD-2

This sample is most representative of those taken from the west door surround room 207 (office). Phase one gray is seen on the wood substrate followed by campaigns of cream poorly mixed with yellow pigments and voids. Phase four is warm white. Green and blue are the same as seen in north window surround samples (207-NW-2) followed by yellow (in the location of the separation in the window surround samples). It is followed by modern warm whites.

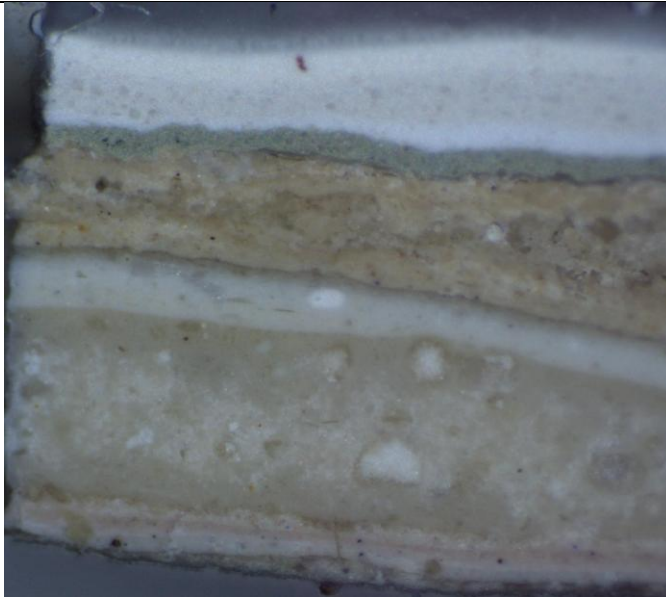
Nathaniel Russell House
Sample Location: 207 office
Detail: south wall
Sample #:207-WS-3

This sample is most representative of those taken from the south wall, room 207 (office). Very similar finish layers are seen in comparison to the north and west wall samples with a few differences probably due to paint prep or repair on this wall. An early translucent and pigmented (pale flesh color) layer is seen before plaster layers. Primer and top coats of cream to cream yellow come before modern layers of green and warm whites.

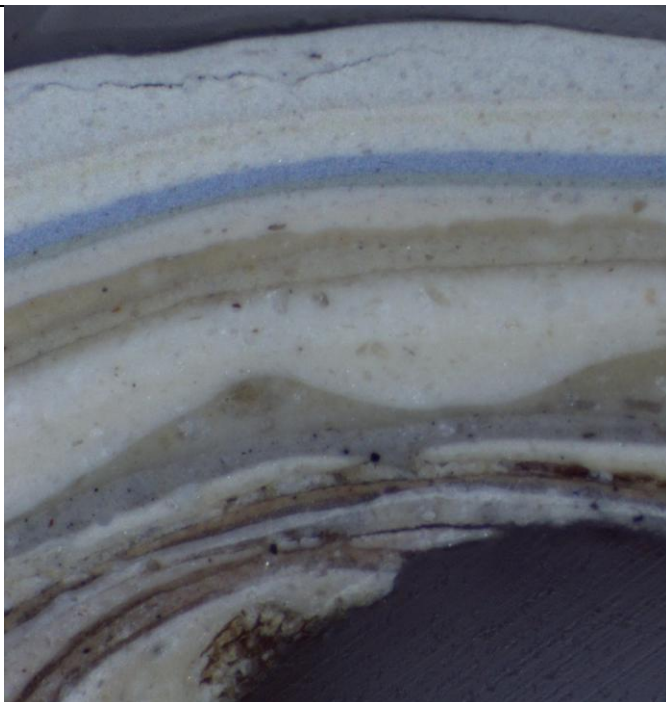
Nathaniel Russell House
Sample Location: 207 office
Detail: south window surround
Sample #:207-SW-3

This sample is most representative of those taken from the south window surround room 207 (office). This sample confirms the chronology found on the north window surround (207-NW-2).

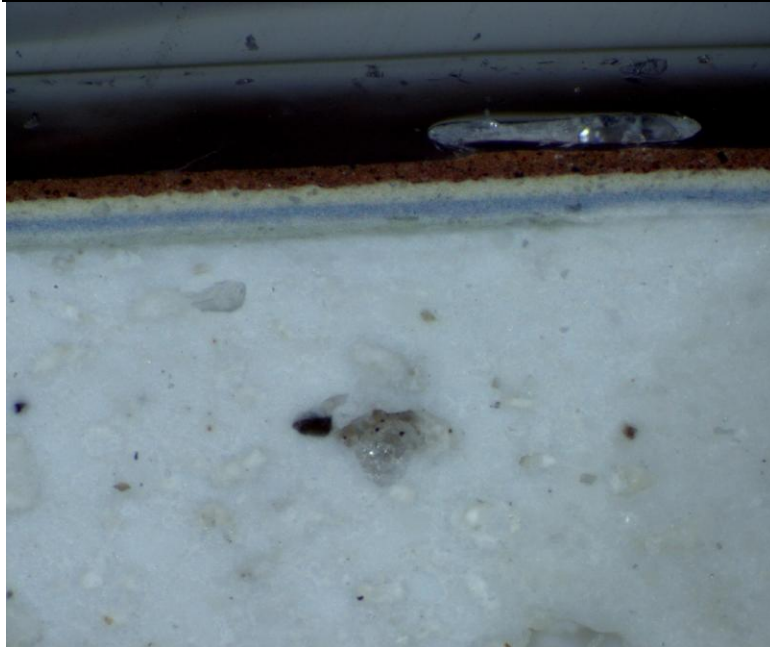
Nathaniel Russell House
Sample Location: 207 office
Detail: east wall
Sample #:207-E-1

This sample is most representative of those taken from the east wall, room 207 (office) inside the closet. A modern plaster layer (possibly a repair or some kind) is finished in a creamy green followed by white primer and blue paint. White primer and yellow and most recent rust red complete the chronology.

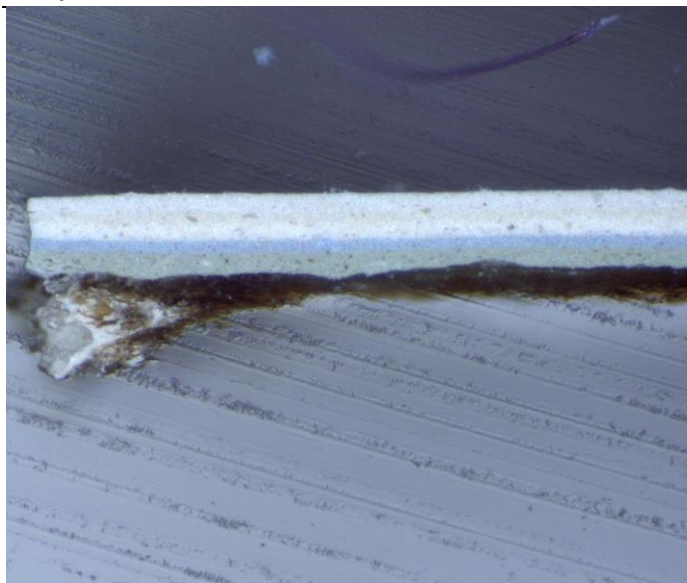
Nathaniel Russell House paint analysis
Sample Location: 207 office
Detail: south wall cornice
Sample #: 207-SC-1

This sample is most representative of those taken from the cornice, room 207 (office).

Cornice samples show little original finishes. Plaster is covered in a sealant (possibly a shellac product as it auto fluoresces orange under UV light). Modern layers of pale green, blue and warm whites follow without primers.

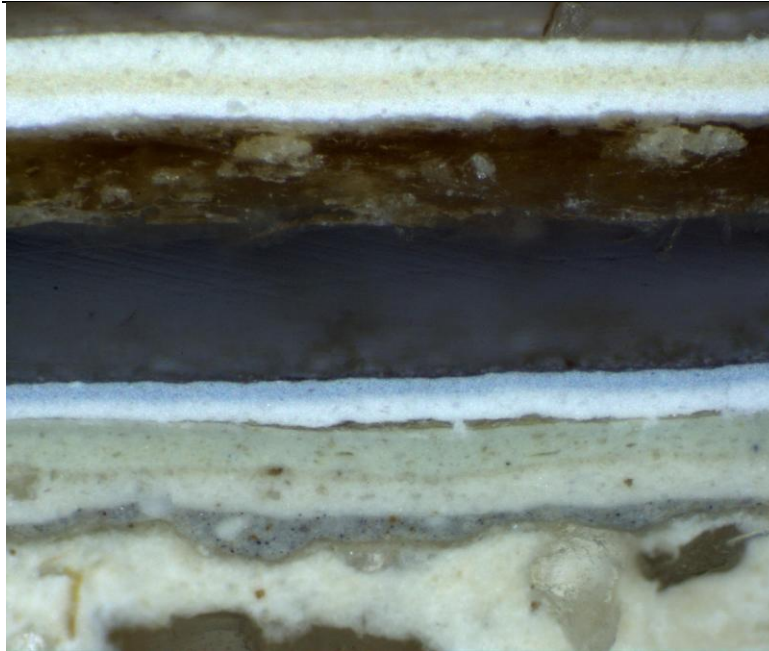
Nathaniel Russell House
Sample Location: 207A outer office
Detail: south wall
Sample #: 207A-S-1

This sample is most representative of those taken from the south wall, room 207A (outer office). A very wavy uneven plaster layer (possibly a repair or some kind) is finished in a highly pigmented gray, cream and creamy green follow. A separation is followed with a white primer and blue paint layer. Another separation indicates a paper layer above which appears in this sample to only have one homogenous color. Modern paint layers of warm white, yellow and warm white complete the chronology.

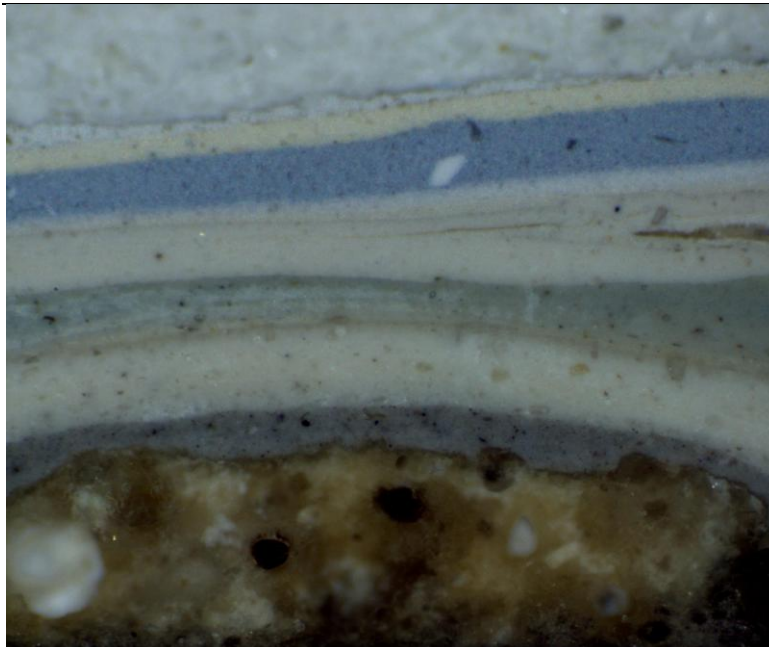
Nathaniel Russell House
Sample Location: 207A outer office
Detail: south window surround
Sample #: 207A-SW-2

This sample is most representative of those taken from the south window surround room 207A (outer office). The most modern layers of white and yellow are not in the photomicrograph.

Wood substrate was originally painted dark, pigmented (black) gray. Cream, green and cream follow. A white primer and blue top coat followed by yellow white, a repair layer and again yellow and white represent the modern finishes.

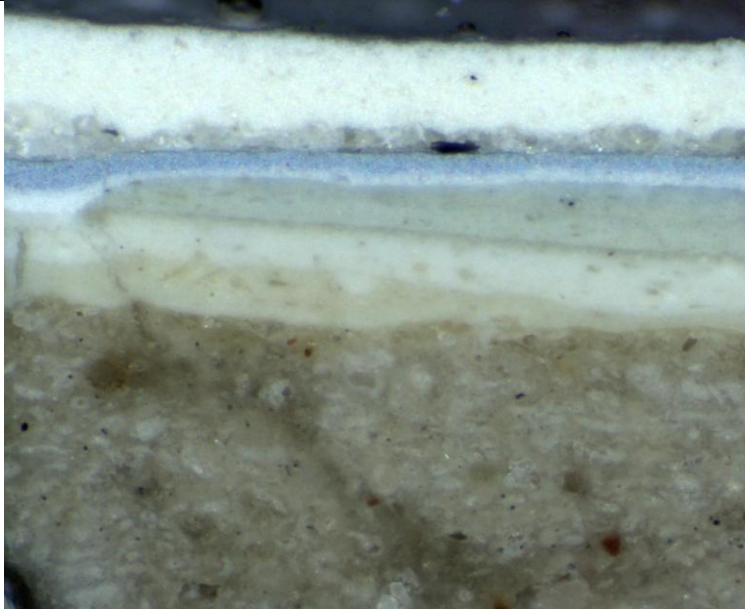
Nathaniel Russell House
Sample Location: 207A outer office
Detail: east wall
Sample #: 207A-E-1

This sample is most representative of those taken from the east wall, room 207A (outer office). Samples from this wall do not show a gray original layer but instead begin with cream, creamy green seen as second generation on the south wall (207A-S-1). The white primer, blue finish coat is the same as found on the south wall followed by repair material (or very cheap primer). The modern layers are warm white. The modern yellow found in south wall samples was not evident on any of the east wall samples.

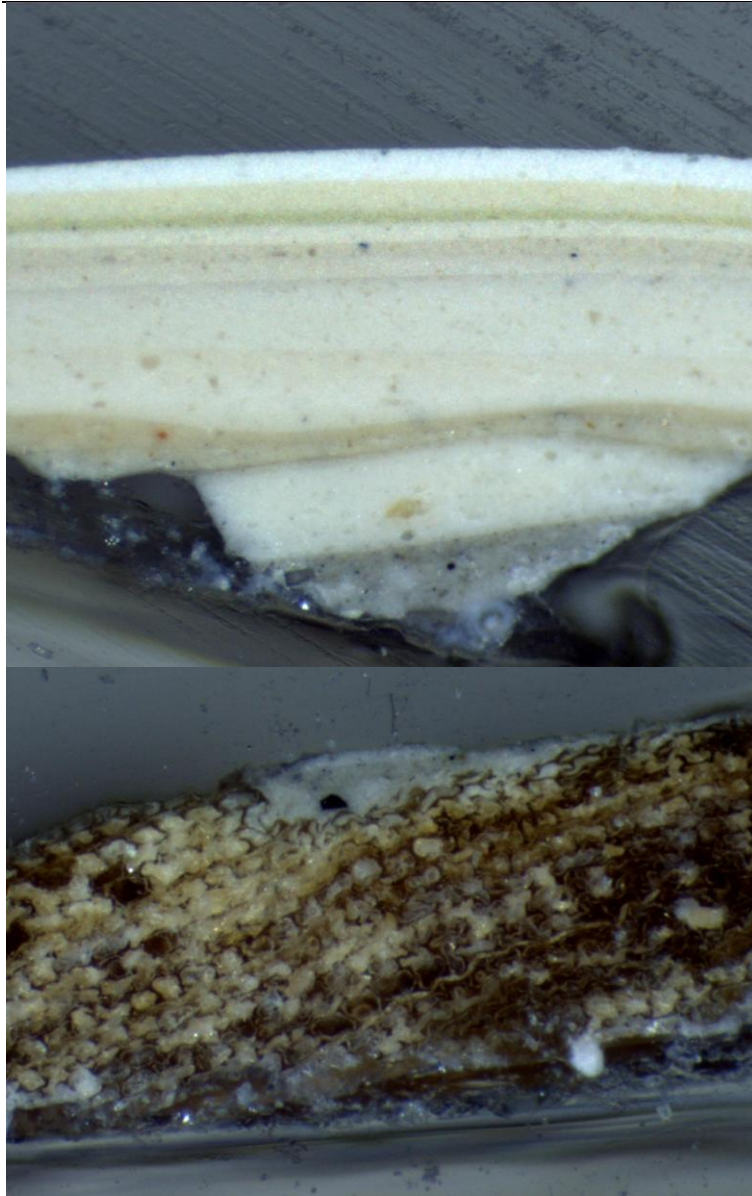
Nathaniel Russell House
Sample Location: 207A outer office
Detail: east door surround
Sample #: 207A-ED-1

This sample is most representative of those taken from the east door surround room 207A (outer office). Wood substrate exists for this sample but fractured (see photomicrograph below). Original finish is a pigmented gray which appears to be the same seen in 207 office, west door surround (207-WD-2). Many generations of warm white to cream hues paints follow. Modern finishes of cream, green and cream yellow are followed by warm white.

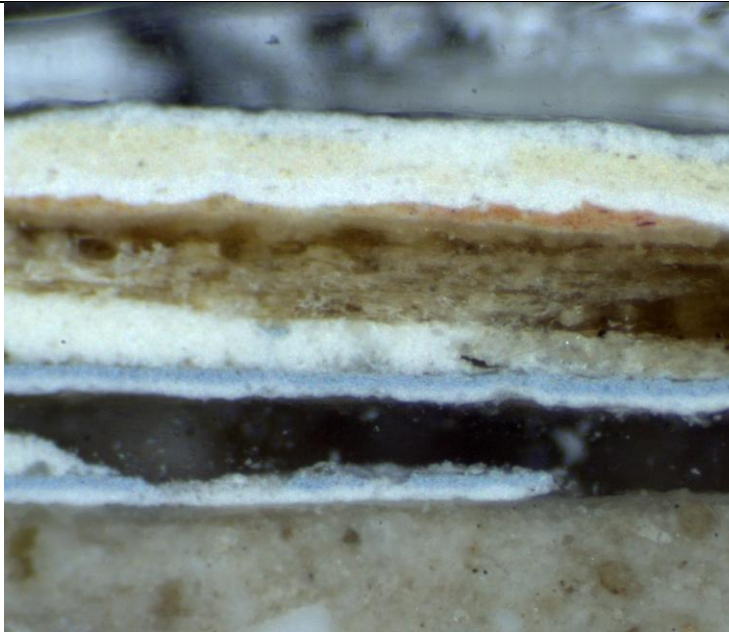
Nathaniel Russell House
Sample Location: 207A outer office
Detail: west wall
Sample #: 207A-W-1

This sample is most representative of those taken from the west wall, room 207A (outer office). Samples from this wall begin with the familiar white primer and blue finish coat layer. Adhesive (wallpaper paste) is followed by wallpaper and a pigmented layer (yellow, orange, white and red) indicating a multi colored pattern. The most modern layers are warm white, yellow and warm white.

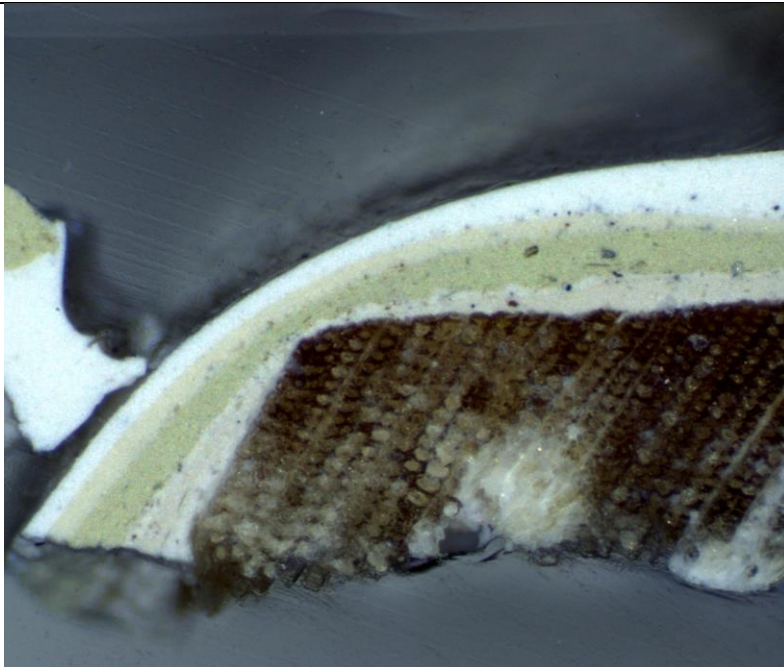
Nathaniel Russell House
Sample Location: 207A outer office
Detail: west wall door surround
Sample #: 207A-WD-1

This sample is most representative of those taken from the west door surround room 207A (outer office). This sample has only modern layers which correspond to the east door surround in this room (207A-ED-1). Cream, green and cream yellow are followed by warm white.
