HISTORIC PRESERVATION CERTIFICATION APPLICATION — PART 1

PART 1 EVALUATION OF SIGNIFICANCE

Address of property: Street 89 Broad Street

Name of historic district in which property is located: Charleston Old and Historic District

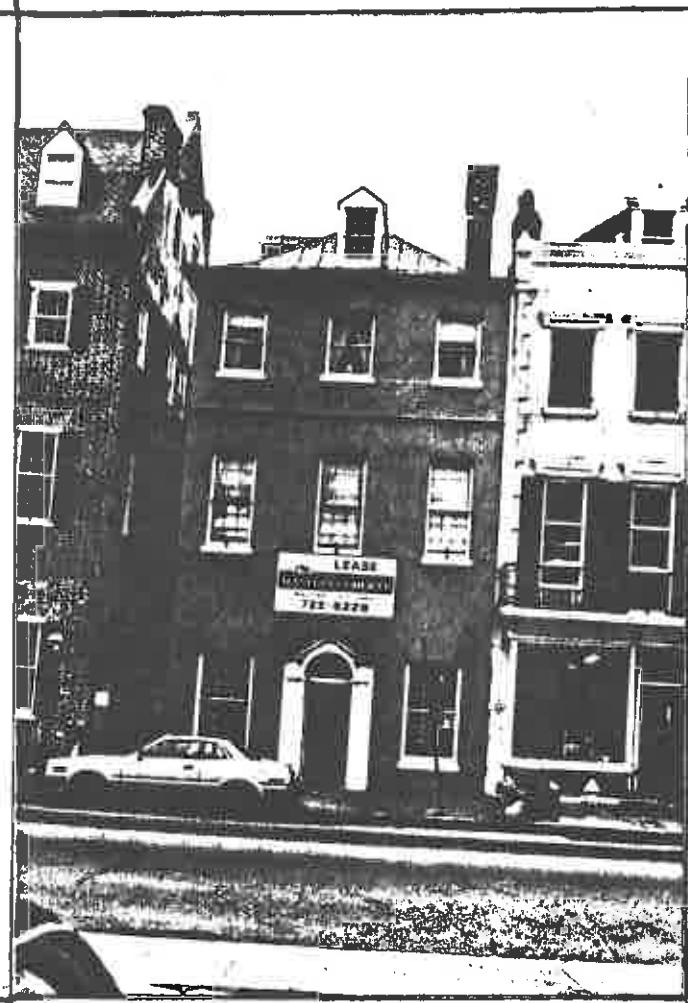
#1

Broad Street (North) Facade
