An Architectural and Historical Analysis  
of the  
Nathaniel Russell House  
Charleston, South Carolina

Volume IV  
Room by Room Catalog of Architectural Features  
Nathaniel Russell House

Orlando Ridout V and Willie Graham  
for  
Historic Charleston Foundation

Volume VI

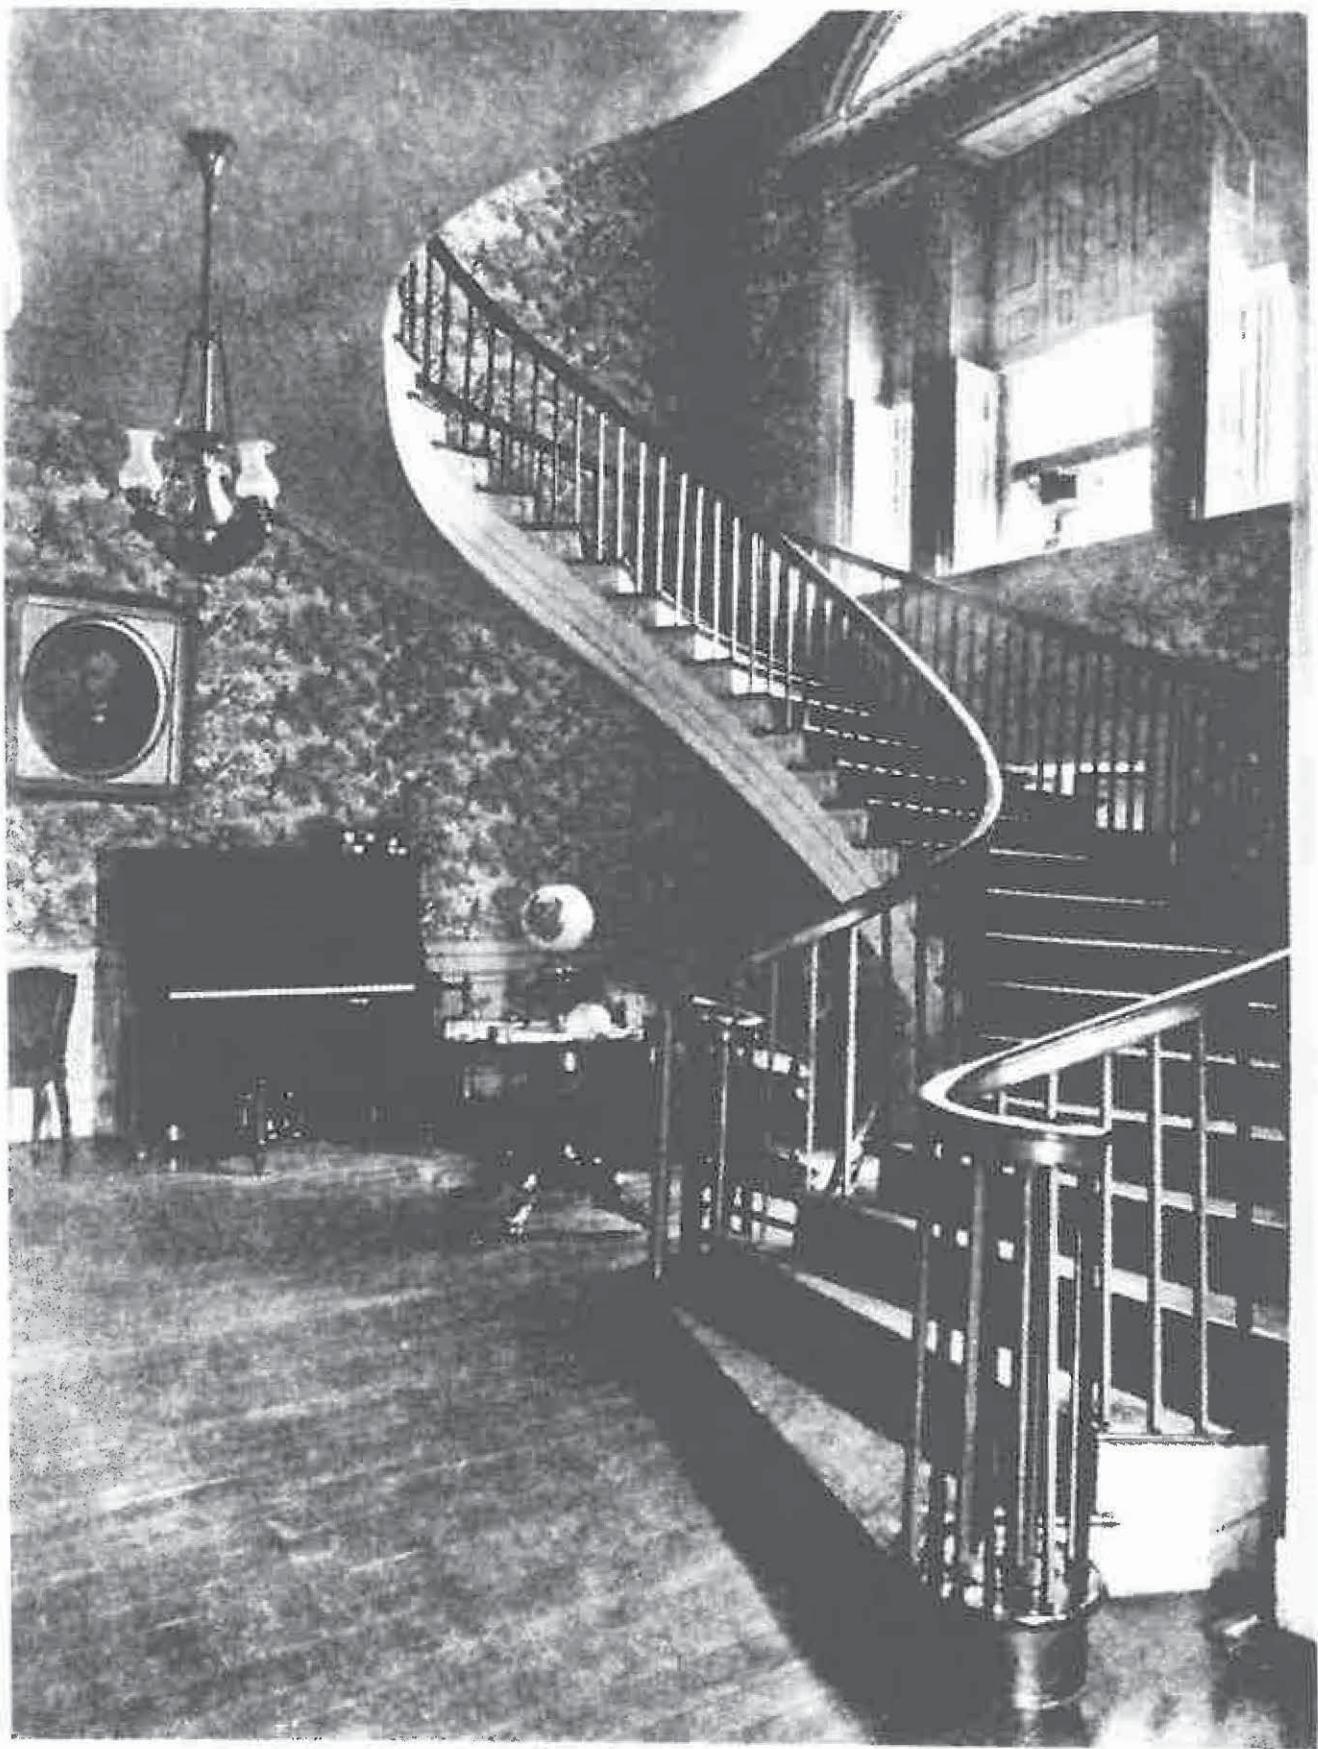
STAIRCASE IN RUSSELL HOUSE

1926 photo

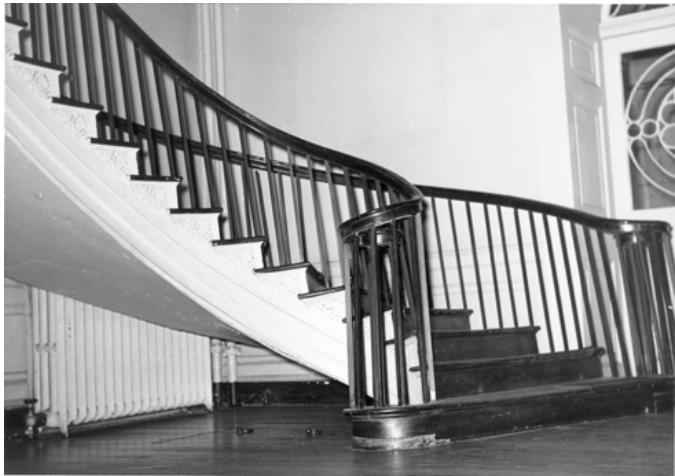
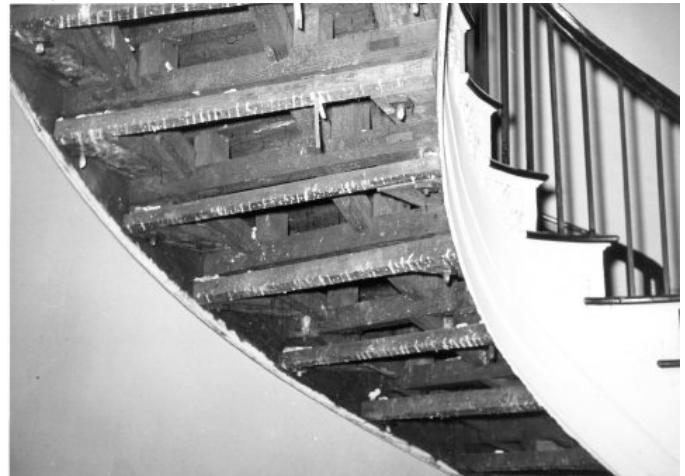
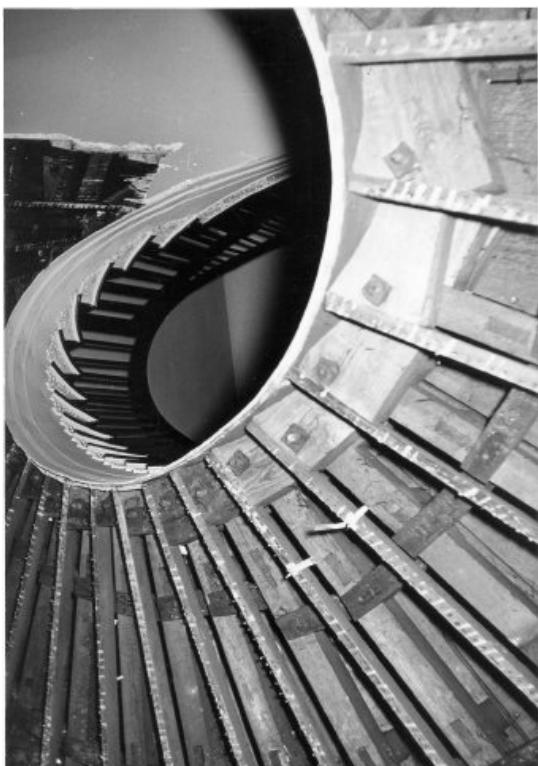
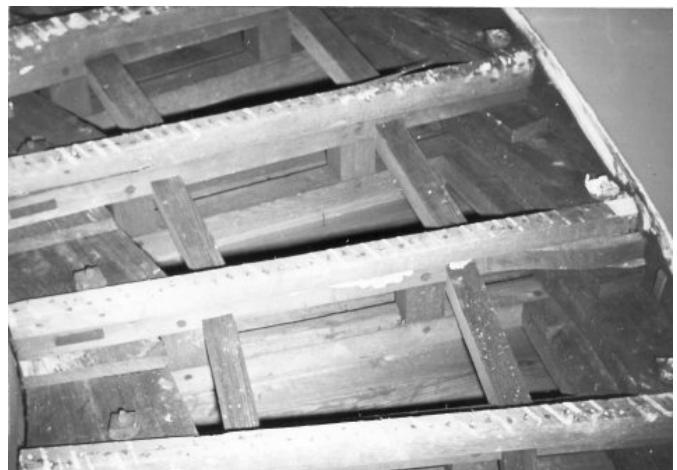
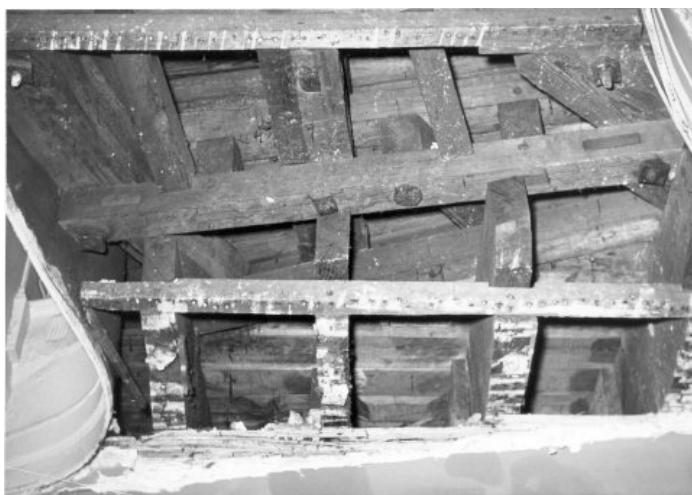
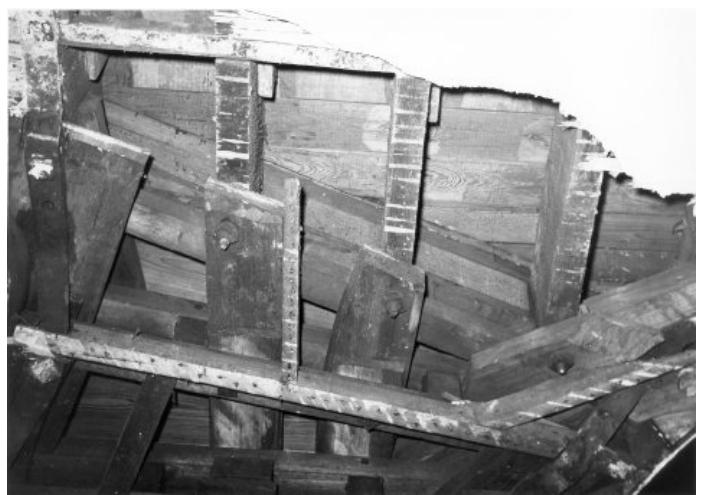
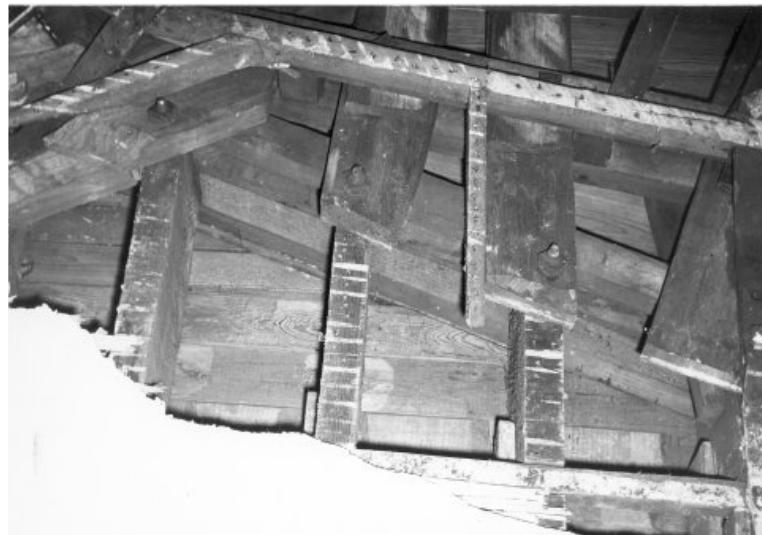
### Photographs of the Nathaniel Russell House Staircase

Historic Charleston Foundation, 1955 Restoration

The soffit of the stair was stripped of plaster during the 1955-56 restoration to permit raising and reinforcing the stair, which had dropped several inches over time. When the soffit was replastered, a window was installed to provide a view of the complex joinery of the stair frame; photographs taken in 1955 provide further documentation of the complex construction of the stair.
