Hurricane Hugo and Historic Charleston: Damage Recordation and Retrieval

REFERENCE: Poston, J. H., "Hurricane Hugo and Historic Charleston: Damage Recordation and Retrieval," *Standards for Preservation and Rehabilitation, ASTM STP 1258*, S. J. Kelley, Ed., American Society for Testing and Materials, 1996, pp. 149-167.

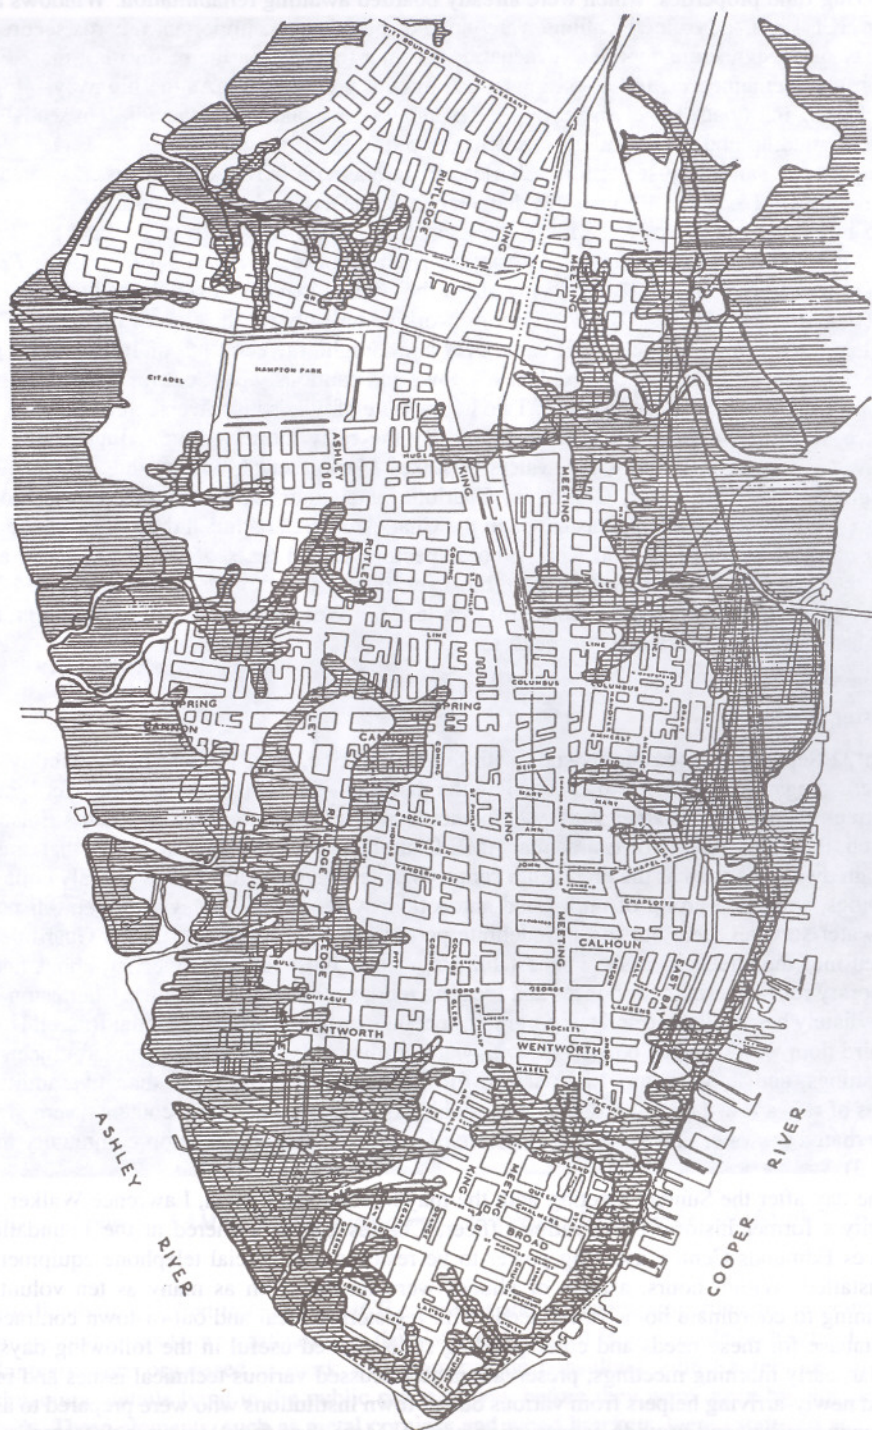
FIG. 1—Map of Charleston; darkened areas show former marshland likely to flood; from This is Charleston, Carolina Art Association (not to scale).

Hurricanes are a relatively common threat to Charleston, striking the city many times since its settlement in 1670. This is a city planned in London on a baroque grid, yet sited on a peninsula with interspersing levels of high ground, pierced by marshes and creeks. A map of the peninsula (Fig. 1) reflects almost to the last detail the areas most threatened by surge (a sudden wave or rise in water resulting from the force of wind) in any hurricane. Severe storms of all degrees bore down on the fledgling municipality from its earliest days. One of the most severe, the Hurricane of 1752, struck suddenly on high tide one September day, flooding the town, toppling houses, breaking up wharves and drowning citizens who could not ascend staircases to upper floors quickly enough. Every vessel in the harbor save one came ashore, and a pilot boat dashed against the Governor's House, knocking a hole in the front brick wall on line with the second story windows [2,3]. The *South Carolina Gazette* described the damage in a manner all too familiar to Hugo victims, pointing out that an "abundance of roofs, chimneys, etc. almost all the tiled or slated houses were uncovered" [4]. A second, though milder, hurricane struck only two weeks later. Nearly 50 years passed before the next wind of 1804 damaged James Island and Sullivan's Island. Other significant storms included the cyclone of 1811 that lifted off roofs in Charleston; the hurricane of 1822 that drowned hundreds of planters and slaves as a surge stormed up the rice delta of the Santee River; and the hurricane of 1854 that again wrecked Sullivan's Island. The cyclone of 1885, with winds of 195 km/h (121 mph), killed more than 20 persons on the Charleston peninsula and was followed a year later by one of the eight largest earthquakes to ever strike the United States [4-6]. Excepting the earthquake, no systematic recodation of architectural damage was undertaken after these disasters, although contemporary newspaper accounts provide brief information on harm to certain structures. Charlestonians generally shored up affected buildings and repaired them as best they could.
