The Gadsden House

329 East Bay, Charleston, South Carolina 29401

Prepared By: Anna Krueger

January 15, 2015

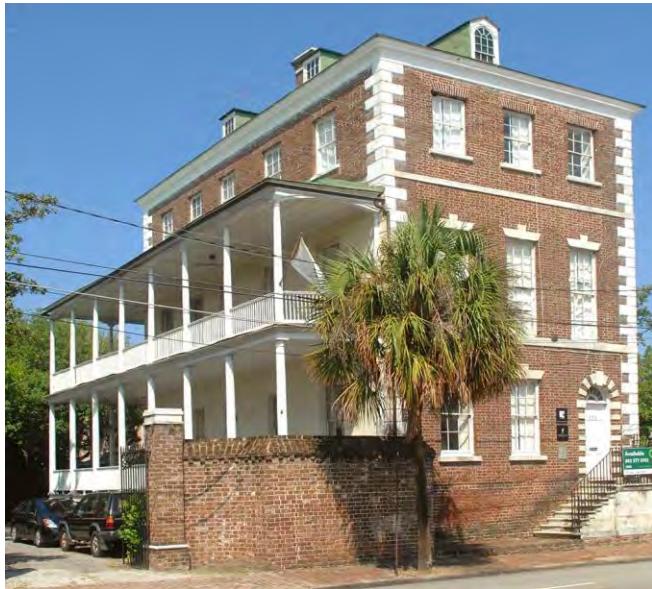
(Figure 1) The Gadsden House, 2014, Photo by Luxury Simplified Group.

The Gadsden House is a three-and-one-half story brick house that was built circa 1800.¹ (Fig 1). It is located at 329 East Bay Street just south of Calhoun Street (Fig 2-6). Christopher Gadsden owned the land, but the house itself is believed to have been built by Phillip Gadsden, a relative of Christopher, although other records indicate that Thomas Morris, Christopher's son-in-law, could have possibly built the house.²

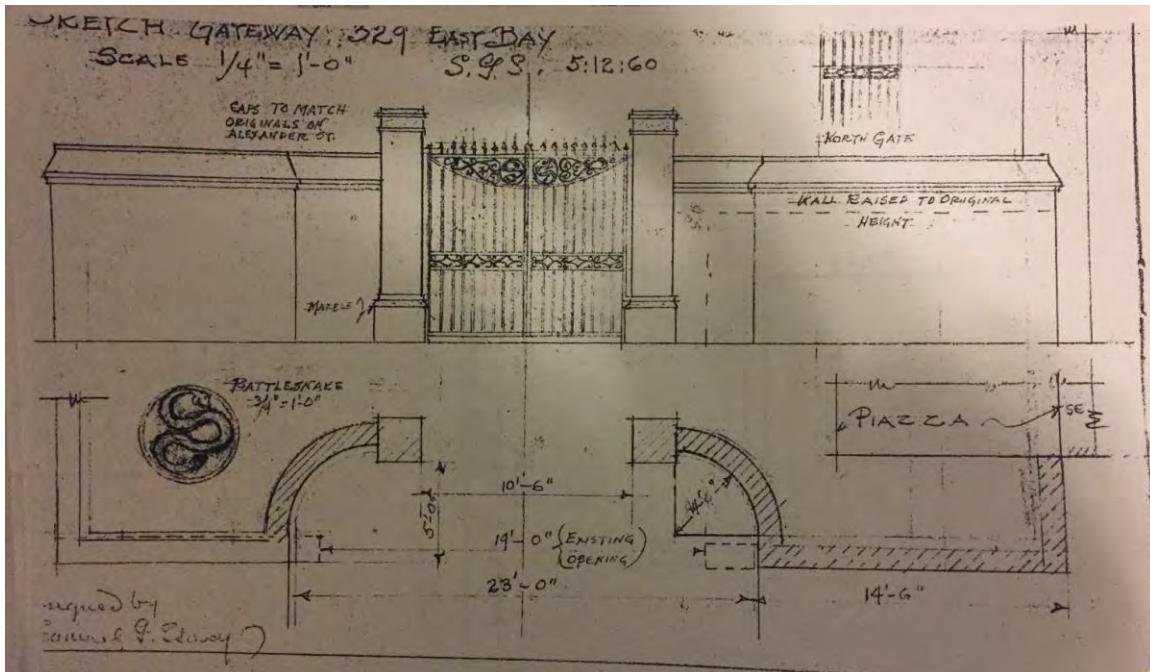
(Figure 7) Photocopy of original sketches for the Rattle Snake gate design by architectural historian, Samuel Stoney, May 20, 1960.

Samuel Stoney began designing the famous “Rattlesnake” Gates in 1960 and finalized the design in the early months of 1961.¹⁷³ According to a letter from Albert Simons, Stoney prepared multiple sketches for the proposed gates and brick wall treatment.¹⁷⁴ Stoney also designed the gate and pillars to have an opening of ten-and-a-half-feet long and half a foot wide as well as having them be recessed five feet back from the inner edge of the sidewalk to protect them from “reckless drivers”.¹⁷⁵ As previously noted, the rattlesnake motif was requested by Mrs. Woodward and references one of her famous ancestors, Christopher Gadsden, who coined the famous phrase “Don’t Tread On Me” a rallying cry for colonial revolutionaries.¹⁷⁶ Phillip Simmons produced the rattlesnake motif and gate ironwork.¹⁷⁷ The rattlesnakes were one the first examples of animal sculpture in Charleston wrought iron and significantly expanded the vocabulary of the local decorative iron working tradition (Fig 31).¹⁷⁸ According to *Buildings of Charleston* by John Poston, Simmons wanted his ironworks to look older so he used old designs and ornamentation as models, such as the lunette panels in the snake gate.¹⁷⁹ These are typical elements used in the eighteenth and nineteenth centuries and can also be found on the gate at St. Philip’s cemetery.¹⁸⁰

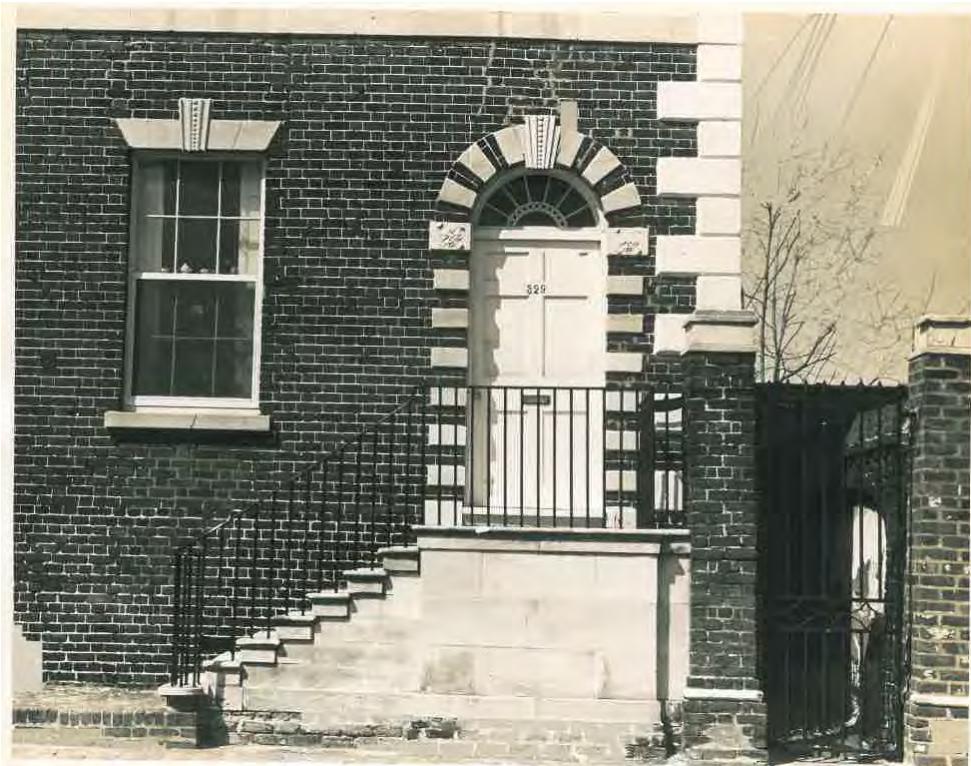
(Figure 11) Front Door, facing East Bay Street. Circa 1958.

The front door of the Gadsden House is one of its most distinct features. It is located on the east side of the building, on the far right corner (Fig 11). The door has a semi-circular arch above it, made out of marble impost blocks, completed with an ornate keystone (Fig 12).⁷⁰ The impost blocks are carved in relief and each one has a rosette in the middle.⁷¹ Marble blocks that have been rusticated are placed on either side of the doorway, leading up to the arch above. The door itself is a six-panel door with a semicircular transom.⁷² The small stairway leading up to the door is also made of marble with a simple iron railing attached.⁷³

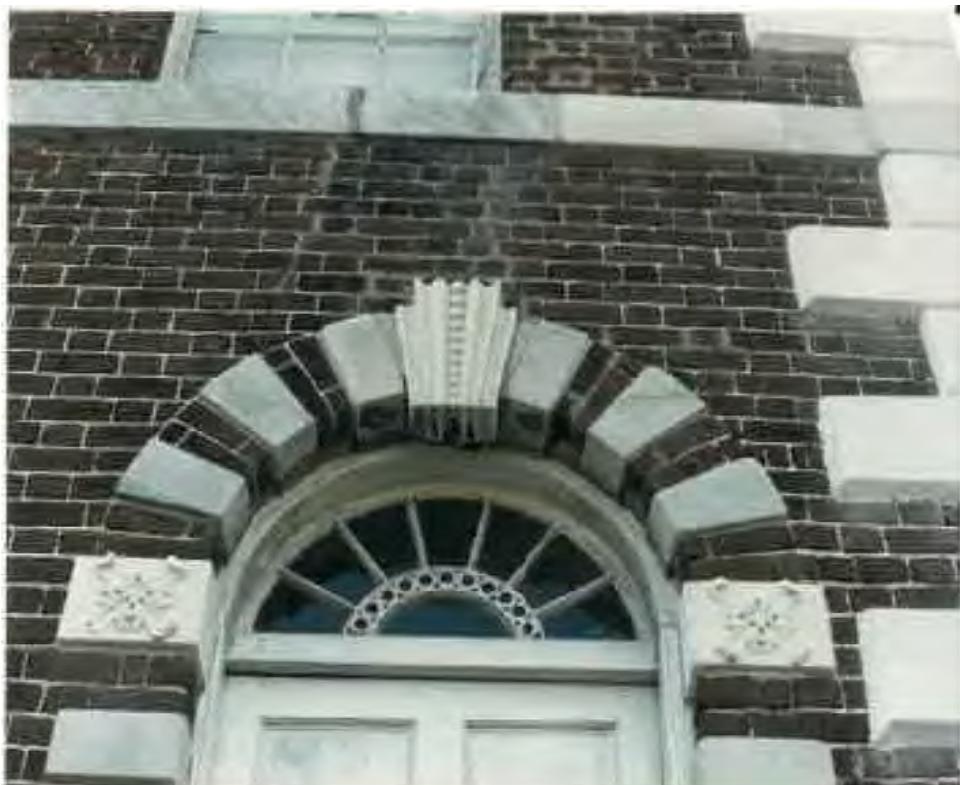
(Figure 12) Front Door, facing East Bay Street. Detail of Keystone, inspection photo. Circa 1980.

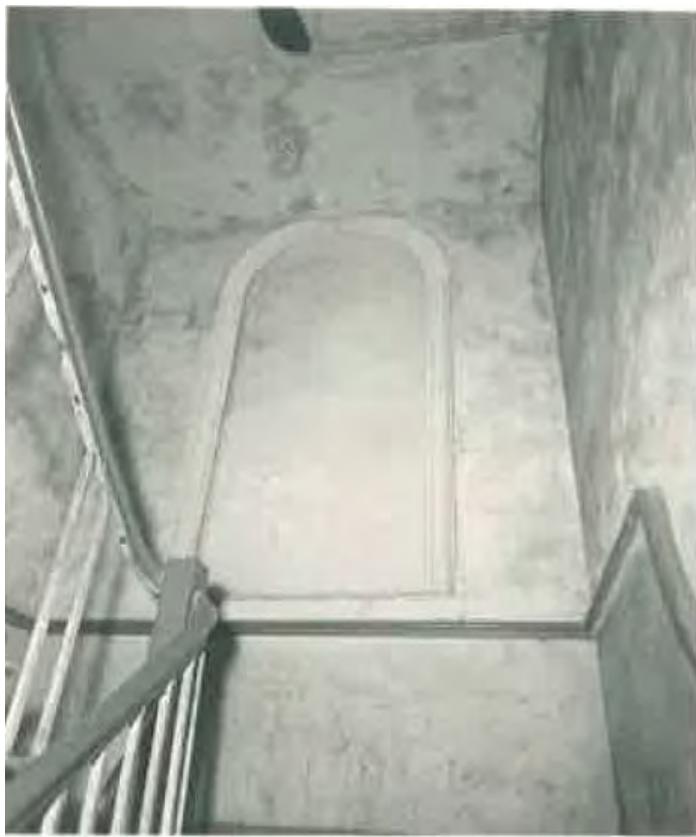
(Figure 13) Closed up/Sealed window from interior staircase. Circa 1950.

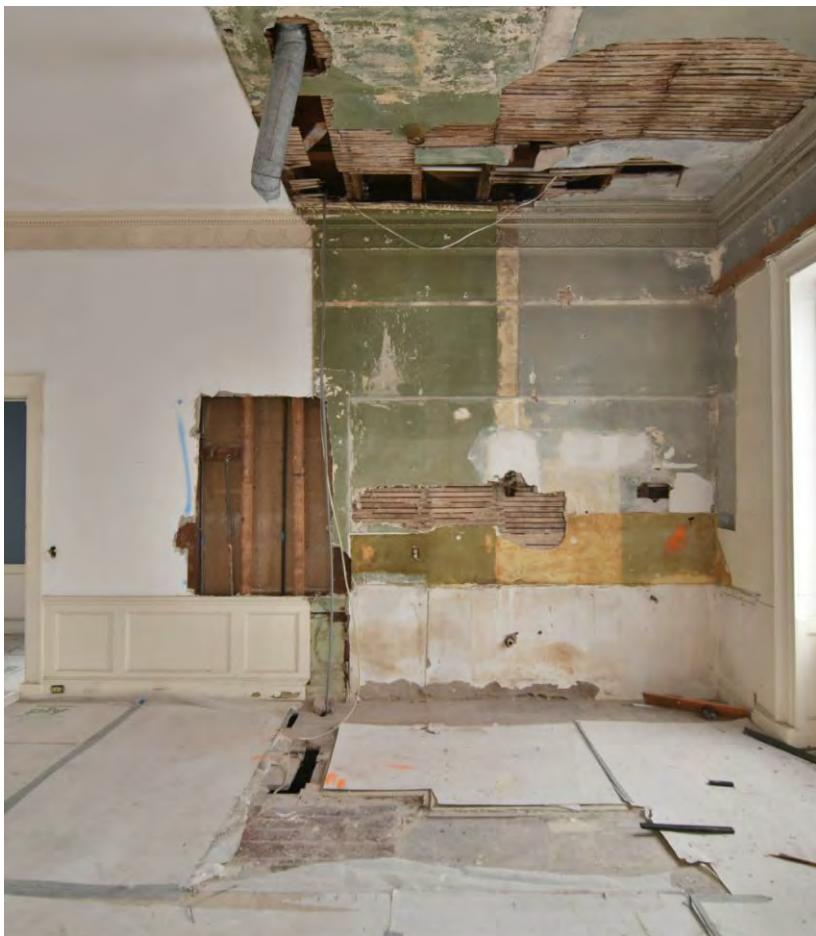
(Figure 15) First Floor, Front Room, showing lath and plaster during Luxury Simplified Restoration.

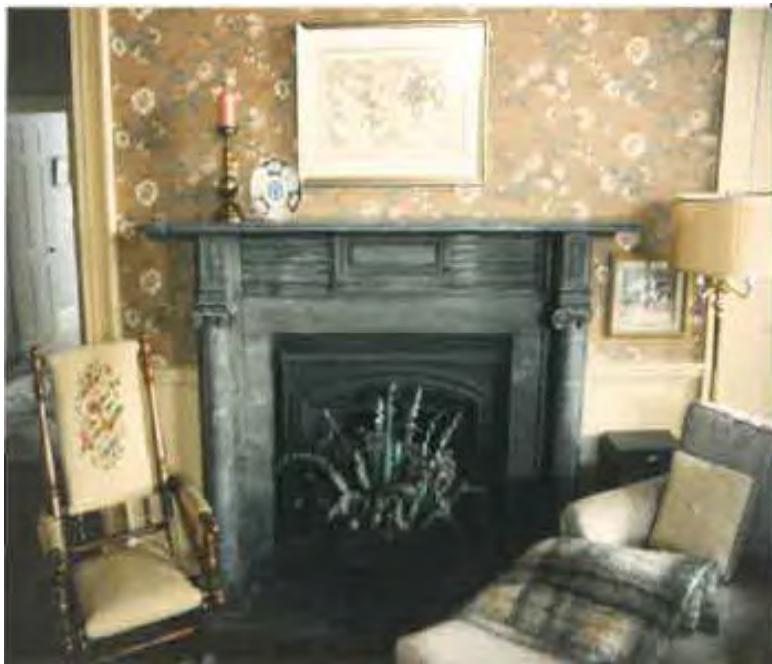
(Figure 17) Second Floor Fire Place with Ionic Pilasters. Circa 1980.

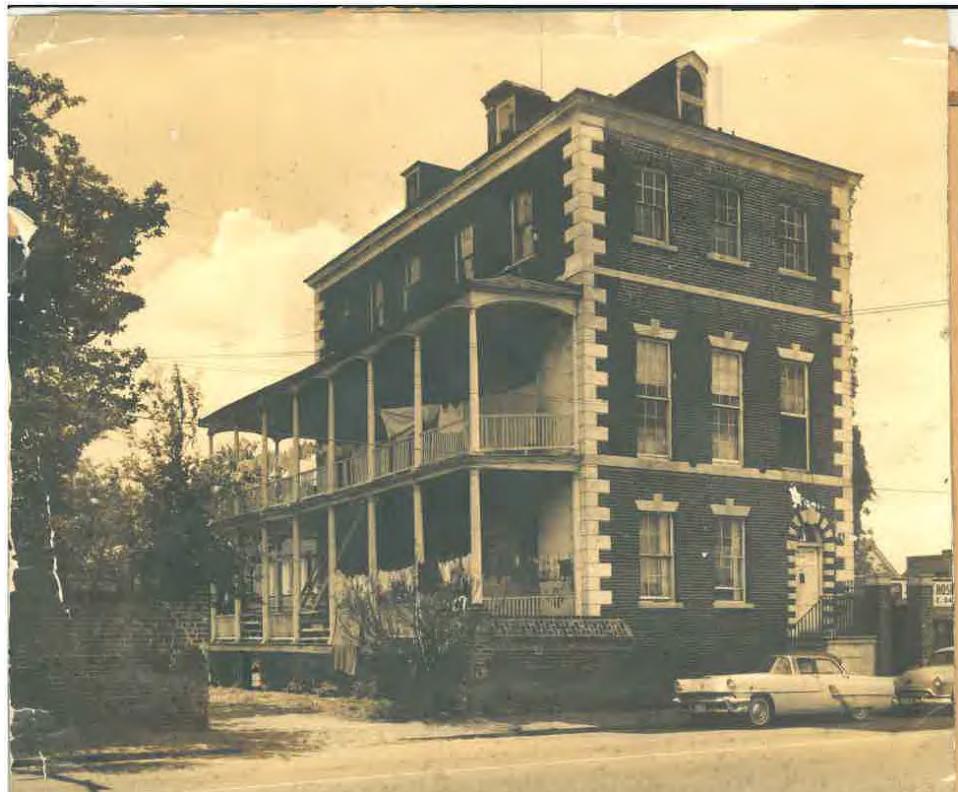
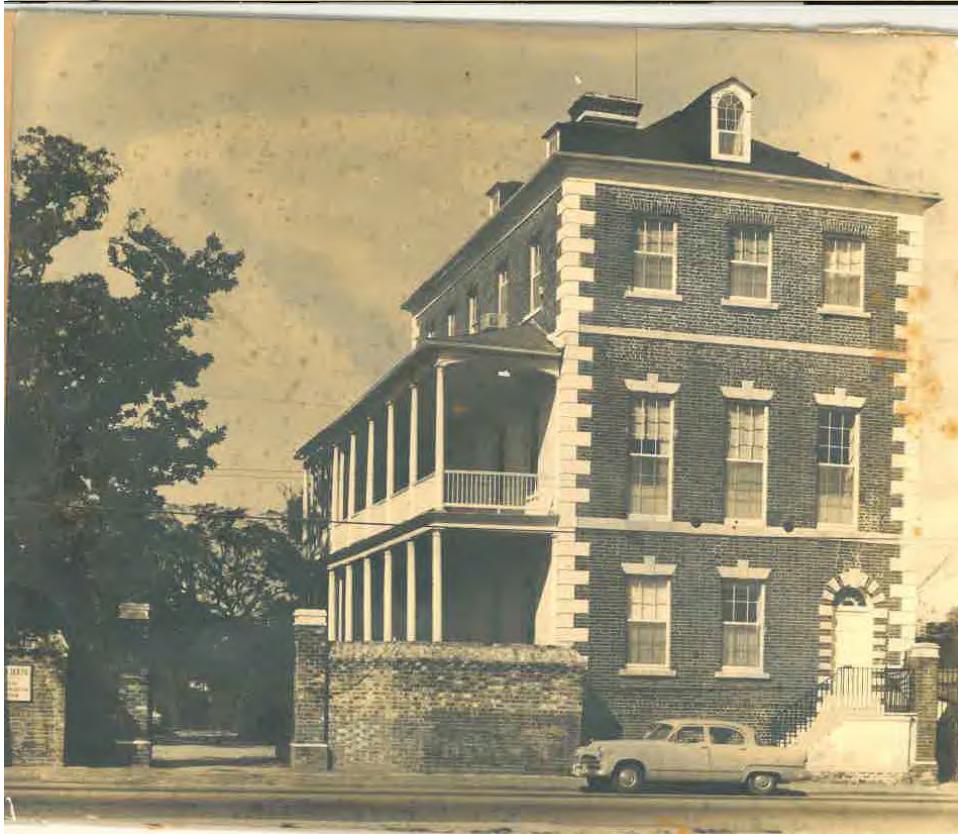
(Figure 19) Before (Top) and After (Bottom) the 1959 Restoration by the Historic Charleston Foundation. Circa 1960s.

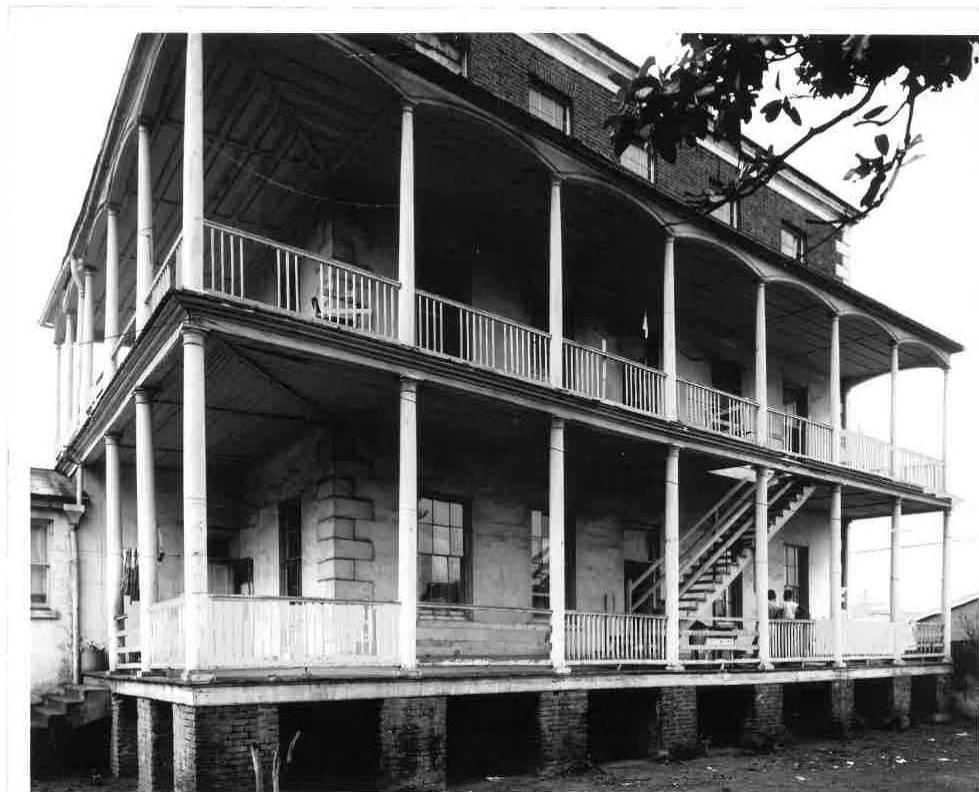
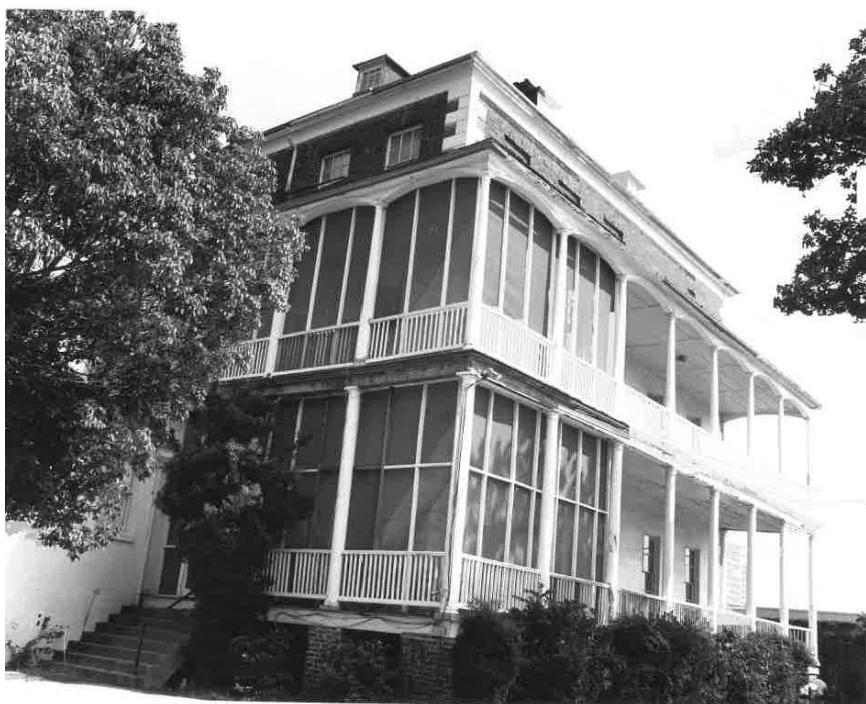
(Figure 20) Before and After Screened-In Portion of Pizza. Photo Undated.

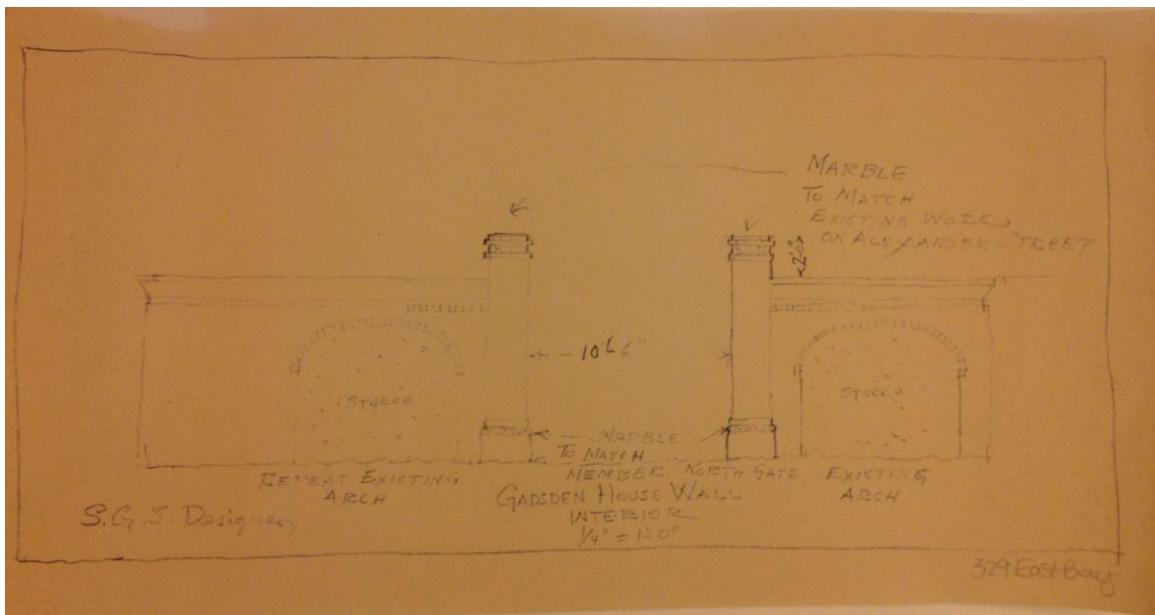
(Figure 22) Original Sketches by Samuel Stoney for the gate entrance at Alexander Street. 1961.

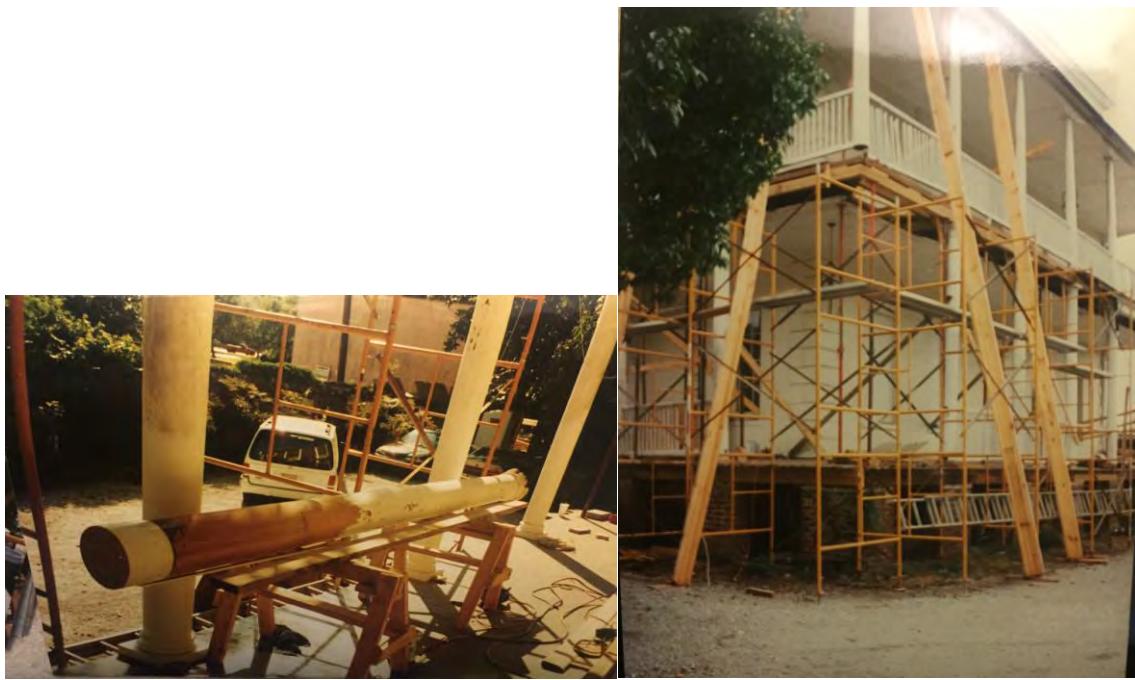
(Figure 23) Pizza Rehabilitation. Repair Pizza Column (Left) and Scaffolding (Right). 1996.

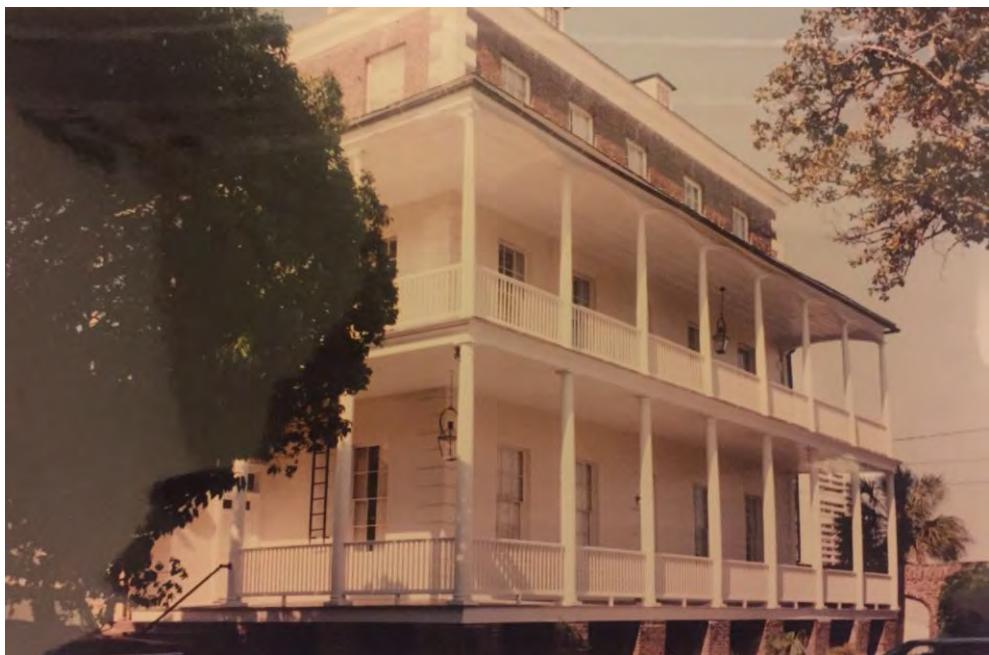
(Figure 27) Finished Piazza Repair. April 1997.

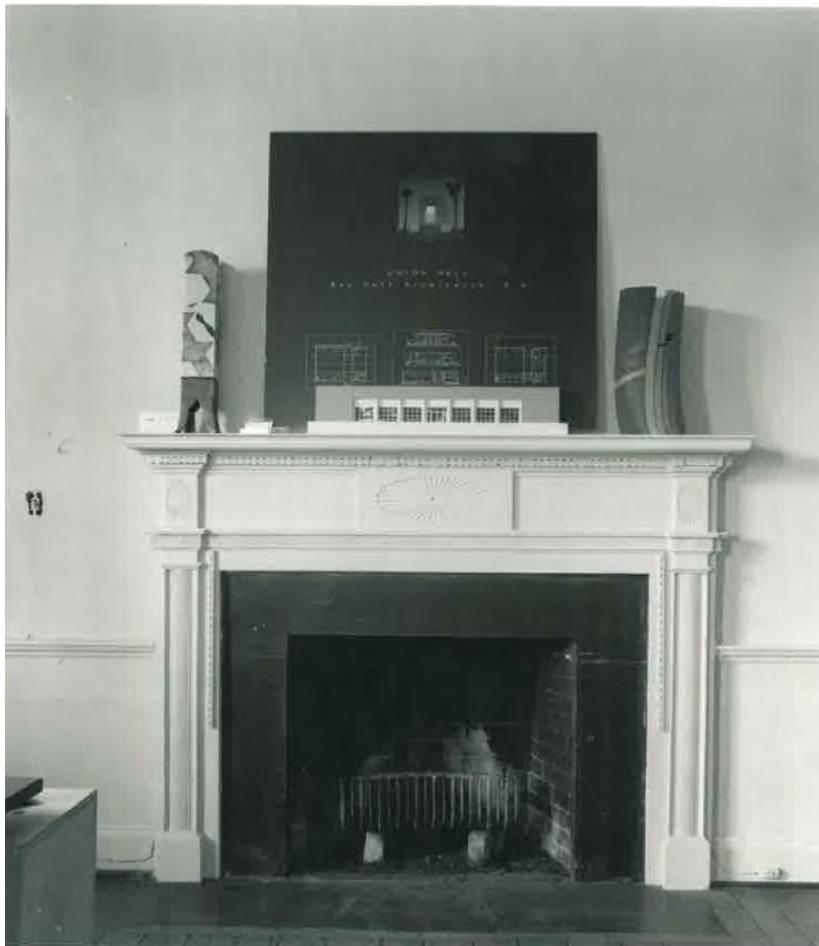
(Figure 30) First Floor Fireplace Mantel with carved paterae. Photograph Undated.

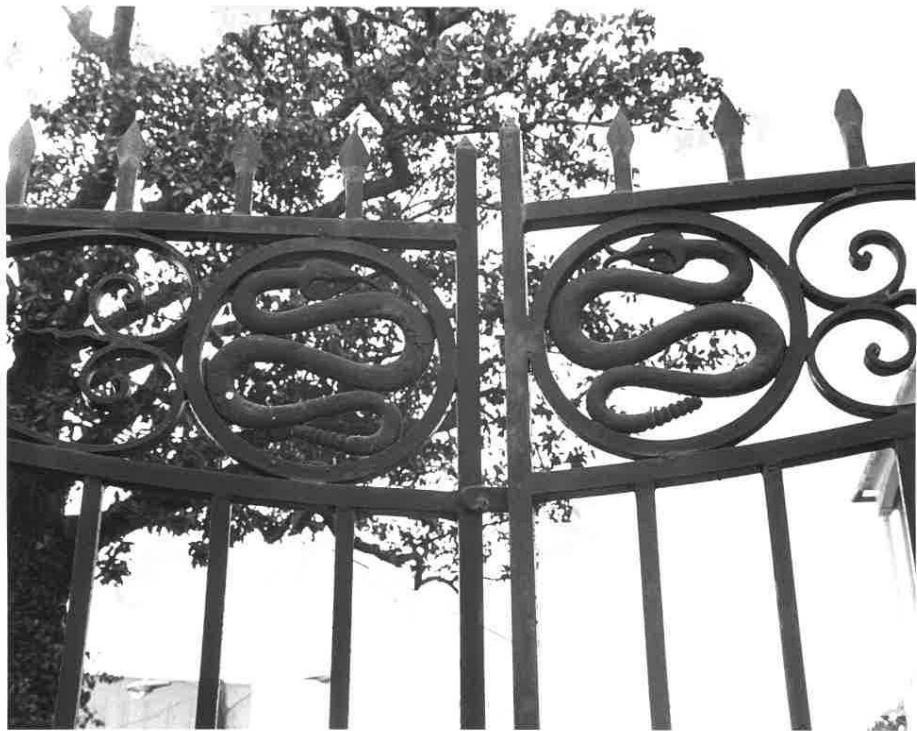
(Figure 31) Detail of Rattle Snake Motif by Samuel Stoney and Phillip Simons. Photograph Undated.

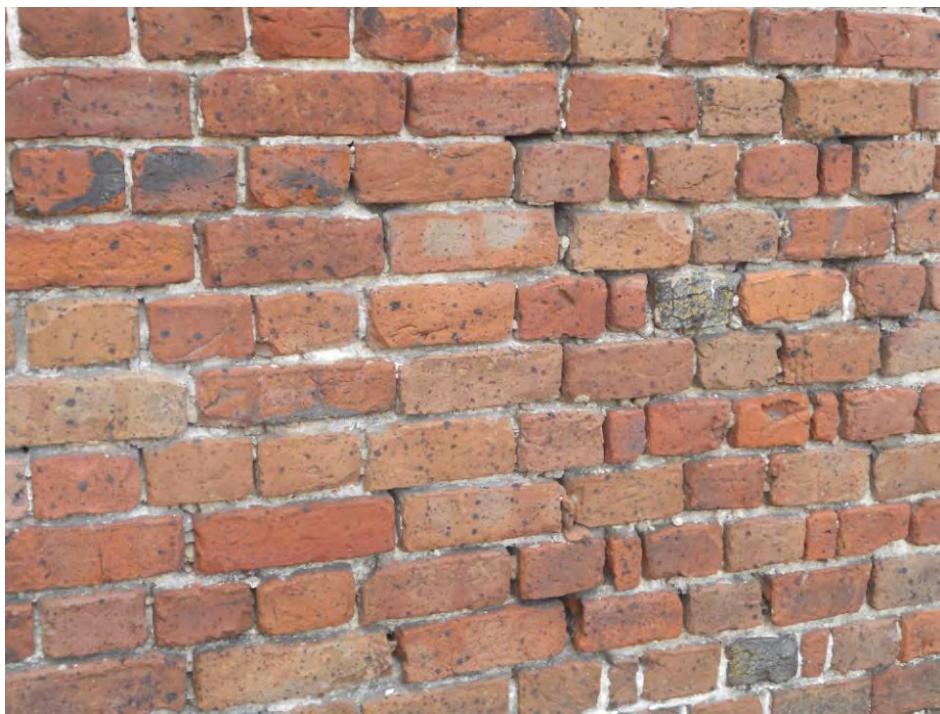
(Figure 33) Bricks on East Façade with missing mortar. 2014

Another brief by the National Park Service describes repointing mortar joints in historic masonry, which involves removing deteriorated mortar from the joints in a brick wall and replacing it with new mortar.¹⁹⁰ This not only makes the building more visually appealing, but it also restores the physical integrity of the masonry.¹⁹¹ Usually repointing is done because there is some apparent signs of deterioration, such as loose bricks or cracked joints.¹⁹² However, repointing alone may not solve these issues and some owners are best advised to turn to consultants, such as an architectural conservator to analyze the building.¹⁹³ It is also important to find an appropriate mortar match when repointing so the historic mortar and new mortar will mix well together and not damage the building.¹⁹⁴ This can be achieved through mortar analysis.¹⁹⁵ While some areas of brick at the Gadsden House are structurally sound and visually appealing, there are signs of minor deterioration of the mortar. (Fig 33). This should be monitored.

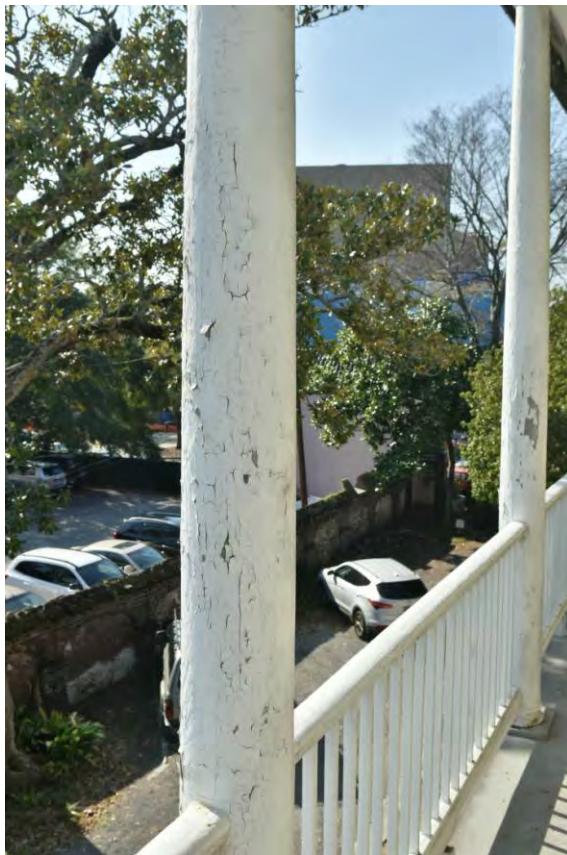
(Figure 34) Close up of wood Column with paint chipping. 2014

Exterior paint applied to wood must tolerate seasonal changes in humidity and temperature.¹⁹⁶ Exterior paint typically requires reapplication every five to eight years according to the National Park Service brief.¹⁹⁷ Since the main cause of wood rot is moisture penetration, paint can be used as a blocking agent to exclude the water from getting inside the wood, thus
