The Pink House

38 Alexander Street, Charleston, SC 29403

Prepared By: Anna Krueger

January 15, 2015

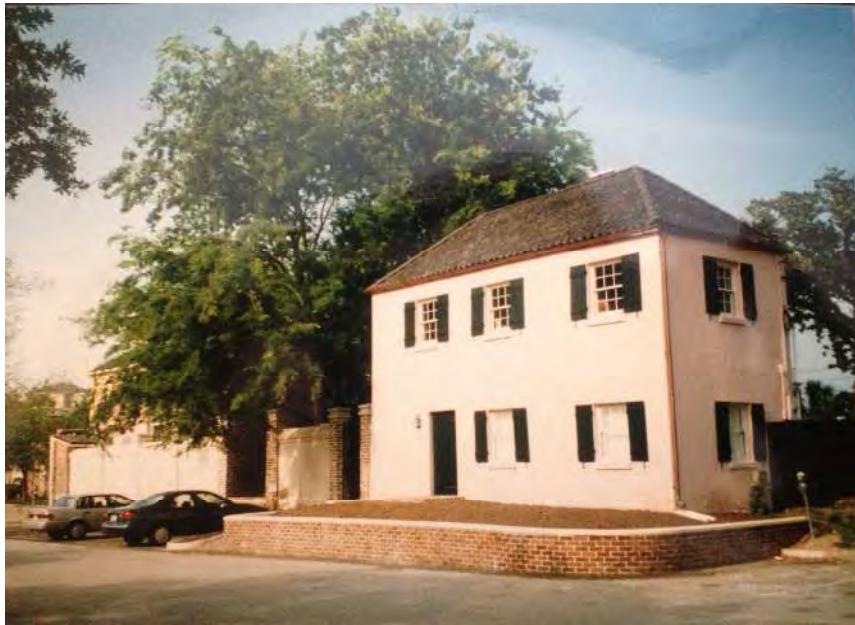
(Figure 1) The Pink House, West Façade. April 3, 1997.

The “Pink House”, a building constructed around November of 1817 is located at 38 Alexander Street, directly adjacent to the Gadsden House (329 East Bay) (Fig 1).¹ The land is part of the original Gadsden Estate owned by Revolutionary War icon, General Christopher Gadsden.² In 1779, the lot was sold by General Gadsden to Robert P. Saunders who then sold it to Captain William Hall.³ The Pink House and the Gadsden House are both located in the Charleston Historic District.⁴ The Pink House is the only surviving building on Alexander Street built when it was formerly known as Middle Street.⁵ Its original address was 12 Middle Street.⁶ However, during the 1960s, Charleston underwent a major urban revitalization in its historic district and the street was renamed Alexander Street (Fig 2-5).⁷

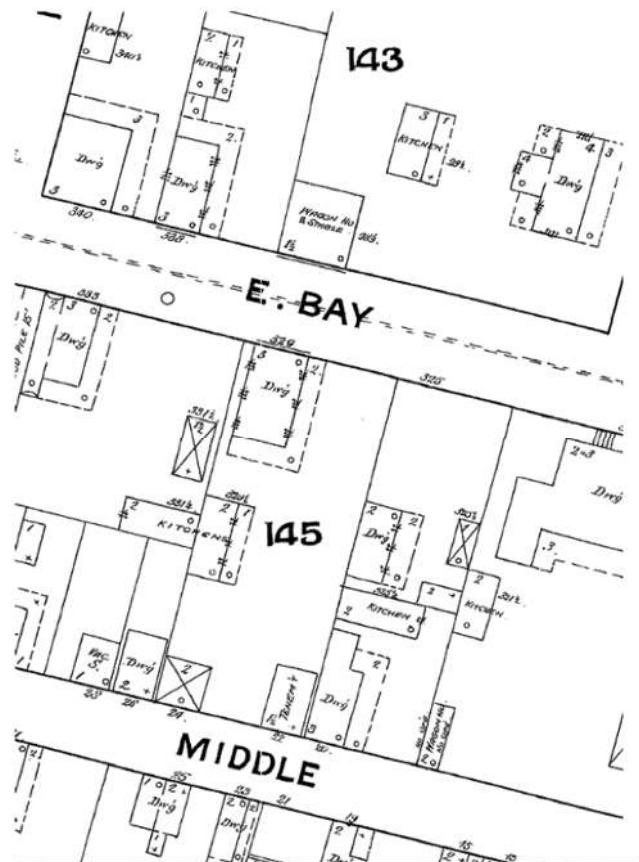
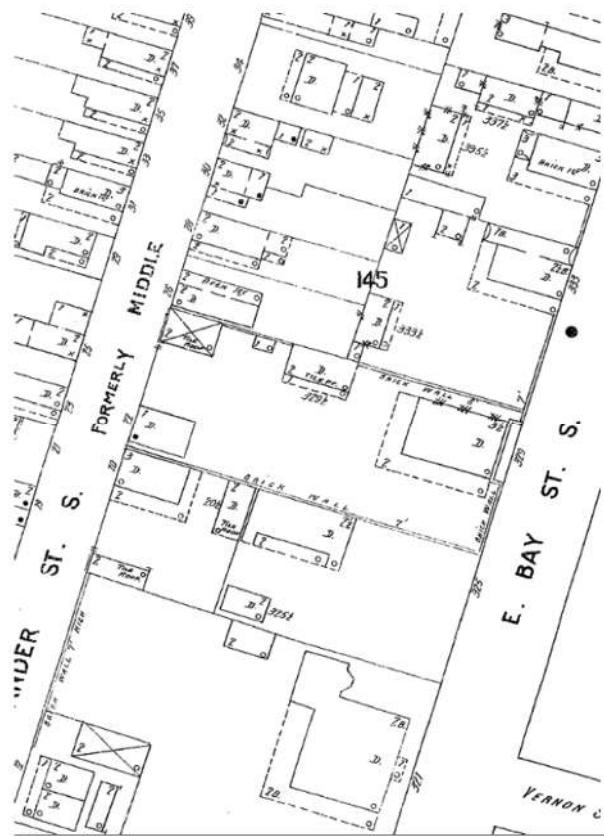
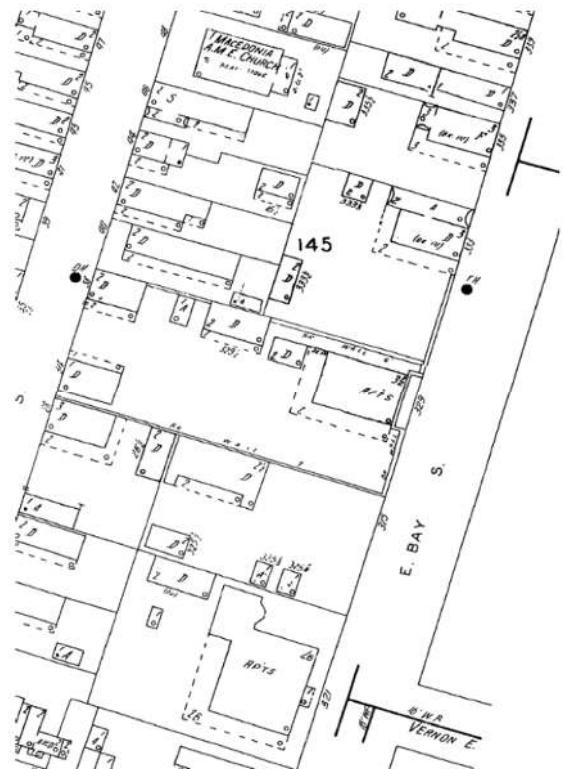
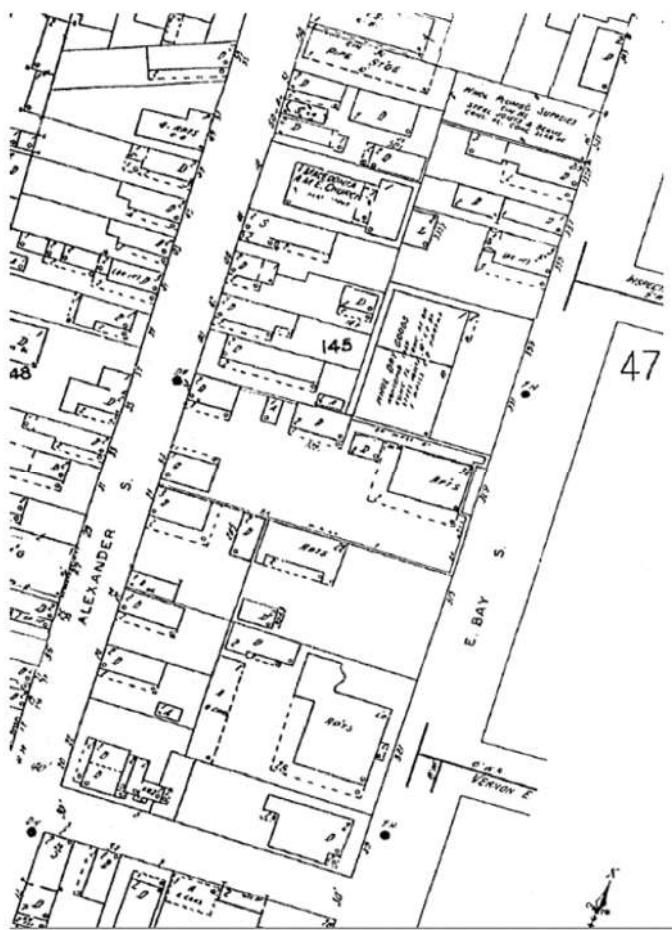
(Figure 2) Sanborn Fire Insurance Map, 329 East Bay. June 1888.

(Figure 3) Sanborn Fire Insurance Map, 329 East Bay. 1902.

(Figure 4) Sanborn Fire Insurance Map, 329 East Bay. April 1944.

(Figure 5) Sanborn Fire Insurance Map, 329 East Bay. 1955 Refurbished.

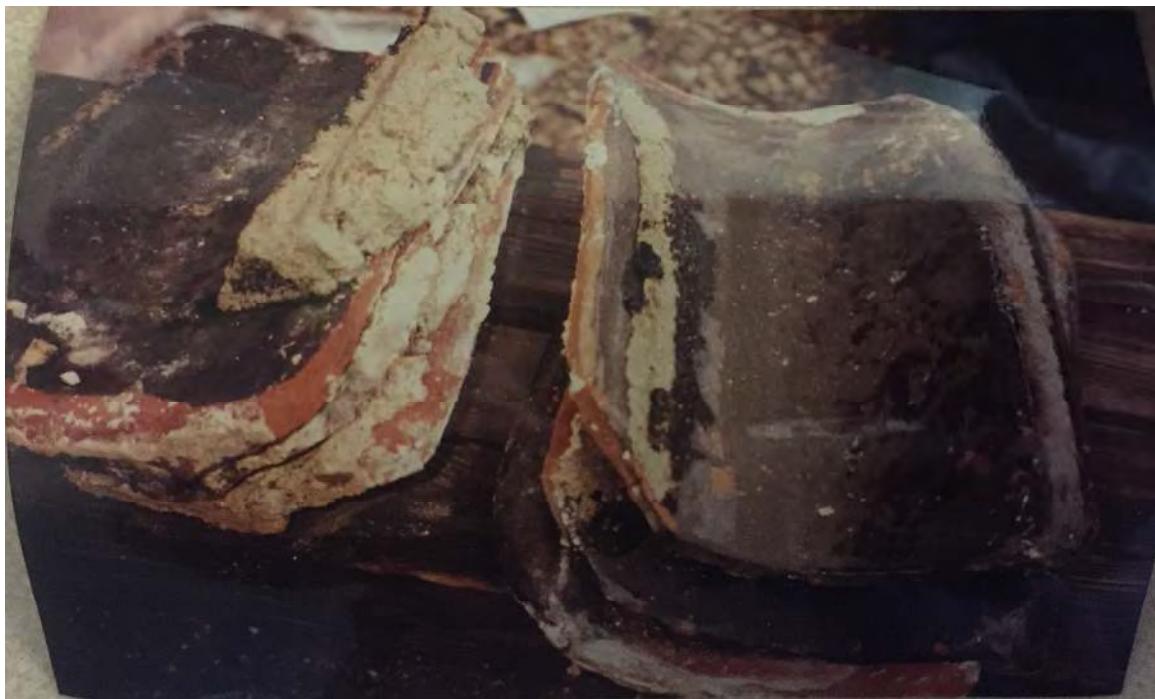
(Figure 7) Close-Up of Clay Tiles from Roof. 1995.

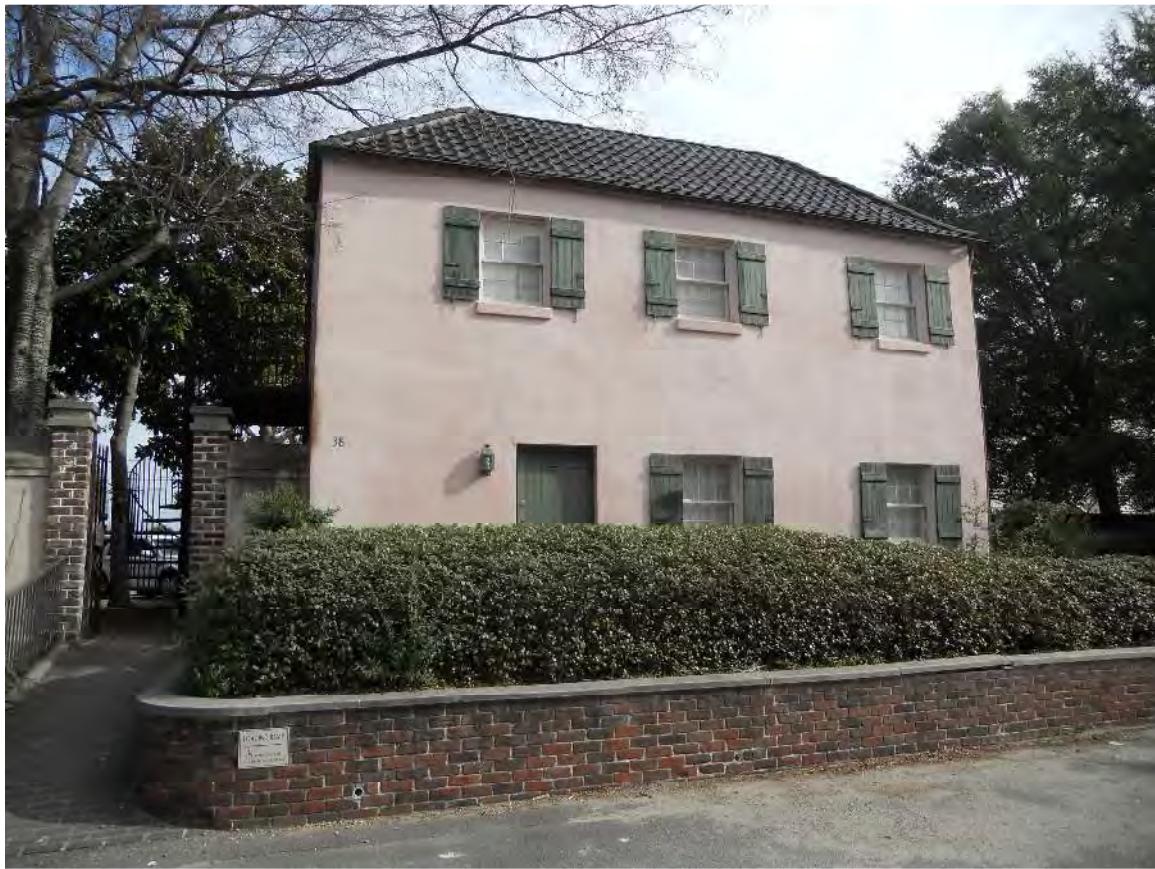
(Figure 8) Pink House board-n-batten shutters. 2014.

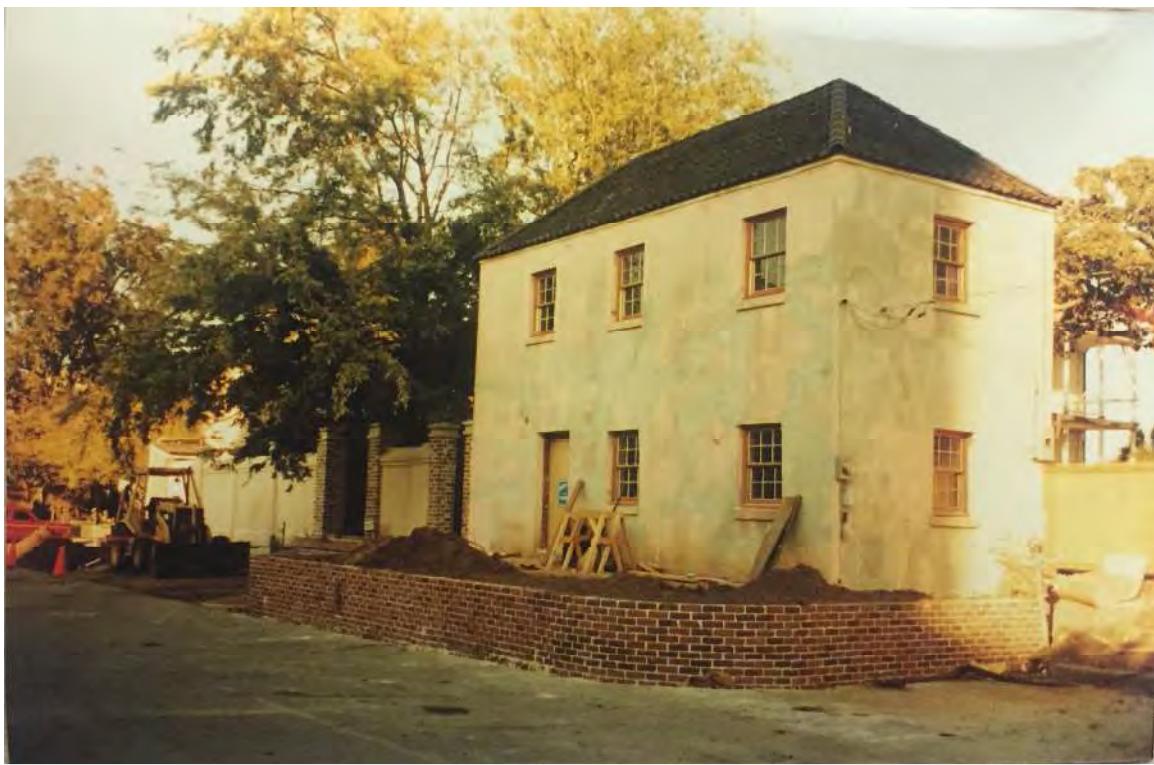
(Figure 9) Construction of new garden. November 1996.

The Pink House is a two-story brick, stuccoed building, located adjacent to the Gadsden House on Alexander Street, consisting of approximately 420 square feet.⁴⁰ The interior of the building has been altered throughout its lifespan, originally designed as slave quarters and then converted to residential and then to business spaces. The exterior has been well preserved and is in good condition. The roof is made up of clay tiles that have been preserved and reused during a large rehabilitation of the building in the mid 1990s (Fig 7).⁴¹ The Pink House has a total of seven, double-hung, six panel windows. All windows have board-and-batten shutters that have been painted forest green (Fig 8). There are three exterior doors, two on the north façade and one on the west façade. All the doors are batten style slabs that have also been painted forest green. The door on the west façade is “unusable” and leads straight out into a small raised garden and faces a parking lot. There is an iron spiral staircase and balcony on the north façade that leads up to the second floor entryway. This is one of building’s most notable features; it was added in to the house in 1996.⁴² A brick walkway leads up from the parking lot along Alexander Street to a small entranceway onto the property. The south brick/stuccoed wall on the south façade at one time was connected to the west wall, but a rehabilitation in the mid 1990s opened that wall along the Pink House north façade and the bricks were reused for the raised garden with over compacted soil on the west façade (Fig 9).⁴³

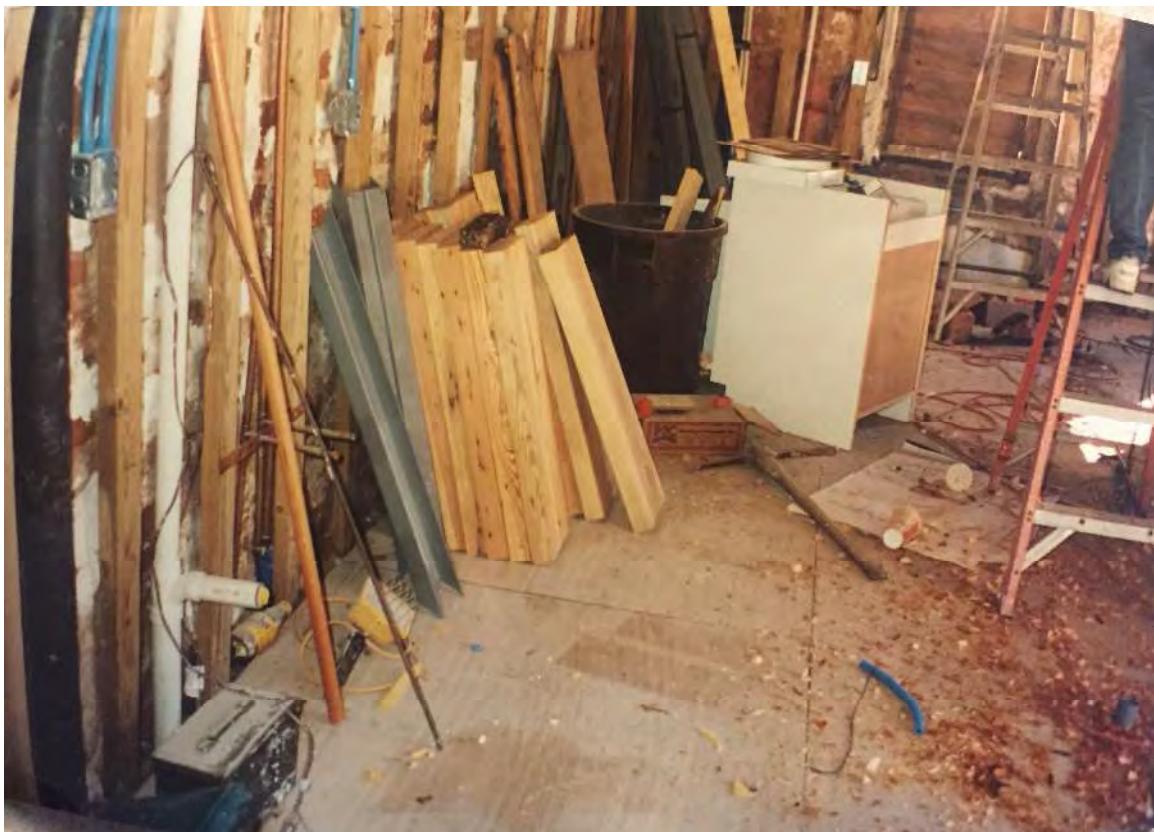
(Figure 10) New, Reused Steps for Stairs from Brewery on East Bay Street. 1996.

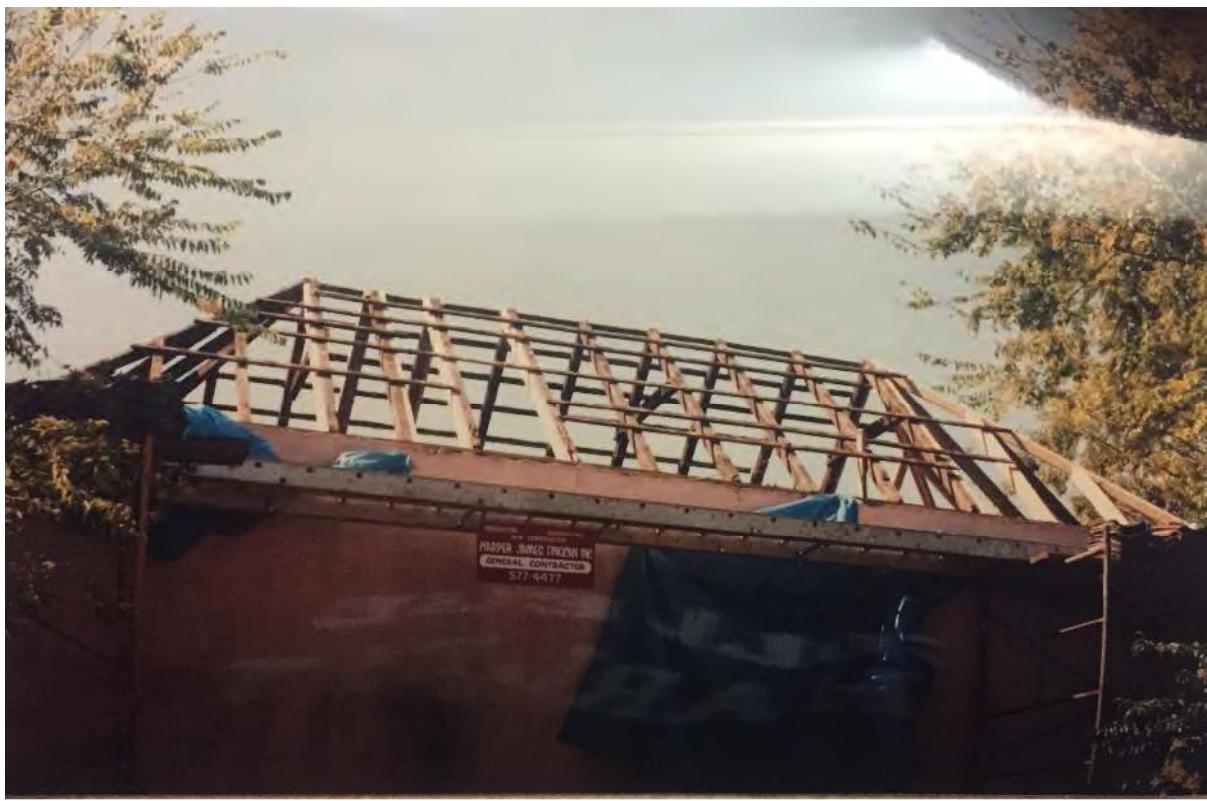
(Figure 11) Roof Repairs. 1994.

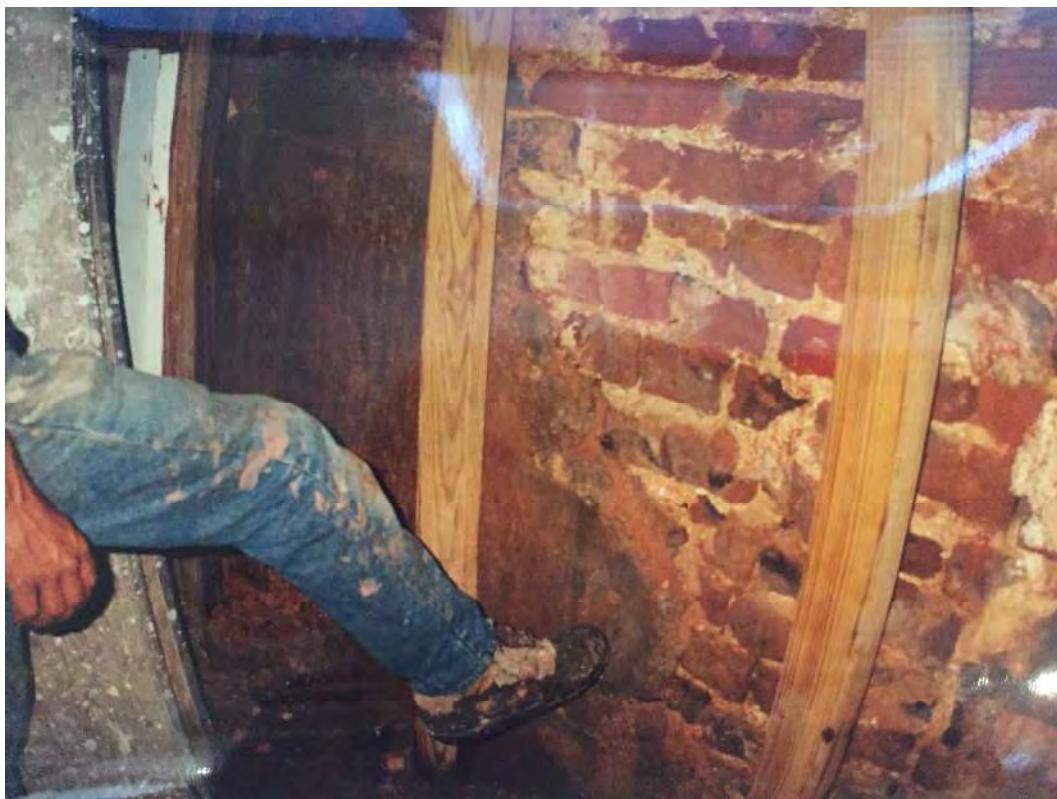
(Figure 13) "Downstairs, east wall, middle, concrete where fireplace was"

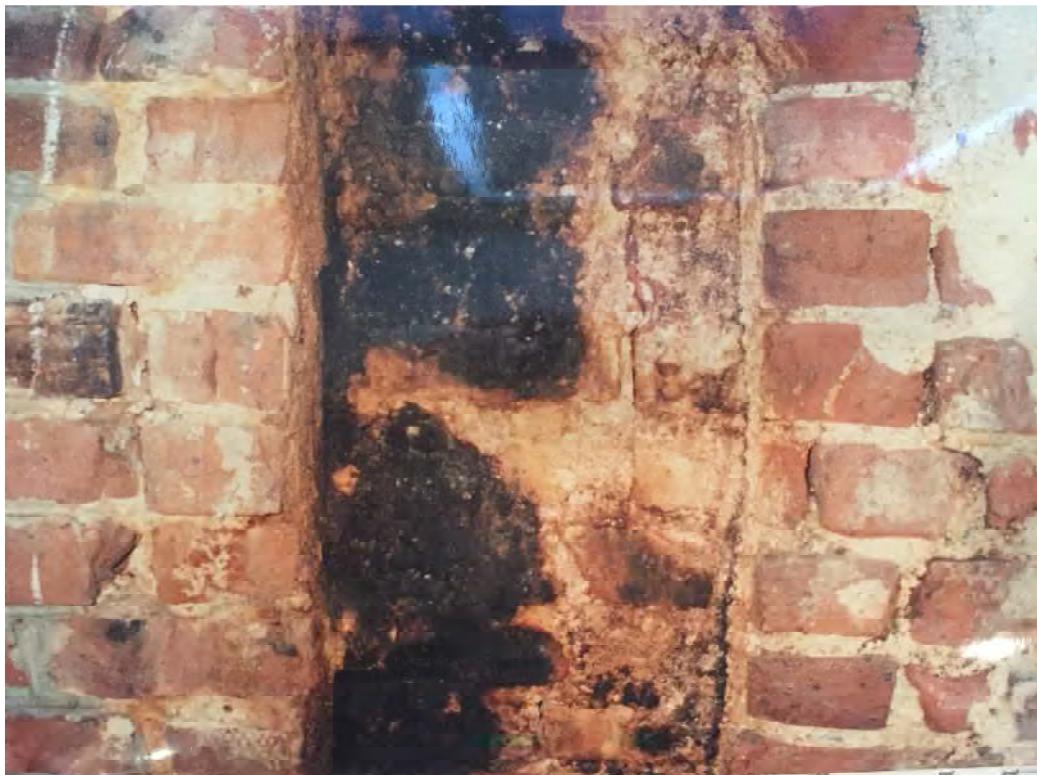
(Figure 14) "Upstairs chimney/east wall, note fire smoke stains"

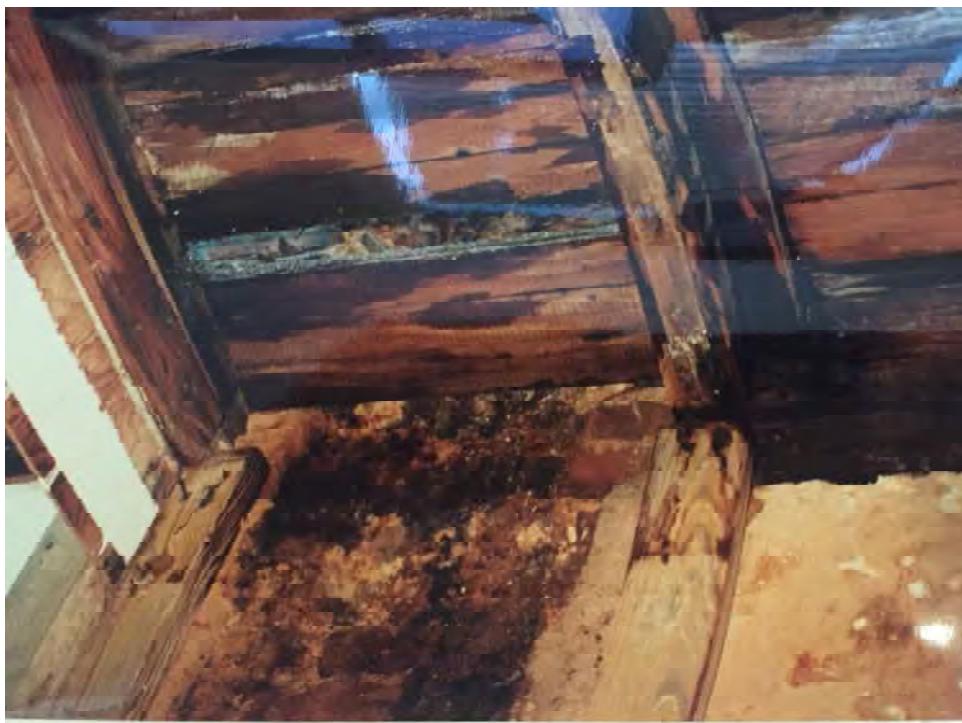
(Figure 15) “downstairs, east wall, middle, where chimney does to 2nd floor”

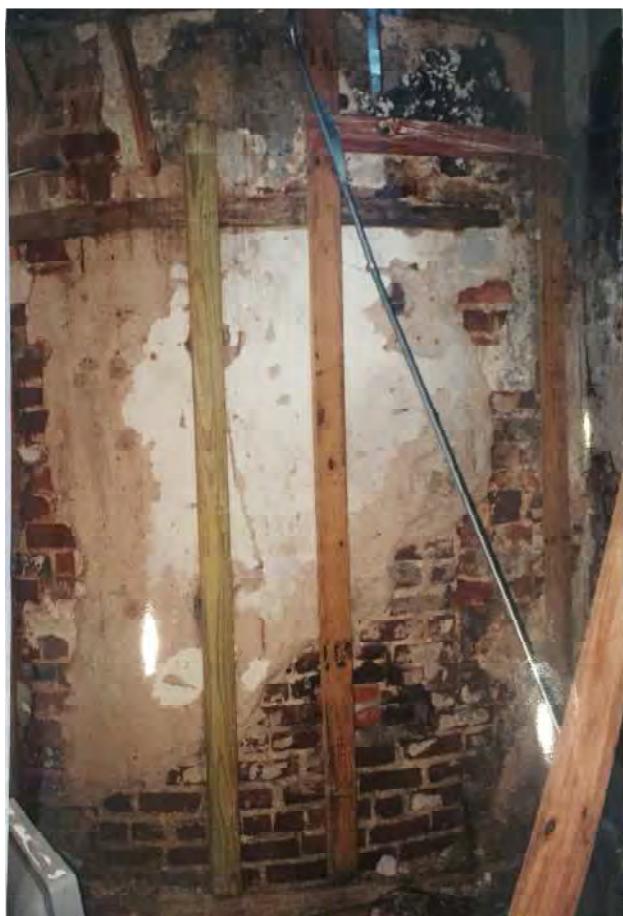
(Figure 16) “downstairs, west wall, north end, showing existence of earlier doorway”

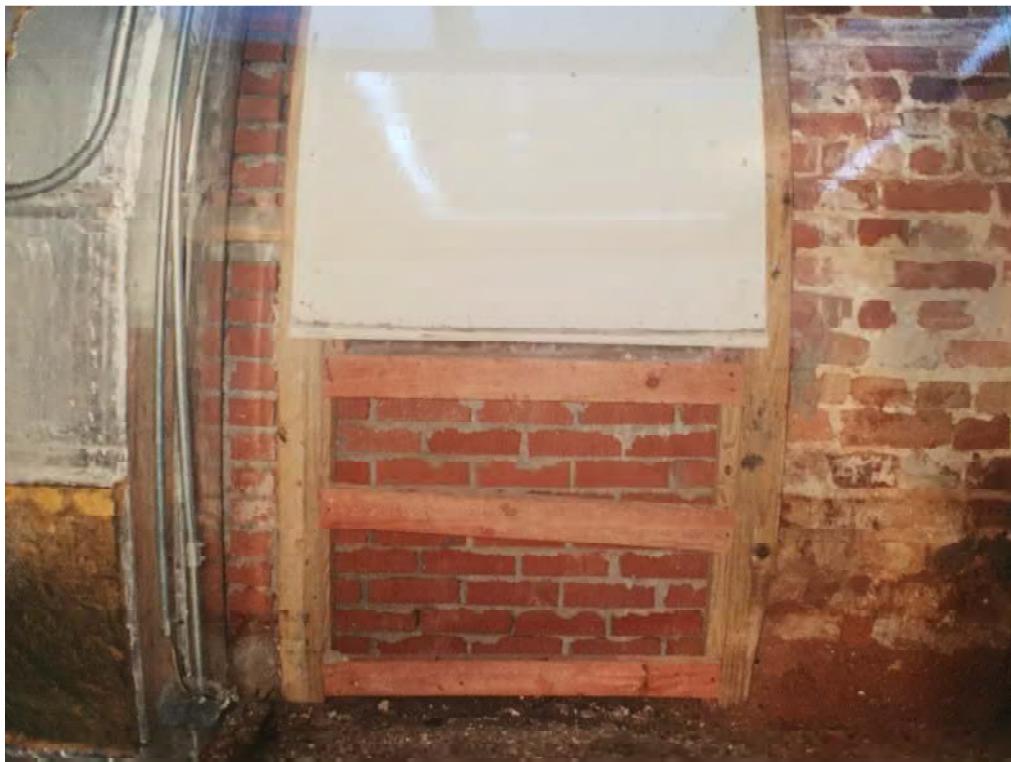
(Figure 17) "West wall, south window, showing that there was originally a doorway"

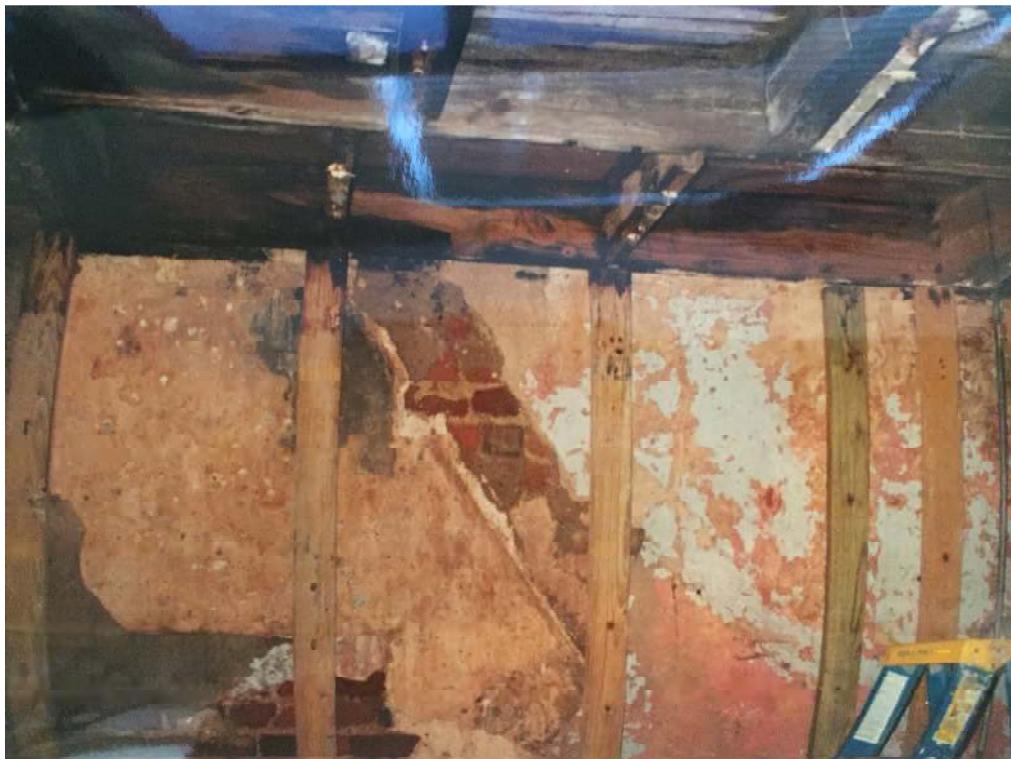
(Figure 18) "Downstairs, east wall, s. side, note original stairway"

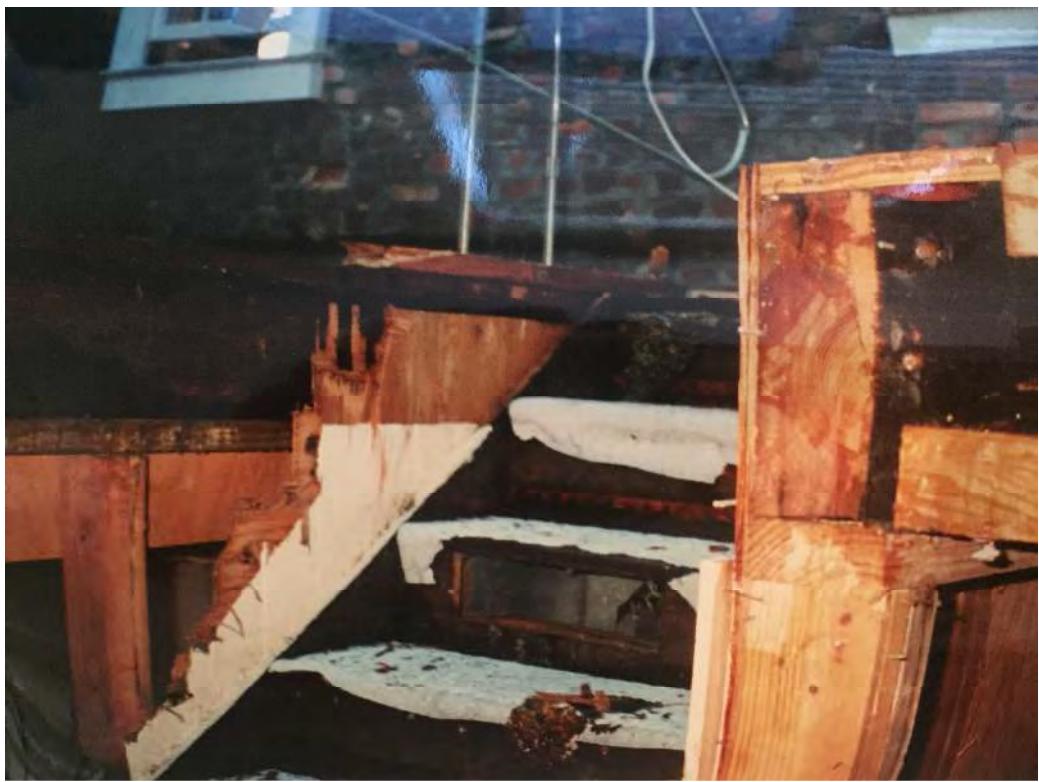
(Figure 19) "1/2 upstairs looking at west wall"

There are well-documented photos, dated October of 1995 that show the condition of the building as well as historic evidence of architectural features that were once part of the Pink House. The house, like many other houses in Charleston, suffered from significant termite damage.⁶⁷ It is also documented that there was once a fireplace on the first floor, located in the middle of the east wall (Fig 13).⁶⁸ Smoke stains are clearly shown on the wall running up from the first floor, through the floor of the second where the chimney would have been (Fig 14 and 15).⁶⁹ There is also evidence of an earlier doorway located on the first floor west wall, towards the north side (Fig 16).⁷⁰ Another photograph documents that there was also a doorway located on the west wall, towards the south side (Fig 17).⁷¹ New stairs are currently located in the same location as the original historic stairway and the original slope of the historic stairway is visible (Fig 18).⁷² Back in 1995 the stairs were leading to the second floor facing the west wall, as documented by photographic evidence (Fig 19).⁷³ On the north wall of the first floor, the

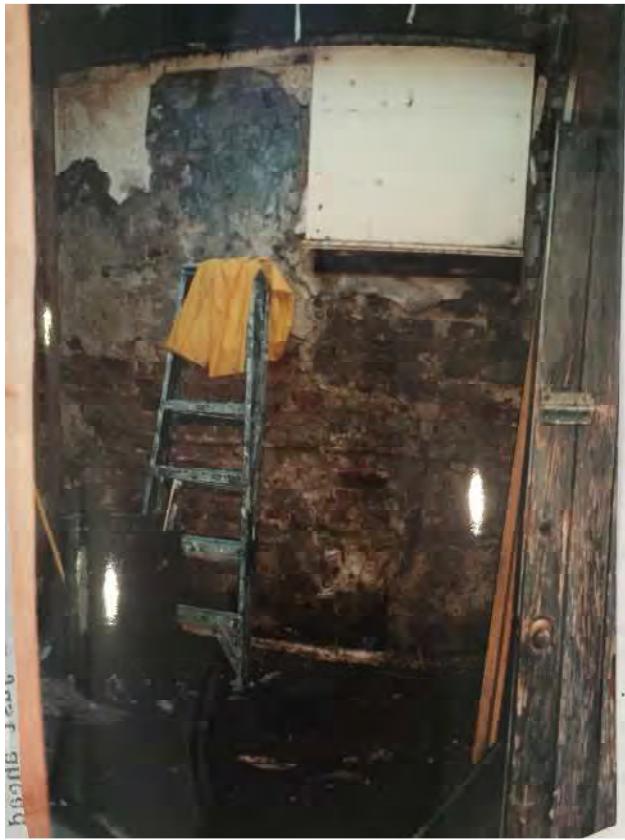
(Figure 20) "Downstairs, north wall, note window was originally much lower"

window was originally placed much lower than it is today (Fig 20).⁷⁴ The clay tiles from the roof were stripped off in October 1995 and preserved to be put back on the roof after the addition of new collar ties (Fig 21).⁷⁵

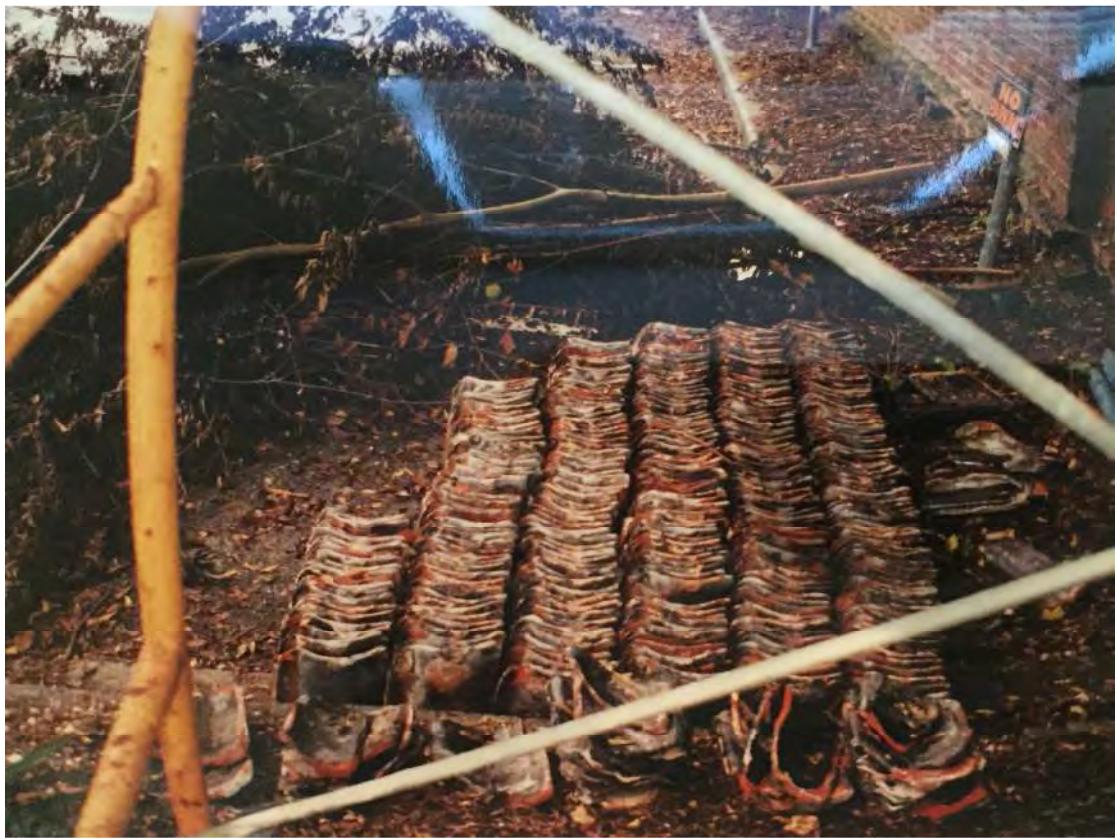
(Figure 21) "Outside/preserved tiles from roof"

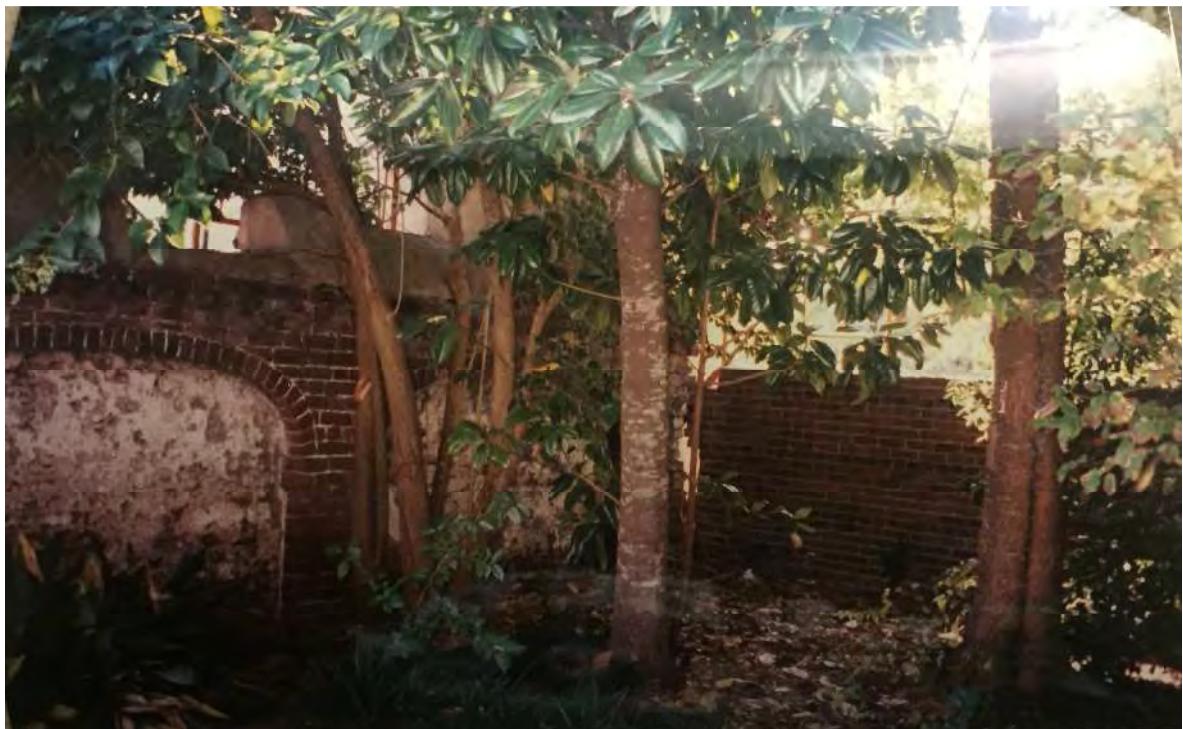
(Figure 22) Stucco/Masonry South Wall before removed for spiral stair.

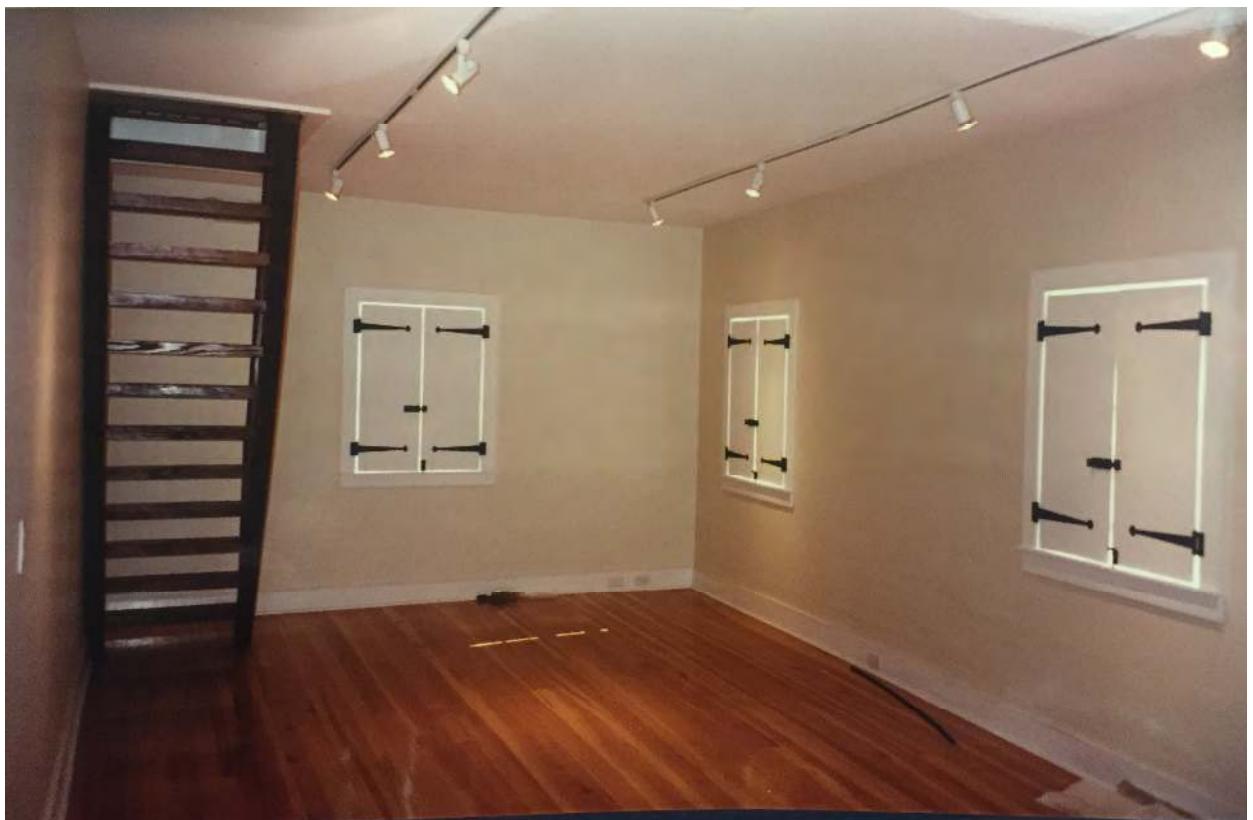
(Figure 23) First Floor Completed. 1997.

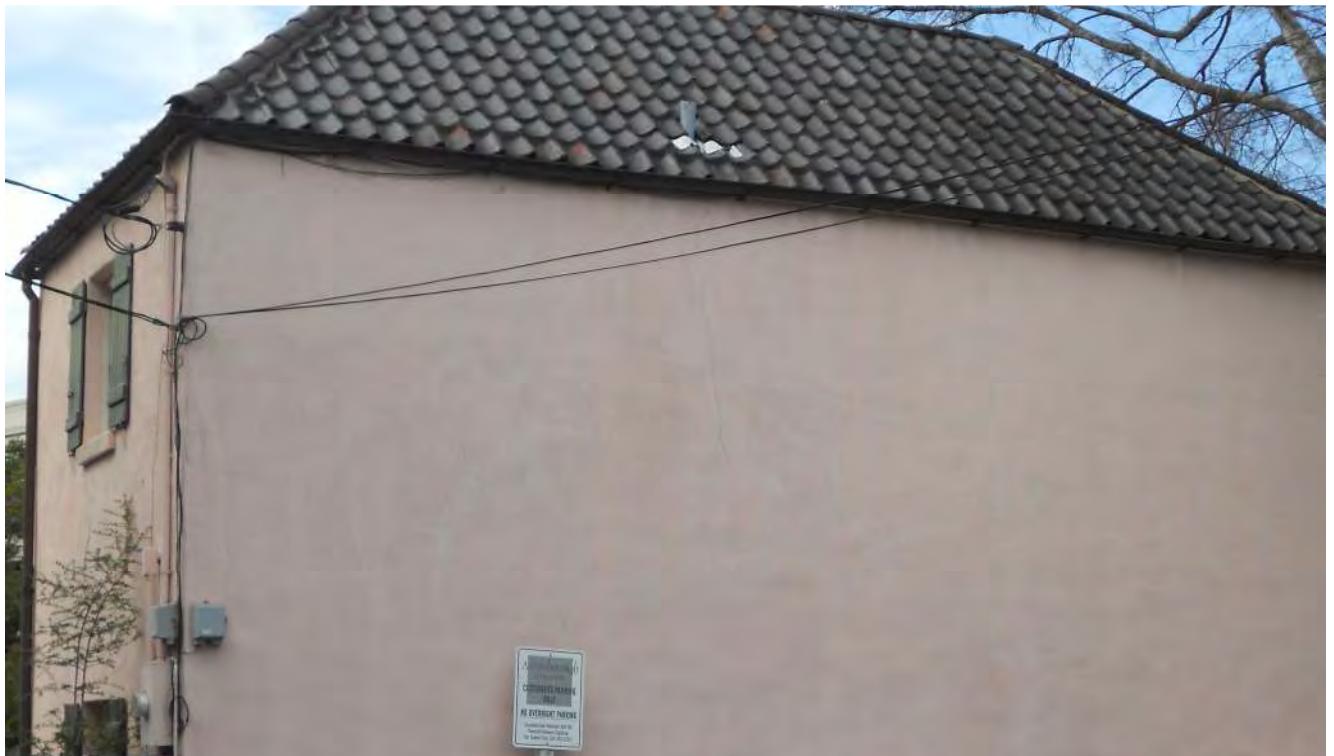
(Figure 24) Stucco On Pink House with Small Crack. 2014.

of stucco is usually determined by the color of the sand or burnt clay used in the mix as well as tinted by natural pigments and also surface whitewashed or color-washed after the application was completed.⁹⁸ One or more of these give the Pink House its historic, nickname worthy bright pick color. Regular maintenance of stucco is very important. Stucco should be whitewashed annually because the whitewash helps to harden the stucco coats and fill hairline cracks before they can become larger and let moisture into the building.⁹⁹ Oil mastics and paraffin, a type of wax, were also used to help improve the water repellency of stucco structures.¹⁰⁰ Today, the stucco coat on the Pink House is in good condition with minor cracks (Fig 24). It should be cleaned regularly and monitored.

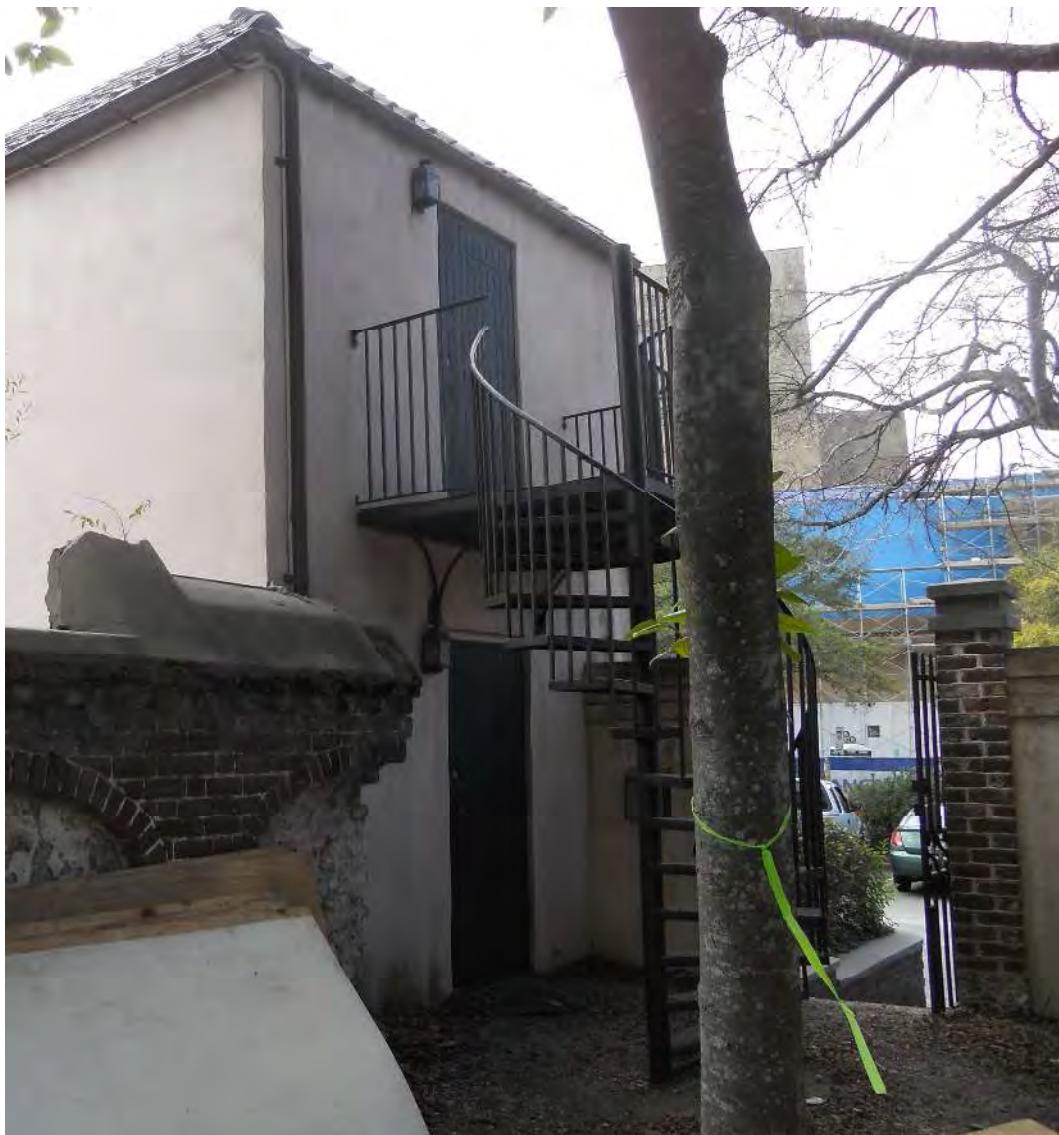
(Figure 25) Iron Spiral Staircase, North Façade. 2014

The iron spiral staircase is one of the Pink House's most notable elements. Structural failures, broken joints, badly rusted elements and impact damage are all typical issues with iron construction.¹⁰¹ Regular inspections, that ideally take place biannually in the fall and spring, should preclude any major or minor problems.¹⁰² One of the most important preservation efforts with respect to iron is to control corrosion and note rusting as soon as possible to take proper action.¹⁰³ Before selecting a cleaning method or paint removal method, test panels should be done on the iron to determine the effectiveness of the technique used.¹⁰⁴ Cleaning techniques are most likely to reveal additional corrosion, cracks, and coating defects that would not have been obvious before.¹⁰⁵ The most common and least expensive methods of removing paint and light rust from iron are wire brushing, hand scrapping, and chipping.¹⁰⁶ Newly cleaned iron should be painted right away with a corrosion-inhibiting primer before new rust can start to form.¹⁰⁷ The iron staircase at the Pink House is in good condition today, but should be monitored for regular cleaning and maintenance (Fig 25).
