Historic Charleston Mortar and Stucco Study

An Analysis of Materials and Compositions

September, 1989

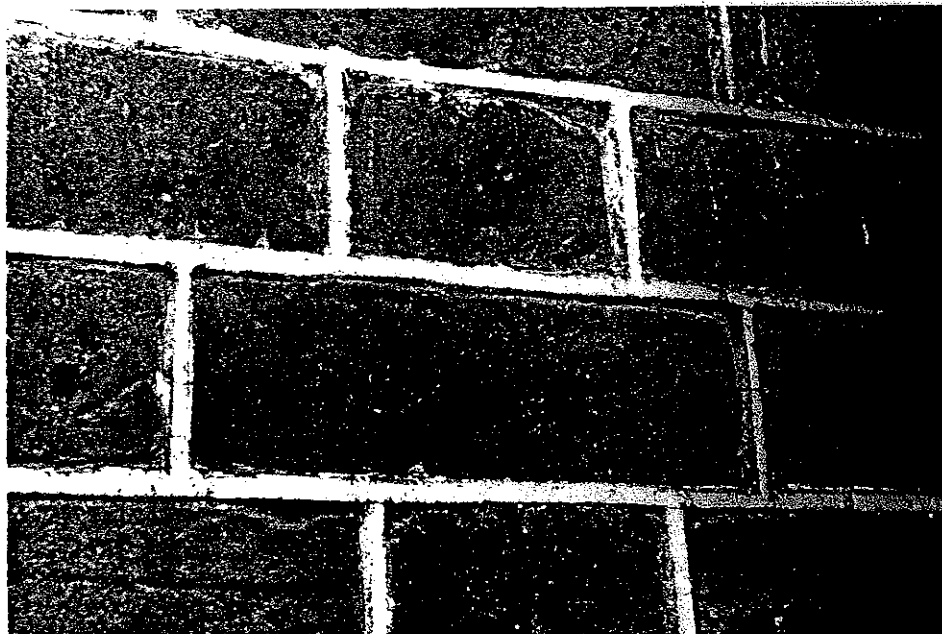
Illustrations 1 and 2. The appearance of a regular geometry in eighteenth and nineteenth century masonry is produced by the fine tooling of the mortar joints. A close examination of the masonry reveals that the bricks are actually somewhat irregular. The white lime mortar was very plastic when freshly mixed, and was easily tooled and shaped to form the various joint profiles. Shown here is an example of ribbon joint tooling from the first quarter of the nineteenth century.

The masonry construction techniques and styles of Charleston's historic buildings are quite broad (Illustrations 1 through 10). Just as the architectural styles of the buildings vary, so do the mortars and stuccoes. A pointing mortar mix of the early eighteenth century may well be inappropriate for the repair of a masonry structure of the early nineteenth century. This is often confusing to the builder, owner or architect, for the mortars, upon close examination, appear to be indistinguishable from one another. But the distinction between the various mortars and stuccoes is an important factor in the preservation of historic structures. Beyond the important cosmetic function of pointing mortars and finish stuccoes are their mechanical functions of moisture dissipation and stress absorption. If a change is made in the original relationship between the masonry units and the mortar or stucco the principal purpose of the mortar and stucco may be compromised. Historically, the design of the mortar and stucco of a masonry system ensured that these materials were significantly more porous and plastic than the bricks. The purpose of this relationship was to allow all of the deterioration processes to be concentrated in those materials which were the easiest to maintain. The periodic repair of pointing mortar and stucco is considered

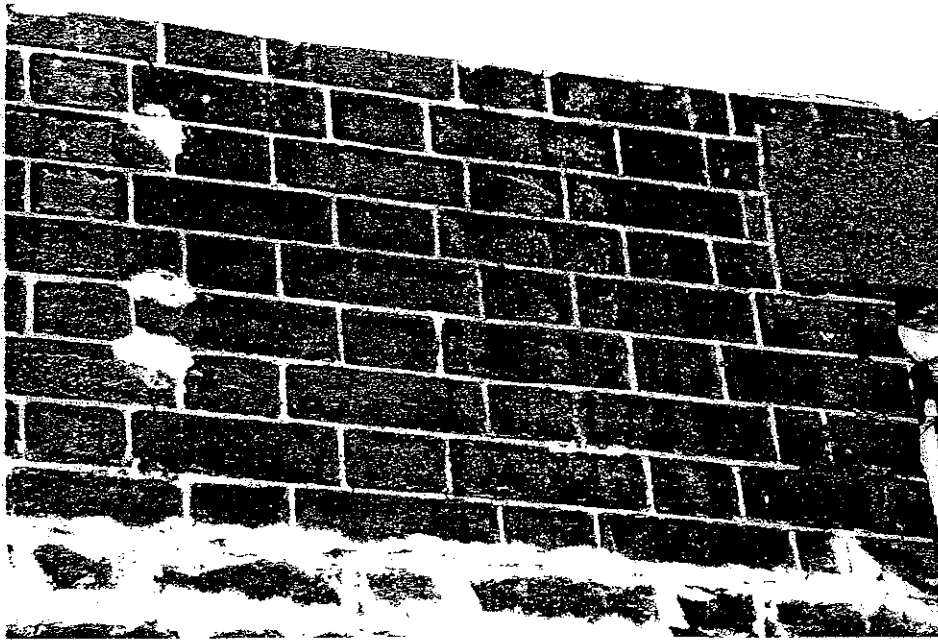
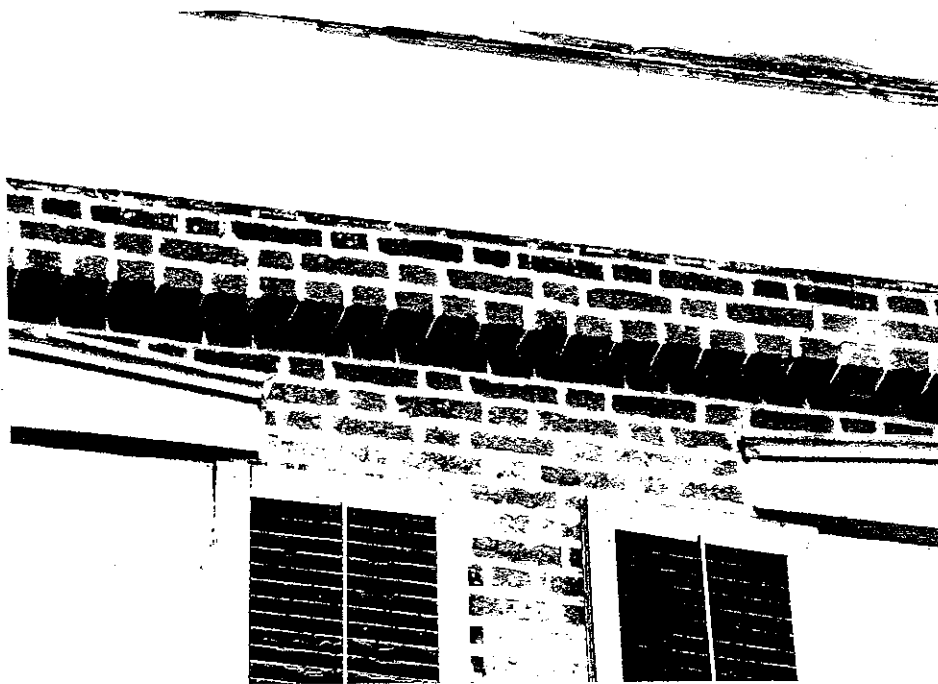
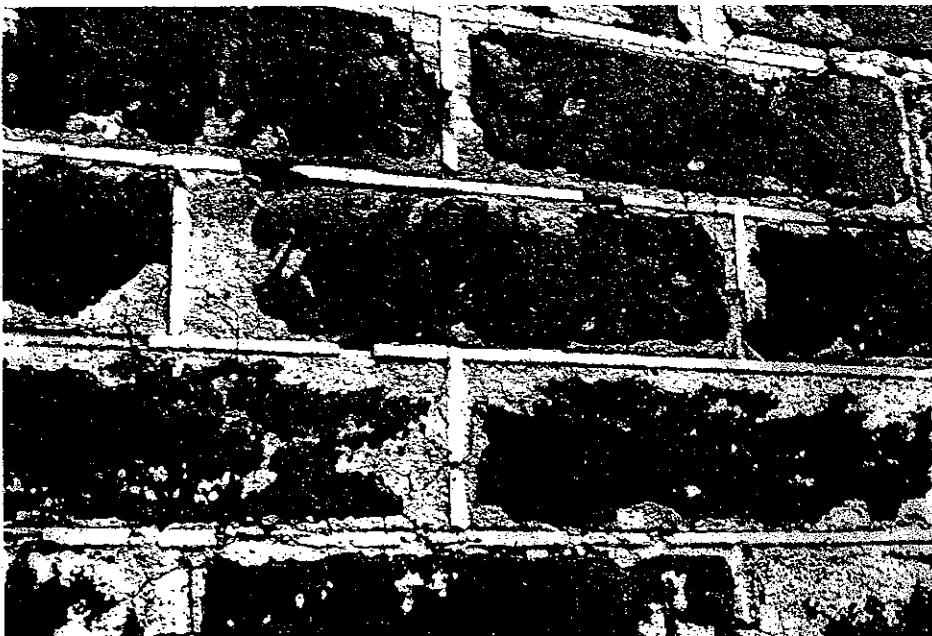
Illustrations 3, 4 and 5. The appearance of a very regular geometry could be achieved by several techniques. Above, at 9 Limehouse Street, a natural cement mortar similar in color to the bricks was applied in a flush joint. The white lime "mortar joints" were painted in, or pencilled. From a distance, this created the appearance of finely tooled mortar joints. At center, at 9 East Battery, a combination of the techniques shown in Illustrations 2 and 3 was employed. The masonry was pointed with a lime mortar finished with a ribbon joint. The uneven edges of the bricks were hidden by rubbing a brick-colored mortar into the space between the brick edges and the white mortar. Below, at 16 Charlotte Street, is an example of tuck pointing. The finished appearance of this masonry is very similar to that of the example at center. The technique of tuck pointing, though, is somewhat more refined. The mortar joint was first filled flush with a brick-color, pigmented mortar. The surface of the mortar was then scored and then a fine bead of a white lime mortar was stencilled into the score line.

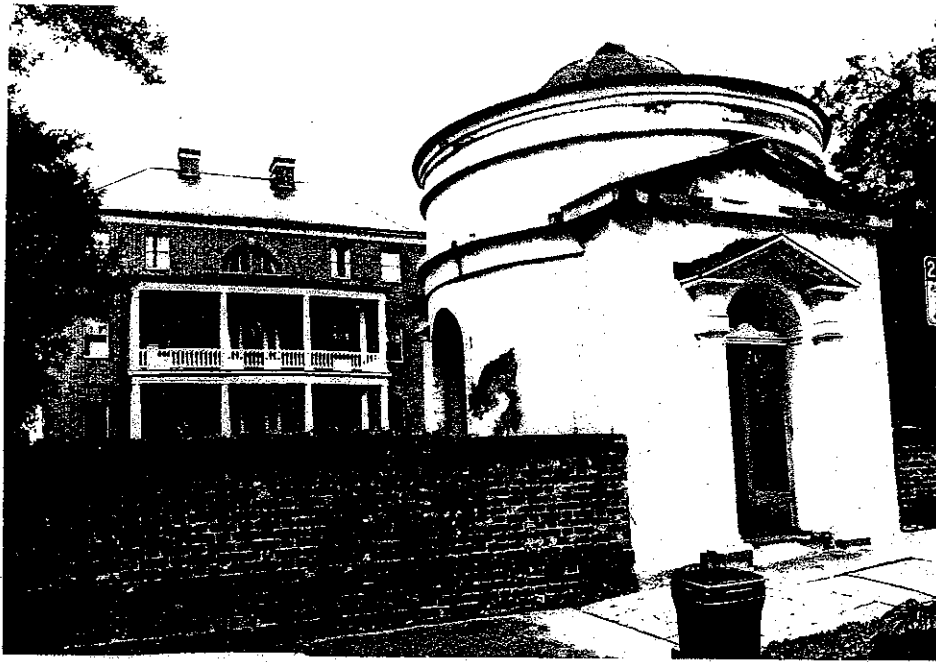
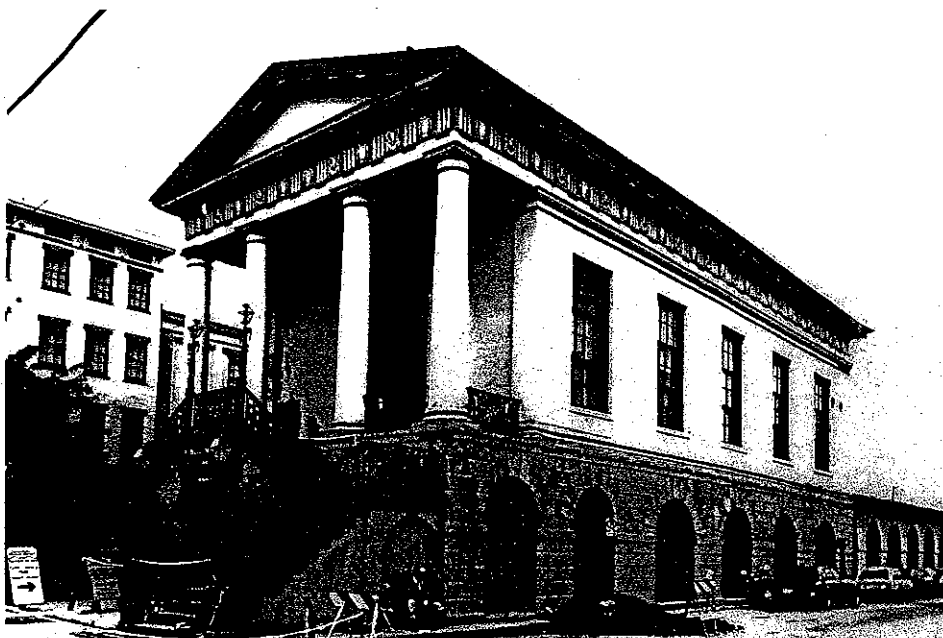
Illustrations 6, 7 and 8. Stucco has been an important finish for Charleston's historic buildings. It was typically used to imitate ashlar stone construction and molded stone elements, such as quoins, cornices and architraves. Many buildings of exposed brick construction were later stuccoed to conceal new additions or repairs. At top is the Manigault gate house on Meeting Street. The unpainted original lime stucco is intact above the level of the splash zone. From the courtyard of the Aiken-Rhett House, at center, can be seen the principal additions to the originally exposed-brick residence. The 1830's addition of the wing at left and the 1850's addition of the art gallery at the far right fall within the transition period when the natural cement stuccoes were beginning to replace the lime stuccoes. Both of these additions, as well as the original portions of the house, were stuccoed with the natural cement stuccoes. The 1841 City Market, at bottom, is an example of the full use of a natural cement stucco. The cornice and capitals of the Market were cut from brownstone. The stucco used on all other elements of the building was formulated to match both the color and texture of the stone. Because of its durability the stucco did not require painting.

cement stuccoes were used on many Charleston buildings from the 1830's until the late nineteenth century, the most notable examples being St. Philip's Church and the City Market (Illustration 8).

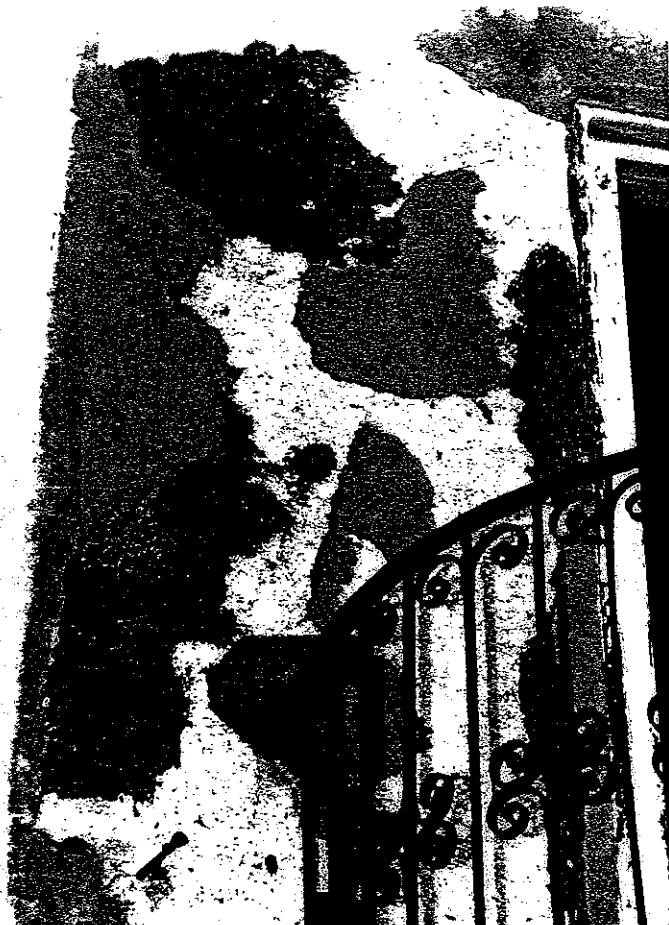
Illustrations 9 and 10. Above is an example of the full history of the stucco materials used in the eighteenth and nineteenth centuries. The original white lime stucco has been repaired several times, first with natural cement stuccoes, seen as the dark patches, and more recently with Portland cement stuccoes, seen as the medium grey patches. It is interesting to note that the lime and natural cement stuccoes are weathering at similar rates, indicating that the two materials have similar porosity characteristics. The Portland cement stucco is somewhat more dense, as indicated by the more rapid deterioration of the surrounding lime stucco. Below is a micrograph of a nineteenth century lime stucco. The oyster shell lime used in the lime stucco mixes in Charleston was generally non-hydraulic. One way of producing this quality in the stucco was to add crushed and ground brick to the mix. In this sample the particles of brick are the medium and dark particles. The lumps of white are ground oyster shell added to "seed" the mix with calcium carbonate.
